SUBJECT: Corrosion Studies Report, Dezadeash Lake Area, Haines-Fairbanks POL

CONTENTS

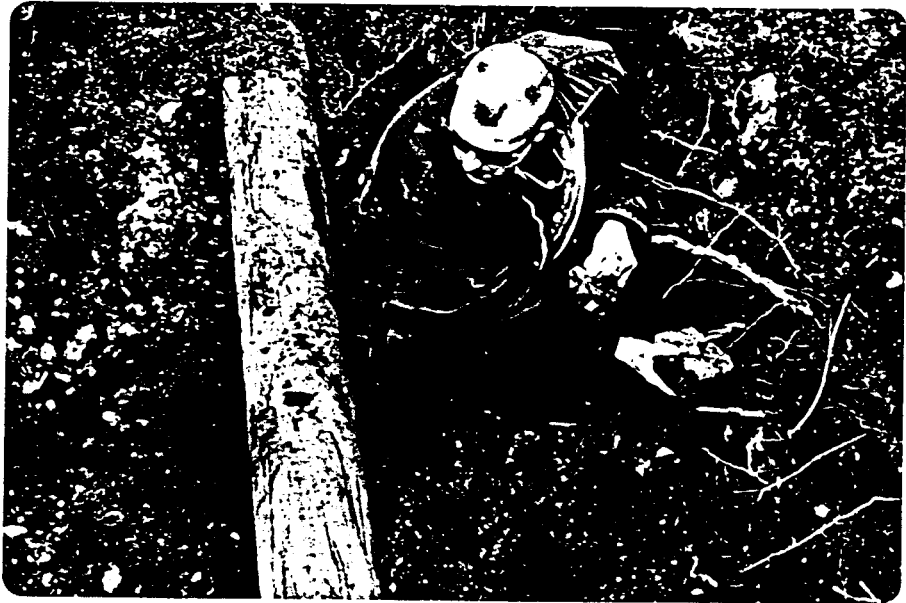
Photo #3

Shows an area uncovered at approximately Mile Post 119.06.
The fill material around the pipe is generally sandy gravel
and corrosion in this particular area is relatively negligible.

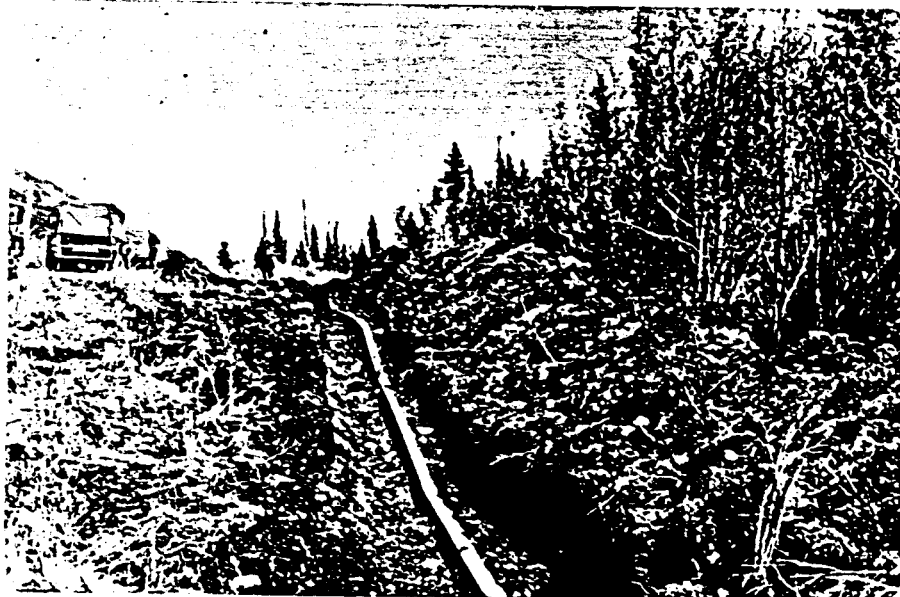
Photo #5

The above photo shows the uncovered petroleum line from approximate Mile Post 119.7 to Mile Post 119.11. This section of the line contains many localized areas of corrosion. The corroded areas were concentrated where varnish has been removed from the original pipe and where fine grain soils existed adjacent to the pipe. Generally the severe corrosion occurred on a horizontal line approximately 90° from the bottom of the pipe and on areas where the varnish had been removed by normal welding procedures.

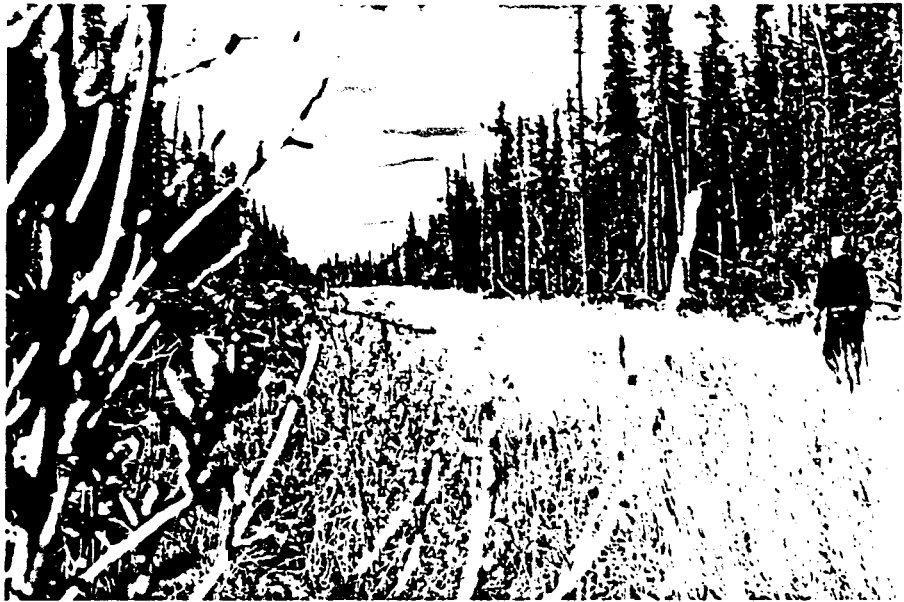
Photo #7

This photo taken at pipeline Mile Post 122 shows well drained soils with the pipe line laying on a thin bed of muskeg. No excessive corrosion was noted where the topography such as is shown above existed.

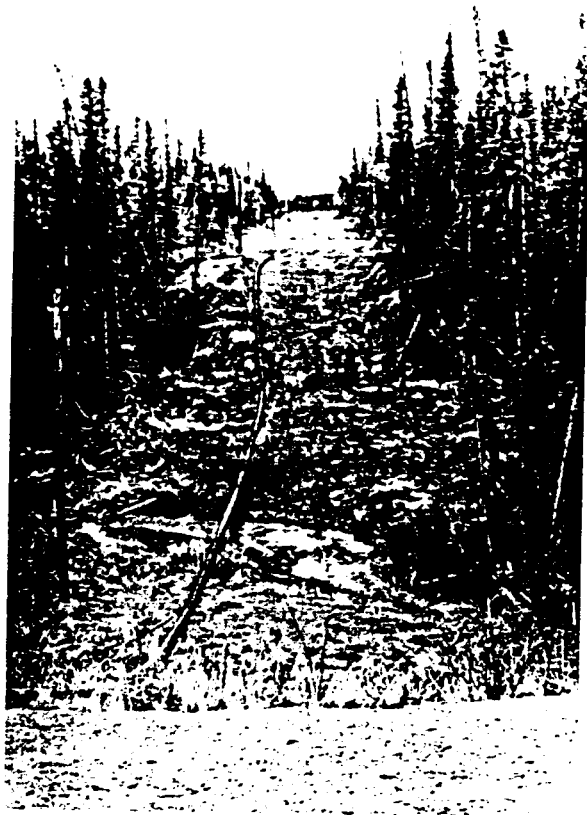
Photo #8

Soil conditions in this stream crossing at Mile Post 122.8 are generally gravelly in nature. It is doubtful that the waters of this particular stream are corrosive. A short section of line found imbedded in the gravels below the flowing water showed little or no deterioration.

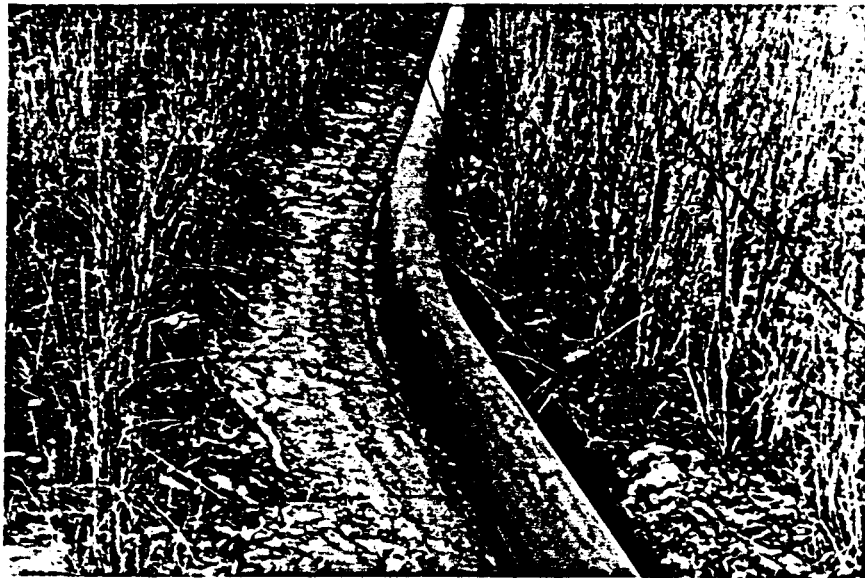
Photo #9

Line movement such as is shown in the above photo contributes to pitting if the soil conditions are favorable for corrosion. A slight film of rust removed from the pipe is shown below and adjacent to the left hand side of the pipe. No excessive corrosion was noted in this particular area.
