**VENUS MINE TAILINGS**

**Study of Remedial Options**

MARCH 1994

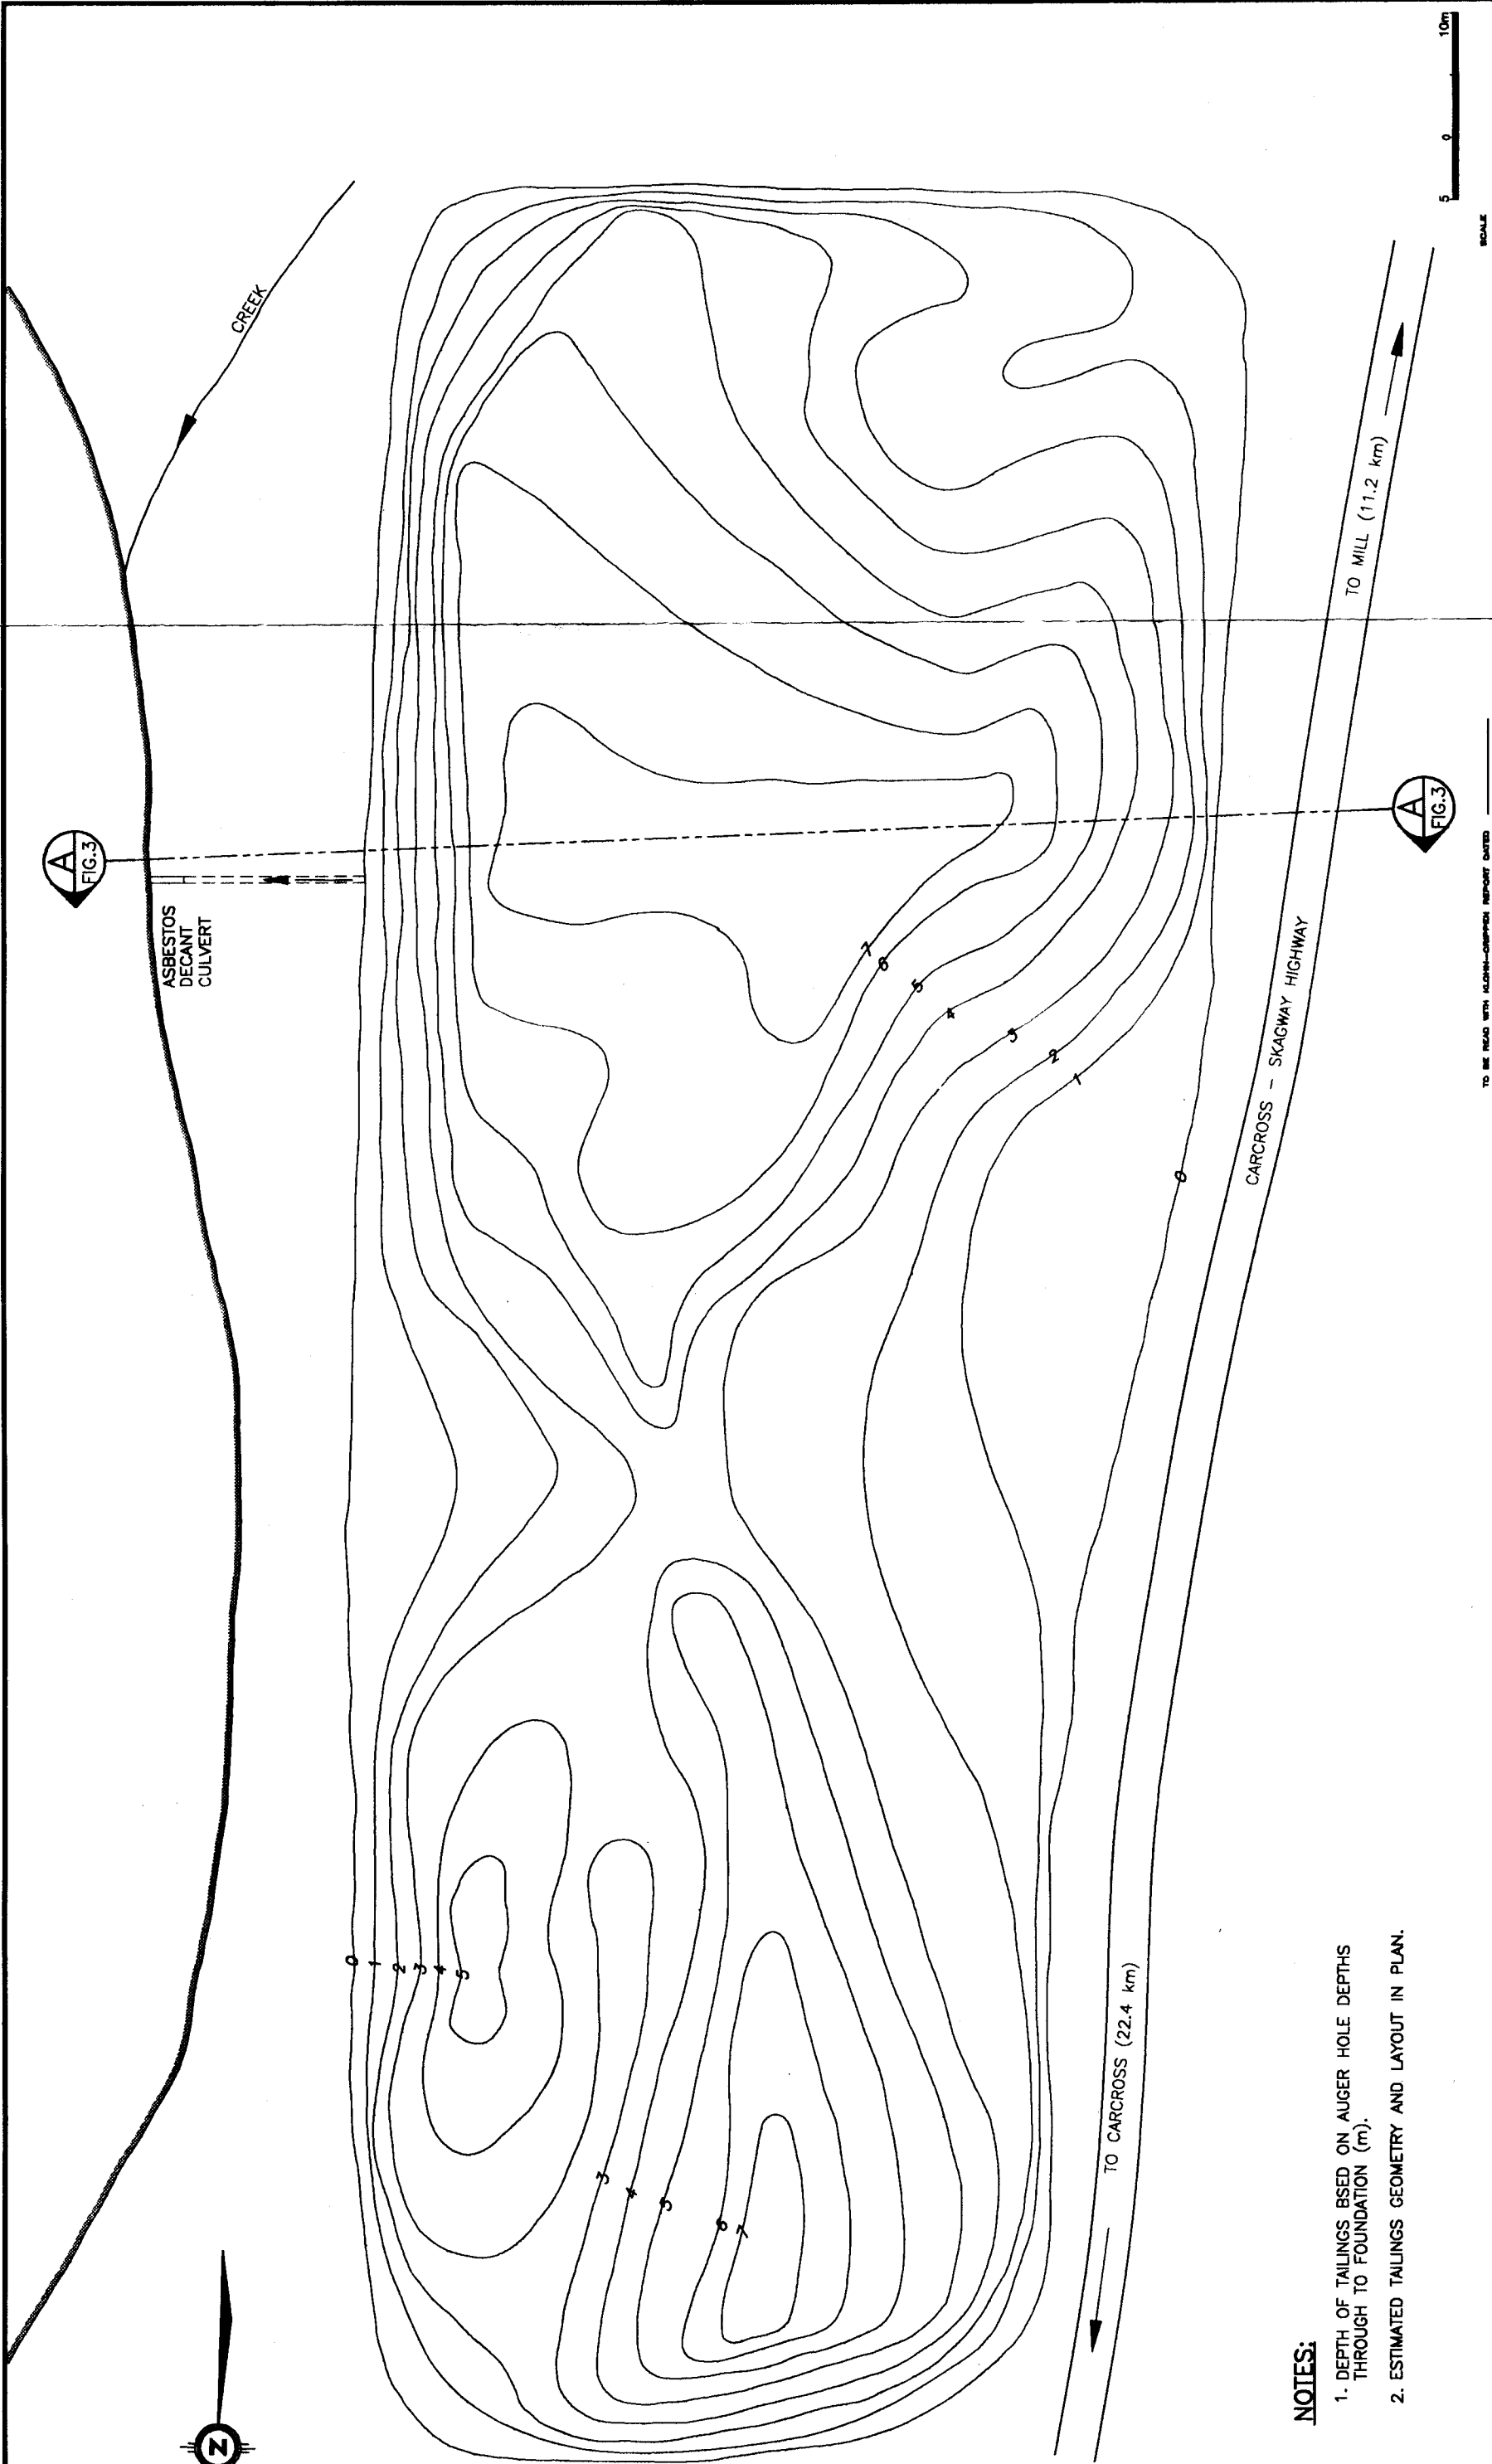
VENUS MINE TAILINGS STUDY				
DESIGNED	BP	MAR.94							
DRAWN	CYW	MAR.94							
CHECKED									
RECOMMENDED									
APPROVED									
CLIENT			'OLD' VENUS MINE TAILINGS SITE DEPTH CONTOURS						
DATE OF ISSUE			PROJECT NO.		DRAWING NO.		FIGURE NO.		
			PR6535 01				FIGURE 2		
REV:

Approximately 57,000 to 60,000 tons (51 700 to 54 400 tonnes) of tailings were placed, of which approximately 400 tons (360 tonnes) were removed in the early 1980s. An upper limit estimate of the amount of tailings stored is 60,000 tons (54 400 tonnes).

Observations made during the site visit indicate that some volume of tailings has also been eroded into the lake from the south-east corner of the site. An excavation through the perimeter dike was made to allow easy access for removal of tailings as discussed. The dike excavation permits the erosion and transport of the fine material during periods of intense runoff, such as storms and spring melt. The result is that an unknown volume of tailings may now exist in the lake further reducing the tonnage presently at the site.

Figure 2 illustrates the observed depth of the tailings as recorded during the auger sampling campaign. Analysis of samples at various depths in each of the 22 holes lead to a reported overall precious metal grade (UKHM) for the tailings of 0.09 oz/ton Au (gold) and 1.31 oz/ton Ag (silver). It was observed that some holes had a sufficiently low grade at depth to make them unattractive for reprocessing. Therefore, the total amount of tailings for reprocessing is reported as roughly 36,800 tons (33 400 tonnes). A volume calculation using the depth of tailings with the UKHM cutoff grade yielded a volume of 22 100 m<sup>3</sup>. At a density of 1.4 tonnes/m<sup>3</sup> the amount of tailings above that cutoff is calculated to be 34,100 tons (30 100 tonnes). A reprocess amount of 33 000 tonnes has been assumed for the evaluation of option 2b, using the grades specified by UKHM.

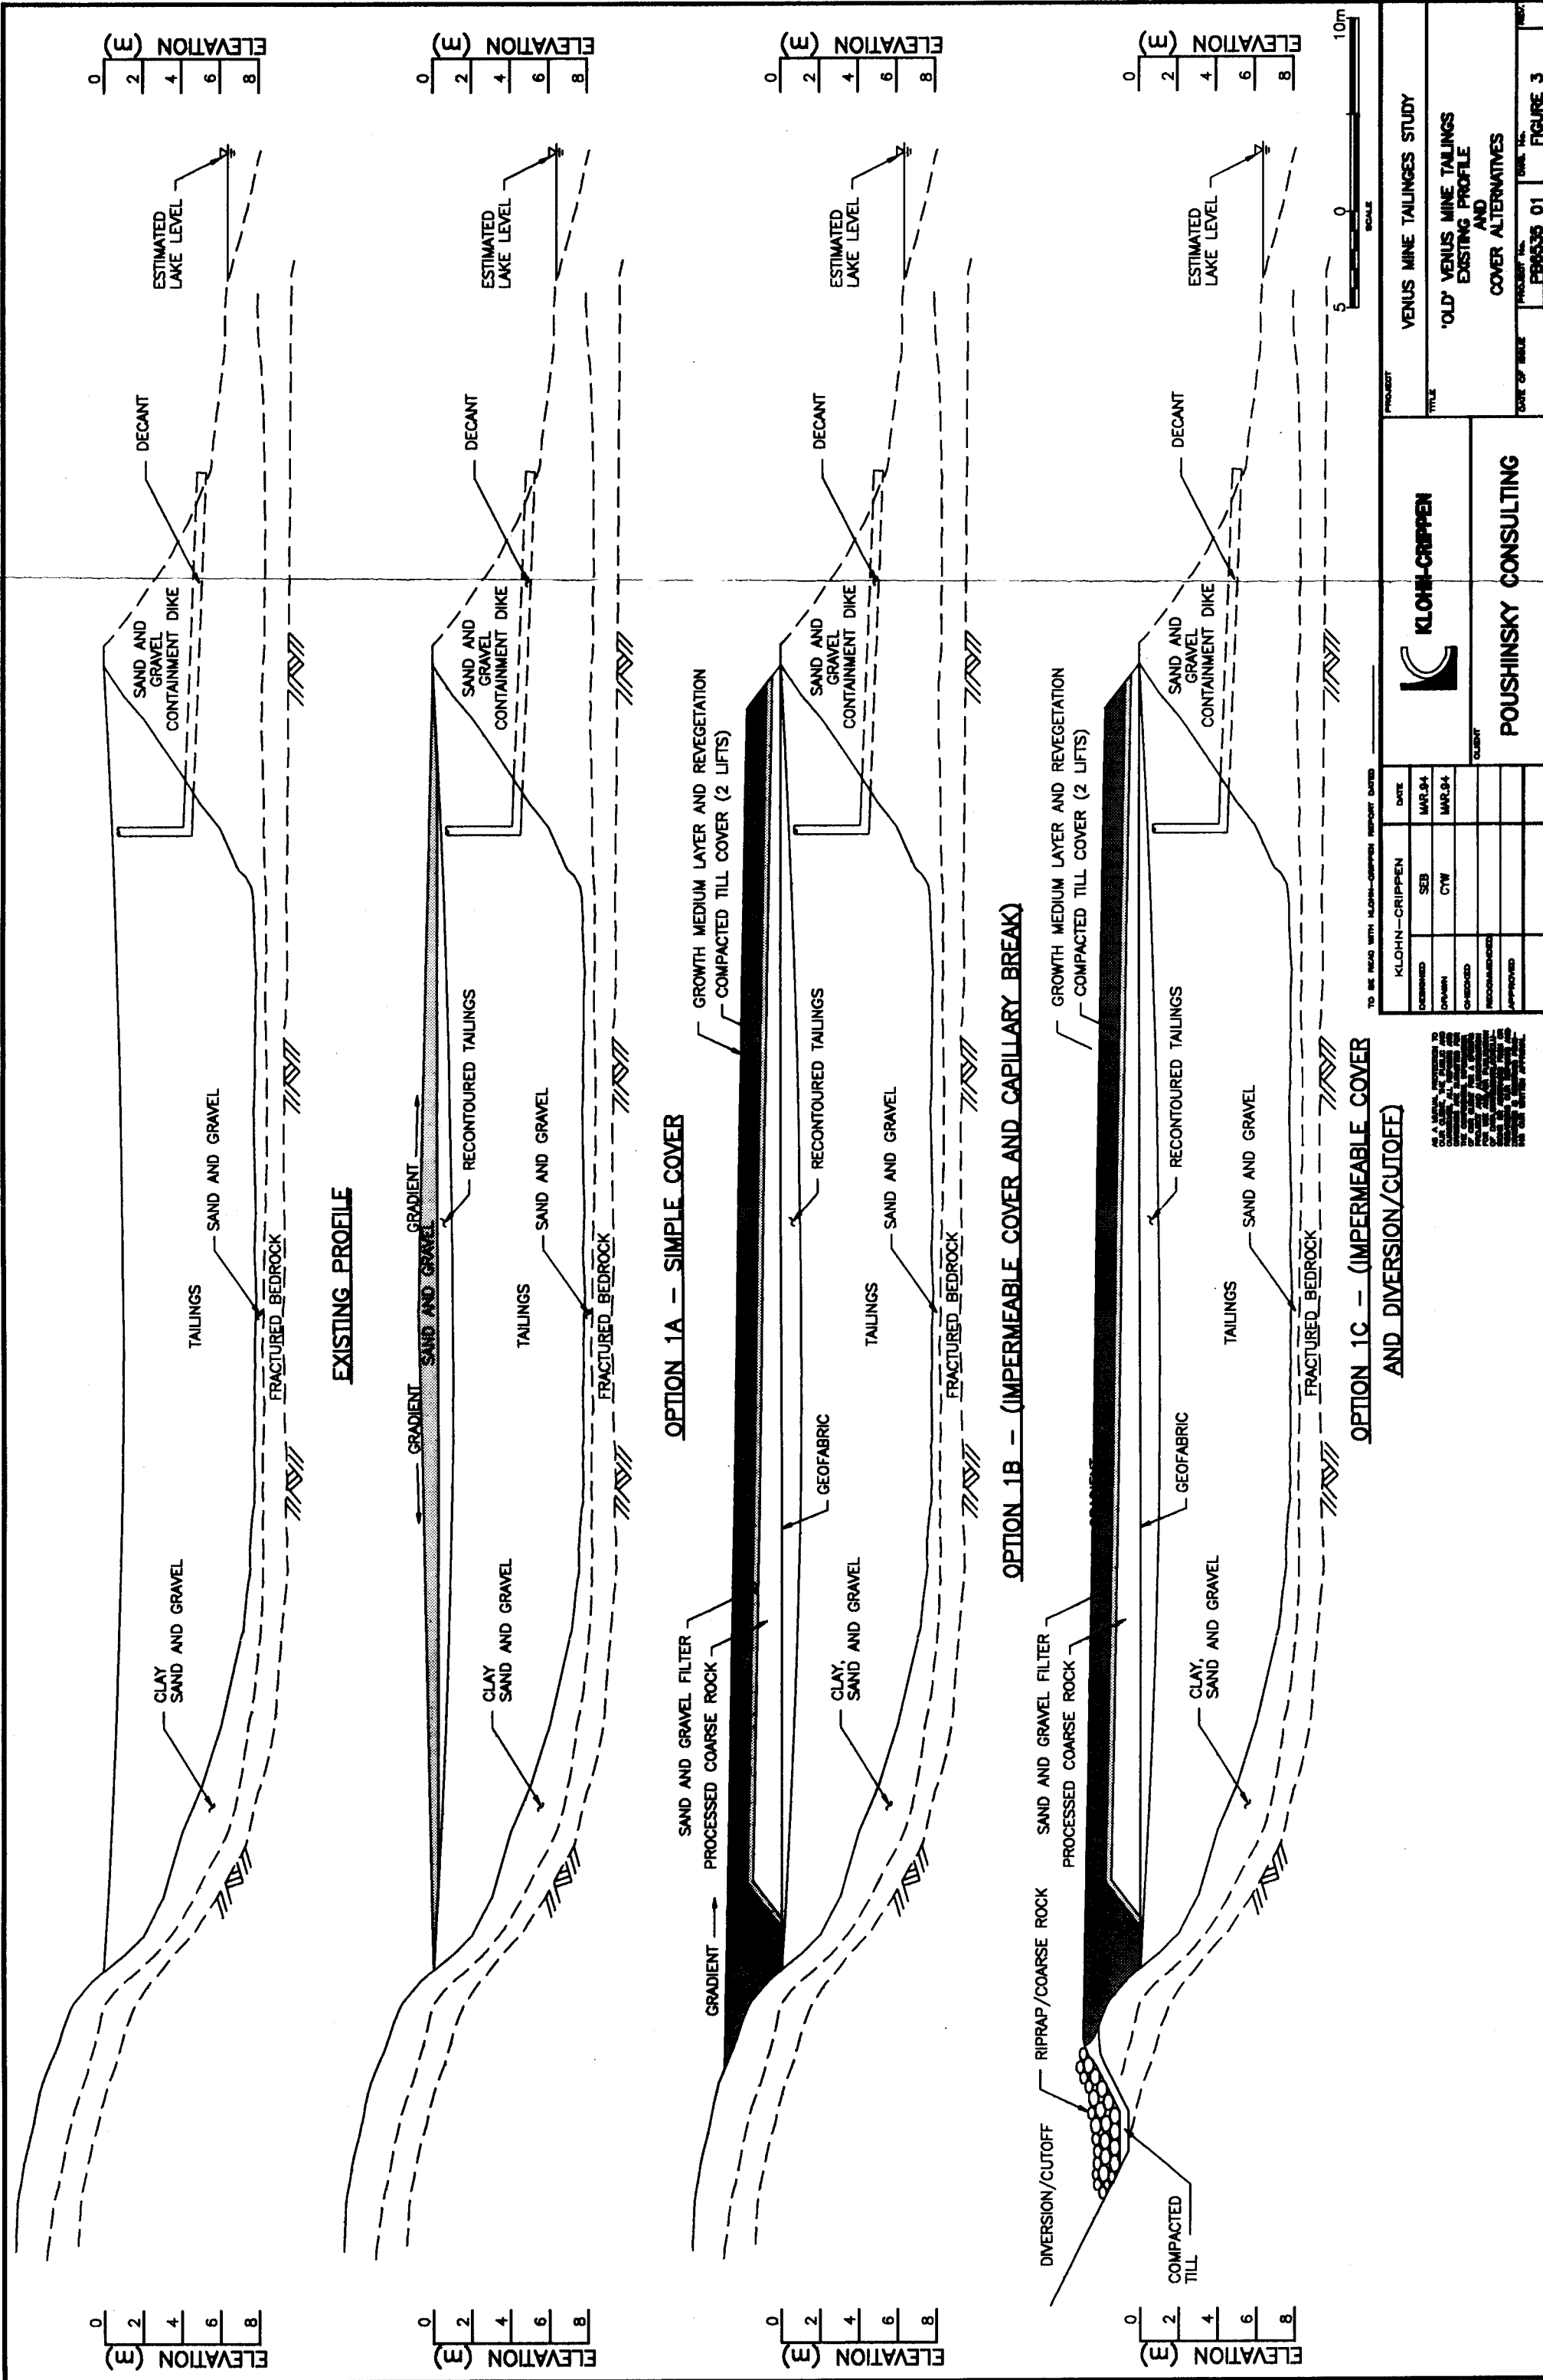
The effectiveness of the impermeable cover system to reduce particulate loading to the lake is rated as high. The effectiveness of this cover for erosion protection of the tailings is also rated as high. The cover will be effective in reduction of Arsenic uptake in the immediate tailings area but not downgradient, thus the effectiveness is rated as medium.

The coarse rock layer would be placed on a geofabric which will effectively filter the tailings. While the thickness of this layer varies (as shown on Figure 3), the average thickness is 1.5 m. The drain material will also produce a trafficable surface upon which the till would be placed. Compaction of the till under appropriate moisture content conditions will produce a plastic impermeable cover capable of sustaining minor deformation, with a long useful lifetime.

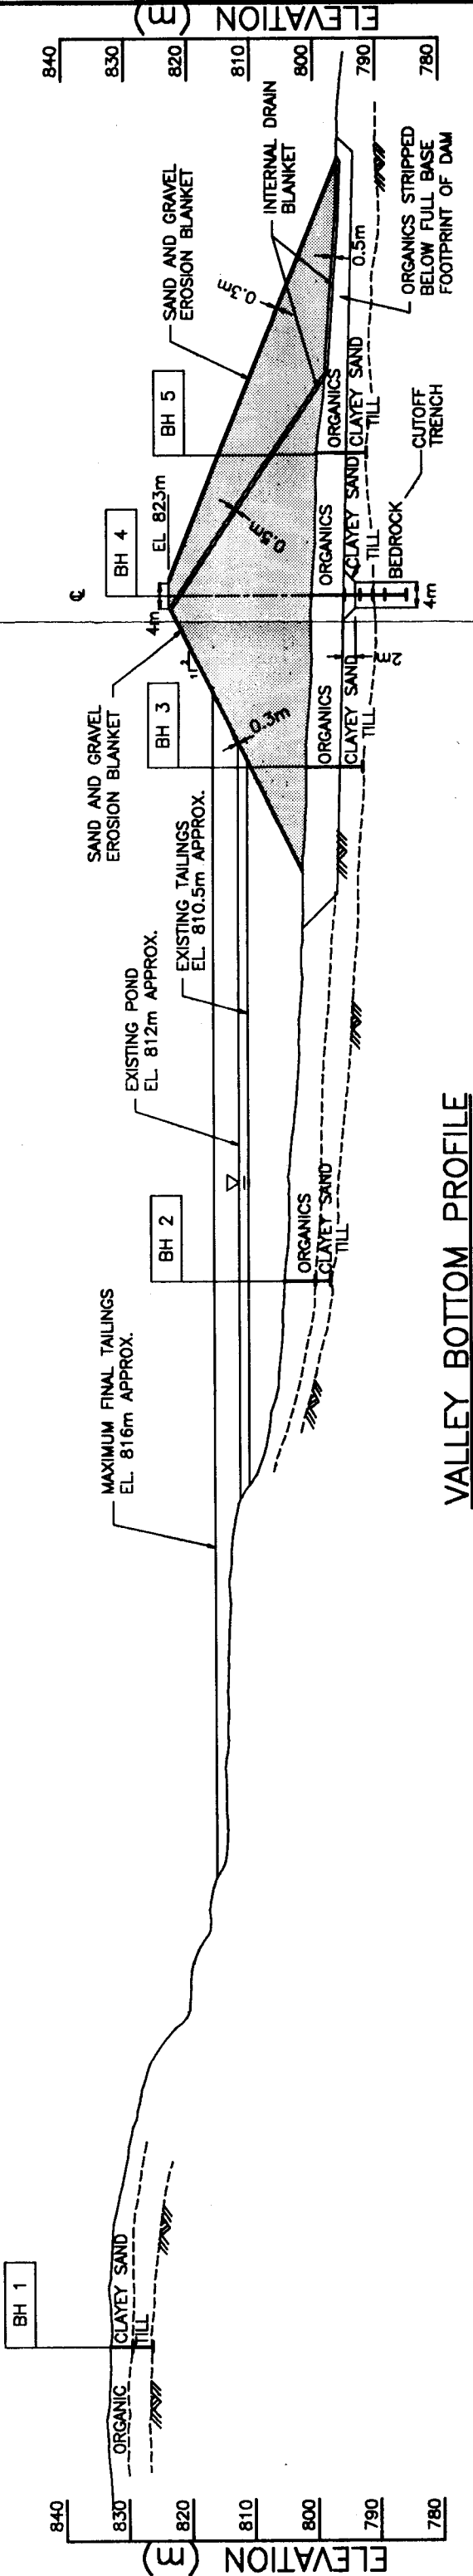
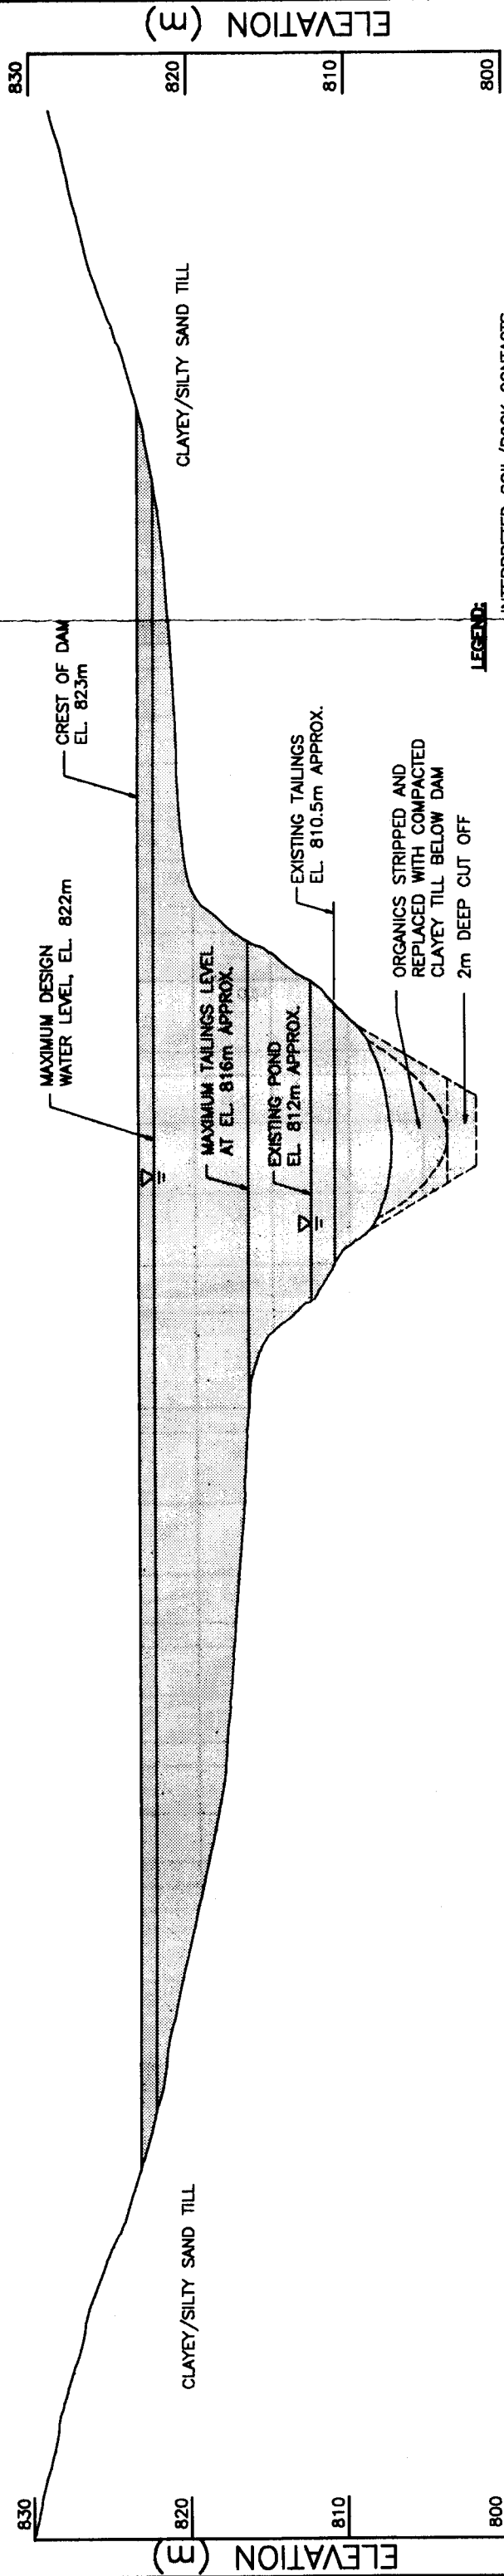
VALLEY BOTTOM PROFILE AND DAM CENTRE  
LINE PROFILE

Assessment of the dam design concludes that the upstream slope of the dam is too steep given the shallow thickness of gravel slope protection, and the fact that the dam may retain water for long periods of time. Saturation of the upstream till slope, effects of freeze-thaw, and seasonal fluctuations of the pond level could cause shallow instability and failure of the upstream slope. It is noted that cracks were reported by Geocon at the upstream crest of the main dam of the fresh water pond (west side of highway) in 1983. Instability of the tailings dam may not have occurred to date because of the low pond levels maintained in the impoundment.

No problems with seepage through the tailings dam are reported in the available information. However, unusual seepage would not be expected at the low pond levels maintained behind the dam. Seepage will increase as the pond level is raised and more of the dam length impounds water. A small, concentrated seepage leak at the downstream toe of the fresh water pond dam was noted soon after filling in 1981. In 1983, the seepage was estimated to be 0.3 l/s. Minor seepage was also noted by SRK in 1988 at the toe of the polishing pond downstream of the main tailings dam.

A preliminary seepage analysis for the existing impoundment has been carried out. An estimated upper bound limit of 0.1 l/s of seepage through the dam and base of the impoundment was calculated assuming a till permeability of  $1 \times 10^{-6}$  cm/s, and that no major defects exist in the till foundation or dam which could cause concentrated seepage. A total seepage of less than 0.1 l/s would be hard to detect in the field and agrees with the historical absence of visual seepage from the dam.
