WATERLOO BARRIER™ SYSTEM

SHEET PILE & SEALANT INSTALLATION REPORT

VENUS MINE SITE
TAILINGS POND
KM 86 - KLONDIKE HIGHWAY, YUKON TERRITORY
D.P.W. PROJECT # 626483

OCTOBER 16th, 1995

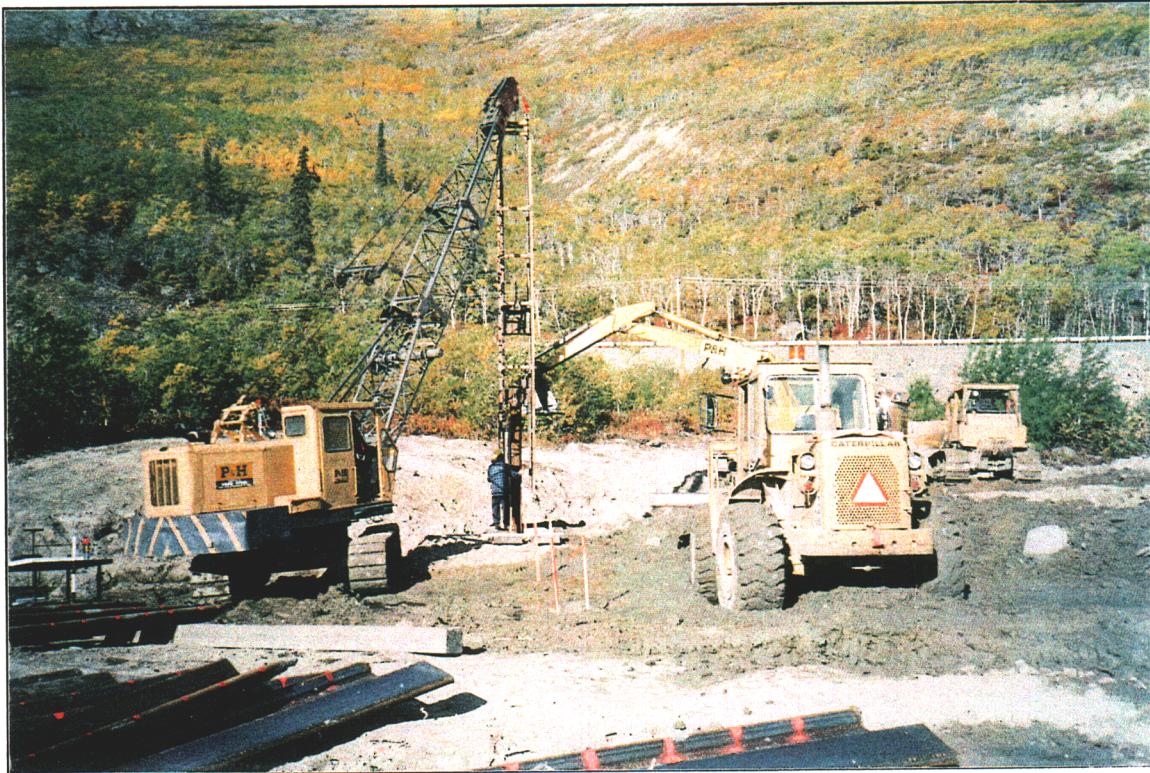
Photo 1: Pile Driving Equipment

Photo 1 shows the pile driving in progress.

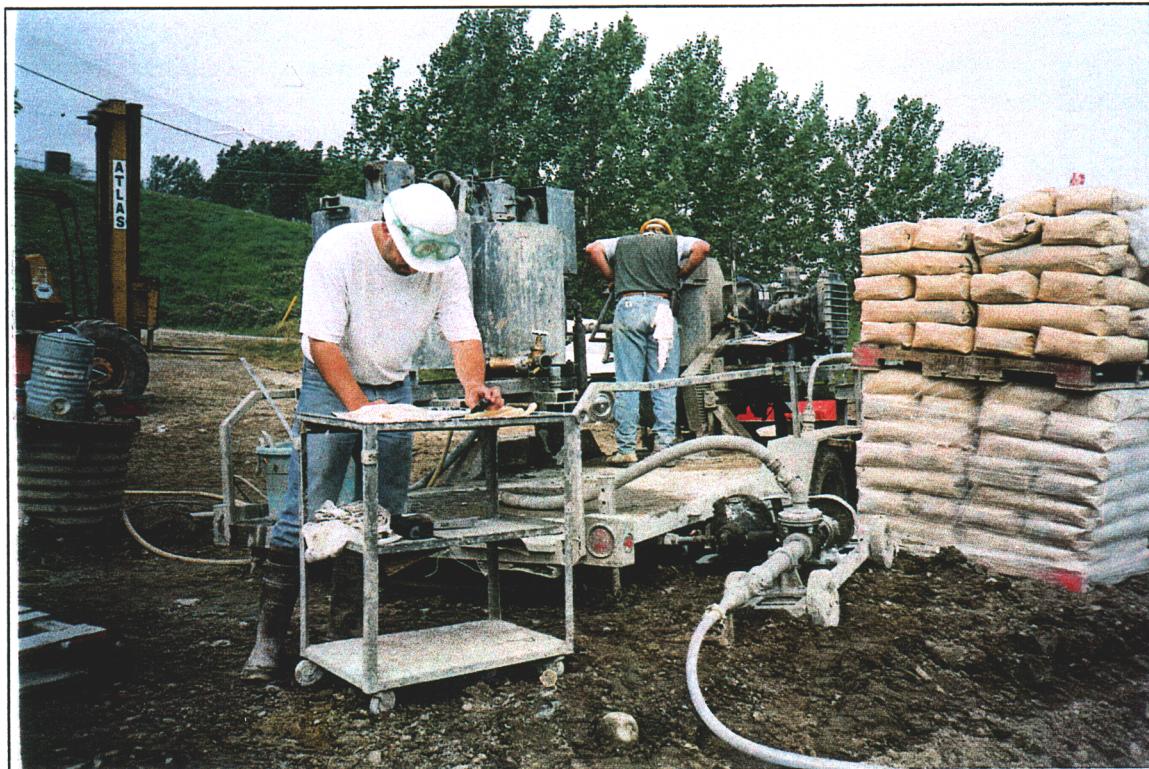
Photo 2: Typical Grouting Equipment

Photo 2 shows the grouting equipment required for this project.

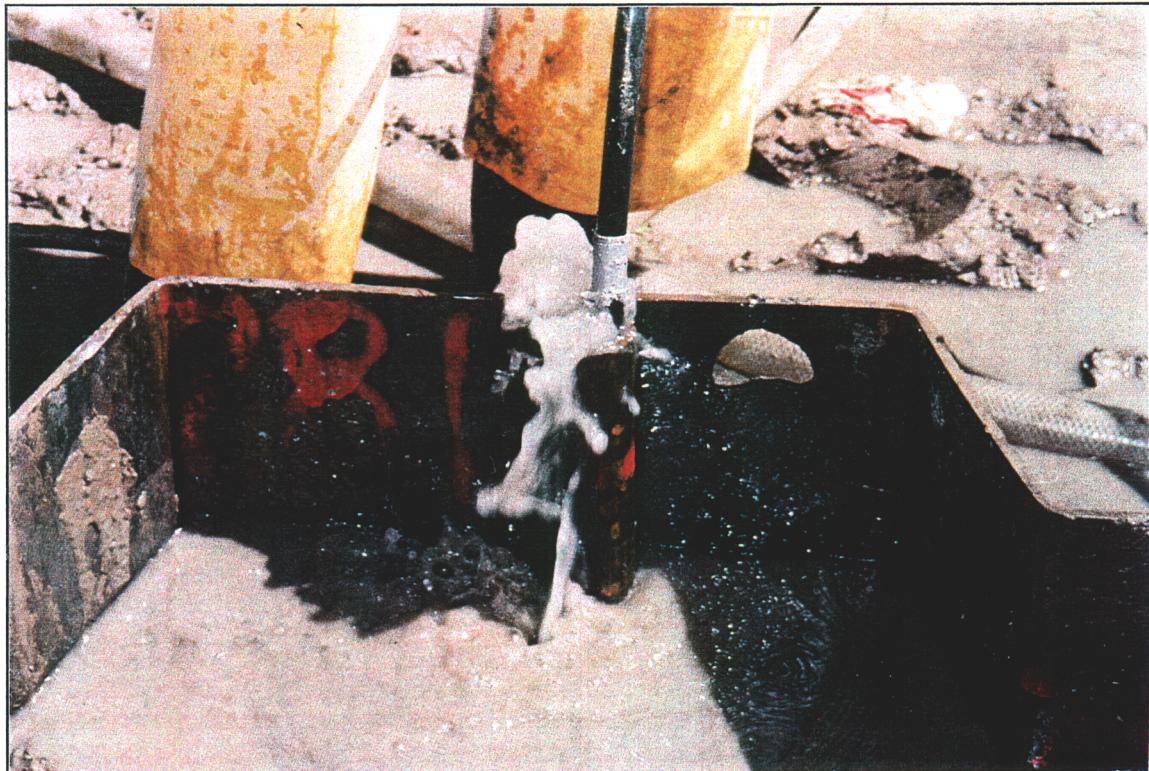
Photo 4: Typical Joint Flushing

- 1) **JOINT FLUSHING** - A high pressure water pump, water tank and rigid hose was used to remove any loose material from the sealable cavities. Flushing was conducted until the return water became clear (Photo 4). The flushing procedure was continued until a sufficient number of joints (20) were cleaned to allow for the installation of sealant.

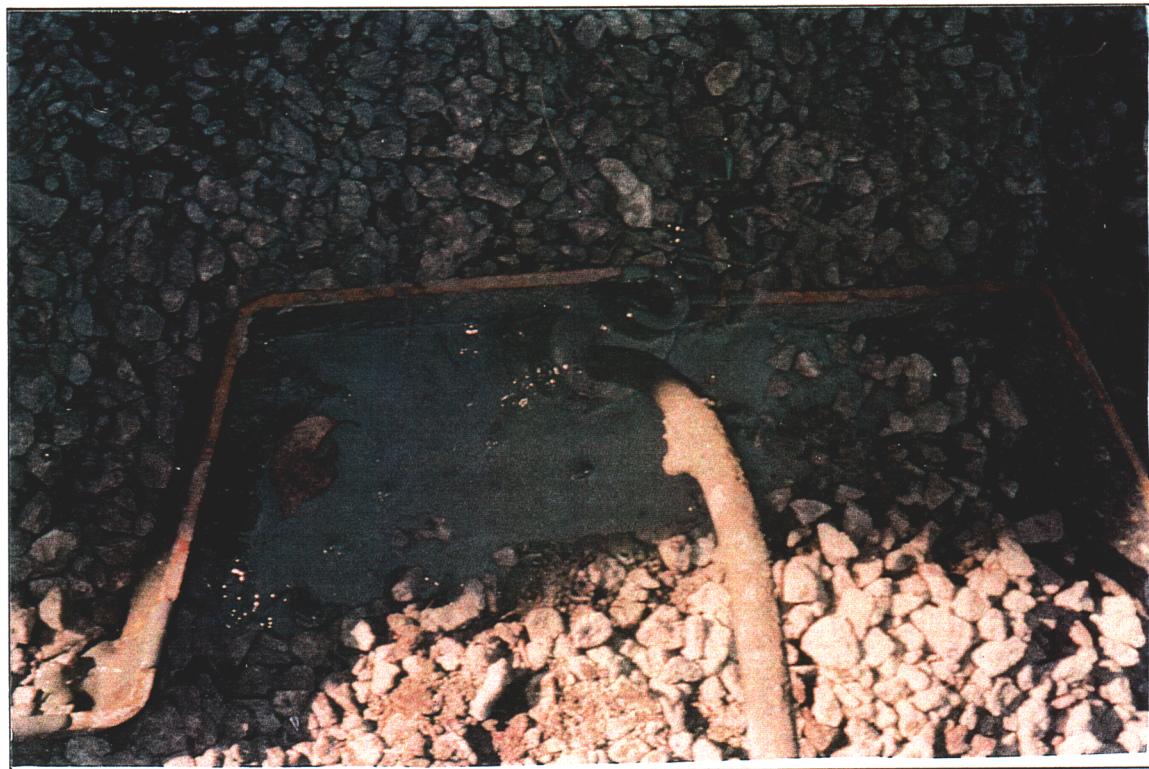
Photo 5: Sealant Injection

- 3) **SEALANT INJECTION** - The grout line was inserted to the base of the clean joint and the sealant was tremied into the cavity.
- 4) **GROUT LINE WITHDRAWAL** - Once sealant was observed to be flowing out the top of the sealable cavity (Photo 5), the injection line was slowly withdrawn.
