Phase I & II Environmental **Site Assessment**

Former Military Site Snag - Enger Lakes Mile Post 1189 Alaska Highway (DIAND Site 36)

Prepared for:

November 1996

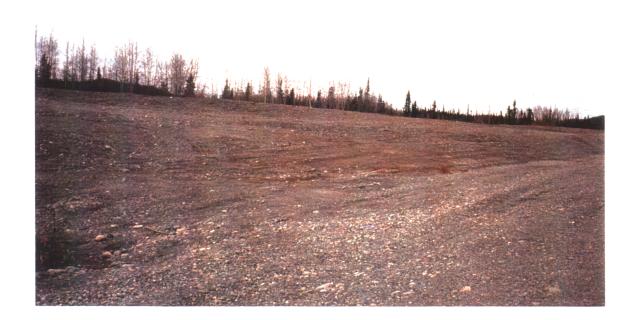
Photograph 1. View of subject site, looking westward. September 1996. (Cover Page)

It was discovered that the clearing at MP 1189 had been covered by at least 3 metres of fill material. The area was flat and there were no surface indications of what might lie below the fill (Photograph 1). The depth of the fill precluded geophysical investigation for shallow buried metal. It also precluded the usefulness of soil sampling to indicate the presence of soil contamination associated with former dumping activities.

Given the depth of fill overlying the site, further investigation of the site would be limited and somewhat problematic. Installation of leachate monitoring wells might be used to determine whether there is any leachate associated with previous activities at the site.

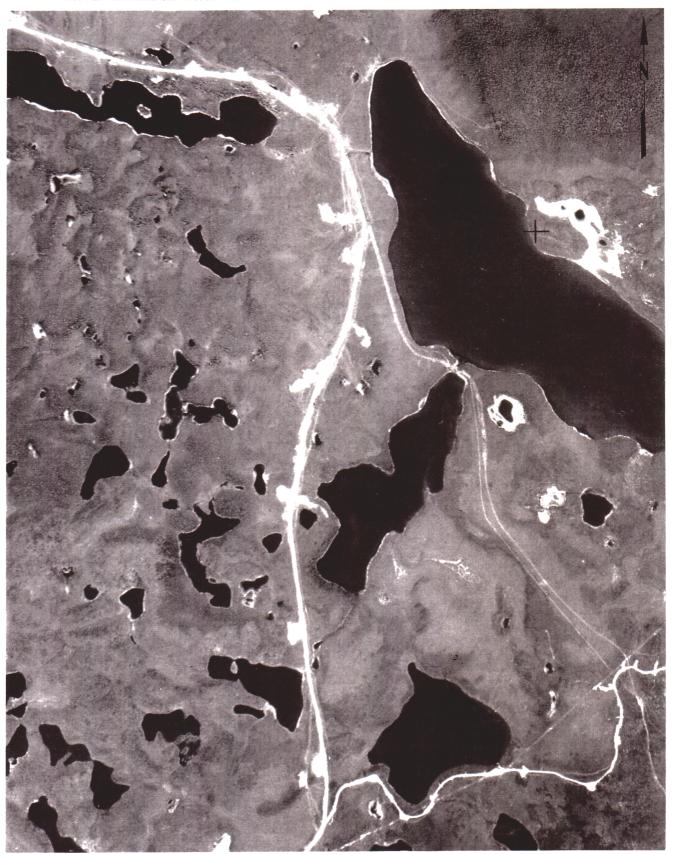
Figure 3. Aerial Photograph of Subject Site, 1948. (115 K 40 A 11452-147)

A review of aerial photographs of the area revealed a clearing in the area of MP 1189 in 1948 (Figure 3). This suggests that the subject site may have been in some sort of use (for dumping or other activities) at this time.
