**ENVIRONMENTAL SITE REMEDIATION
HJ011-MARSHALL CREEK ROAD
HAINES JUNCTION, YUKON**

REPORT NO.: 8054-24

PROJECT: Environmental Site Remediation

LOCATION: HJ011, km 5.2, Marshall Creek Road
Haines Junction, Yukon

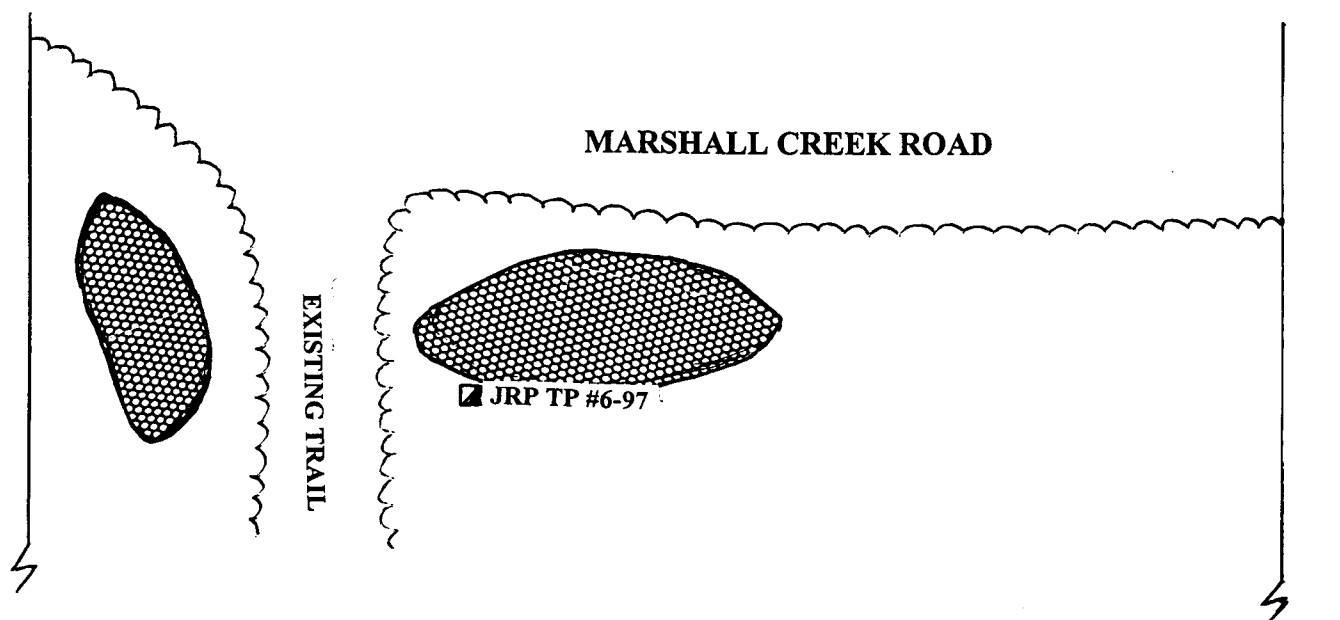
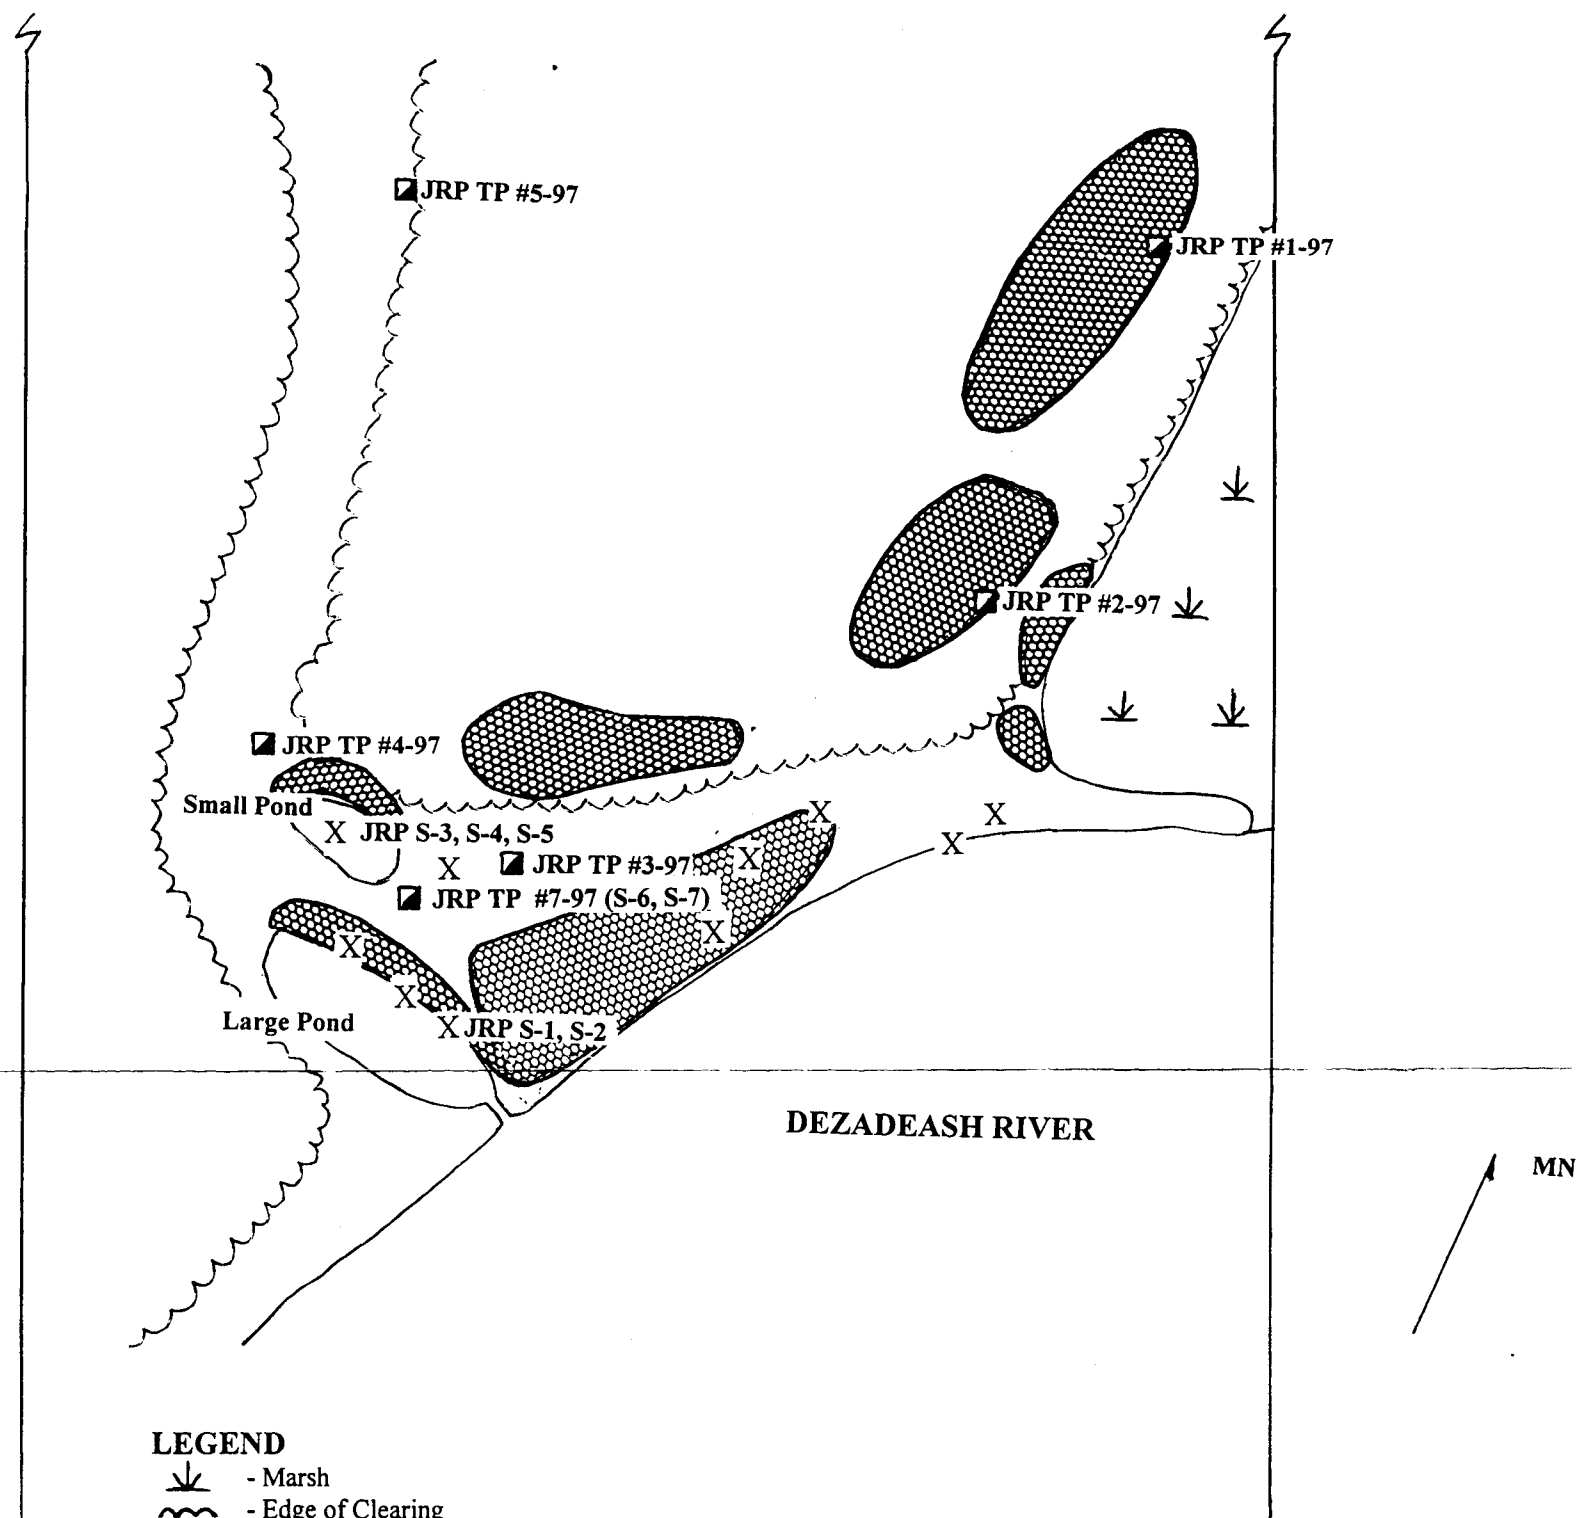
FIGURE 2-
Remediation Operations,
Test-pit & Sample
Locations

The areas where the surficial hand clean-up operations were carried out are depicted in the Site Sketch shown in Figure 2. In general, clean-up operations were successful in removing all surficial debris originally identified at the site. However, it became apparent during the removal program that a larger quantity of vehicles/debris was present at the site than previously determined. The debris was located along the periphery of the large pond and the Dezadeash River underneath the surficial vehicles/debris, supporting the theory that waste materials were bulldozed into the existing ponds and nearby Dezadeash River

Locations of the equipment clean-up operations are depicted in the Site Sketch shown in Figure 2.

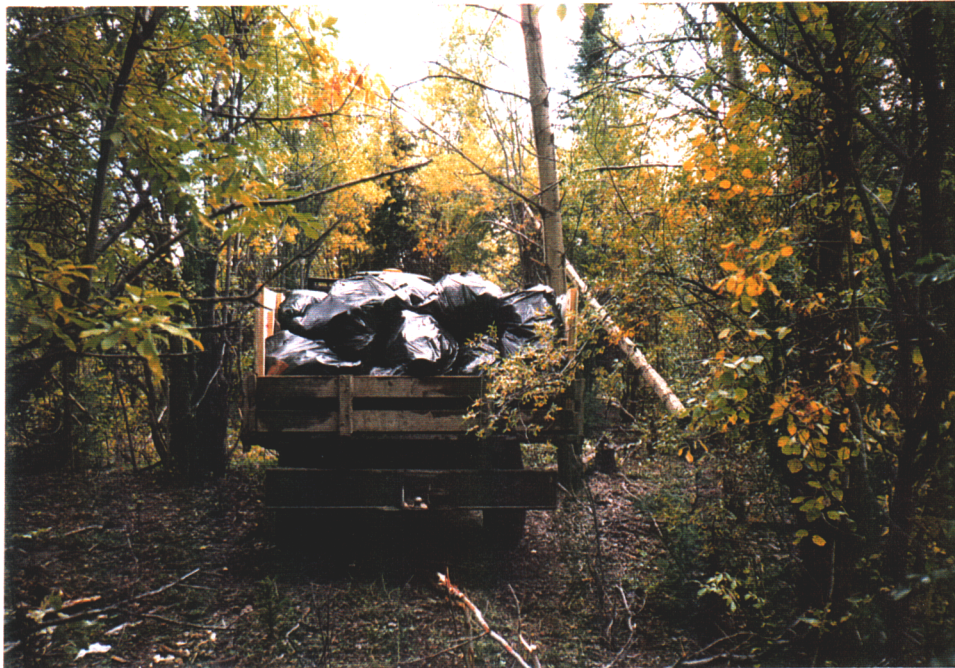
Photo # 1- Typical haul load during hand clean-up operations.

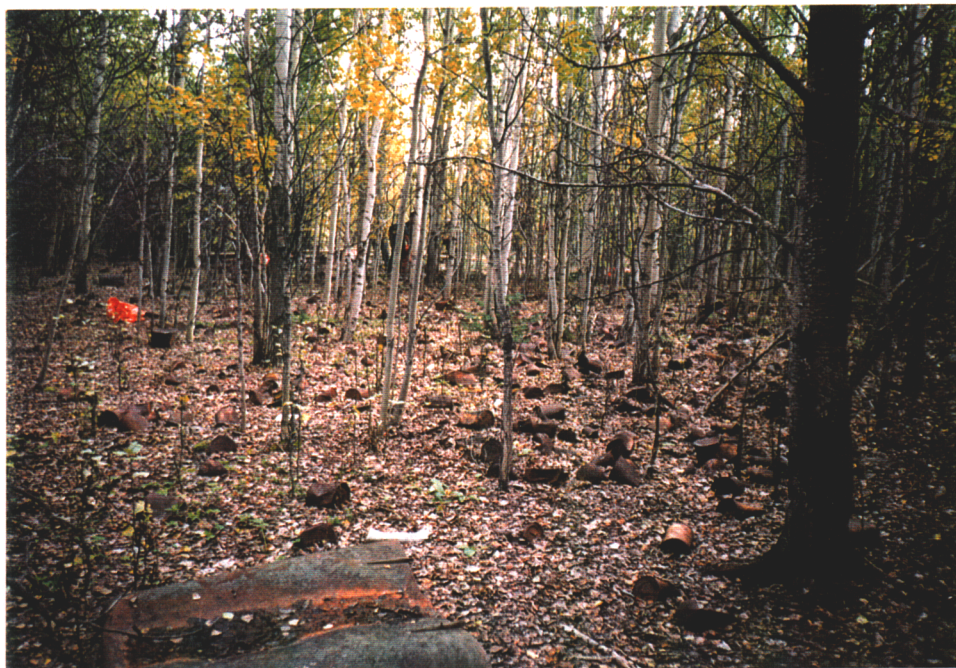
Photo # 2 - Site conditions near T.P.# 1-97 prior to hand clean-up operations.

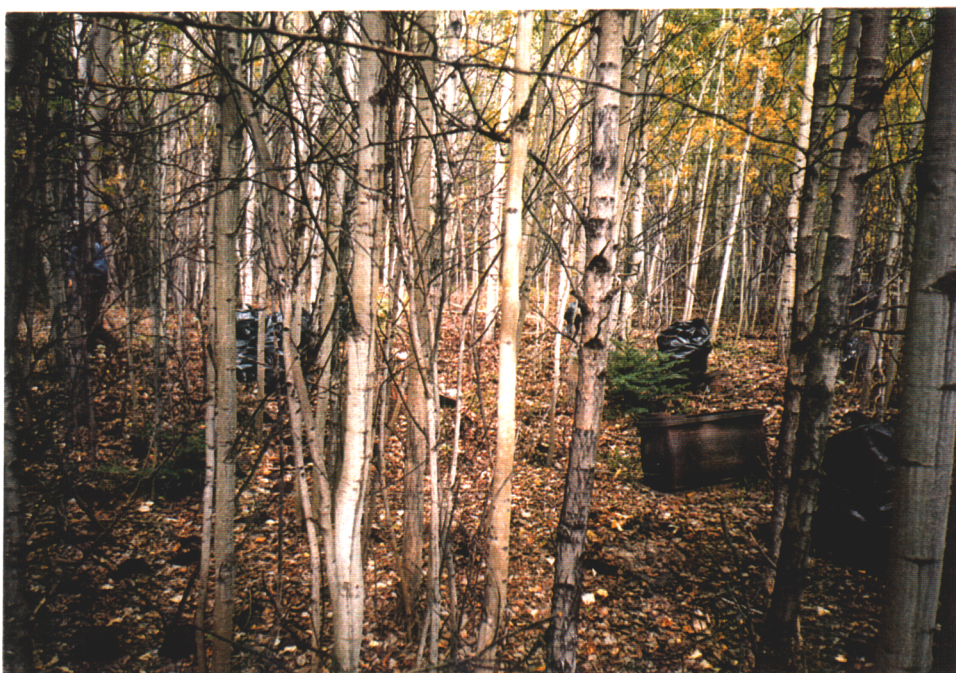
Photo # 3 - Site conditions near T.P.# 1-97 near completion of clean-up operations

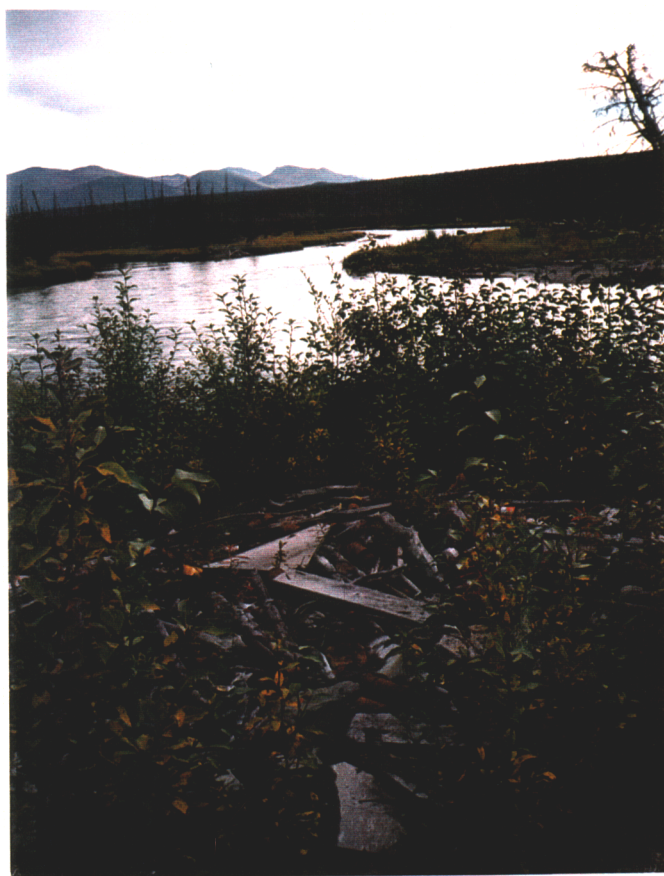
Photo # 4 - Site conditions near the Dezadeash River prior to hand clean-up operations.

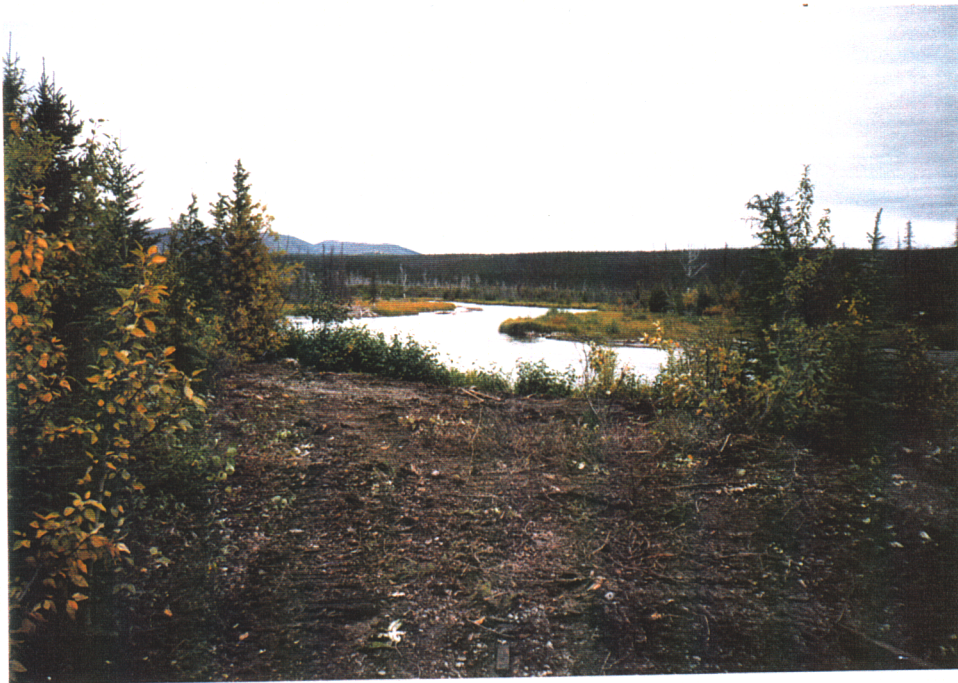
Photo # 5- Site conditions near the Dezadeash River upon completion of hand clean-up operations.

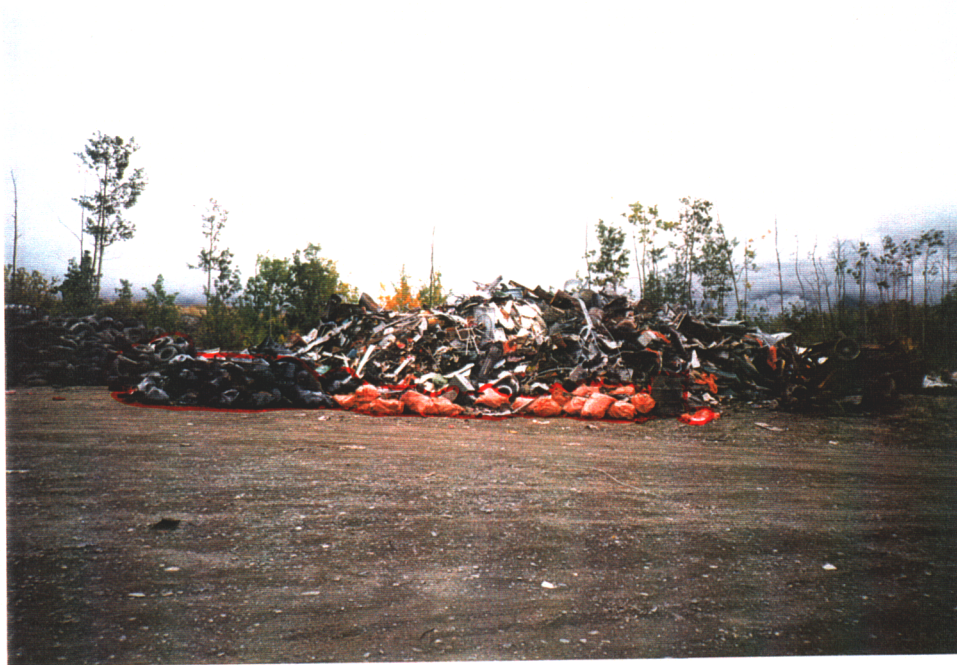
Photo # 6 - Surficial debris removed near completion of hand clean-up operations.
Photo taken at Haines Junction landfill.

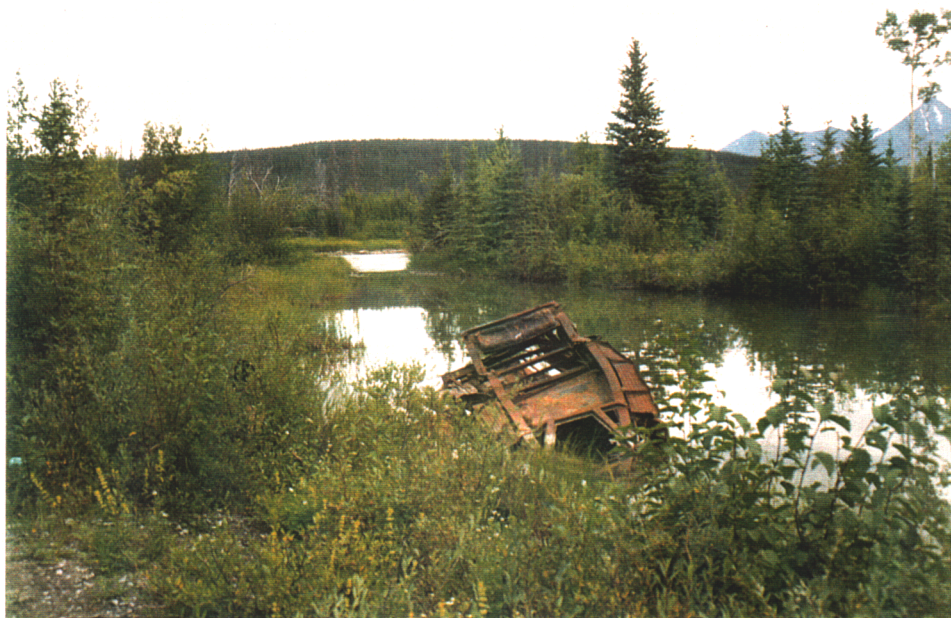
Photo # 7- Site conditions in the large pond prior to clean-up operations.

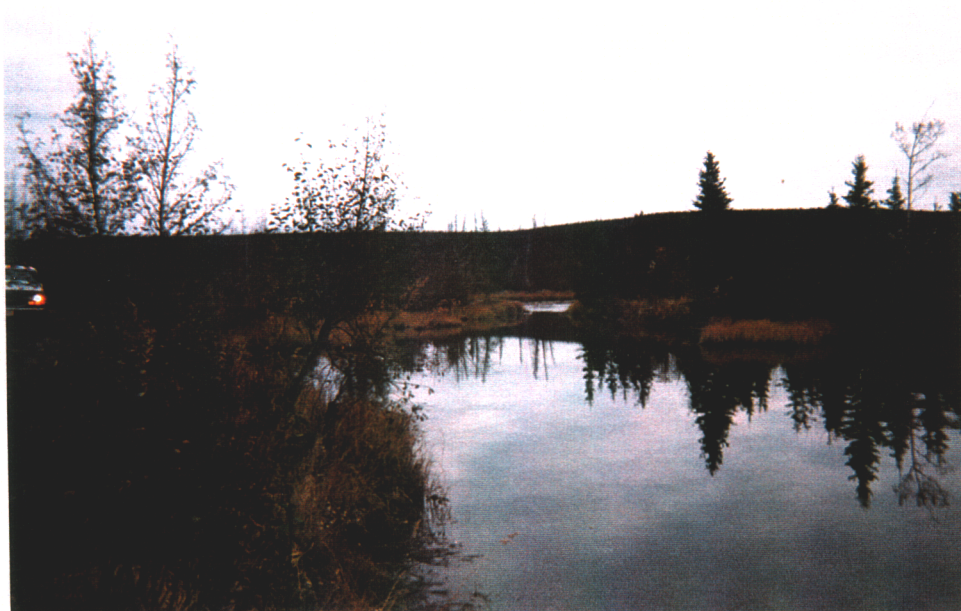
Photo # 8 - Site conditions in the large pond upon completion of clean-up operations.

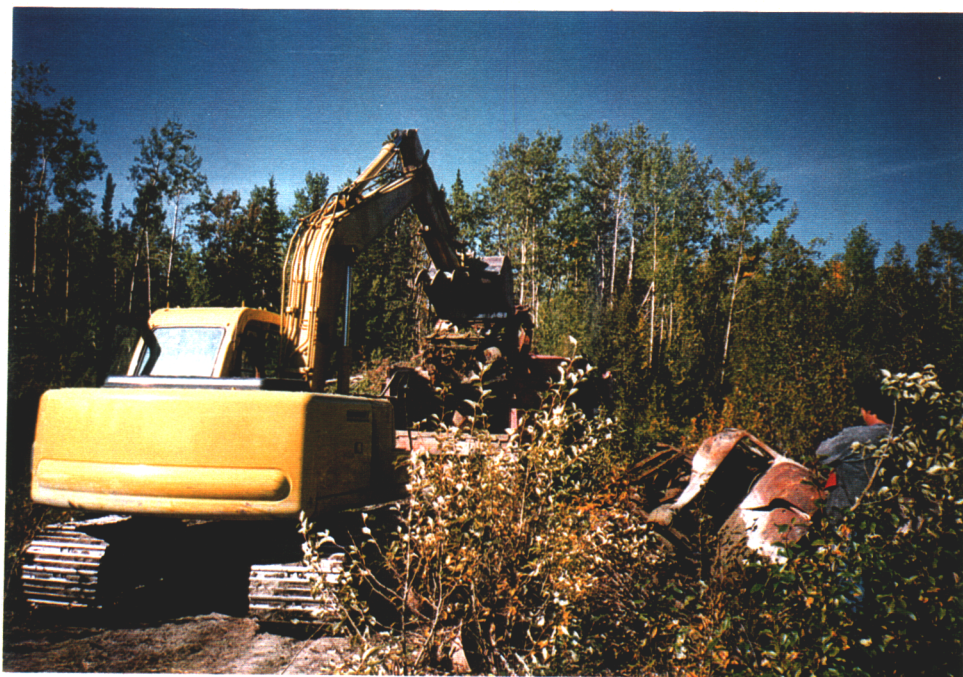
Photo # 9 - Removal of debris during heavy equipment clean-up operations.

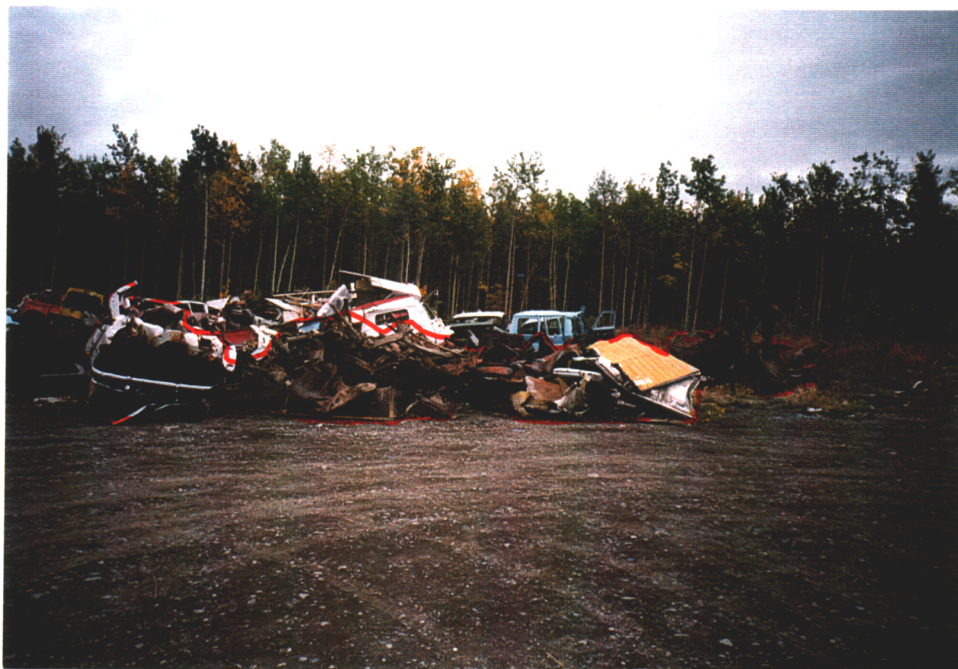
The equipment clean-up operation utilized a claw equipped tracked backhoe (Caterpillar 215 equivalent) in conjunction with an end-dump dump truck on September 4th and 5th . Operations generally consisted of utilizing the backhoe claw in conjunction with chains to remove old vehicle bodies, metallic drums and similar oversized debris (please see photos # 7-9). This debris was subsequently placed in the dump truck and hauled to the Haines Junction municipal landfill. Approximately ten truck loads were hauled to the landfill during the clean-up operations (please see photos # 10 & 11).

Photo # 10 - A portion of surficial debris removed near completion of heavy equipment clean-up operations.
Photo taken at Haines Junction landfill.

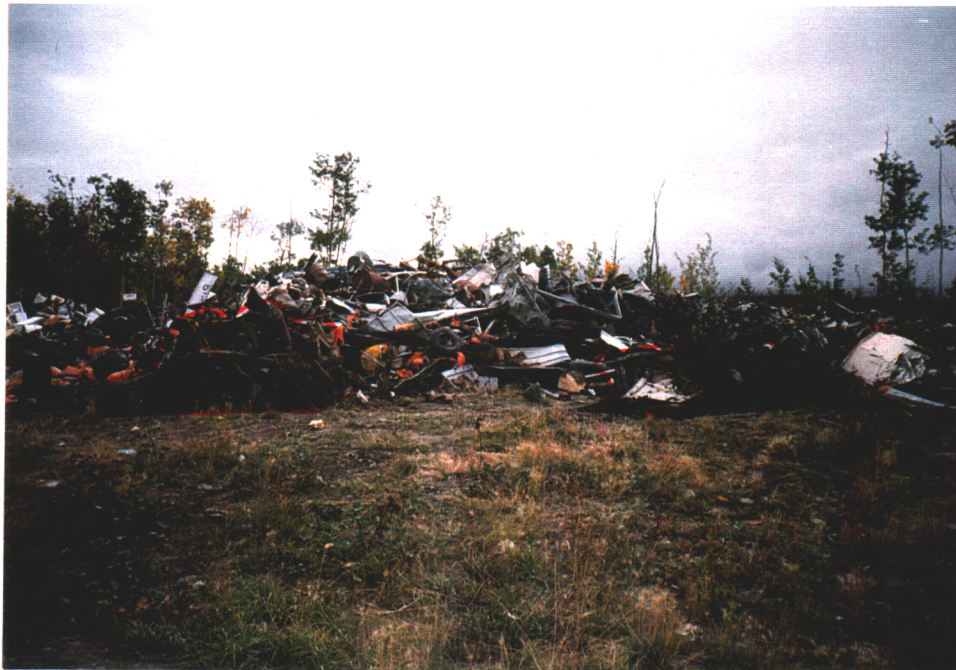
Photo # 11- A portion of surficial debris removed near completion of heavy equipment clean-up operations.
Photo taken at Haines Junction landfill.

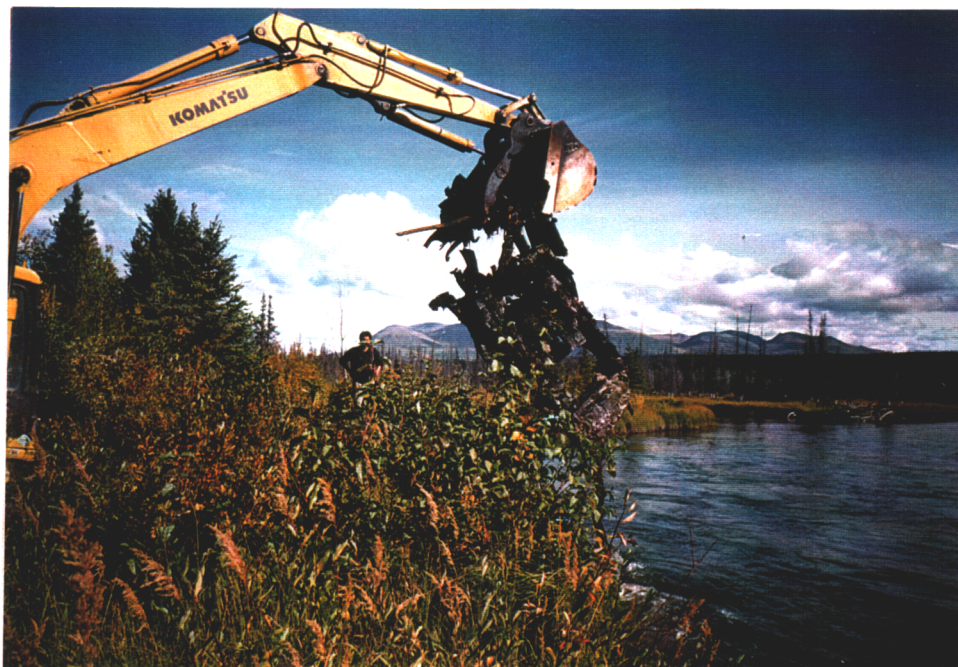
Overall, all accessible vehicle bodies were removed from the site. Three vehicles were however left in densely forested areas due to their relative inaccessibility. It was determined that these vehicles represented only a small contaminant liability and that excessive destruction of forest would be necessary to facilitate their removal. As such, these vehicles were left in-situ. As mentioned above, it became apparent during the removal program that a larger number of vehicles/debris was present at the site than previously determined. This debris was located along the periphery of the large pond and the Dezadeash River underneath the surficial vehicles/debris, supporting the theory that waste materials were bulldozed into the existing ponds and nearby Dezadeash River (please see photos # 12 & 13). As such, in accordance with our scope of work, it was

Photo # 12 - Site conditions near the Dezadeash River during heavy equipment clean-up operations.

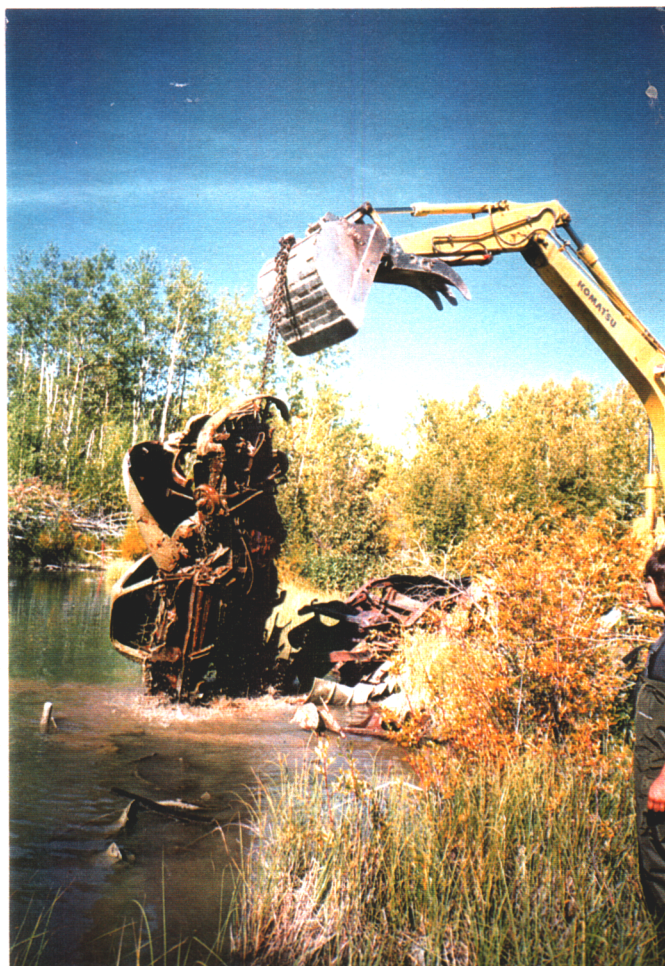
Photo # 13 - Site conditions near the large pond during heavy equipment clean-up operations.
