Environmental Investigation

Destruction Bay Pumping Station

HJ031

September, 1997

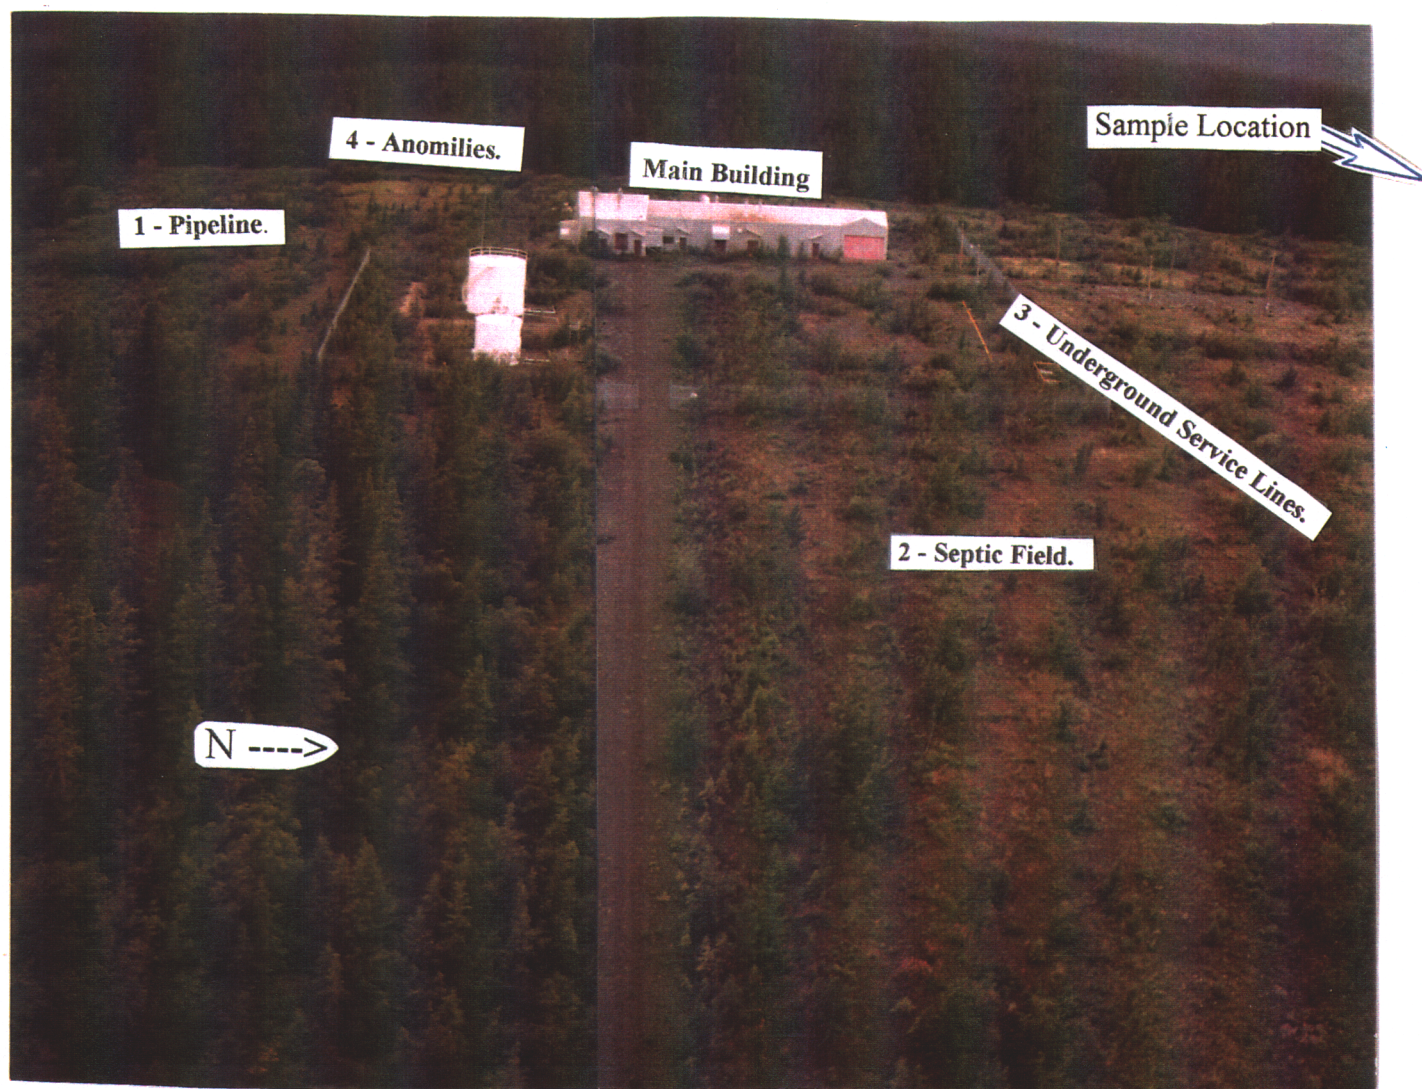
Photo 1. Site Layout - Main Building

Sample Location N.W. of main building. (See Photo 2)

1 - Underground Pipeline.

2 - Septic Field situated W.E.

3 - Underground Service lines to maintainance garages.

4 - Anomilies detected in initial area of excavation.

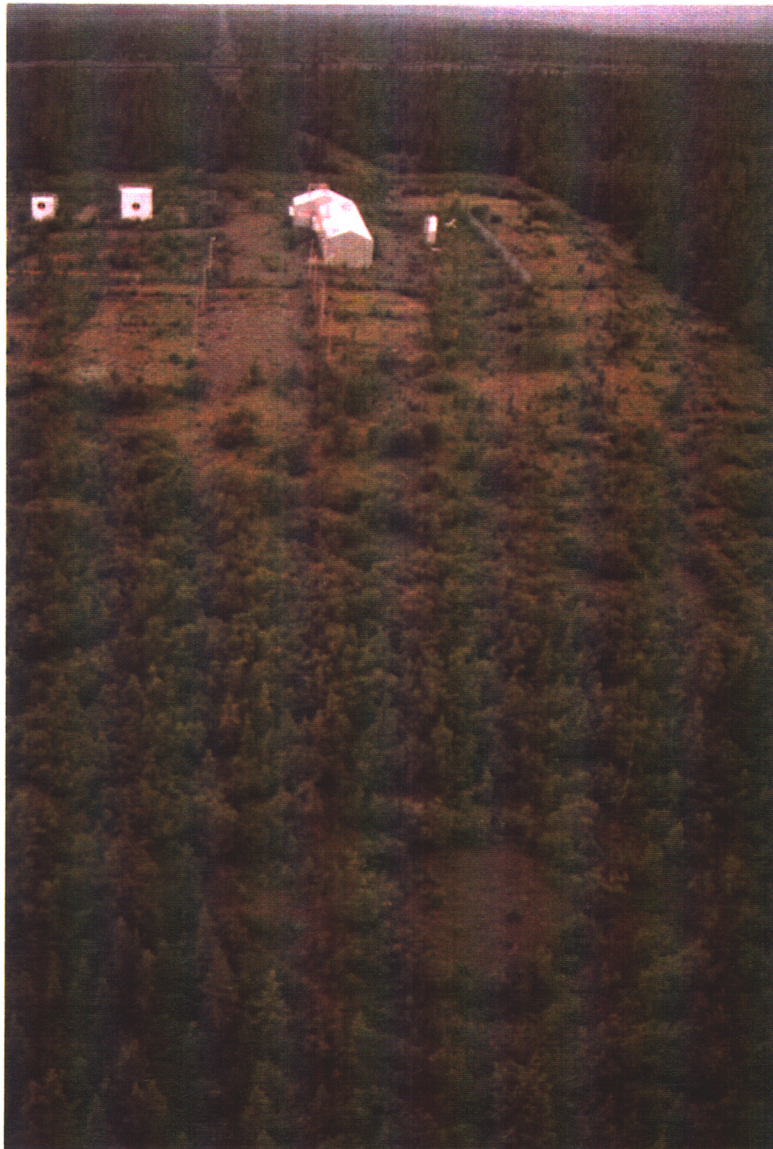
Located in the Northwest corner of the property is a circular area 11 x11 meters void of vegetation. A 1.5 meter deep hole was excavated in which strong hydrocarbon odours were emitted. A layer of pea gravel covered the contamination. A soil sample was obtained from excavated soil. The soil was analysed for PCBs, TEHs and phenoxy acid herbicides. All soil analysis meet Yukon Regulations for Contaminated Sites, 1996. Results are located in Appendix C

Photo 2. Sample Location - Situated approx. - 190 m NW of main building.
- 30 m East of pipeline treeline.
Area approx. 11 m diameter.

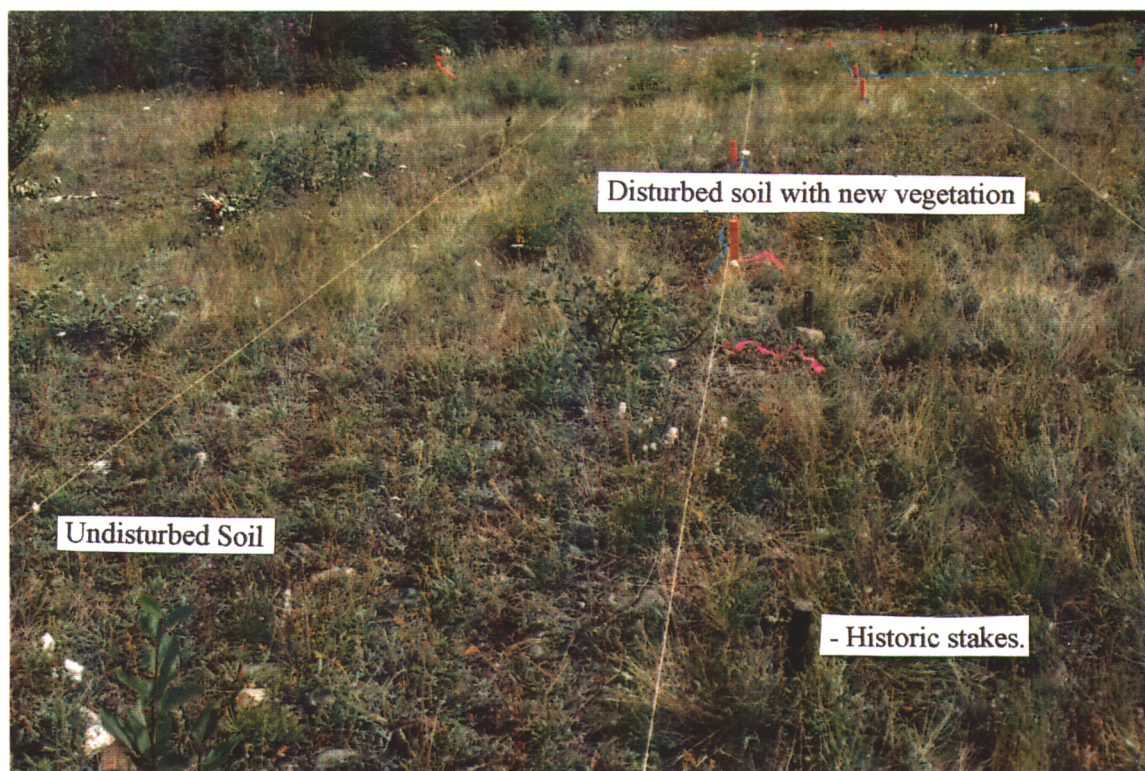
Photo 1. Burial Trench Indication - *South-west corner of compound.*
- Historic stakes.
- Disturbed surface soil with new vegetation
- Undisturbed surface soil

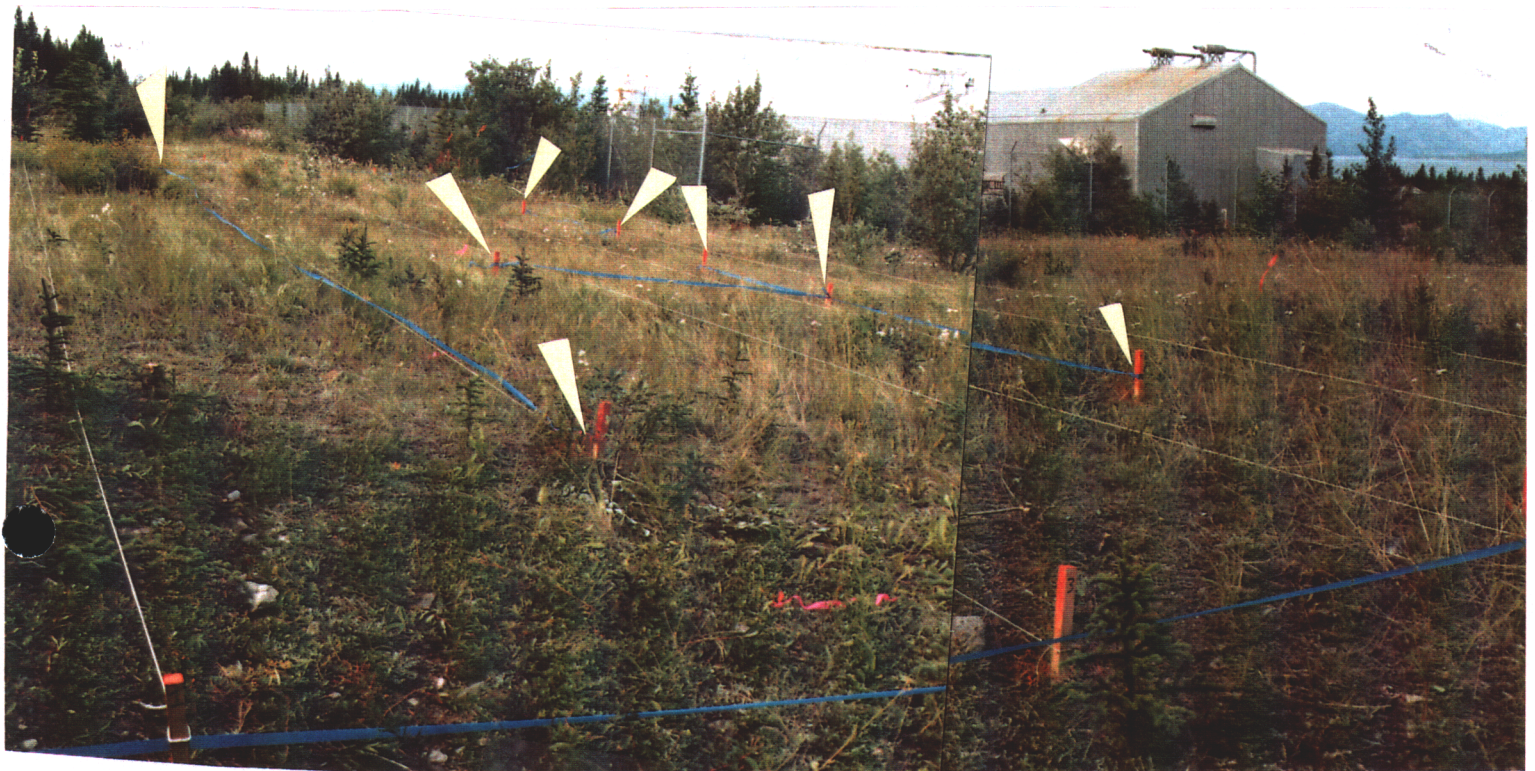
The subsurface penetrating radar was completed using an EM 61 Electro Magnetic Indicator. The initial suspected bury trench was thoroughly scanned for anomalies using one meter grid intervals. Several areas indicated the presence of metal object resembling barrels; these areas were painted and flagged. Anomalies were situated approximately in the middle of the excavation foot print. Approximately 15 similar anomalies were identified within the staked area, four to five feet below the ground surface. (See Appendix: B - Photo 2)

Photo 2. Anomaly Locations - Blue tape and orange stakes inside grid, indicates the locations of metal anomalies.
- No buried drums were located in this area.

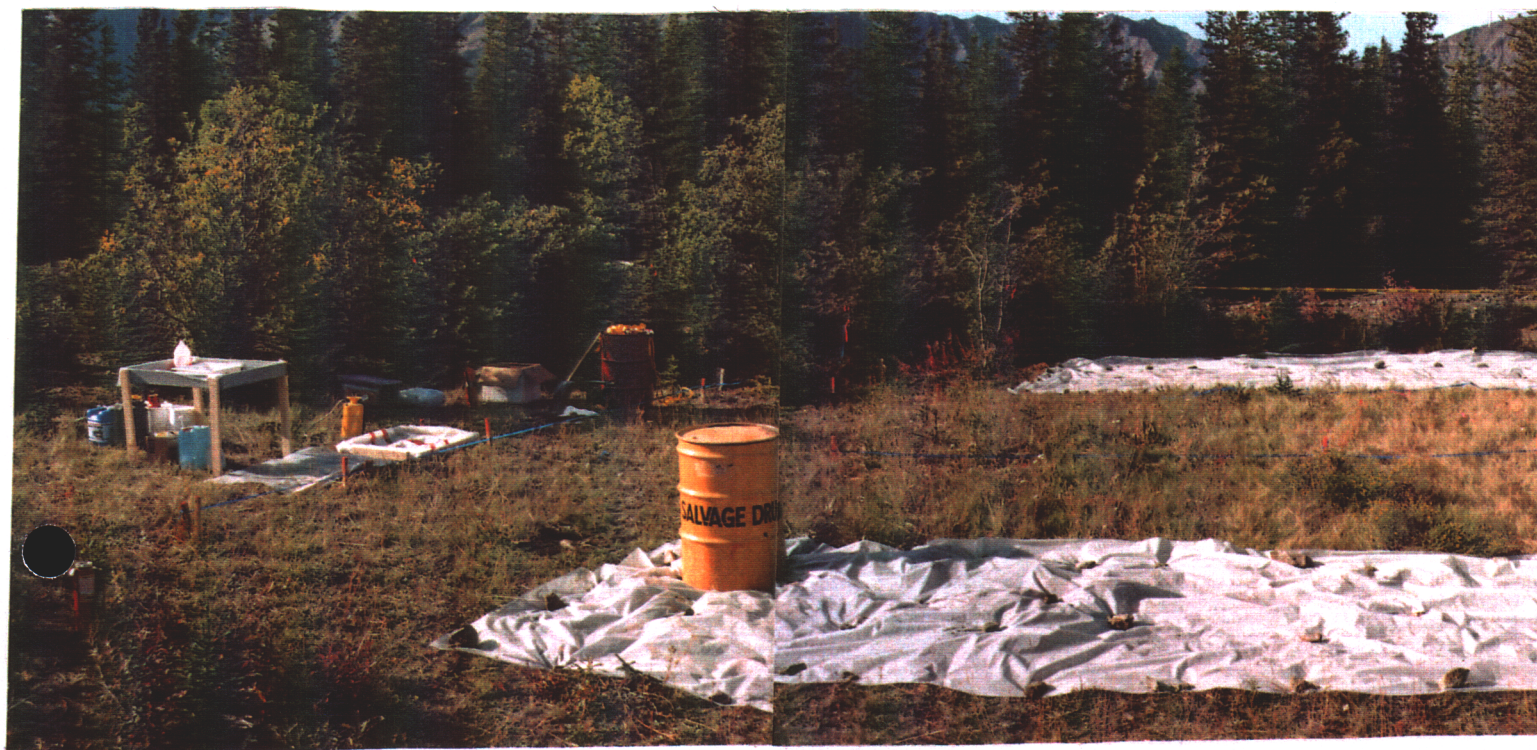
Photo 3. Hazmat Set-up - Containing; two overpacks, lined decontamination centre, poly sheeting to contain excavated soil, two barrels and pump to remove any free product, protective clothing and respirators, fire protection devices, drum hoist, and a photoionization detector.

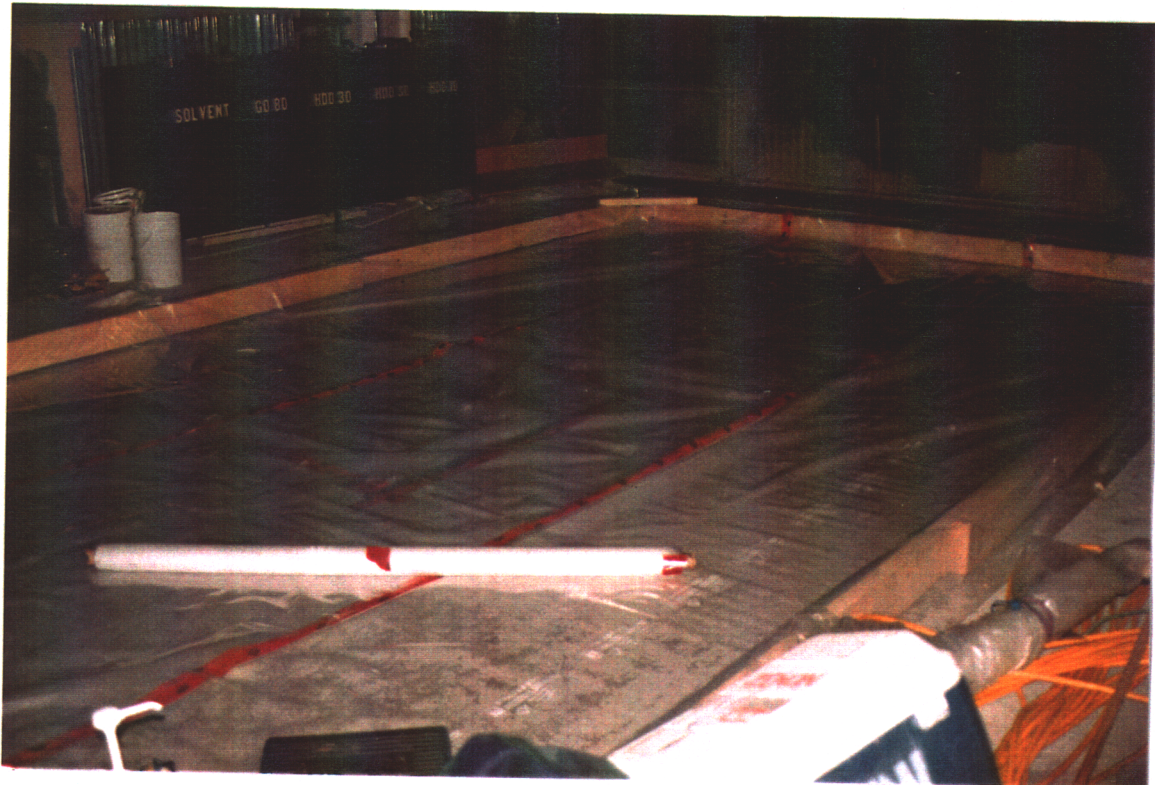
Photo 4. Hazmat Containment Cell - *Located inside the main building.*
- 10 m x 17 m x 0.2 m poly lined containment cell.
- containment cell was not used.

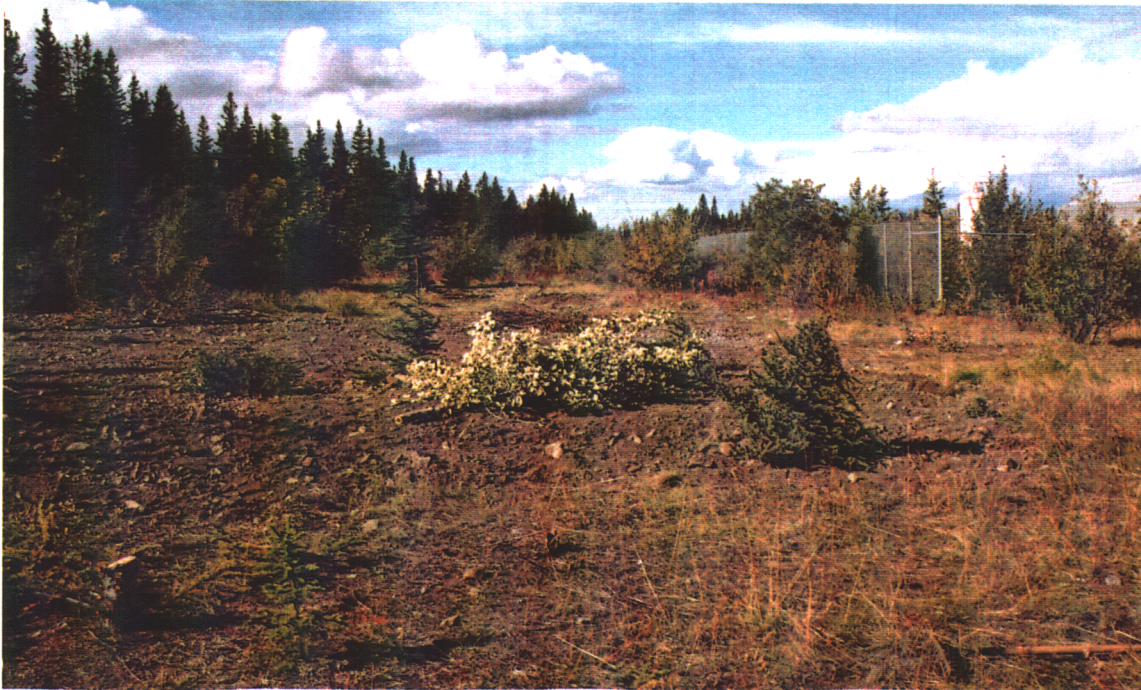
Photo 5. Excavation #1 - *Southwest of main building.*
No buried drums were located in this area.

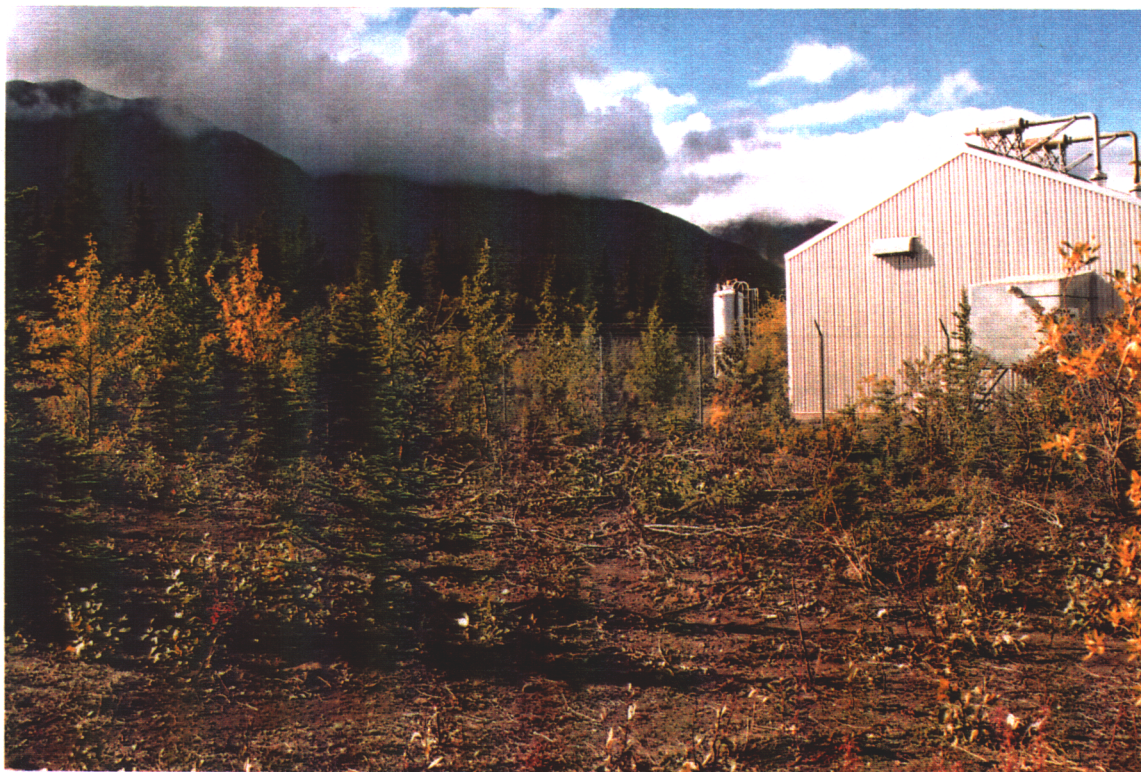
Photo 6 Excavation # 2 - South of the main building
No buried drums were buried in this location.

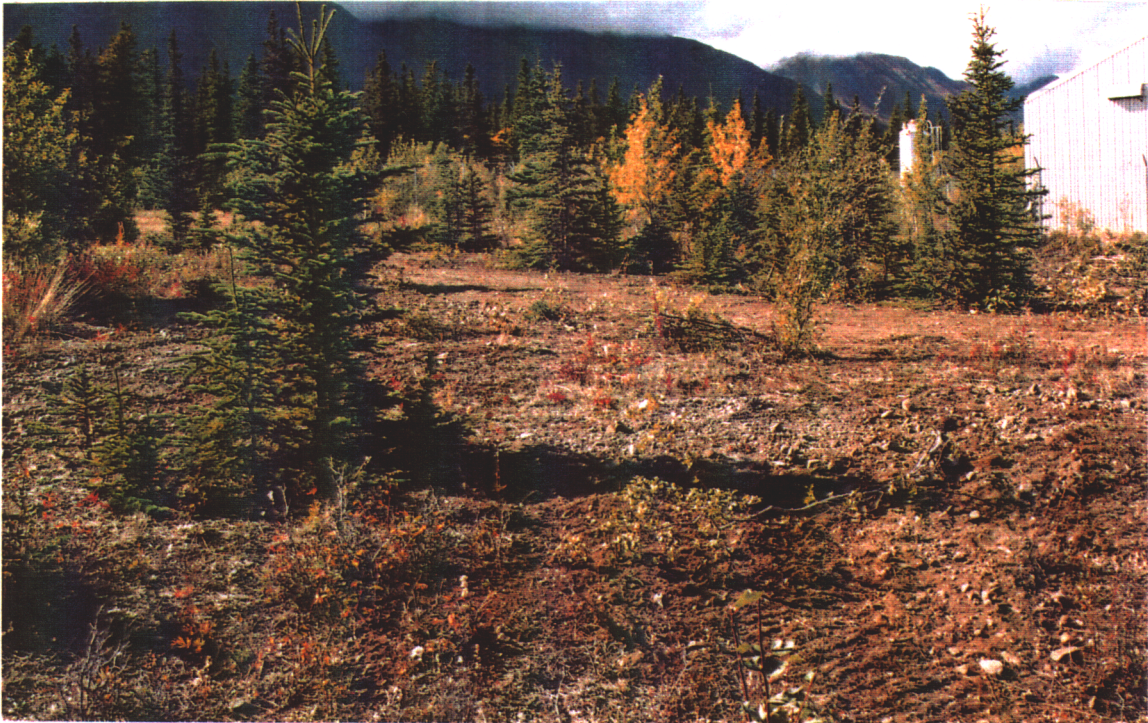
Photo 7 **Excavation #3** - Further south of the main building.
No buried drums were located in this area.

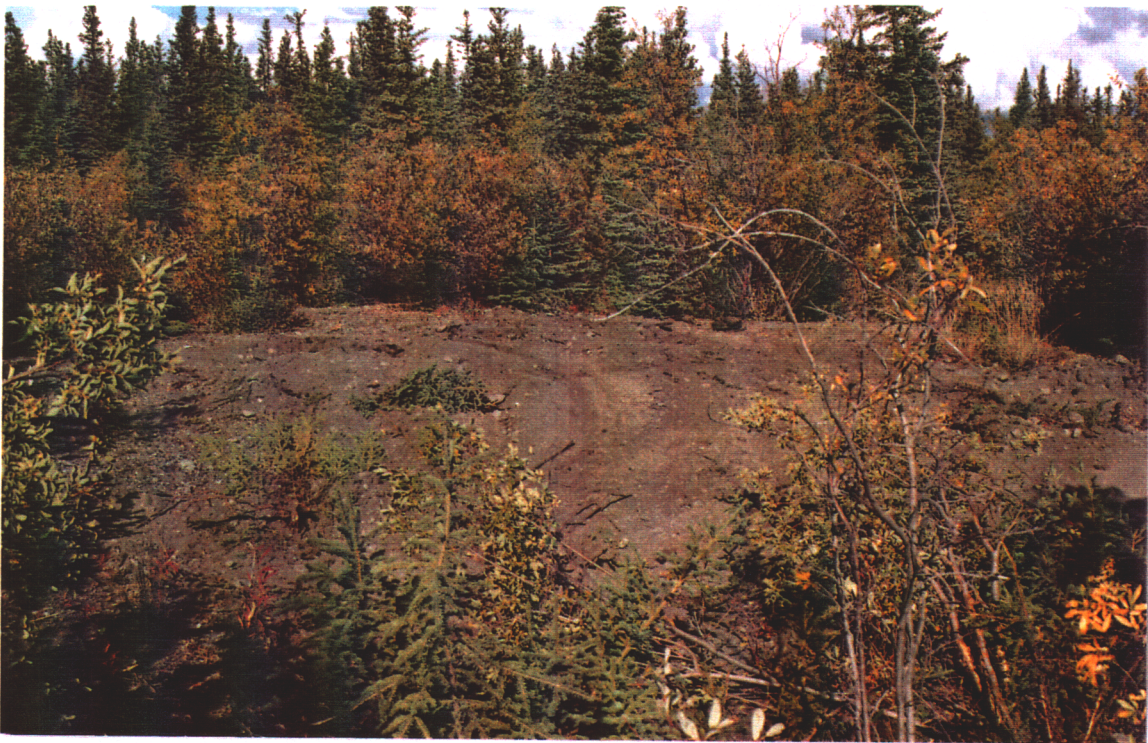
Photo 8 **Final Excavation #7** - Northwest corner of property.
No buried drums were located in this area.
Soil staining was evident. (See Analytical Results)

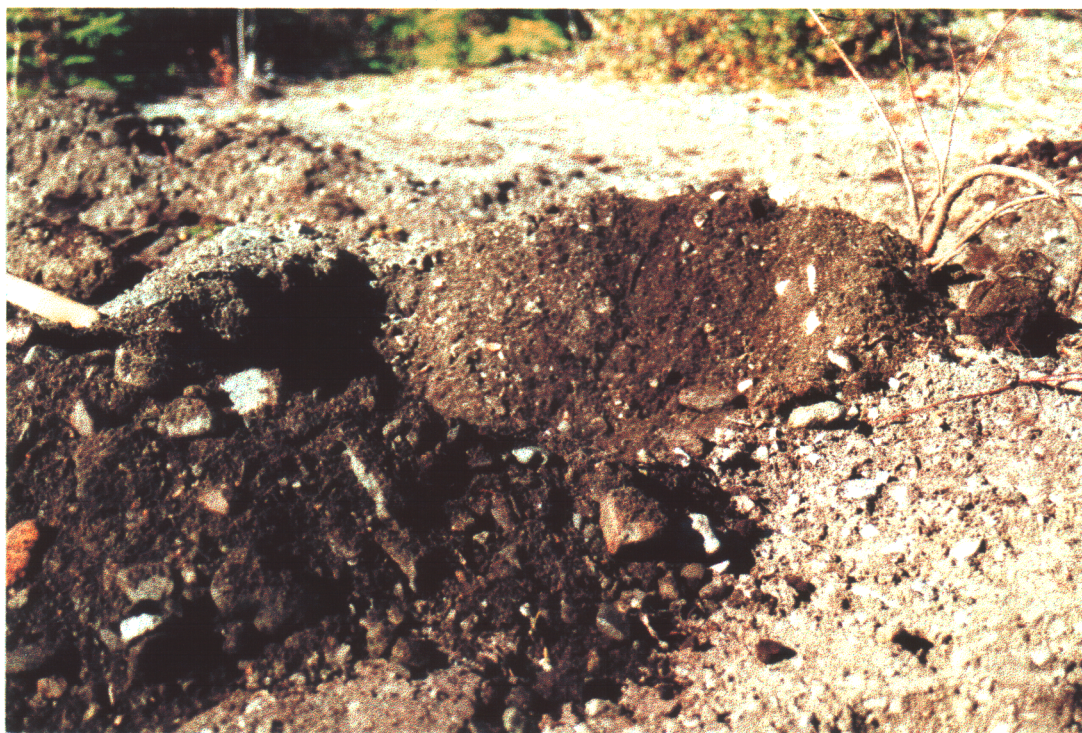
Light/Heavy Petroleum Hydrocarbons - (LEPHs) soil concentrations were recorded at 14, 15, and 56 ug/g; Yukon Contaminated sites Regulations, 1996, Schedule 1 Generic Numerical Soil standards pg. 30, states a 1000 ug/g soil concentration limit for LEPHs. **(HEPHs)** soil concentrations were recorded at 41 ug/g; Yukon Contaminated Sites Regulations, 1996, Schedule 1 Generic Numerical Soil Standards pg. 30, states a 1000 ug/g soil concentration limit for HEPHs on park land.

Photo 9. Contaminated Soil - *Located in the Northwest Corner of the property.*
- Quantity unknown,
- Containing hydrocarbons.

Groundtrax (Yukon) Inc., *Environmental Systems* recommends to maintain awareness that hydrocarbon contamination is evident on-site at concentrations of at least 56 ug/g.
