**1997 Environmental Investigations along the
Canol Road**

Prepared For:
Ross River Dena Council

Prepared By:
Gartner Lee Limited

May, 1998

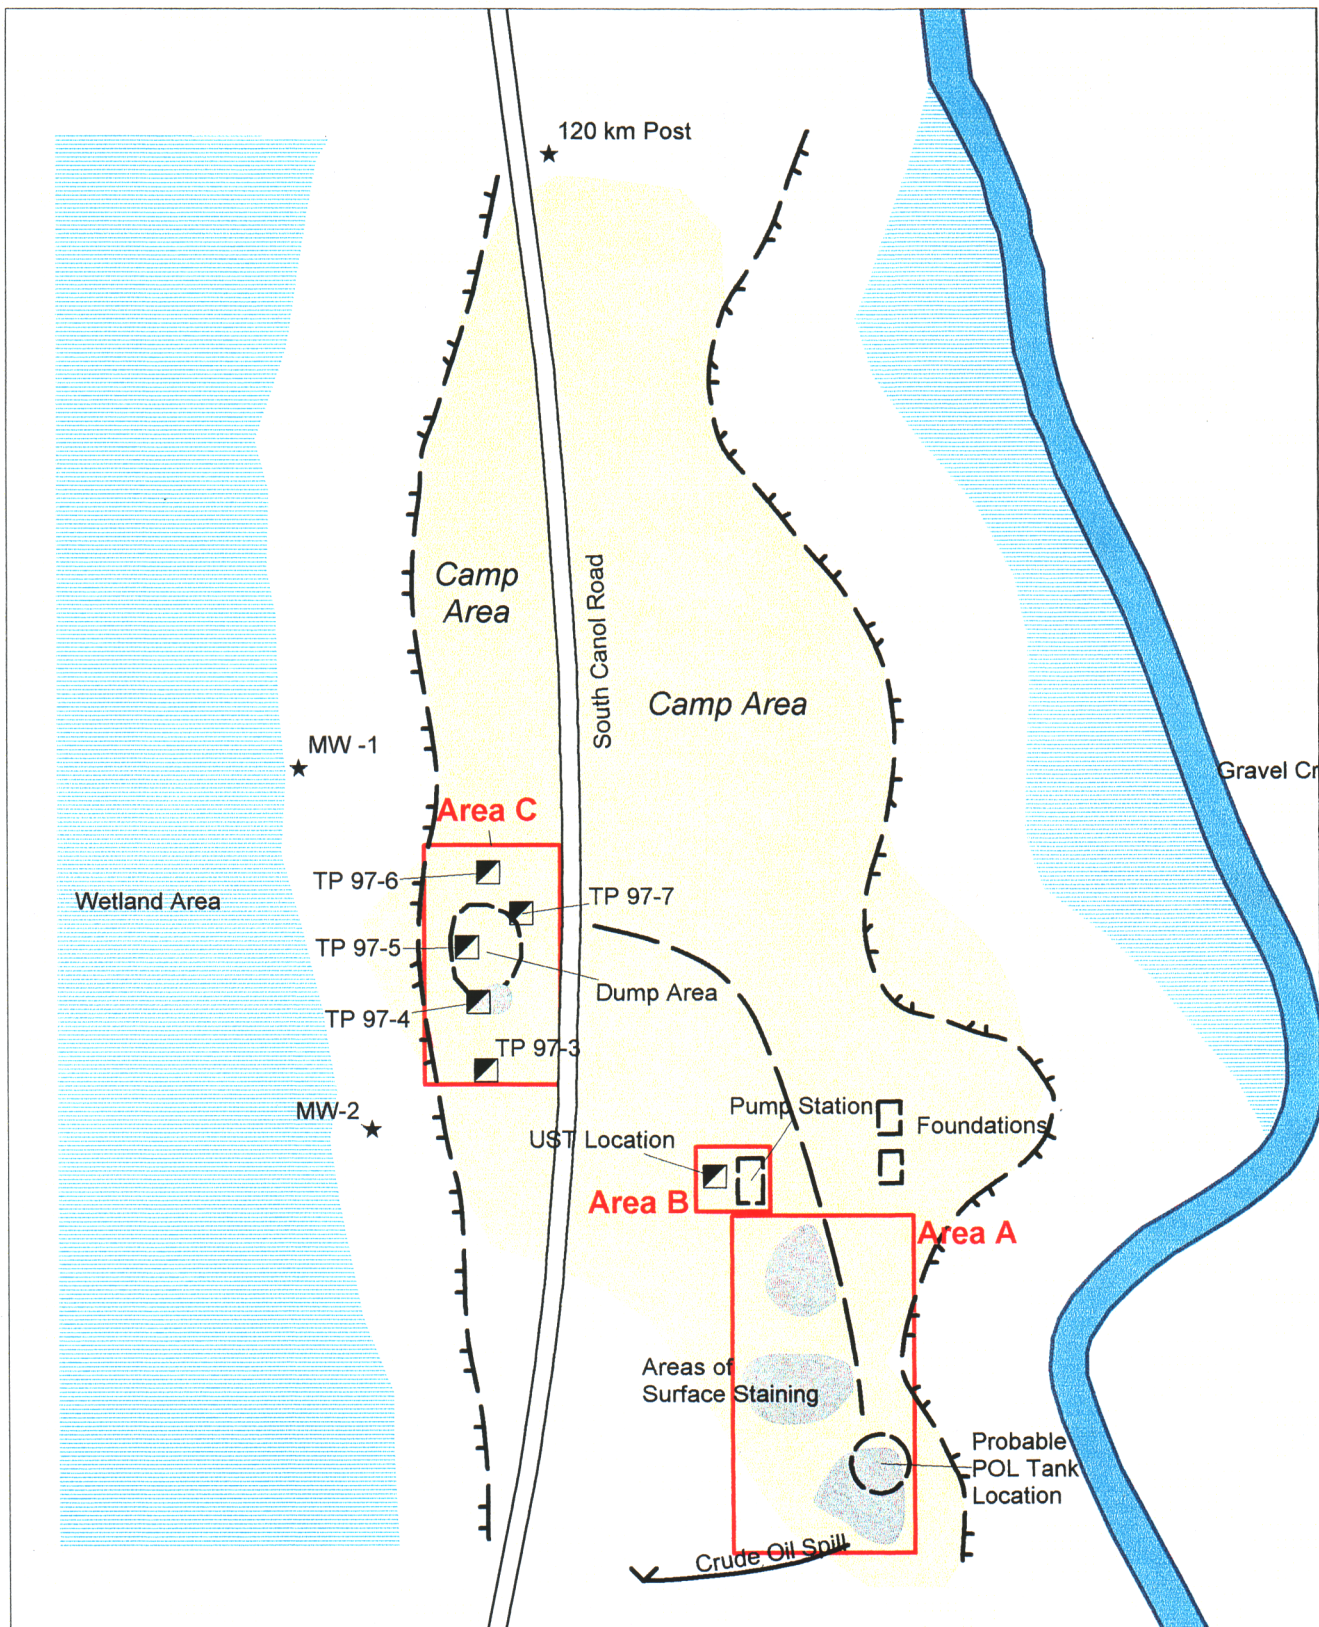
The site is found on both sides of the road (see Figure 4) with the east site formerly occupied by a pumping station and the west side being an abandoned camp dump. A gravel access road provides access while the west side of the site is partially cleared.

1. soils in excess of 2 m in depth around the POL tank site (Area A in Figure 4) have been impacted by petroleum hydrocarbons at concentrations which exceed the Parkland and Industrial criteria;
2. an Underground Storage Tank (UST) is located adjacent to the pump station foundation (Area B in Figure 4) and the soils beneath the tank have been impacted by petroleum hydrocarbons at concentrations which exceed Special Waste criteria;

The dump site area has been defined as shown in Figure 4 with an extent of approximately 25 x 20 m.
Debris has been encountered in test pitting up to 1.5 m below the surface. The dumps site was found to
contain drums of grease and motor oil (Phillip sample ID 97031496). These drums represent potential
sources of contamination since they contain free hydrocarbon product. Soil samples from the dump site

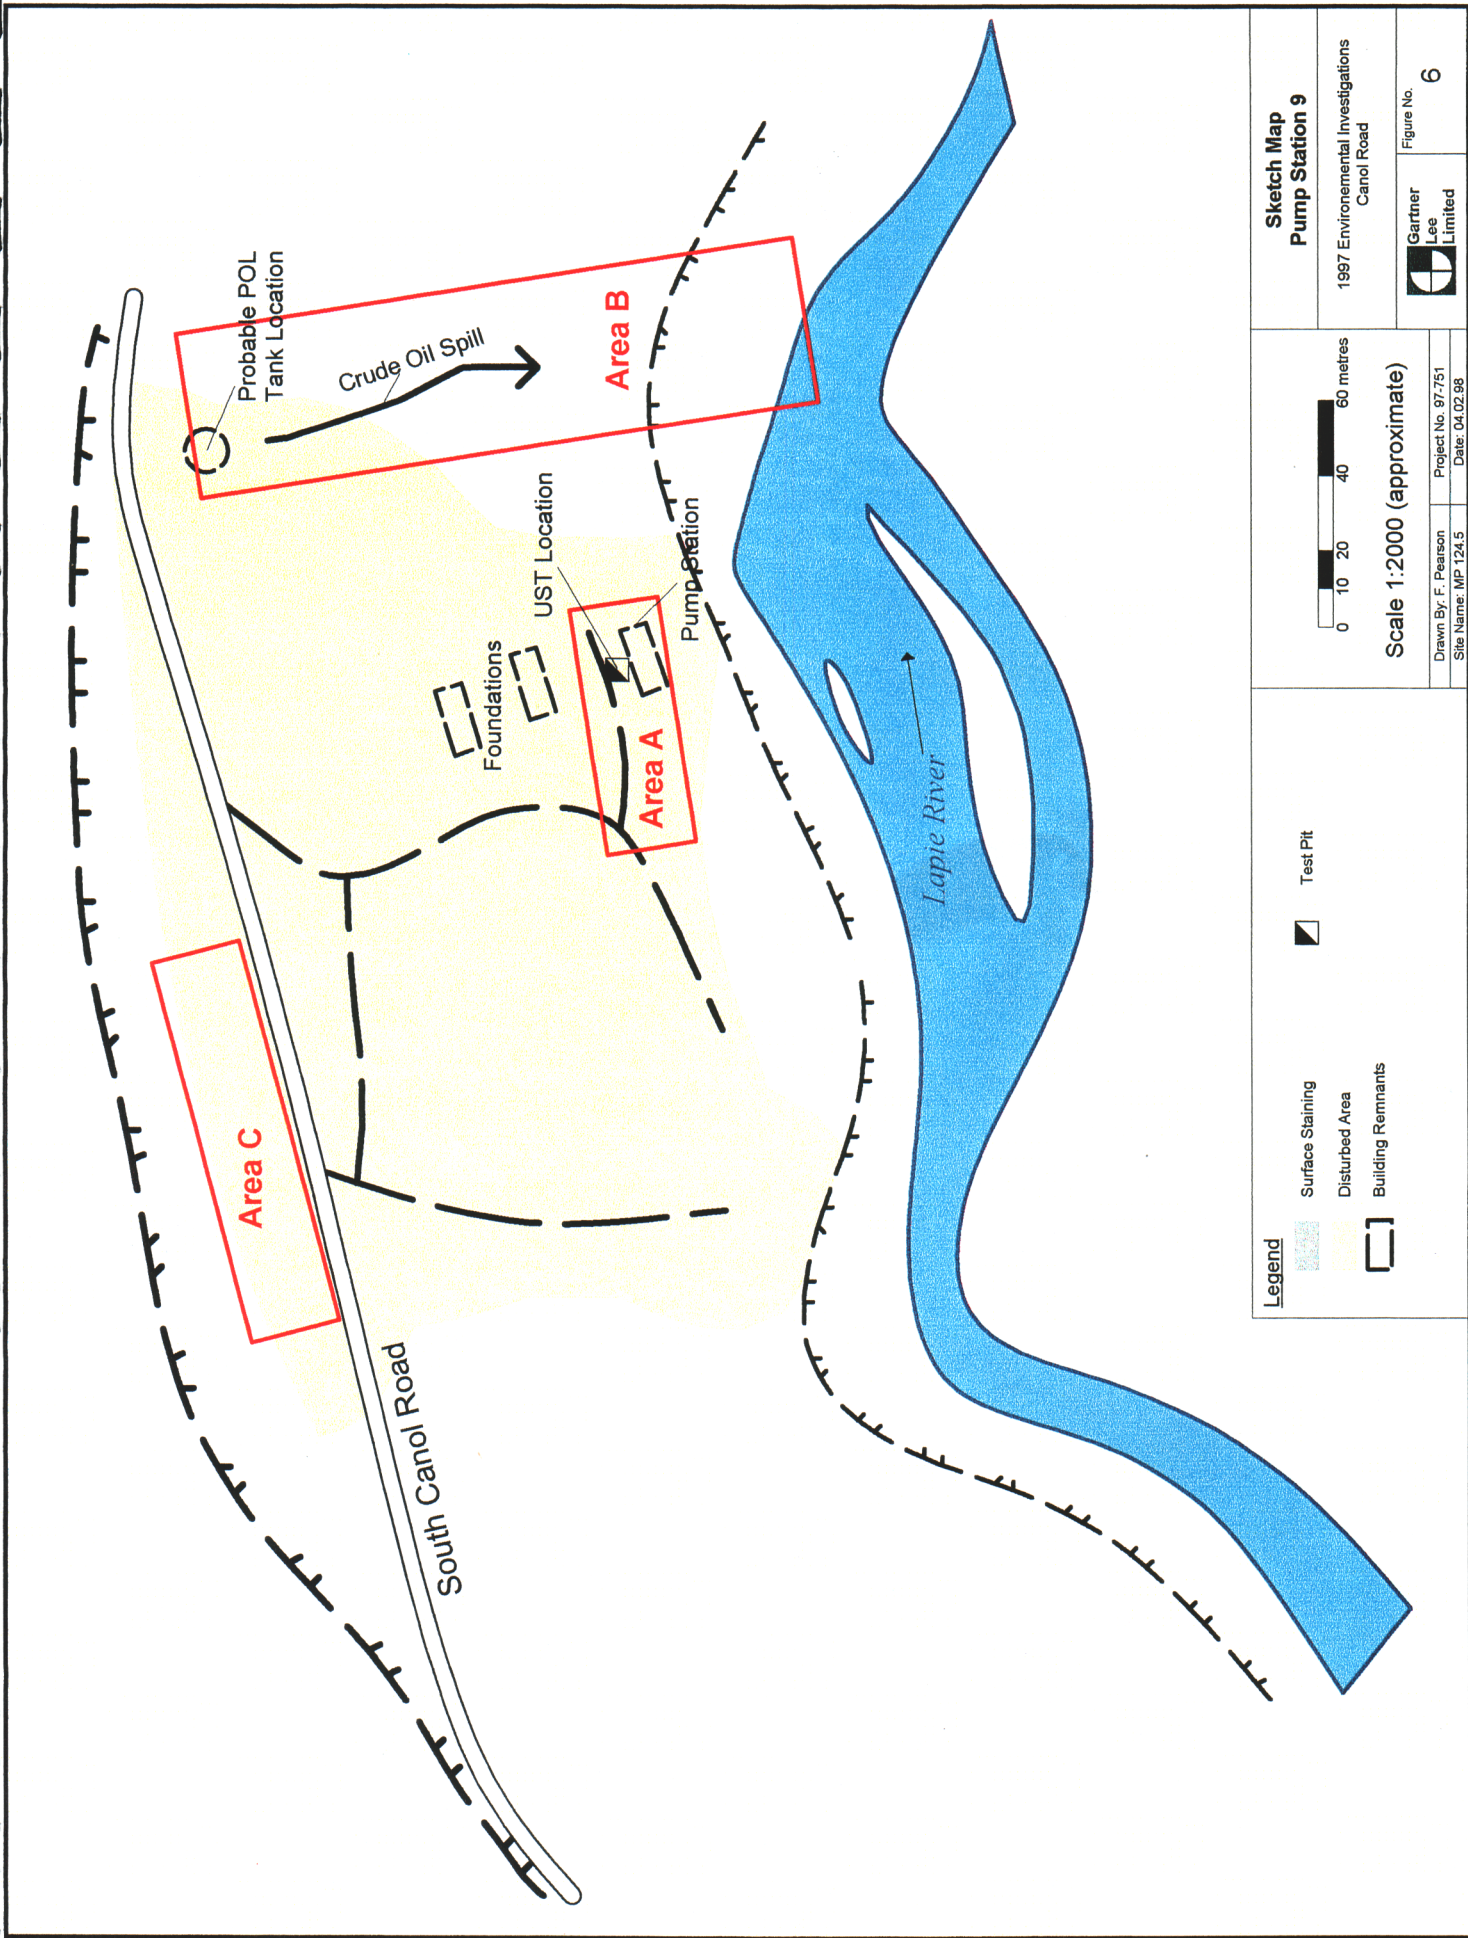
Figure No.
5

Remnants of the pumping station were observed at east end of the site, on the south side of the Canol Road adjacent to the Lapie River (Figure 6). The buried area identified in Area B is now interpreted to be the location of the pump station's POL tank. There is dried crude oil in the swale leading south from the tank location towards the river. This is a typical source of contaminant associated with the POL tanks. The concrete foundations west of the pump station, identified in Area A, is most likely the footings for the "surge tank" seen along the Canol Trail in the Northwest Territories (RRMC, 1994).

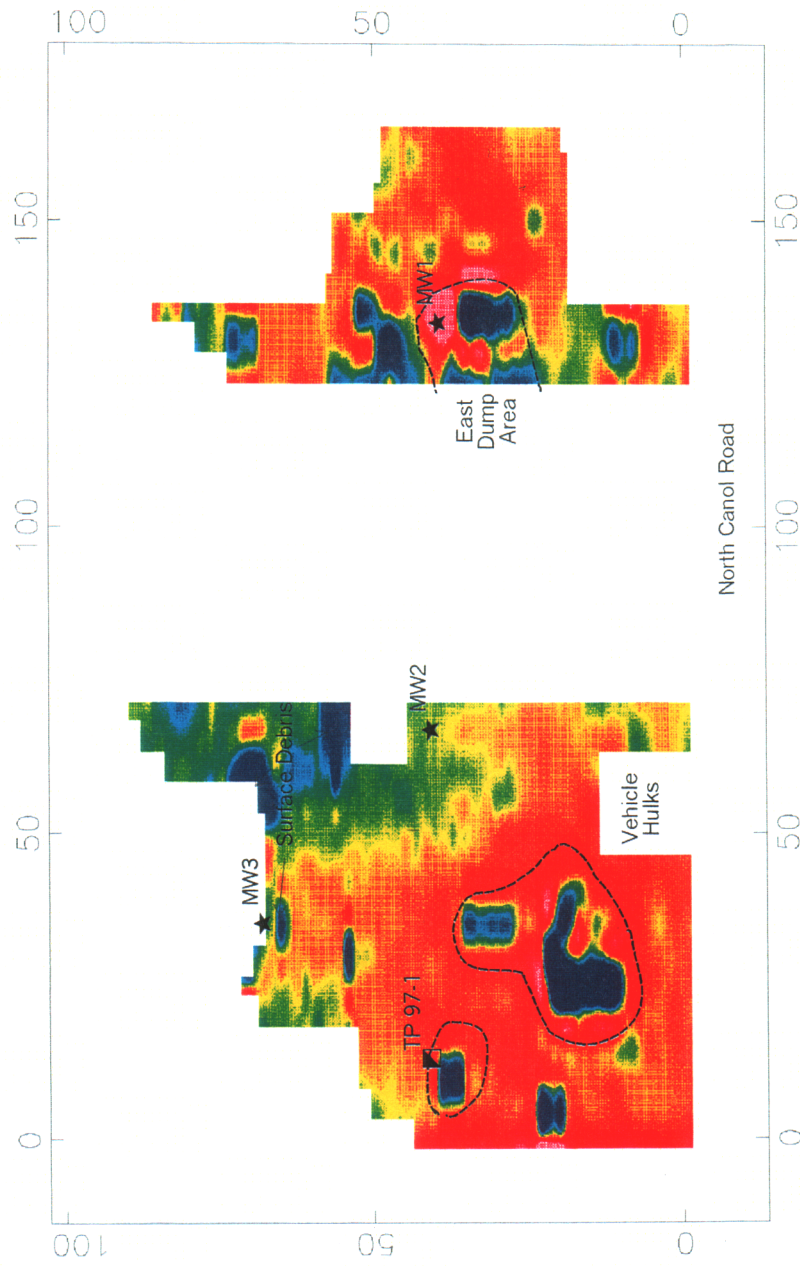
Mile Post 234 Terrain Conductivity (mS/m) DRAFT MAP

A second area to the east of the original burial had been found during excavation of MW-1. The geophysical survey has indicated an eastern extent to the buried material, but due to time constraints, the westerly limits of the dump area are yet to be determined. Soil sampling in this eastern dump area should be conducted to determine if soil contamination is associated with the burial of the metallic debris encountered.
