**PHASE II ENVIRONMENTAL SITE  
ASSESSMENTS  
Sites HJ035, HJ036 & HJ041  
Kluane Lake Area, YT**

0201-97-12447.1

Submitted to:  
Indian and Northern Affairs Canada

March, 1998

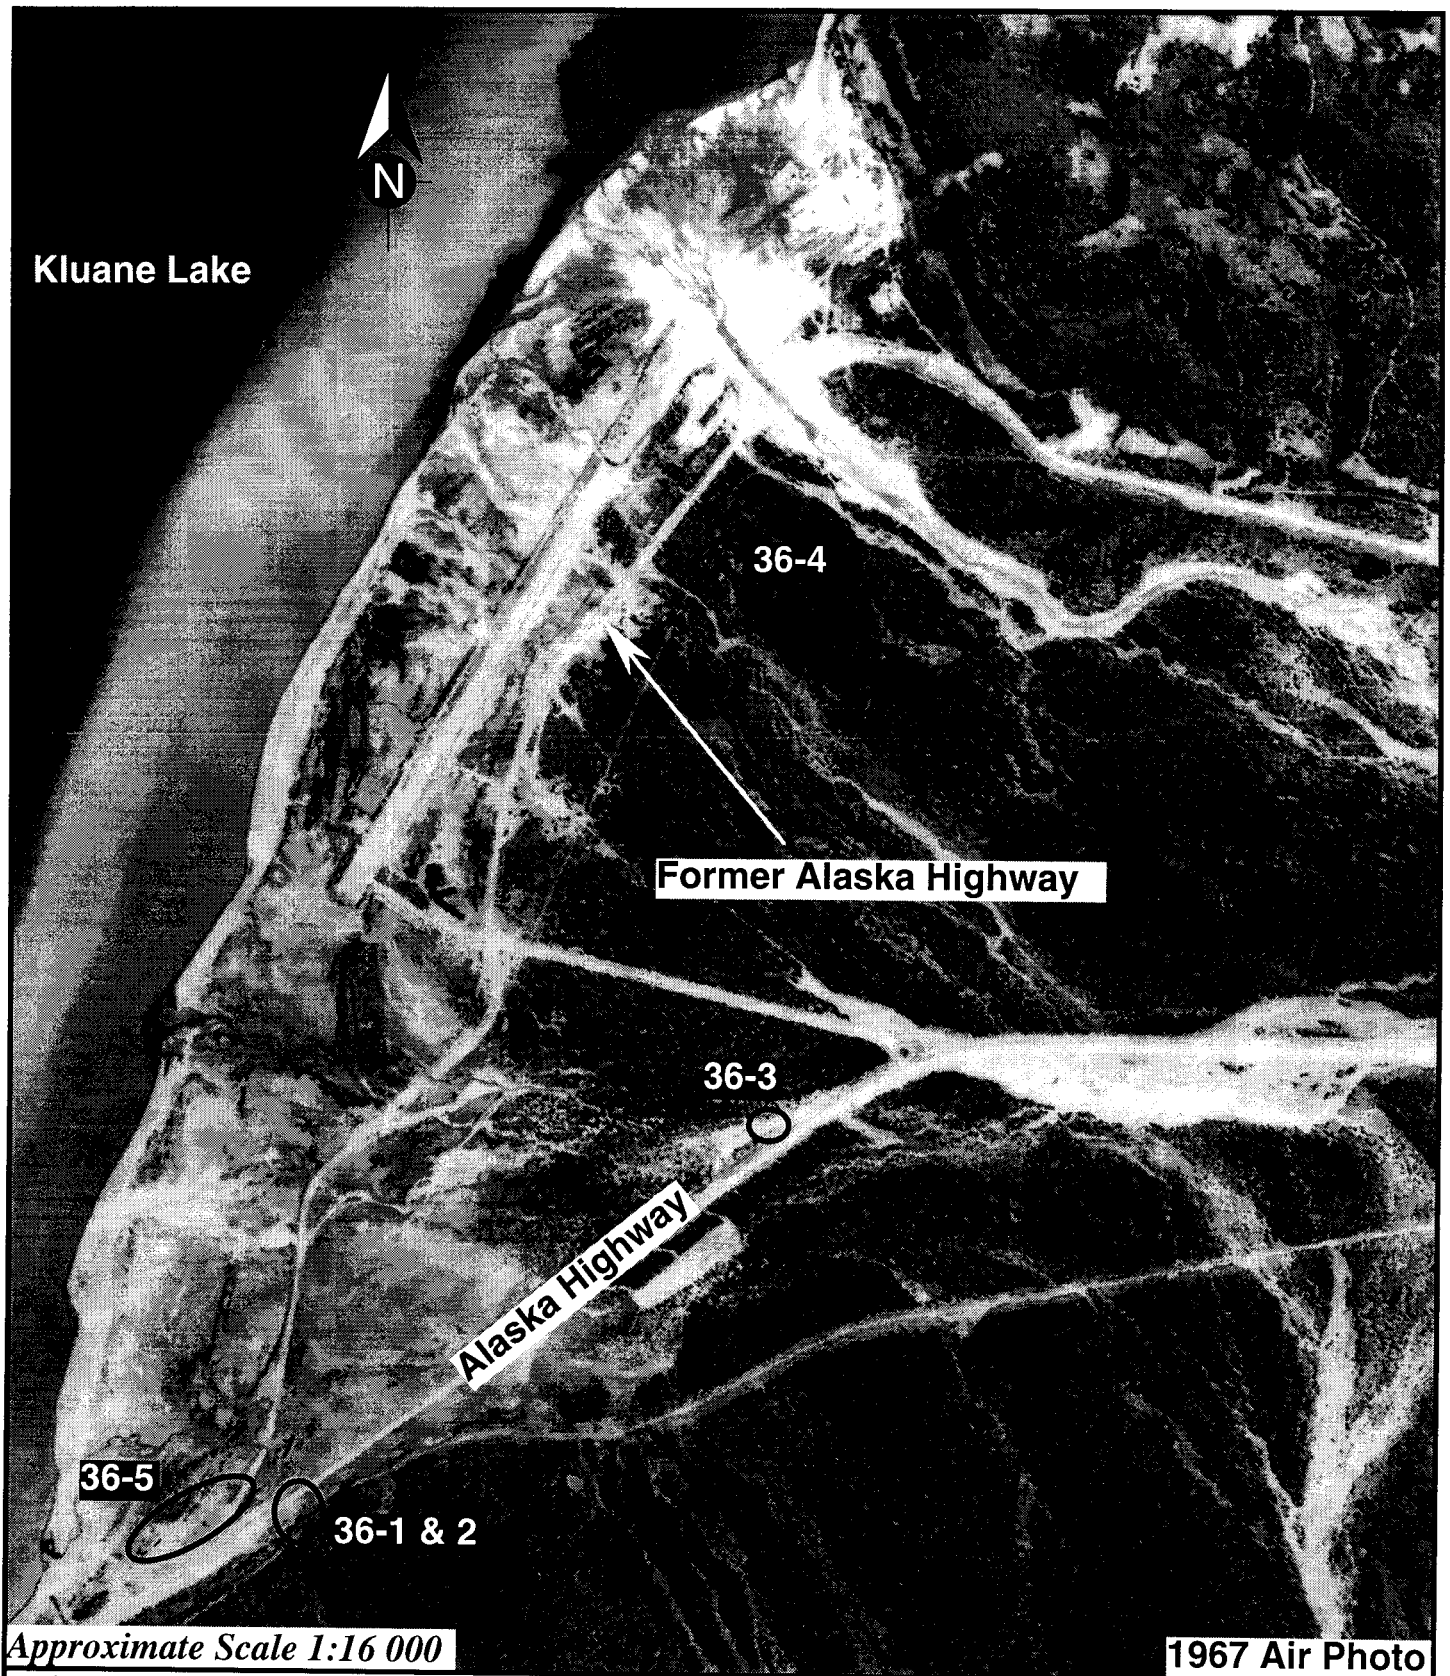
The Phase I work had identified two areas (Locations 36-1 & 36-2, Figure 5) of potential contamination at the former maintenance camp. 36-1 was a site where waste was reportedly burned and 36-2 was a site where drums had been stored (Edey, 1976). A solid waste disposal site (36-3) was later identified, this site had remained active until the spring of 1997.

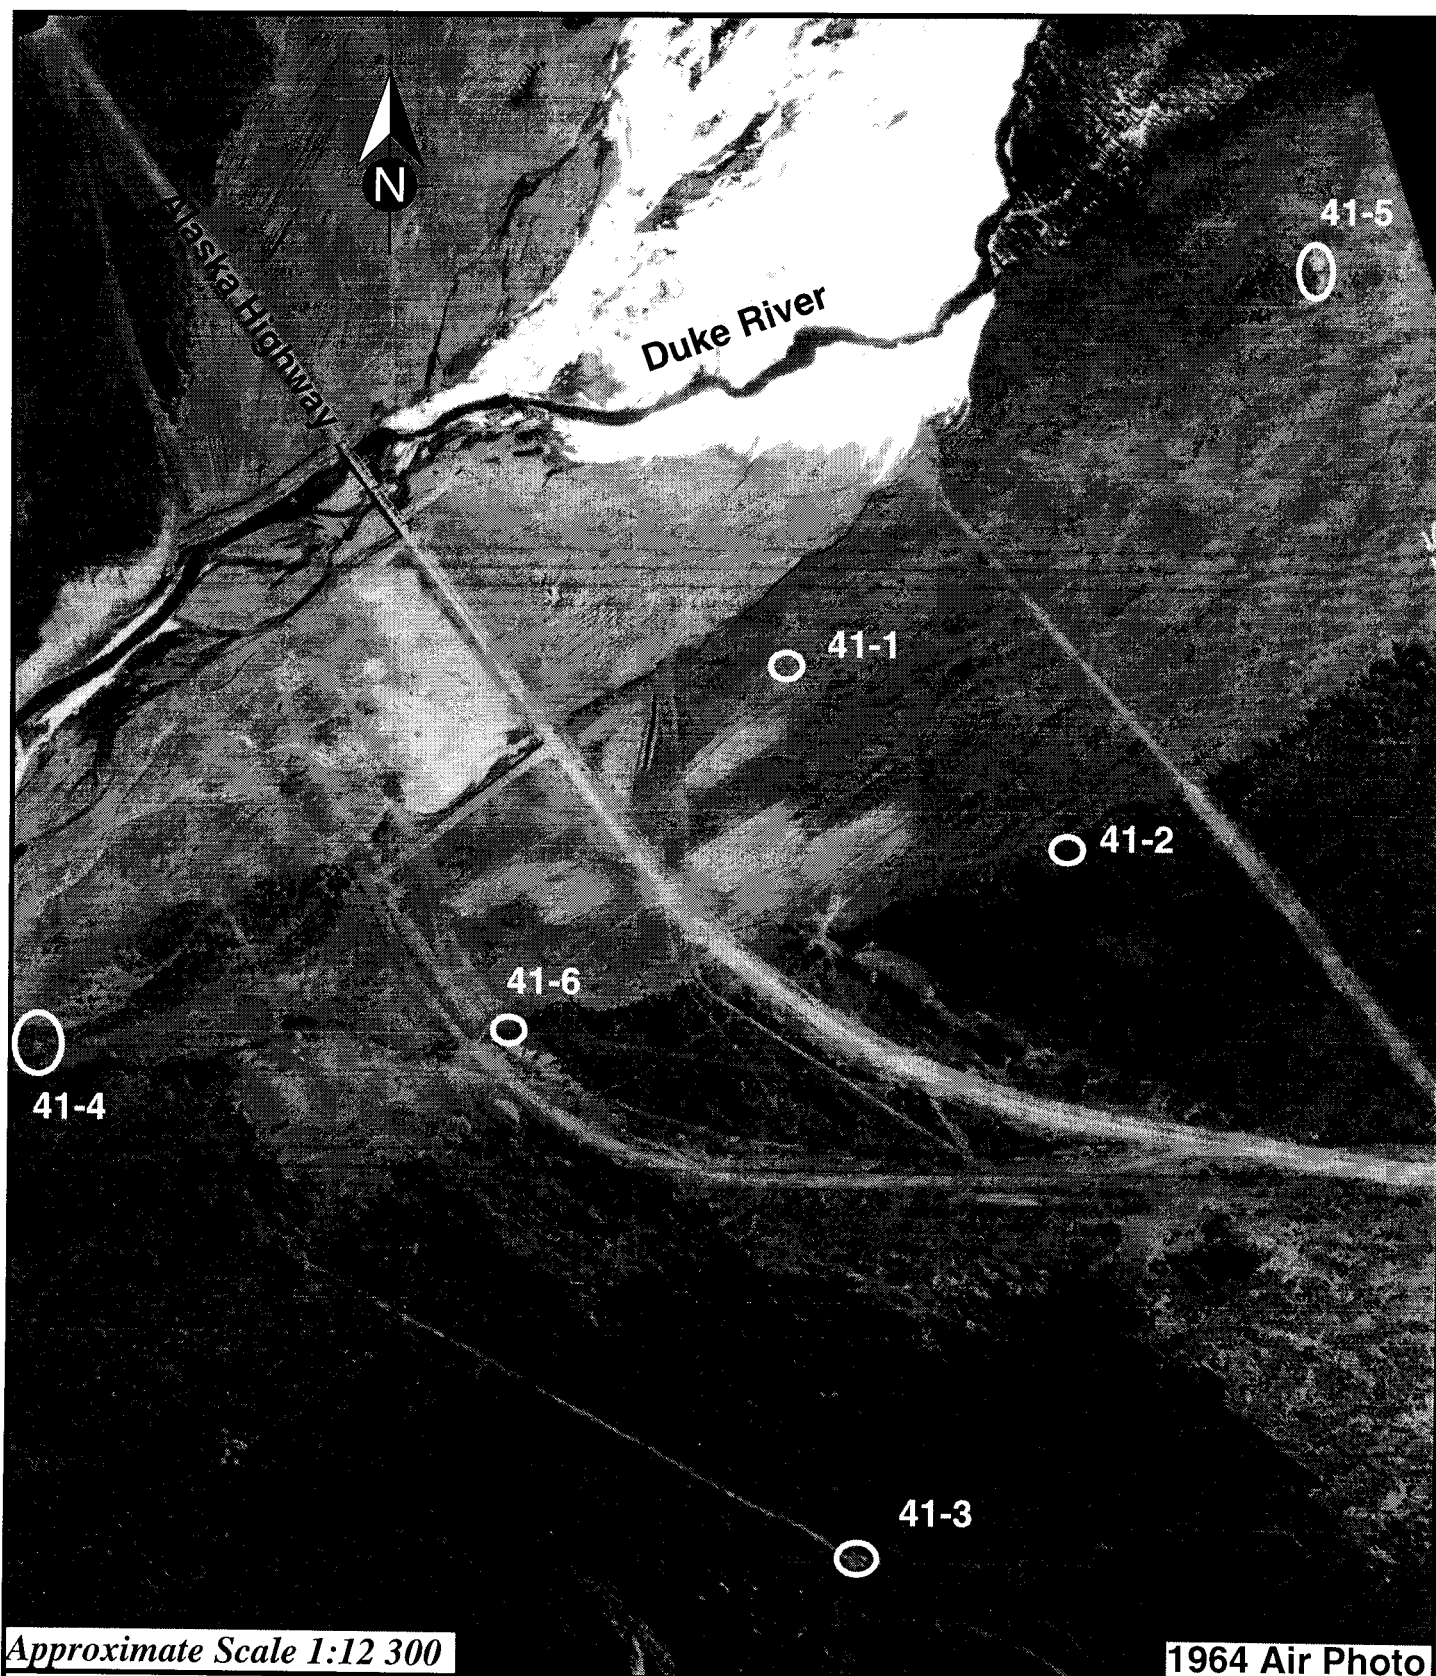
Location 41-4 is along the east bank of the Duke River as shown in Figure 8. There were drums and containers throughout the site. These had generally been crushed or had one end removed. There were no signs of staining or stressed vegetation. Based on the mature spruce and the lack of evidence of ground disturbance soil vapour testing was used to investigate the near surface soils. No drilling or soil sampling for laboratory analysis was undertaken for this location.

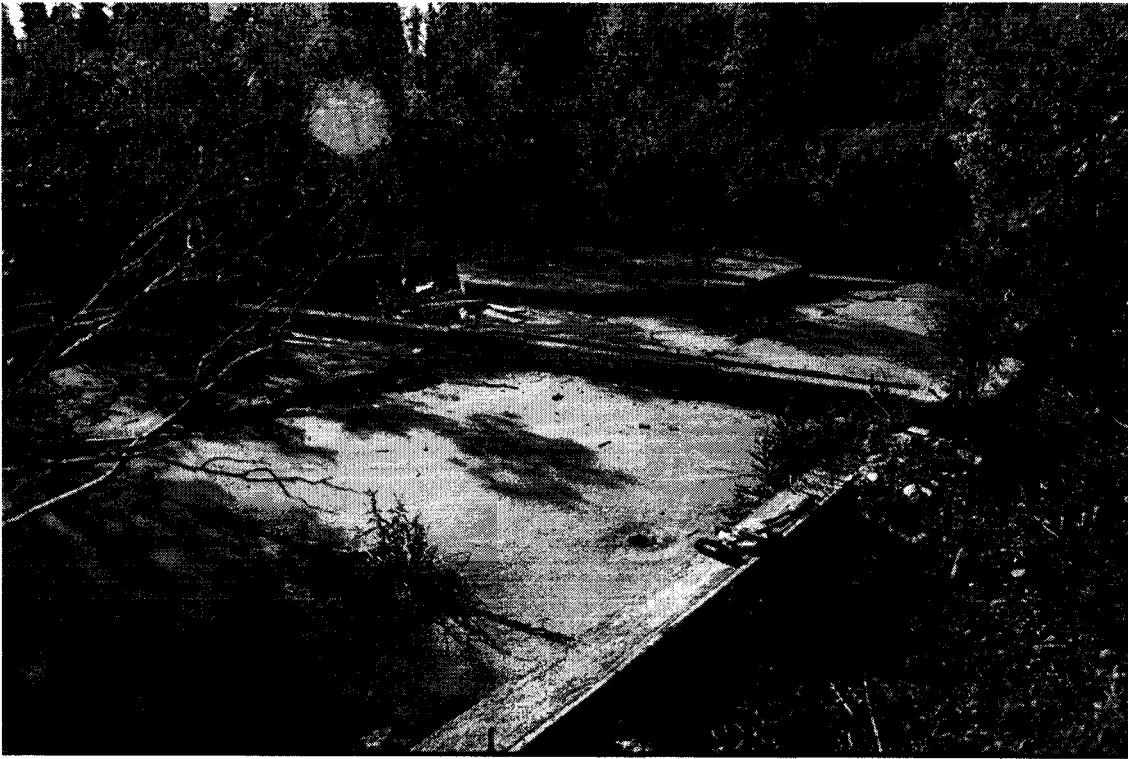
The pipeline is reported (Bisset, 1995) to have operated from November 23, 1943 to the mid 1950's and to have been dismantled in 1962, Pump Station D (which was reportedly never in operation) is located adjacent to the former alignment of the Alaska Highway (Figure 3), the current alignment is approximately 200 m away. The remains of concrete building foundations are still visible as shown in Photographs #1 & 2.

**Photograph 1:** Site HJ035 showing concrete foundation remains at west end of site.

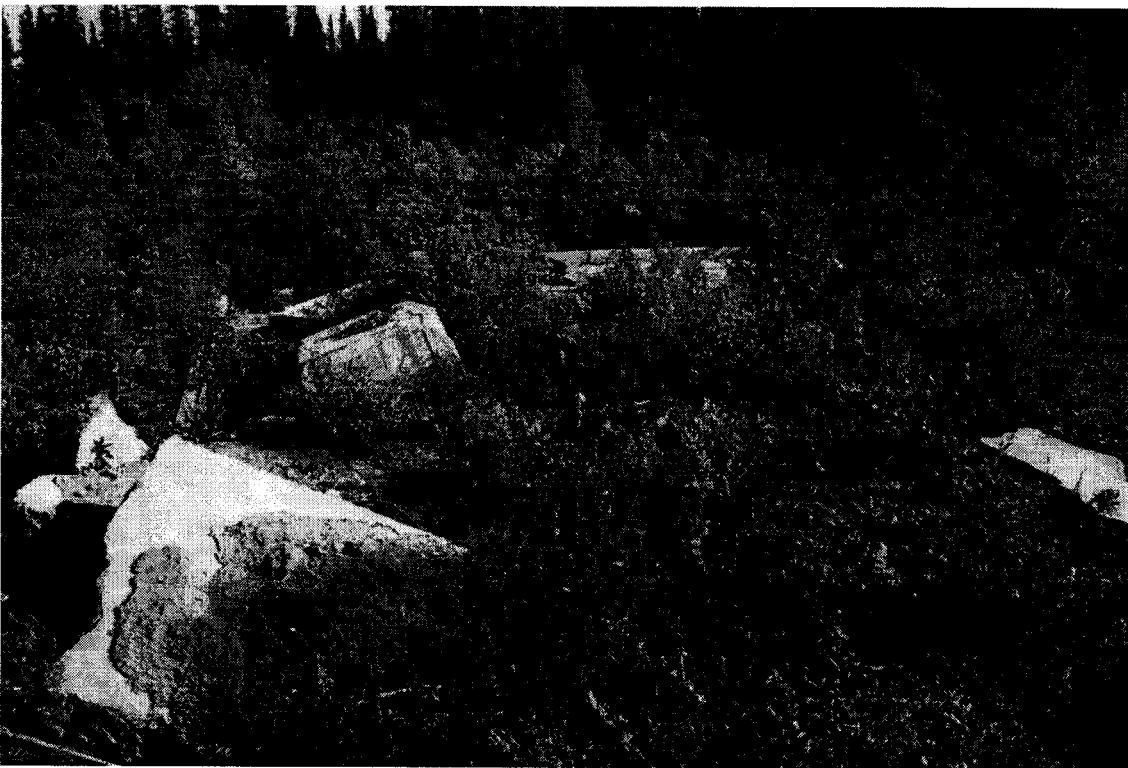
**Photograph 2:** Site HJ035 showing concrete foundation remains in center of site.

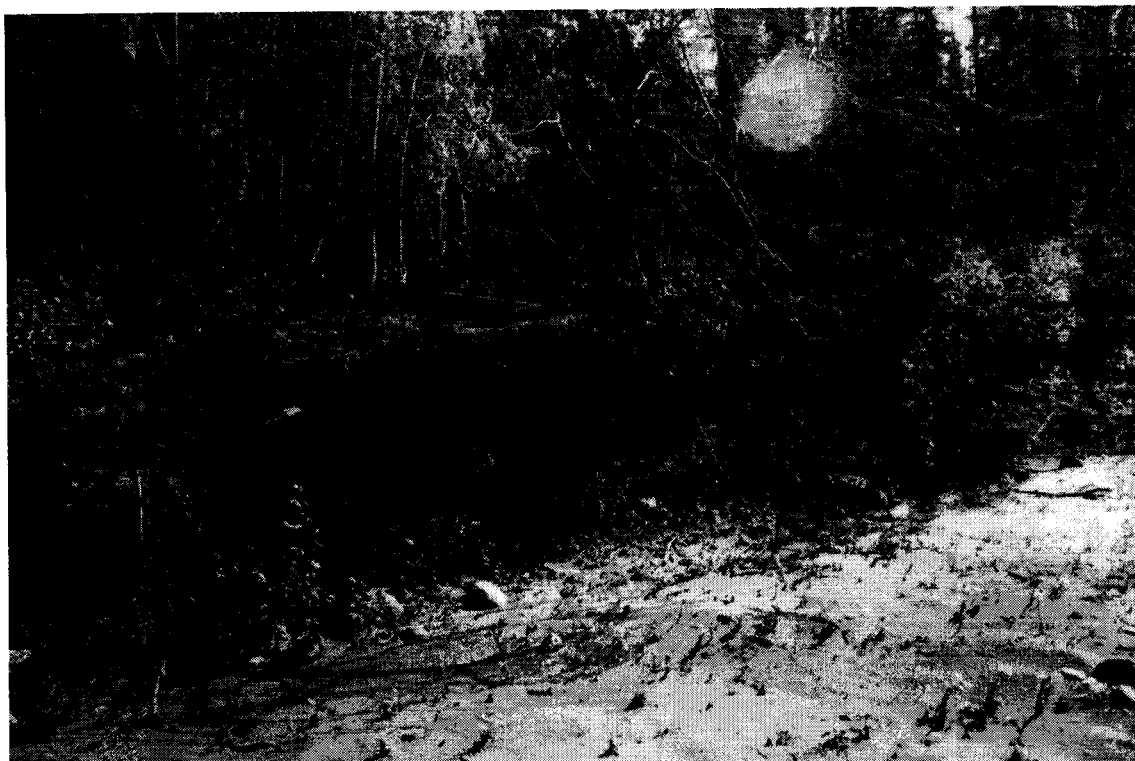
Wastes found at Location 41-4 were mainly drums, wire and scrap metal. These were scattered along the eastern bank of the Duke River and approximately 40 m into the wooded area along the bank. There was no evidence of wastes being buried at this location although the Duke River appears to be eroding the western edge of the site and wastes are evident along the bank (Photograph # 5). There was no visible staining and no vegetation stress was observed. The site is accessible by vehicle from the original camp.

**Photograph 5:** Site HJ041-4 showing drums and waste metal scattered along bank of Duke R.

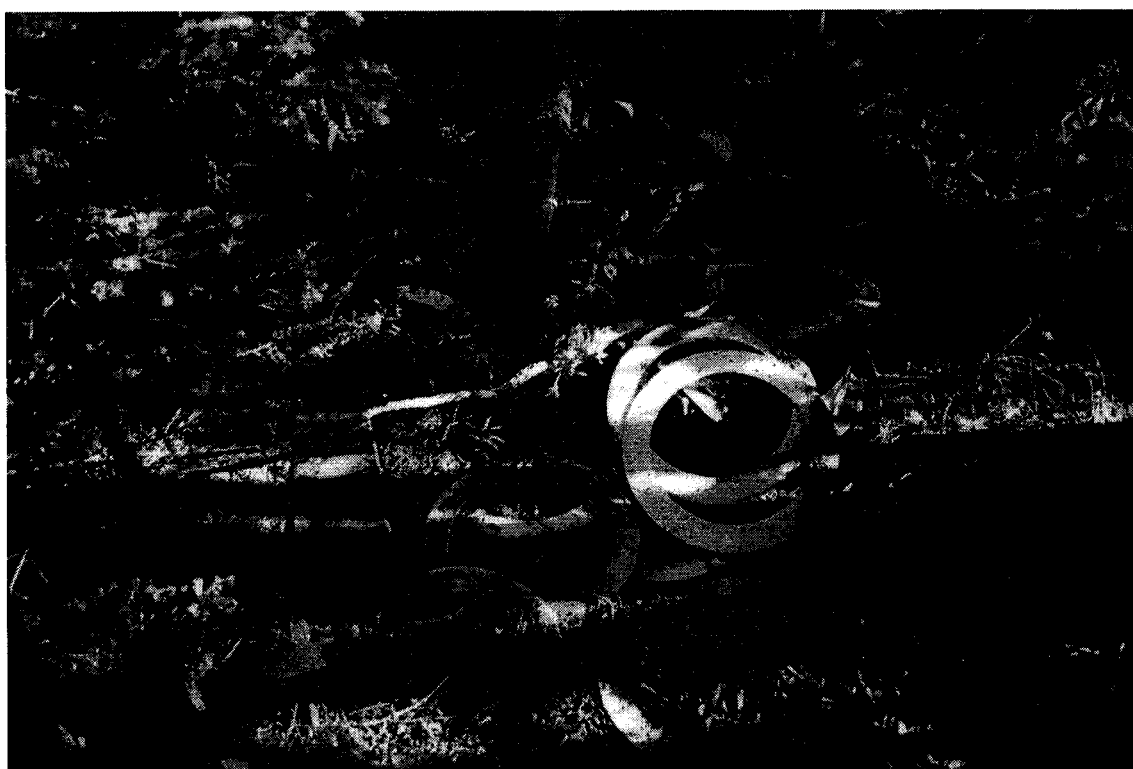
Location 41-6 is a small area adjacent to the former camp site. The small amount of waste at this location appeared to be associated with vehicle parts and repairs. There were no signs of staining in the area and no signs of stressed vegetation. No sampling was conducted at this location.

The second contaminant was the asbestos brake pads found at 41-6. Friable asbestos fibres are a human carcinogen. The brake pads are currently intact and are not creating an environmental risk, however, they should be considered a human health concern as long as they remain accessible.

**Photograph 6:** Site HJ041-6 showing asbestos brake pads and scrap metal.

Asbestos material found at 41-6 should be double bagged and buried as per protocols for disposal of asbestos.

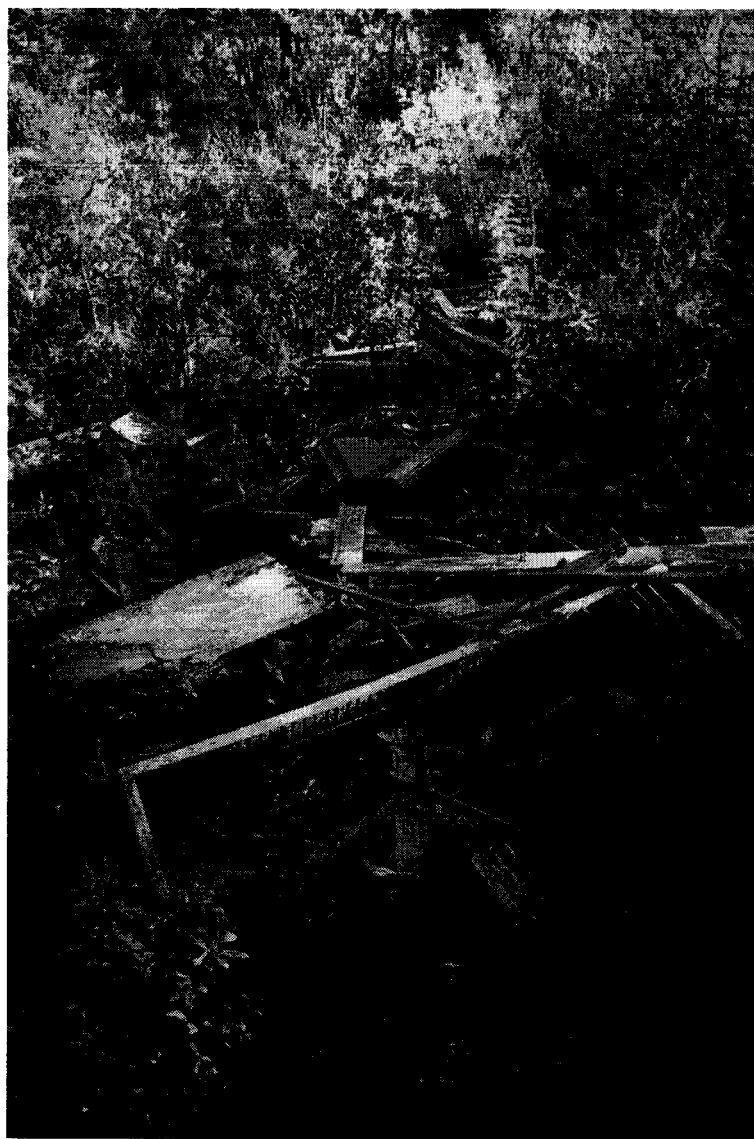
Location 41-3 was an area identified by Edey, 1976. The material present was mainly wood debris (Photographs # 7 & 8) with some small cans and other miscellaneous wastes which are scattered on the surface of the ground. Based on the extent of deterioration of the wood it is suspected that this site was not from the same era as the maintenance camp. Trails accessing the site were impassable by vehicle due to standing water. The area is overgrown with willow and immature spruce. The surrounding area has been used for cutting firewood, this does not appear to have disturbed the actual waste disposal site.

**Photograph 7:** Site HJ041-3 showing waste disposal site with wood and metal wastes.
