**A Preliminary Environmental Investigation
of Site HJ034 - Canyon Creek**

D. B. Craig, Consulting Engineer
and
W. J. Klassen and Associates Ltd.

February, 1998

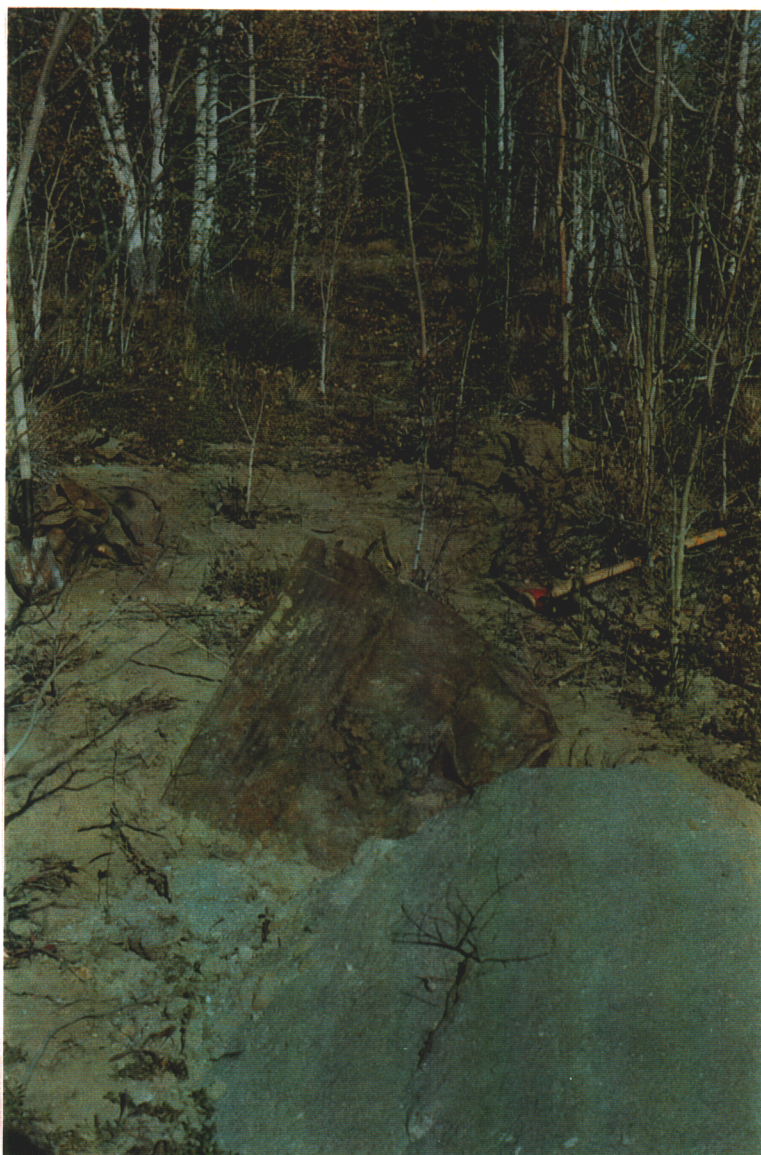
Test Pit Site 1 - A

There was an obvious shallow trench of approximately 100 m. in length and approximately 3 m. in width, trending southwesterly from the Old Alaska Highway. In the test pit dug where the EMI indicated the presence of bulky metallic materials in this shallow trench were found buried truck tires, a wheel hub, a flattened barrel, rusted metal cans of various sizes up to one gallon, 1 quart oil cans, and metal strapping.

Flattened 45 gallon drum found in test pit.

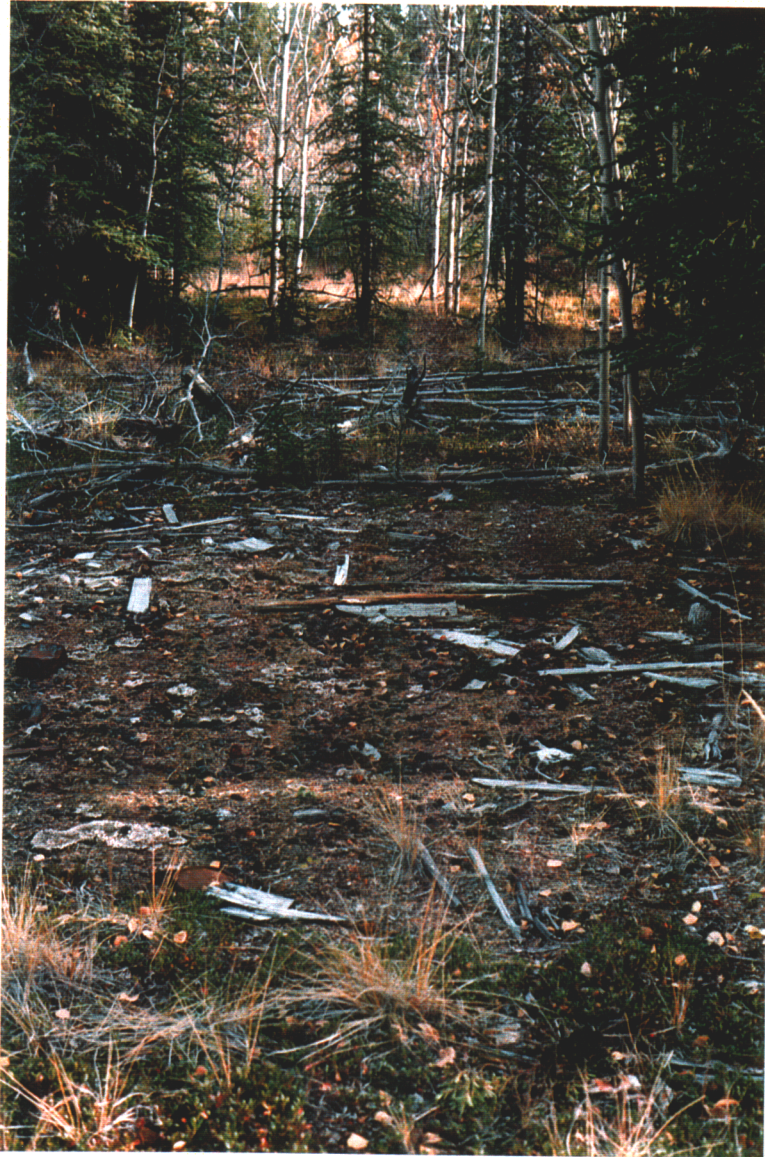
Test Pit Site 2 - A

This site is located on the north side of the Old Alaska Highway, where an area of approximately 100 m by 100 m of the somewhat disturbed ground surface is covered with a variety of scattered debris. It includes: rectangular U.S. military anti-freeze tins, food tins, 45 gallon drums, building material, partially-burned dimensional lumber, bottles, wire, broken crockery, a small quantity (less than .25 cu. m.) scattered asbestos shingles of the kind used for siding, and flattened cans.

The test pit was dug at a point where EMI indicated buried metal materials. Found in the test pit were a crumpled 45 gallon drum and a variety of bottles, cans, wire and other miscellaneous debris.

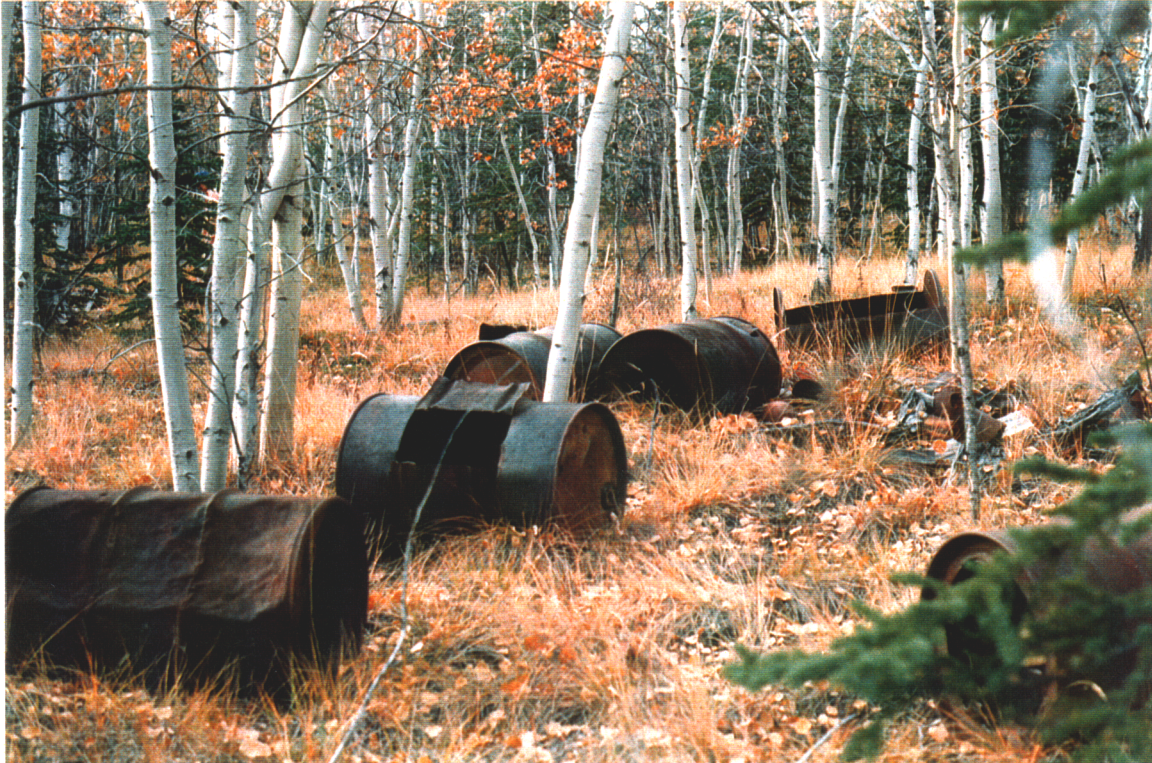
Site 3 - A

The surface garbage at this location consisted only of a group of six or more 45 gallon drums which had been modified for use as stoves and perhaps bathtubs in a stand of aspens. There was no evidence of any buried debris at this site.

- 6.1 The surface garbage and debris such as broken glass and sharp metal (Sites 3-A, 3-B, 3-C) should be removed and disposed of appropriately.
- 6.2 The standby generator slab and "well" (Site 4-B) should be removed. This work will require the use of loader with a backhoe. When this removal is being carried out, this location should be investigated for the presence of a buried fuel tank. The excavation on the north side of the slab should be filled and the site levelled.

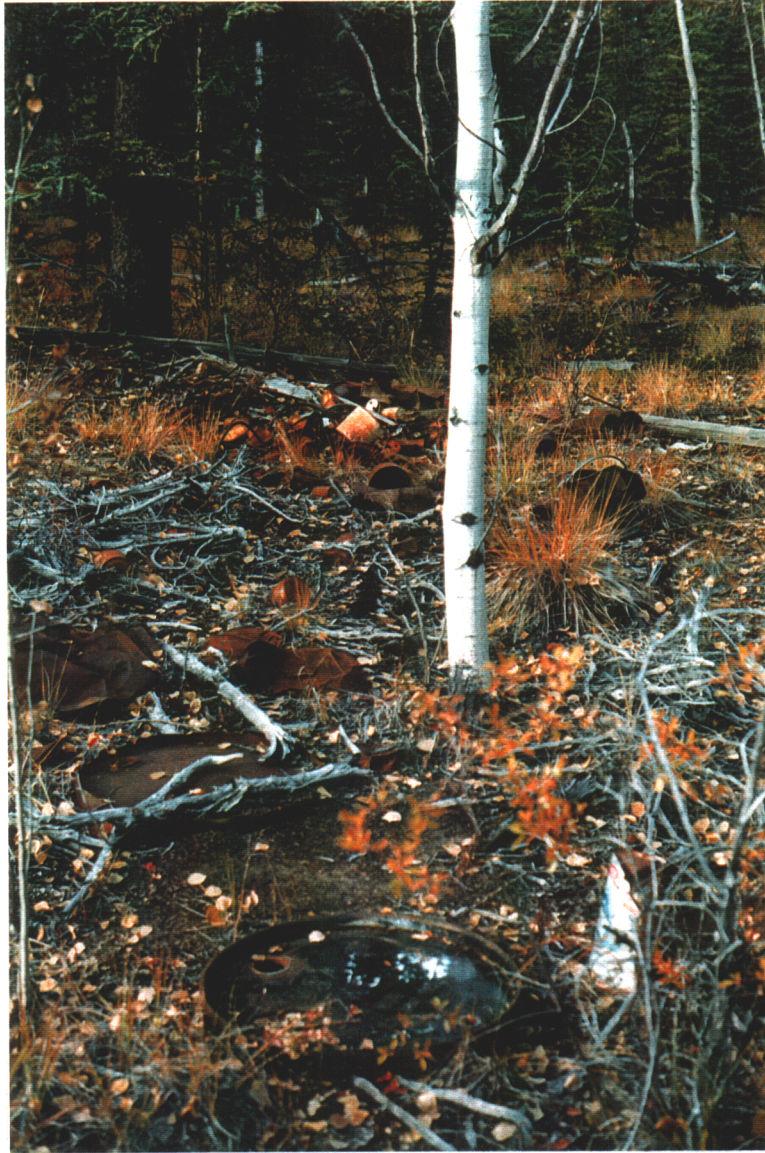
Site 3 - C

Surface garbage at this location included cans, bottles, cable, and oil drum tops at the base of a large mature white spruce. There was no evidence of any buried debris at this site.

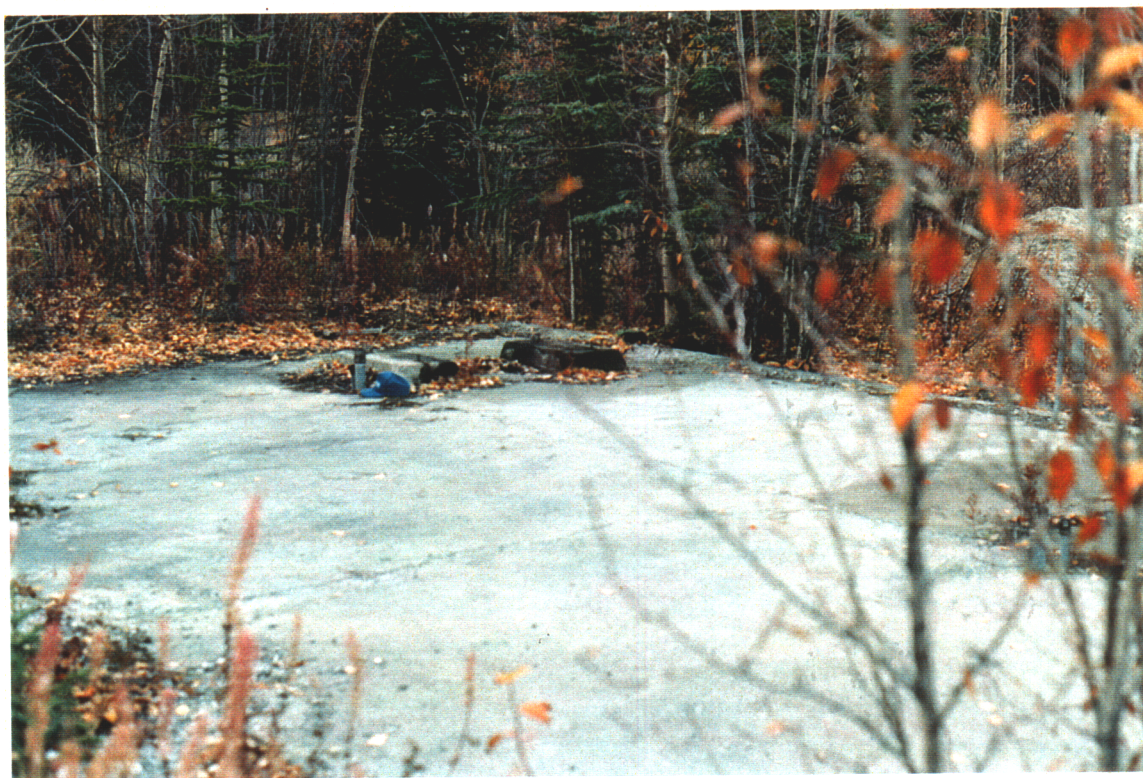
Site Test Pit 4 - B

The test pit at this site is immediately adjacent to the NW corner of the concrete slab of the former diesel plant building which itself is located 20 m. west of the fenced former repeater site. It would

appear that there may be a fuel tank buried beneath or adjacent to this slab. There is an old excavation on the north side of this slab surrounding a concrete "well," approximately 1.5 m. deep, at the bottom of which are visible copper lines, possibly leading to the fuel tank. The vertical pipe in this well may have been for filling the tank. (Not having anticipated a buried tank at this site we did not have with us the means to determine if the vertical pipe lead to a tank and, if so, were there petroleum products in it.) There was no soil discolouration in the test pit nor in the excavation although the concrete slab appears to be discoloured by petroleum products. There appears to be an oil sump in the slab adjacent to the engine mount bolts.

Slab foundation of generator building.

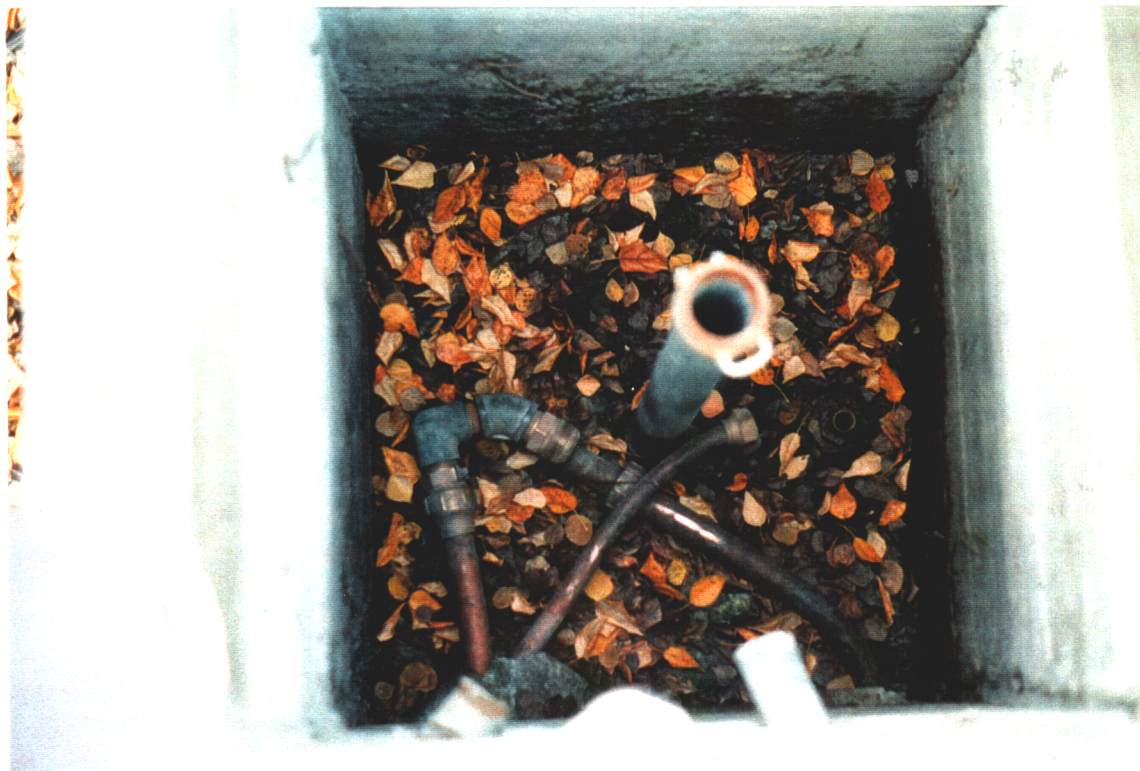
Concrete well with copper fuel lines.

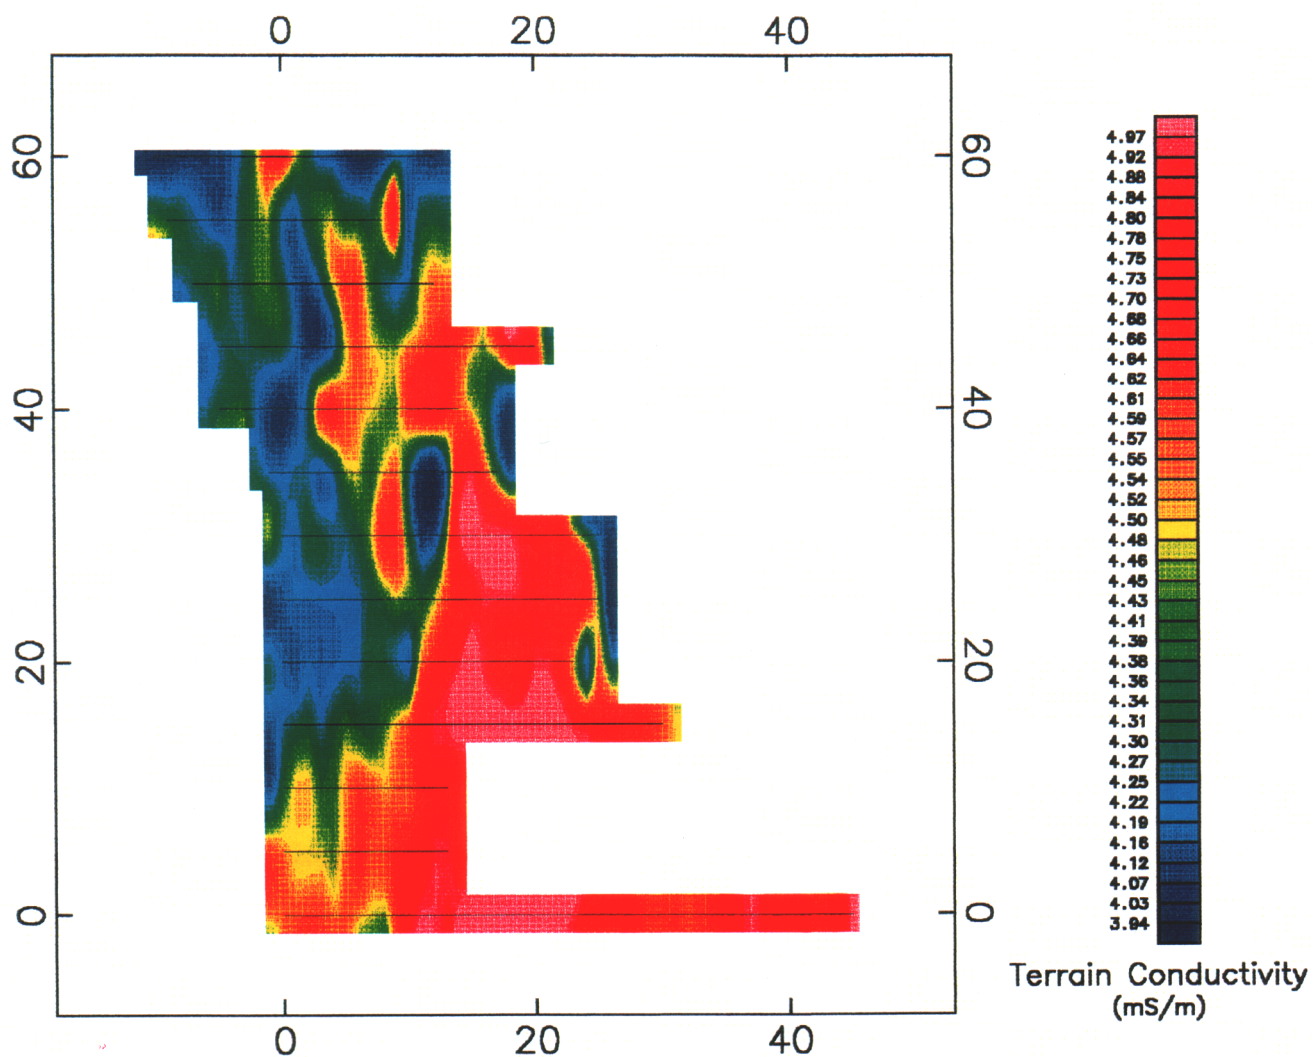
Figure 3a: Canyon Site MDA-3A
Terrain Conductivity

Figure 3a represents the terrain conductivity over this site. Again, terrain conductivities are low, in the 3-4 mS/m range which is in accordance with the soils in this area. A conductivity high can be seen in the lower right (northwest side) of the map; this corresponds with the shallow swale northwest of the clearing. This could be due to higher moisture content in the soils or perhaps finer grained soils. No significant anomalies are visible in this survey.

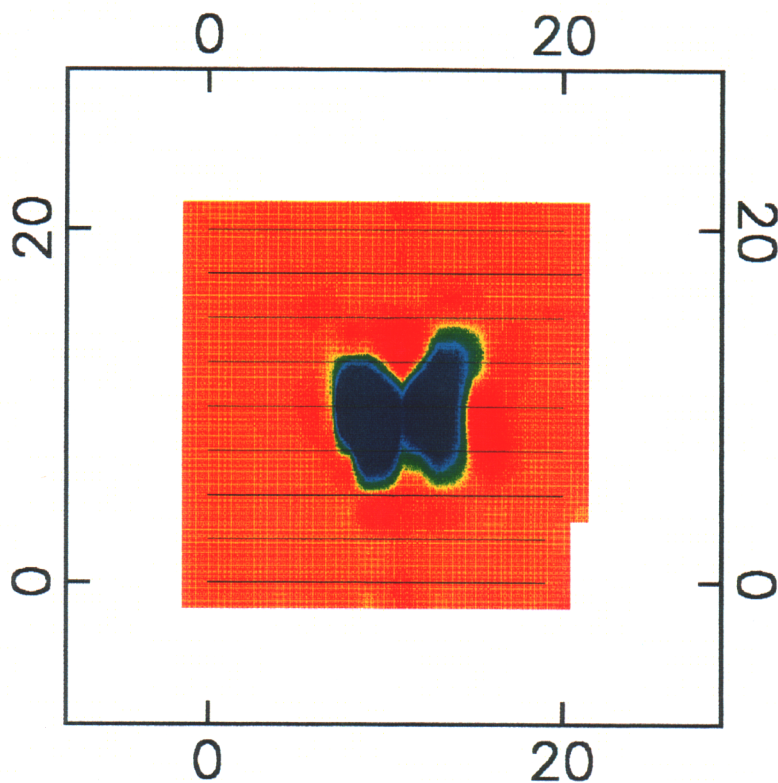
Figure 4b: Canyon Site 1A
In-phase Component

anomalies are present. For comparison, the major metal anomaly found at Canyon Site 1A is shown in Figure 4b; note the scale on the right hand side of the Figures.

1. No further work is required be taken at Sites MDA – 1A, B, C. Further investigation should be undertaken at Site 1A to determine the cause of the anomaly.
2. During causal geophysical surveys conducted after completing the survey of Site 1A, a large area of refuse was encountered. This area lies approximately half a kilometre northeast along the Old Alaska Highway from Site 1A. This area presented many geophysical anomalies representing both buried and surface debris. This area appears to either be an old army camp/s, or dump. Can middens and burnt building remains were seen though the forested area. Follow-up work should be conducted at this site to determine the extent of the refuse in this area
