# **NORTH MERRICE CREEK**

## ***Environmental Investigations and Remediation***

**November 1999**

**Prepared for: Indian and Northern Affairs Canada  
Waste Management Program**

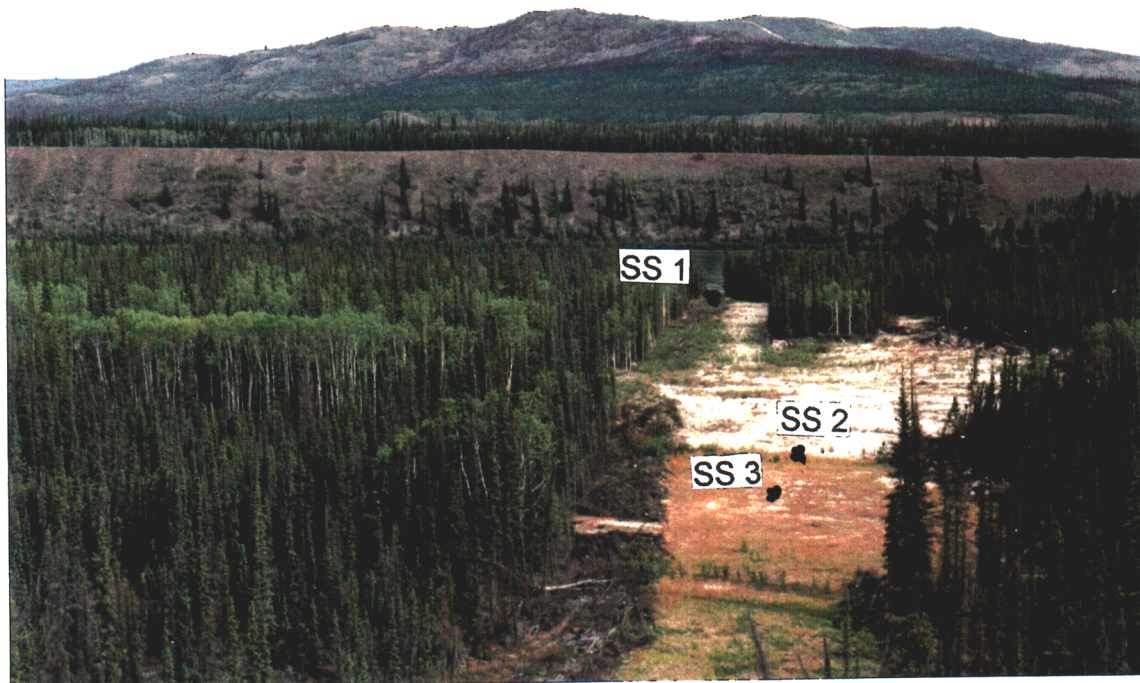
**Photograph 1:** Merrice Creek Sample Area #1.  
Overview facing north.

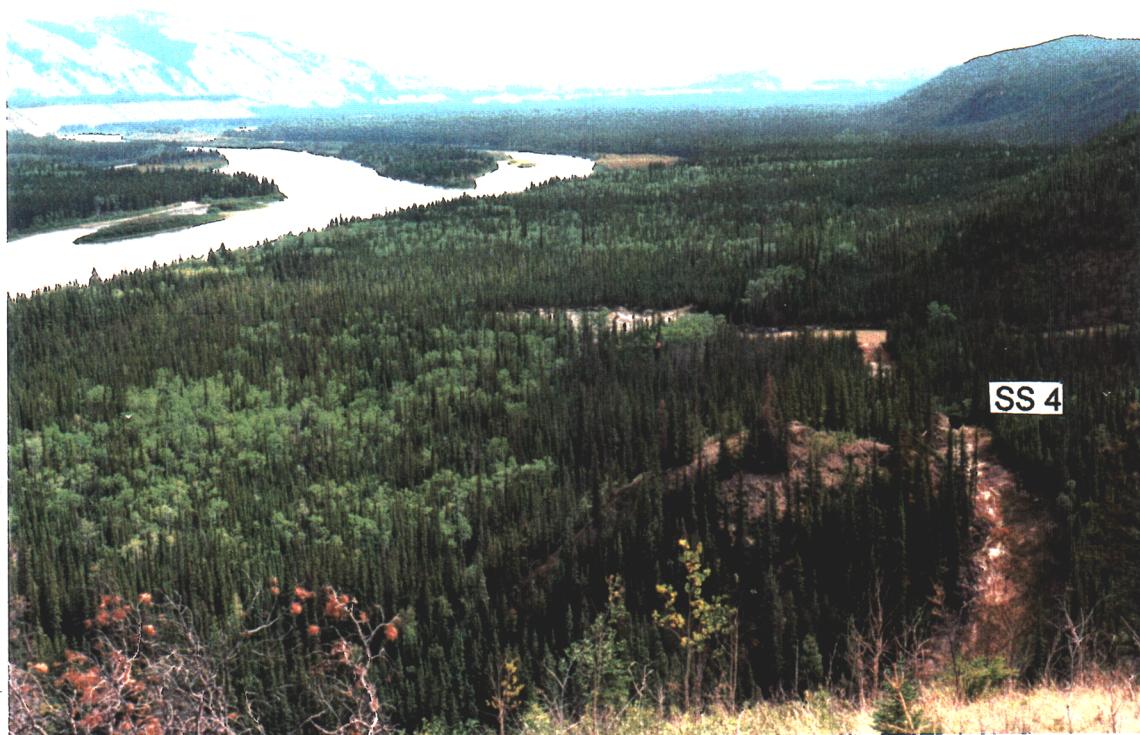
**Photograph 2:** Merrice Creek Sample Area #1.  
Overview facing east.

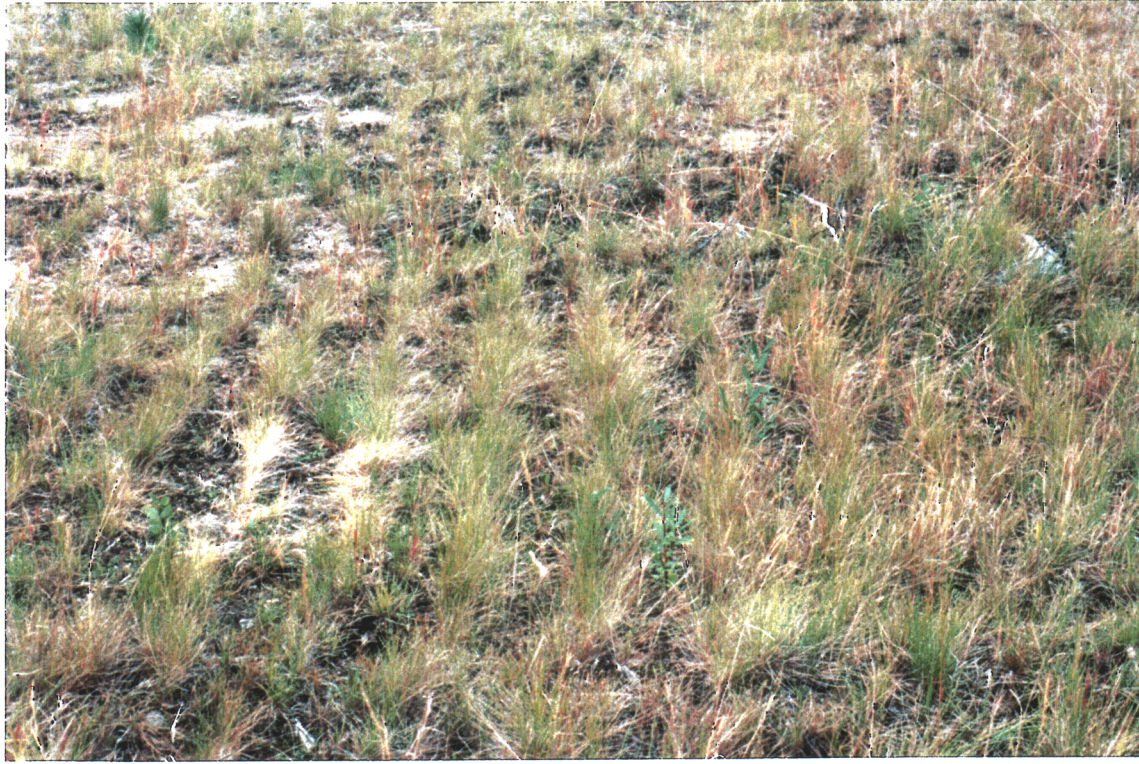
**Photograph 3:** Merrice Creek Sample Area #1. Linear depressions indicating heavy machinery work on flat area. Grass growing in track depressions.

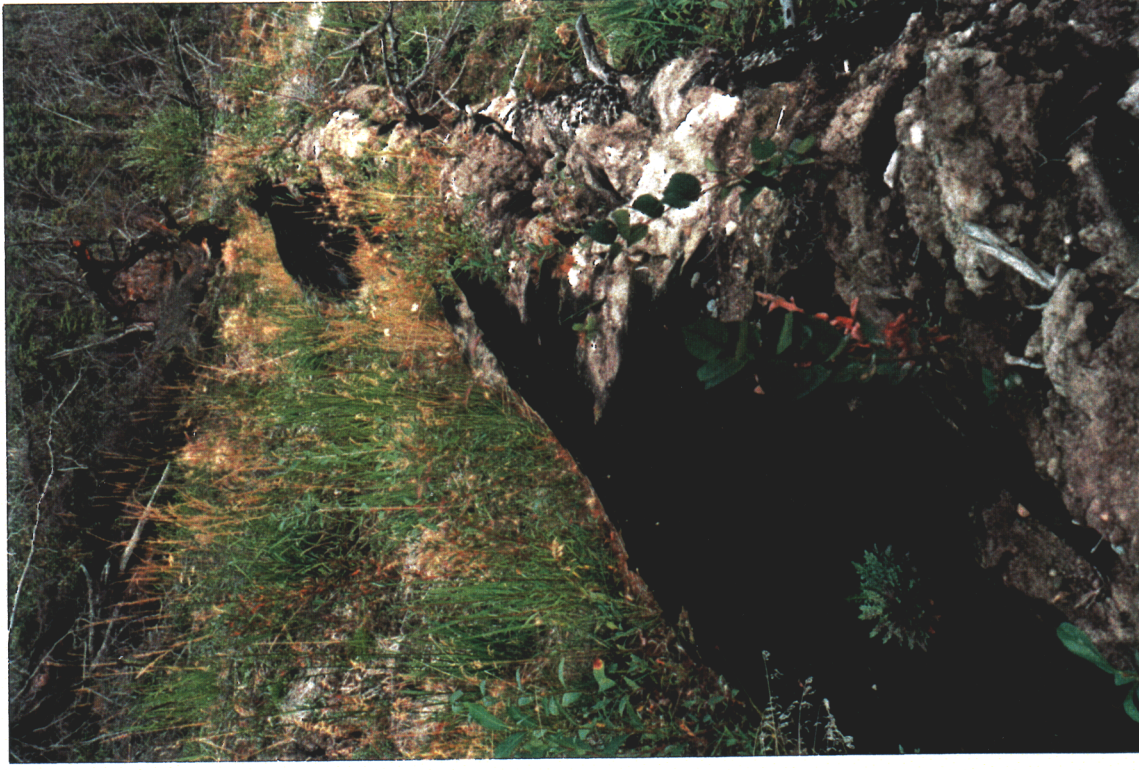
**Photograph 4:** Merrice Creek Sample Area #1. Geo- textile barriers on hill sloping south of site.

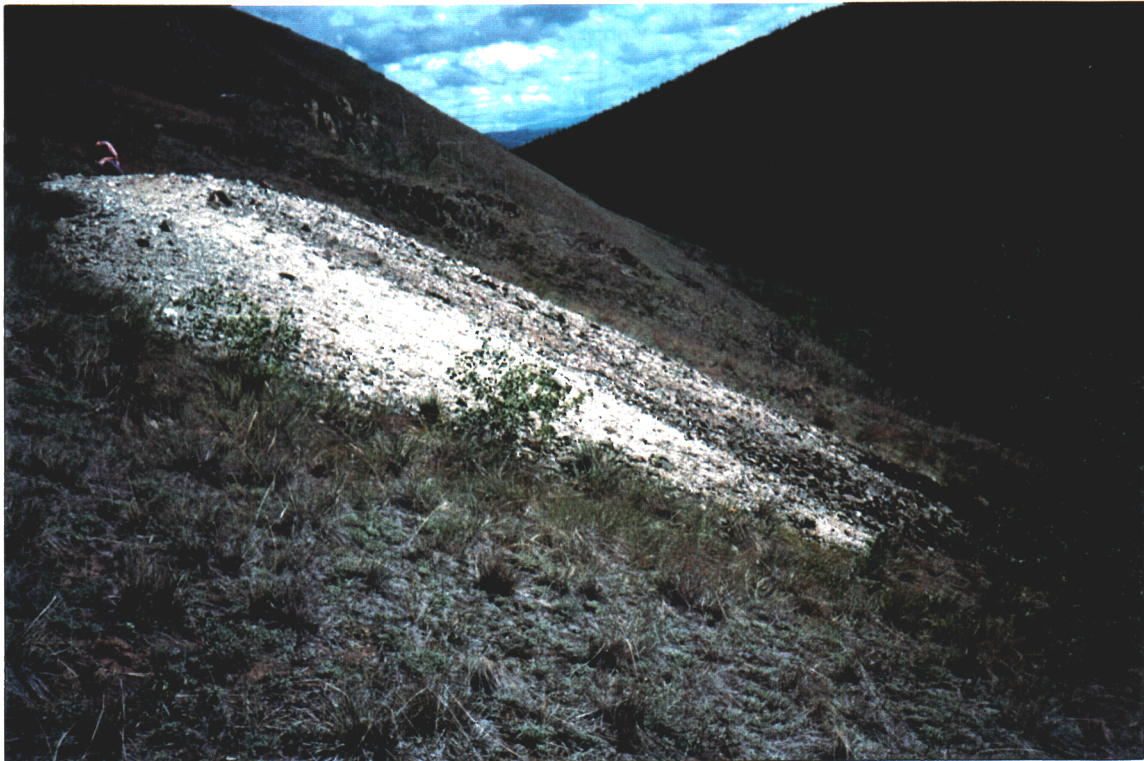
There was a waste rock pile located on the slope immediately below the mouth of the vertical shaft. The pile was composed of broken-up, mineralized rock (pink quartz, oxide copper – malachite; iron staining; pyrite – silver grey), and was approximately 2 m wide, 25-50 cm deep, and extended 8 m down the slope.

**Photograph 5:** Nancy Lee Creek Sample Area. East facing view of waste rock debris from mine shaft excavation.

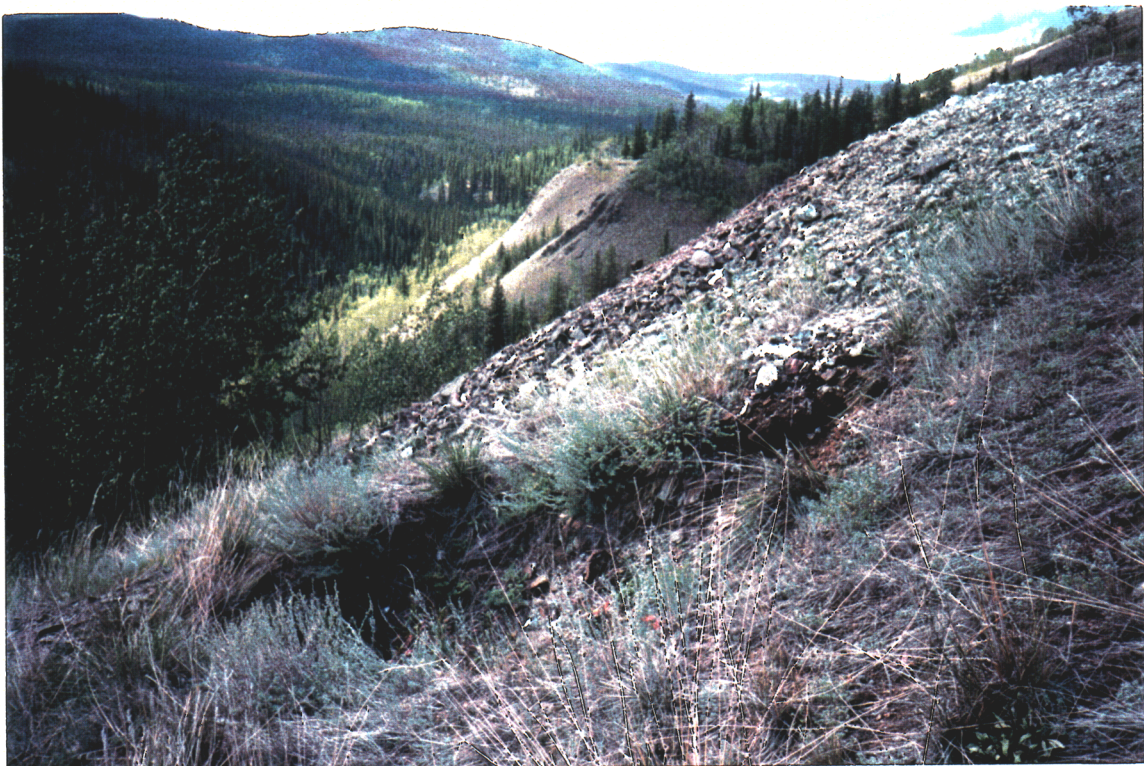
**Photograph 6:** Nancy Lee Creek Sample Area. West facing view of Pit 4 and waste rock.

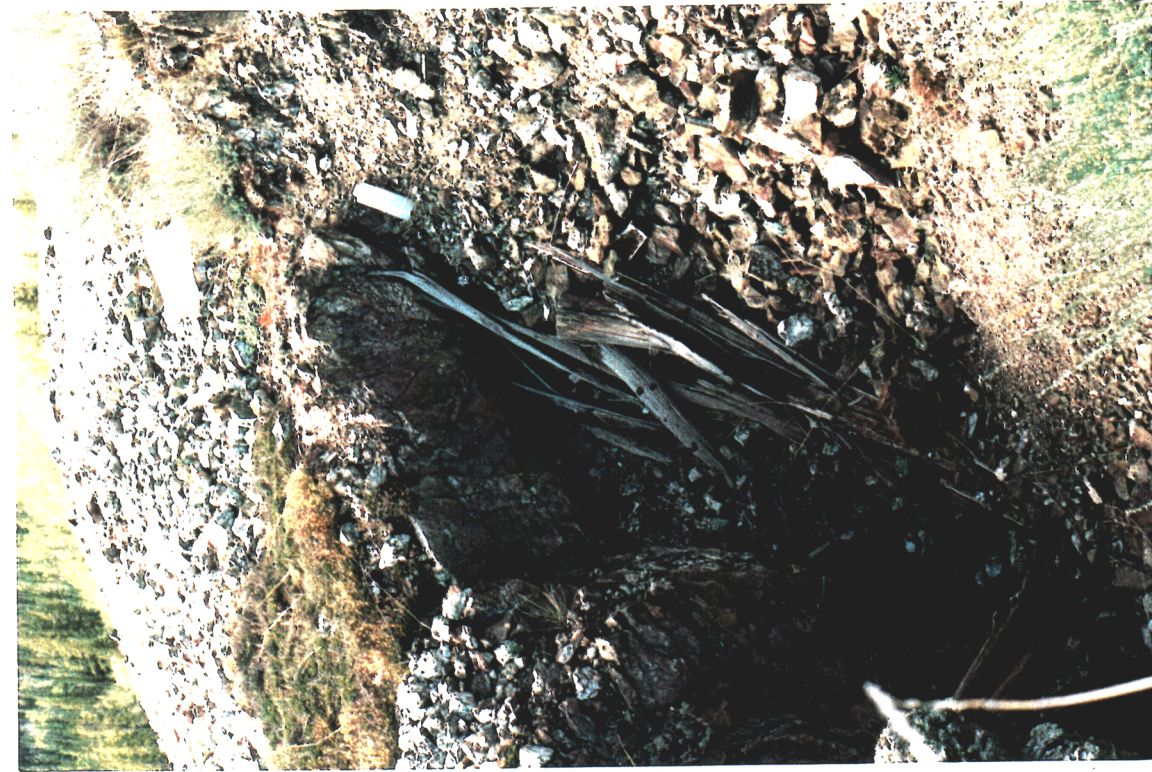
**Photograph 7:** Nancy Lee Creek Sample Area. West facing view of Pit 1 with wood debris and waste rock.

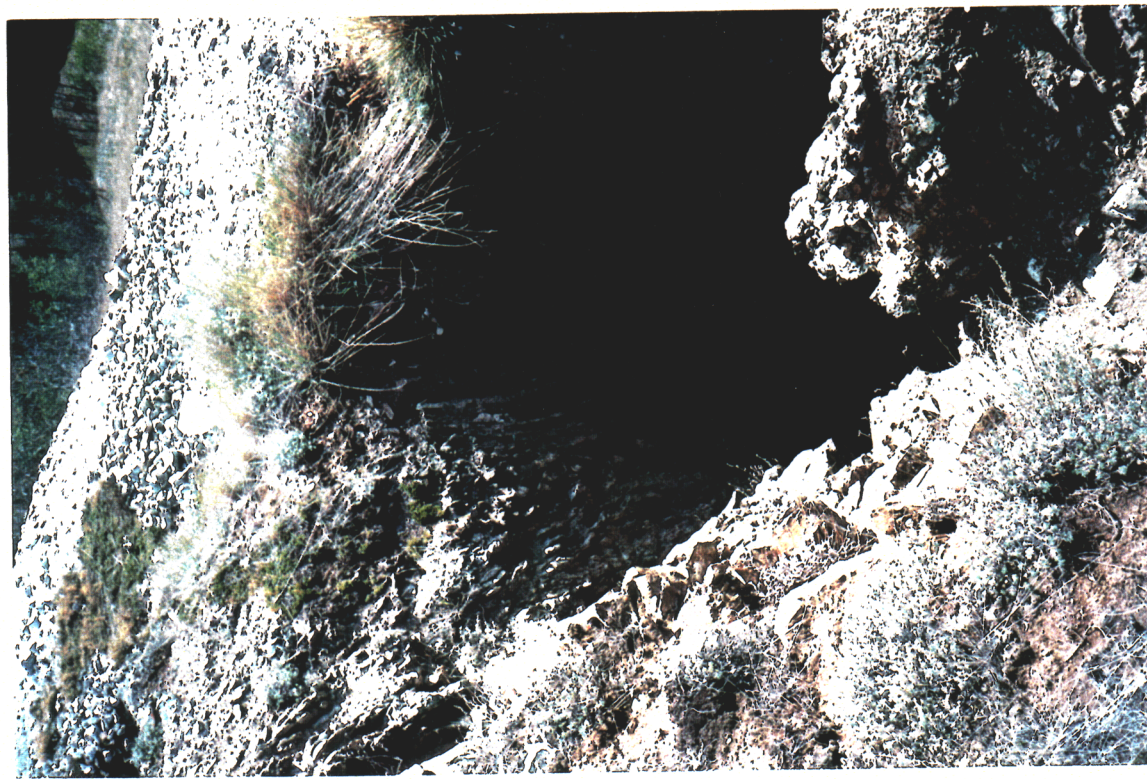
**Photograph 8:** Nancy Lee Sample Area. View of Pit 2 facing south. Pit is three metres deep.

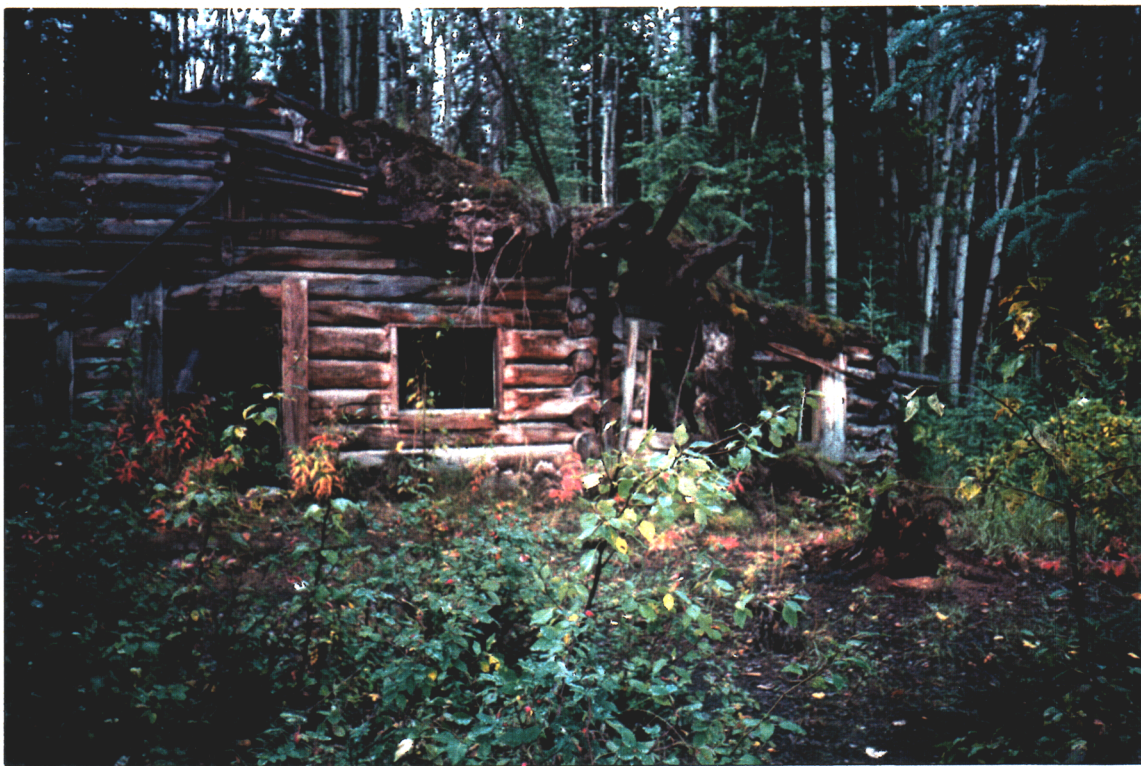
A number of buildings were encountered on the north side of Merrice Creek, where it empties into the Yukon River. One of the cabins was in excellent condition, and appeared to be recently used. The door on the cabin had "Williams Mining Co." A second, larger cabin was in disrepair, with a caved-in roof; and a number of other smaller buildings were also in poor condition.

**Photograph 9:** Merrice Creek Sample Area #2. Cabin at confluence of Merrice Creek at the Yukon River.

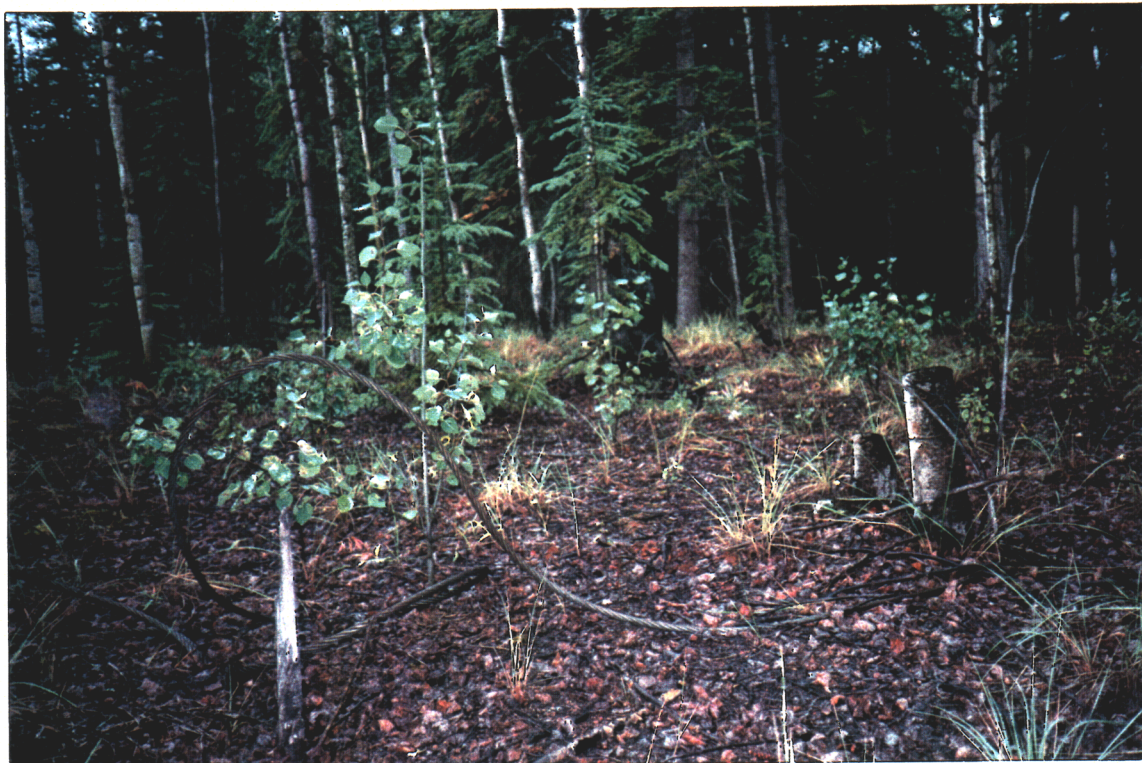
Scattered in the woods along the east side of Merrice Creek are rusted cans. Similarly, near the cabins at the confluence of Merrice Creek with the Yukon River, are rusted cans and some wire (see Photograph #10 in Appendix C).

**Photograph 10:** Merrice Creek Sample Area #2. Wire and can debris near cabin north of Merrice Creek.

- The waste debris (rusted cans and wire) be removed.
