**PHASE 1 AND 2
VENUS MINE TAILINGS REHABILITATION PROGRAM
NEAR CARCROSS, YUKON**

**EBA ENGINEERING CONSULTANTS LTD.
Whitehorse, Yukon**

**Public Works and Government Services Canada
Environmental Services**

Project No. 0201-98-13604

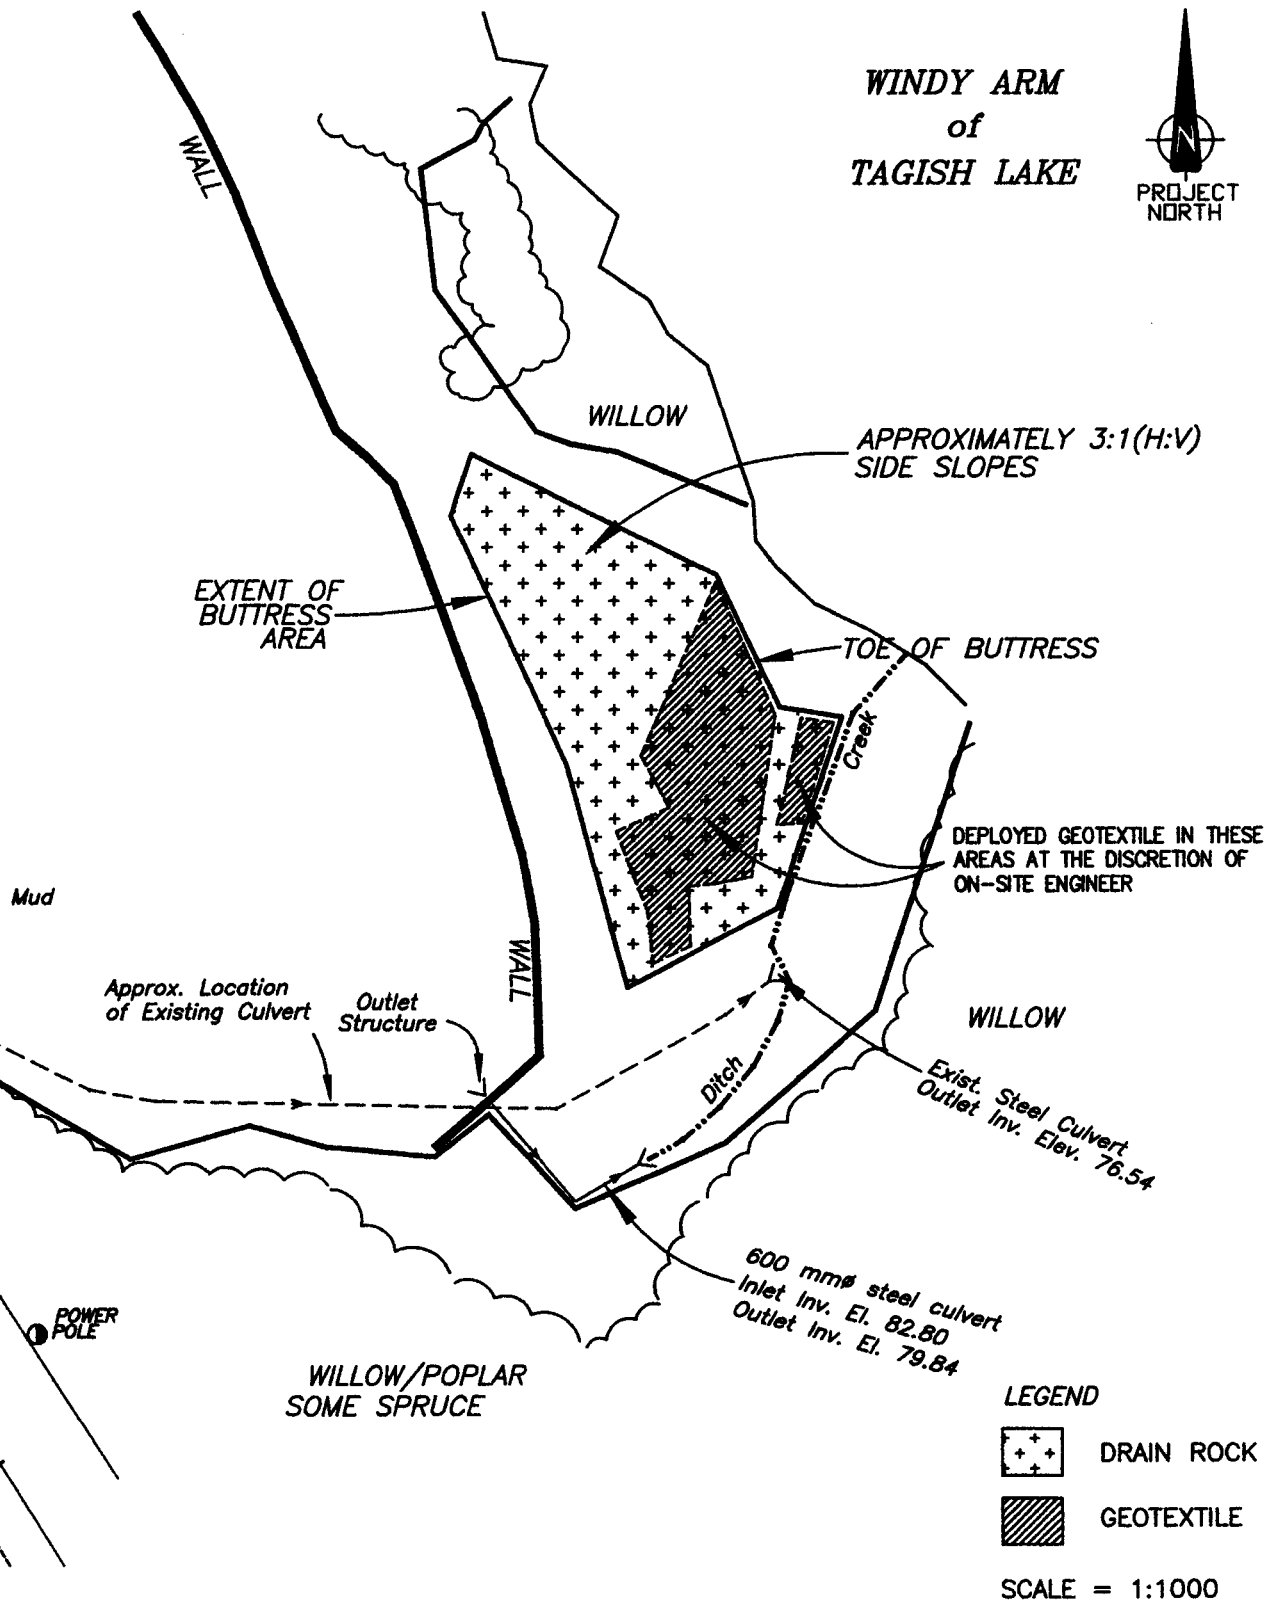
FIGURE 1

The buttress construction is described in Section 1003 of the Program specifications (Appendix A). The construction initially involved placing a non-woven geotextile over the saturated, soft soil areas. Pit run material was then hauled to the site and placed in the appropriate areas to meet the required buttress specifications. EBA representatives Mr. Ed Grozic, P. Eng., or Mr. Chad Cowan, E.I.T., or Mr. Mike Billowits, P. Eng, were on site during the construction of the buttress, which commenced on November 2nd, 1998 and finished on November 7th, 1998. Daily Reports, located in Appendix B, describe the procedure followed for construction of the buttress. During the construction it was noticed that there was a soft spot in an area of groundwater seepage between the buttress toe and small creek to the east. To alleviate this problem, additional drain rock, geotextile, and pit run were placed in the area. Figure 1 shows the location of actual geotextile that was placed beneath the buttress fill material and also identifies the approximate completion boundaries of the constructed buttress.

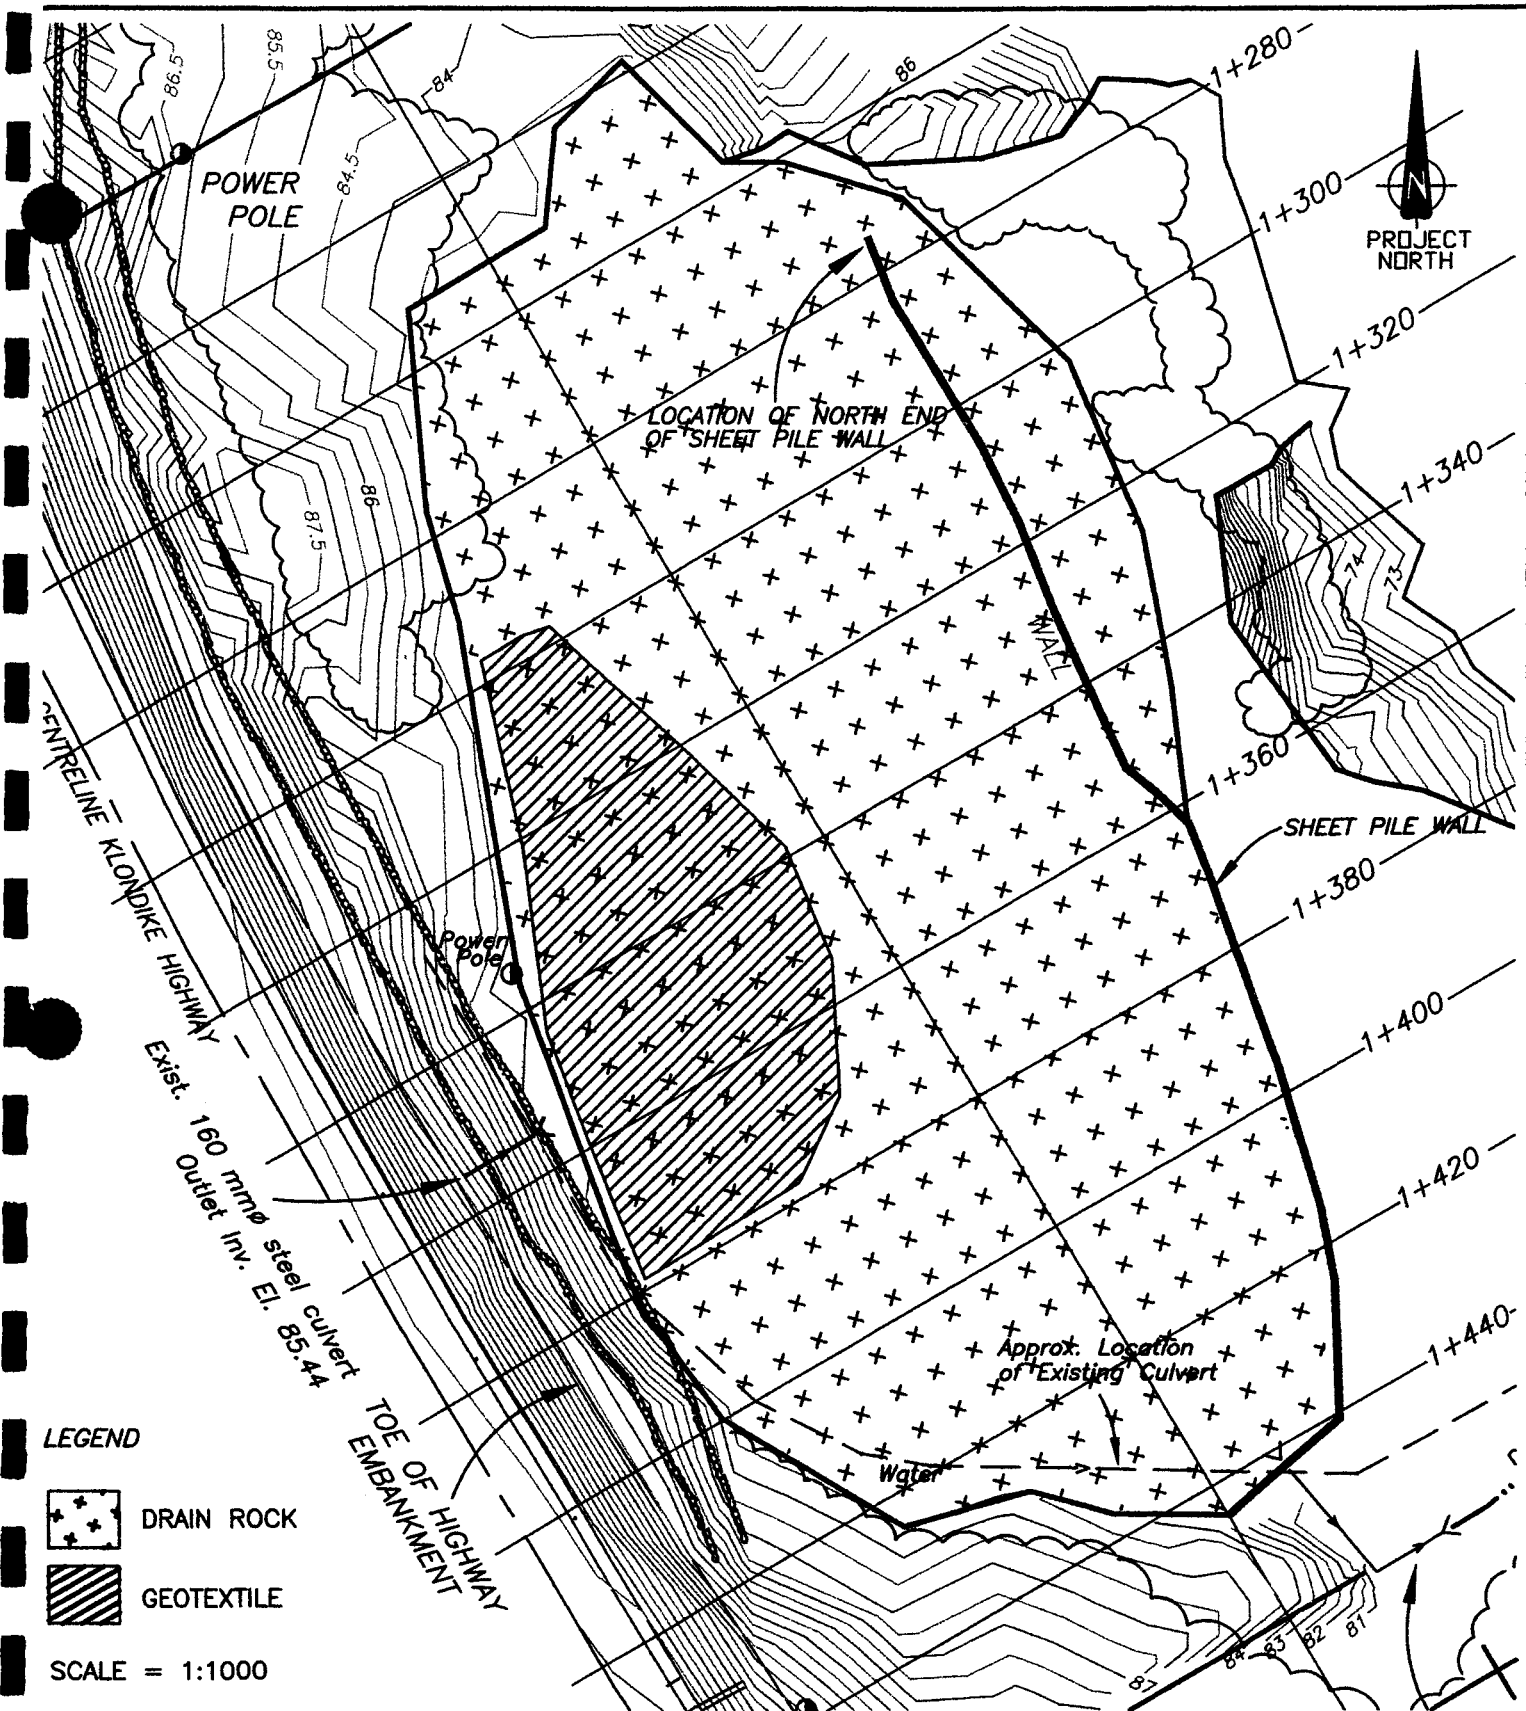
The Drain Rock placement is described in Section 1004 of the Program specifications (Appendix A). Mr. Michael Billowits, P. Eng., or Mr. James Buyck, Eng. Assist., were the EBA representatives on site during this part of the Program which was performed between March 3rd, 1999 and March 9th, 1999. The Daily Reports included in Appendix B summarize the work that was completed during this phase of the Program. The Program tasks for Drain Rock placement involved laying out non-woven geotextile in the appropriate areas and then spreading Drain Rock on top of the tailings area including the area of geotextile. The boundaries for the geotextile and Drain Rock placed on the site are shown on Figure 2. In general the Drain Rock placement was conducted in accordance with the Program specifications with the exception of one item that has yet to be completed. The Drain Rock at the site requires a final grading which is scheduled for May, 1999.
