**ABANDONED CLINTON CREEK ASBESTOS MINE
ENVIRONMENTAL LIABILITY REPORT**

DRAFT
Prepared for:
Indian and Northern Affairs Canada

Prepared by:
UMA Engineering Ltd.
1479 Buffalo Place
Winnipeg, Manitoba, R3T 1L7

May 2002

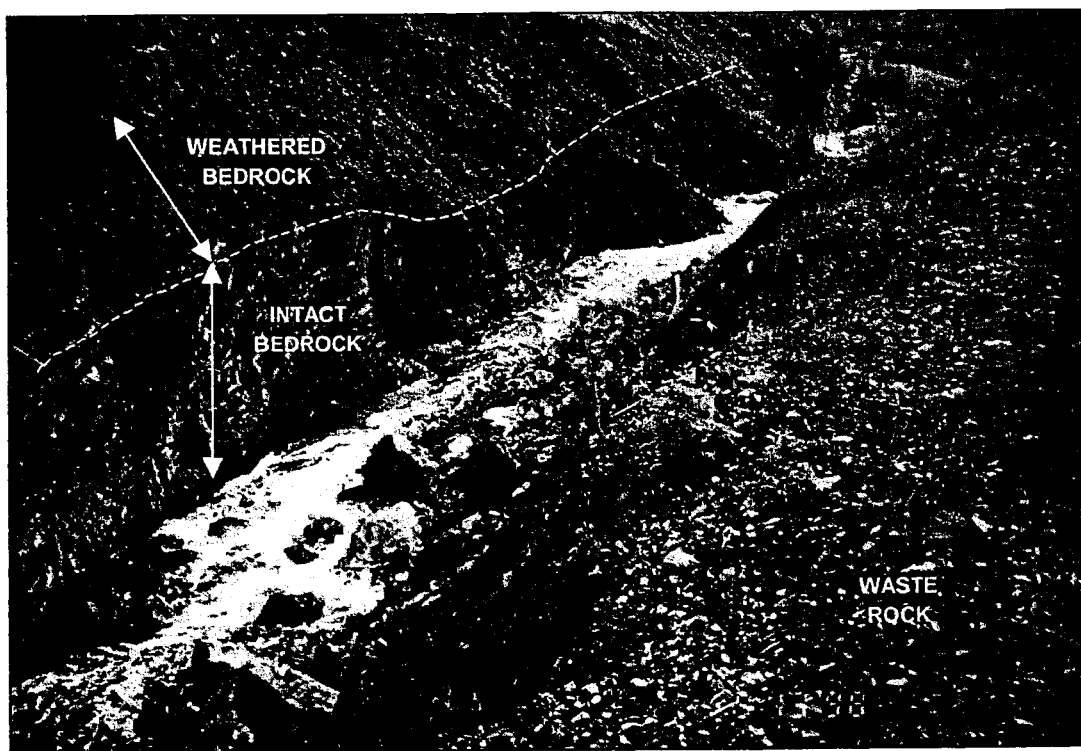
Figure 3-3

Clinton Creek Channel (View Downstream)

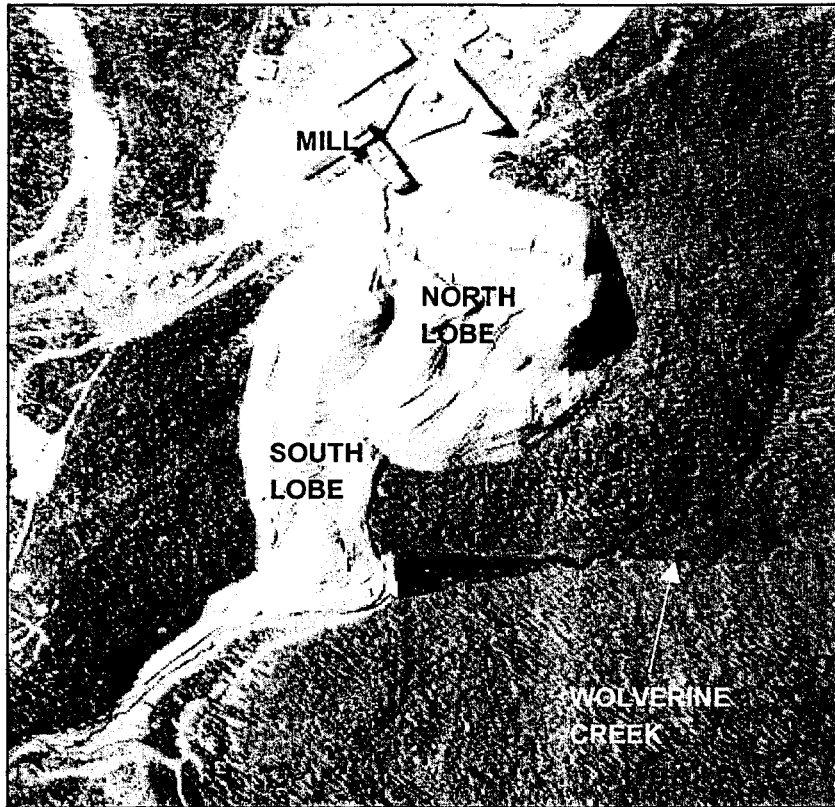
Between 1968 and 1974, tailings were deposited on the upper portion of the west slope of the Wolverine Creek valley (referred to as the south lobe). A failure of the south lobe in 1974 resulted in blockage of natural flow in Wolverine Creek, backing up approximately nine metres of water behind the landslide material (Figure 4-1). In the spring of 1974, a sudden breach of the tailings occurred resulting in a flash flood down Wolverine creek to the confluence with Clinton Creek. The eroded tailings were deposited several metres deep in the creek valley downstream of the tailings. Although the majority of the tailings are believed to have been deposited upstream of the access road, some of the finer material including asbestos fibres entered the Clinton Creek channel where it was deposited possibly as far downstream as the Forty Mile River.

Figure 4-1
Failed South Lobe
(1976)

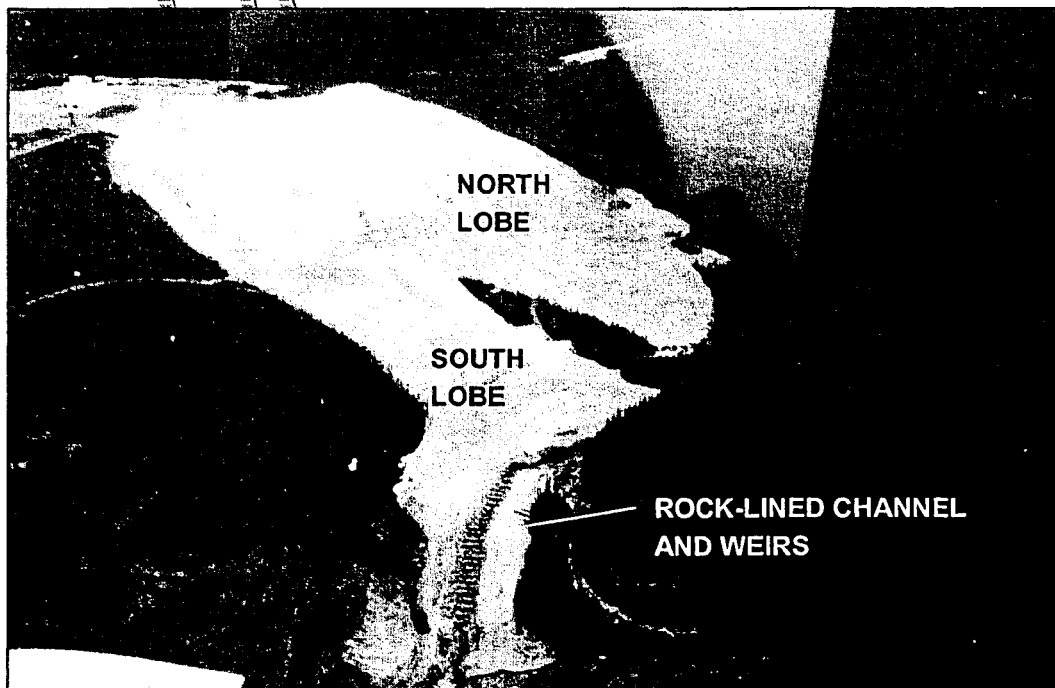
Figure 4-2
Rock-Lined Channel and Weirs

- The toe of the north lobe has entered the lake in the valley bottom and extends an estimated 6m beyond the 1983 shoreline.
 - The rock-lined channel constructed over the failed mass of the south tailings lobe has continued to perform well. (*Rock-lined channel was constructed in 1978*).

Recommendation made to install a rip-rap apron downstream of the last weir and to rehabilitate any damaged weirs.

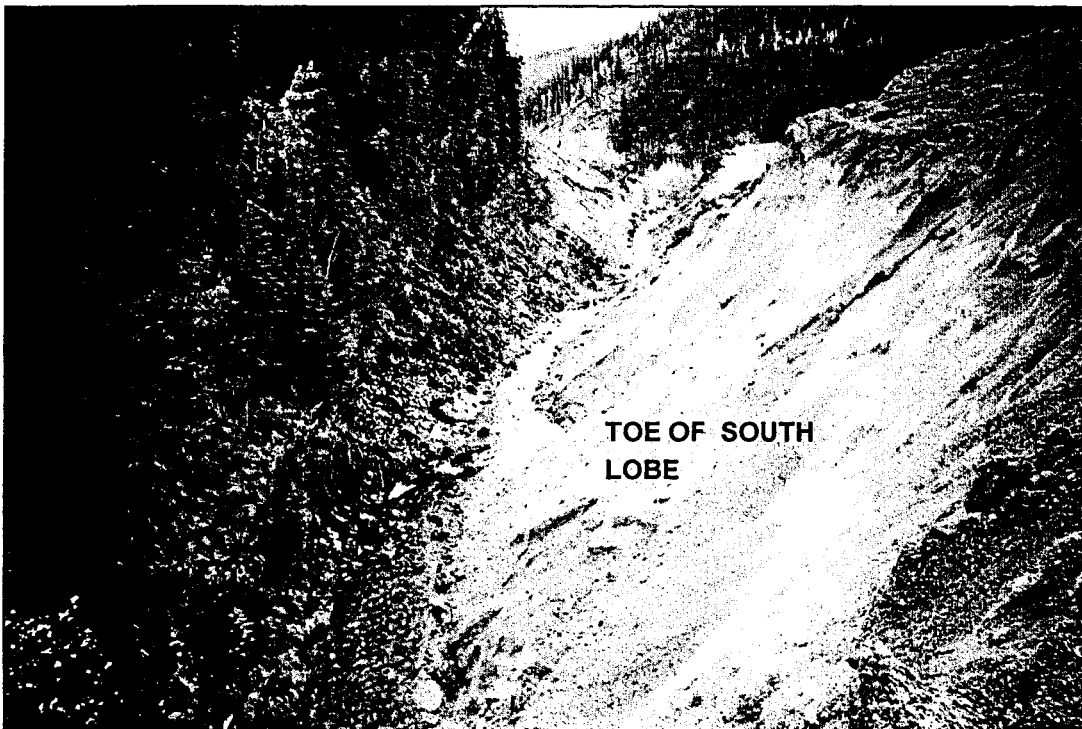
A plan view of the existing tailings piles and Wolverine Creek profile are shown on Drawing 09. Representative creek channel cross sections are illustrated on Drawing 10. As a result of the channel blockages, the alignment and elevation of Wolverine Creek is now about 25 metres further to the east and about 13 metres higher than it was naturally. This new alignment has resulted in erosion of the east valley slope and the tailings that form the west bank of the creek (Figure 4-3).

Figure 4-3
Erosion at Toe of South Lobe, View Downstream (1998)

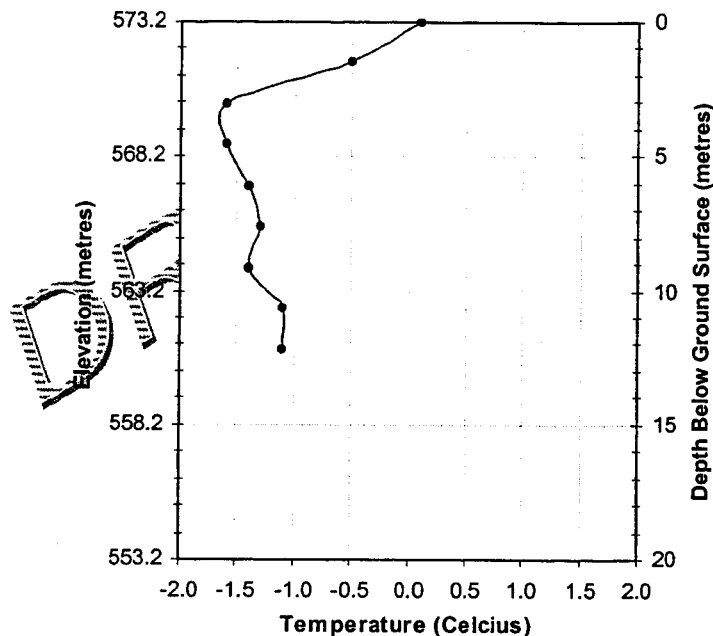
Figure 4-5
Temperature Profile for T6

Thermistor string T6 is located about 60 m northwest of the tailings pile. The monitoring results indicate that the overburden soils are frozen to depths of at least 12 m. The relatively warm temperatures 5 feet below ground surface indicate that the active layer could extend to 1.5 m in this area although additional monitoring would have been necessary to measure the active layer thickness. In general, the ground temperatures decrease rapidly with depth to about -1.6 degrees C at 3 m below ground surface and then increase slightly to about -1.3 degrees C below the 3 m depth. This data supports the observation of widespread permafrost.

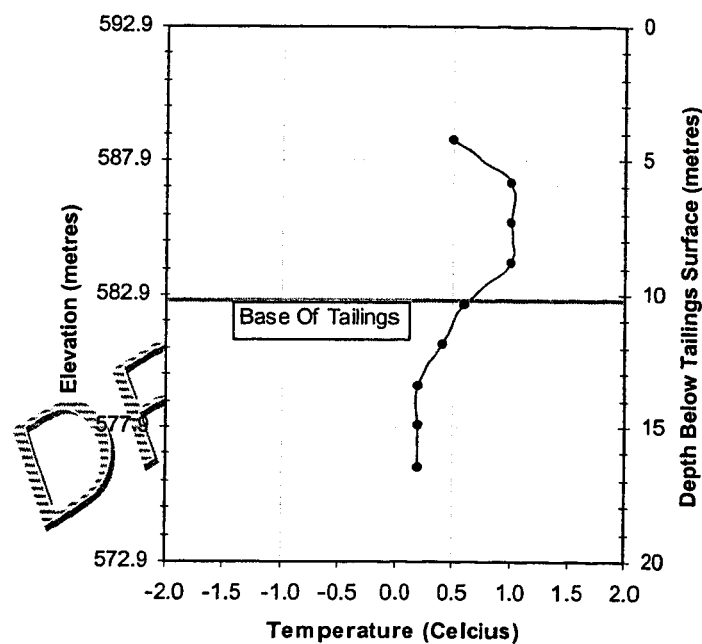
Figure 4-6
Temperature Profile for T5

three points just below, possibly indicating a cool or frost front is advancing from ground surface. The points in the overburden were typically between 0.2 and 0.5 degrees C indicating some degradation of the permafrost had occurred. The temperature profile in T8 decreases gradually from 0.6 to -0.1 degrees C with depth. The temperature of the overburden material appears to be very close to 0 degrees C. The slightly cooler temperatures in the overburden may be due to the thicker depth of tailings at this location (18 m). This is about twice the thickness found at thermistor string T5.

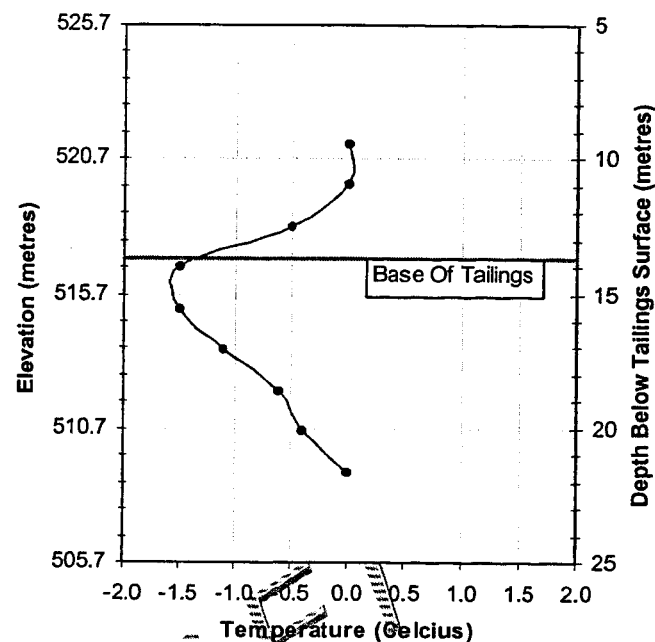
Figure 4-7
Temperature Profile for T7

Thermistor T7 is located near the northern edge of the tailings pile. The data indicated that the tailings and foundation soils were frozen with the coldest temperatures (-1.6 degrees C) just below the interface of the tailings and foundation soil. The temperatures of the foundation soils appear to gradually increase from -1.5 degrees C at the interface to nearly 0 degrees approximately 6 m below the tailings. It is possible that these tailings were placed during the winter season which would help to insulate the frozen overburden soils. This also might explain the cooler temperatures of the tailings just above the overburden soils.

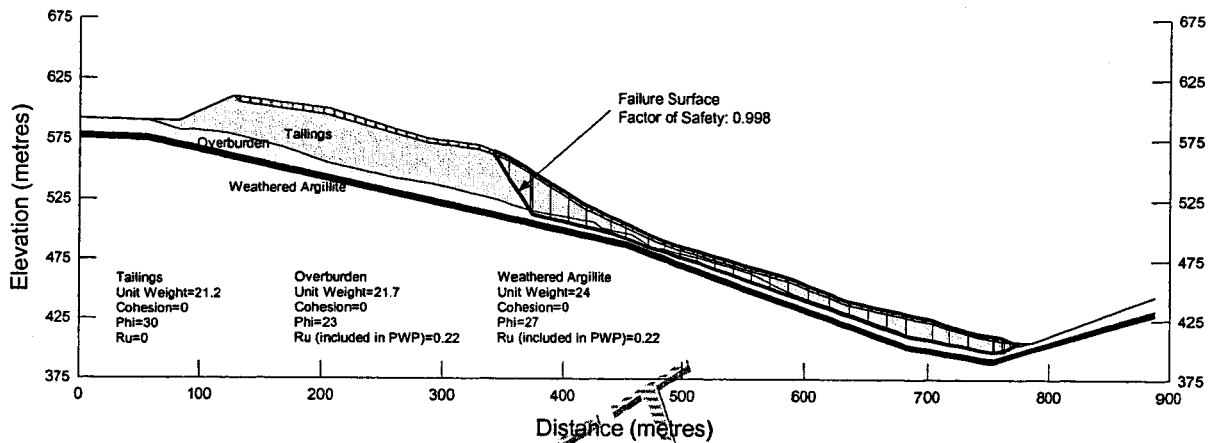
Figure 4-8
North Lobe - Existing Geometry

The analysis indicates that a combination of residual shear strengths and high pore-water pressures in the overburden material are required to achieve a FS of unity. This observation provides further evidence that unique geological conditions, in particular a shallow weak layer within the overburden, the slope of the valley and lack of toe support are responsible for continued movement of the tailings pile. Almost certainly, disturbance of the thermal regime, in particular thawing of the permafrost resulting from the placement of tailings over the valley slope has been a contributing factor. Although detailed knowledge of the changes to the thermal regime that occurred during and following active placement of tailings is not known, it is possible that the thermal regime has still not reached a state of equilibrium.

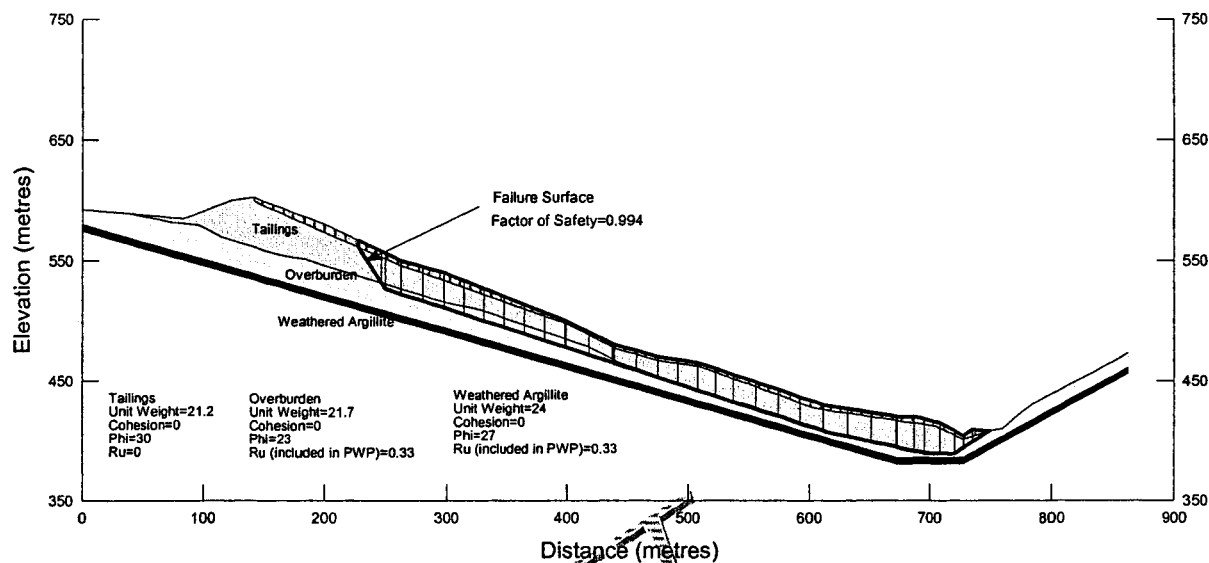
Given the limited site-specific geological information, there is considerable uncertainty in the absolute values calculated from the back analysis. The model is however, considered sufficient to comment on and assess the relative improvement available through remedial options for the purposes of comparing remediation alternatives (stabilization) and selecting a preferred long term strategy for the same.

South Lobe - Existing Geometry

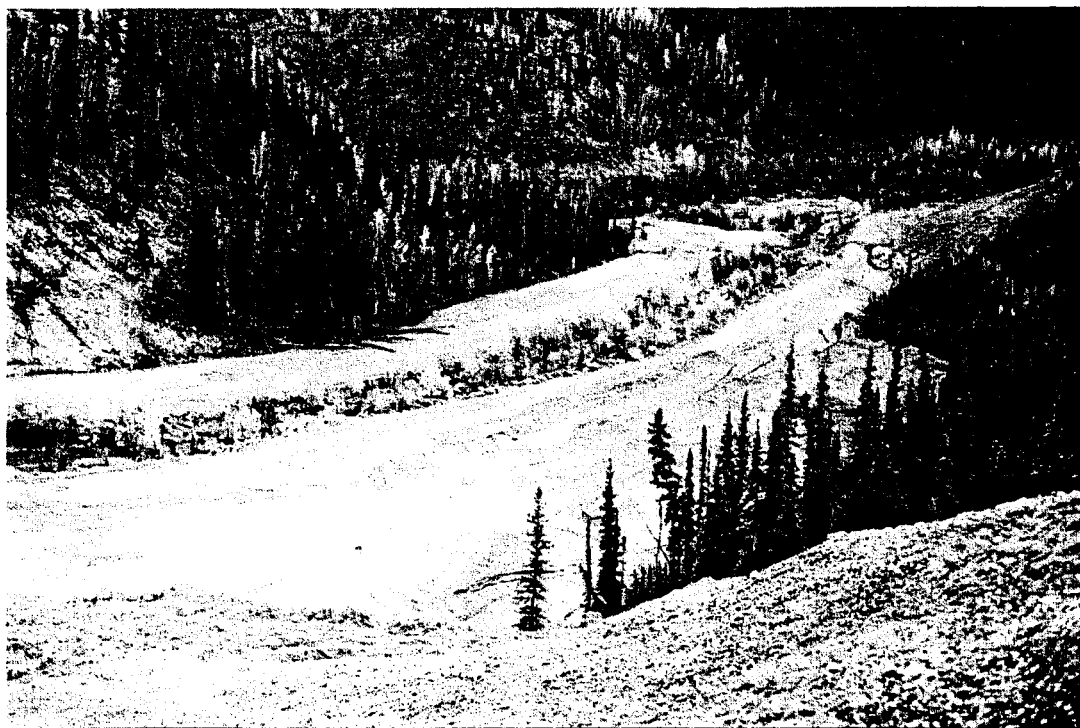
Since the existing rock-lined channel and rock weirs downstream of the north lobe have performed reasonably well it is desirable to leave them in place. To reduce the erosion potential of the tailings adjacent to the rock-lined channel it is recommended that this area be graded towards the rock-lined channel and that the small gully along the outer edges of the tailings be filled to blend in with the natural valley slopes. Placement of rocks across the tailings in a 'V' pattern pointing downslope will help direct surface runoff to the rock-lined to channel and minimize the development of erosion channels in the tailings adjacent to the lined channel. The presence of vegetation along the rock lined portion of the channel suggests that it may be possible to establish vegetation in the tailings adjacent to the rock-lined channel if moisture can be preserved to support plant growth (Figure 4-10). Since the establishment of vegetation would help to provide long-term stabilization of the tailings, growth could be encouraged by spreading organic matter such as wood chips, mulch or coniferous trees over the tailings in this area. Rehabilitation of the channel outlet at the confluence with Clinton Creek should also be considered to prevent future overtopping of the road and erosion at the downstream end of the culverts.

Figure 4-10
Vegetation Along Rock-Lined Channel
