ASSESSMENT REPORT

105D-03-2

BECKER COCHRAN

DIAND TECHNICAL SERVICES

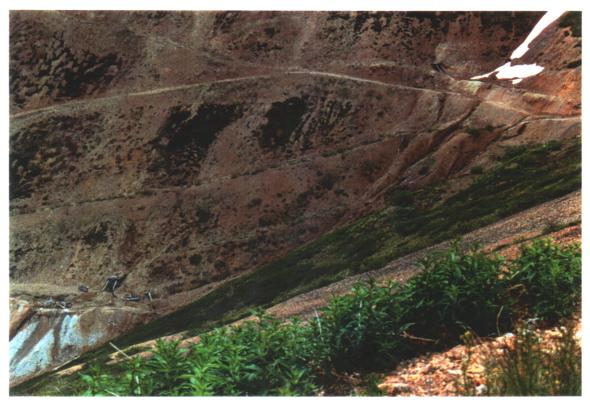
Approximately 2000 cubic metres of waste rock from both adits was dumped over the steep bank in front of each entrance. Avalanche tracks above the exploration adits are filled with snow and annual melt is causing erosion through the waste rock piles and into the valley below. The waste rock at the lower adit contains sulphides and was giving off a distinct odour of sulphur at the time of inspection.

UPPER AND LOWER ADITS AND WASTE DUMPS (NOTE EROSION)

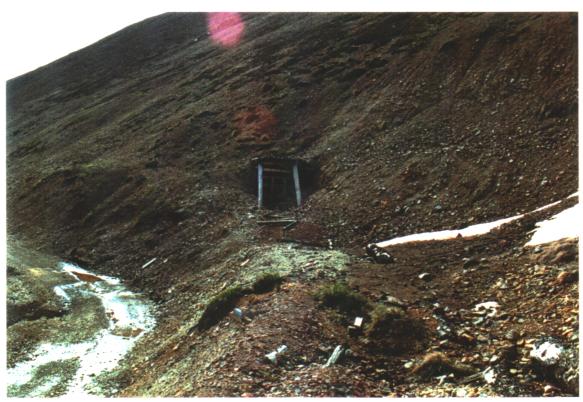
UPPER ADIT

A total of three adits were found at the time of inspection on 1993/06/24. Of the three accessible adits at the time of inspection, one adit is collapsed at the entrance and the other two adits are still intact. Both adits are sealed with widely spaced wooden cross bracing. Access to each adit could be gained by crawling through the openings in the bracing. Low volumes of water (less than 3-4 litres/minute) was flowing from both adits at the time of inspection. Most of the flow appears to be from snowmelt inside the adits.

The mine adits are secured against entry, but still accessible to the public because of the way the adits were sealed. As this site is accessible by road and relatively close to populated areas (Whitehorse and Carcross), it is recommended that the adits should either be better secured or at least posted against entry.

Posting of the adits against entry should be completed to warn the public about the potential danger if these adits are entered.

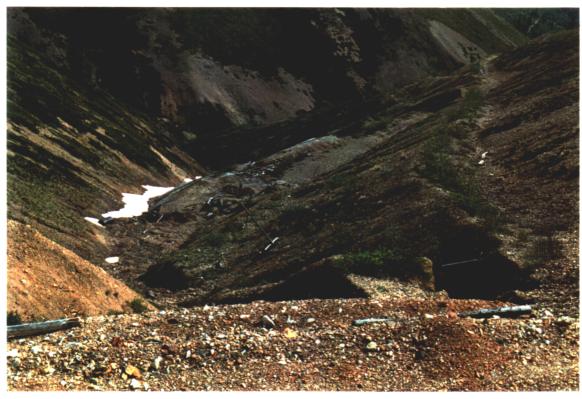
The waste area has been developed by extending railway track from the adit to the edge of the slope and dumping the waste rock over the slope below the adit. As noted, the waste rock was dumped down the slope below the adit and is perched at a steep angle between 35-45 degrees. Because of development in the area with road cuts, and wasting material over the slopes, the exploration area in the very confined gully has been oversteepened. This material is susceptible to both wind and water erosion, both which are occurring. The obvious erosion is caused by the snowmelt channeled through the waste area. Whether or not any of the metal waste in the gully below the site was caused by this erosion or was originally dumped downslope, is unknown. As the dumped material is so coarse, it is unlikely that much of it has found its way into one of the tributaries to Becker Creek below the site. It may be possible that the sulphides are being dissolved in the water and a weak acid is being generated. If this is the case this likely has been occurring naturally for a long time. It is recommended that water samples be taken and analyzed to determine the water chemistry from this area. Because the local streams are so steep fish habitat is not suspected in the vicinity of the site. This erosion process is expected to continue as part of a much larger geologic weathering process in the area, so the downstream impacts from this one site are expected to be minimal. It is recommended that the site not be disturbed any more to avoid any additional impact in the area. Revegetation of the area is also considered impractical in an area that is so dry, steep and void of organic cover.

LOWER WASTE ROCK DUMP AND EROSION IN GULLY

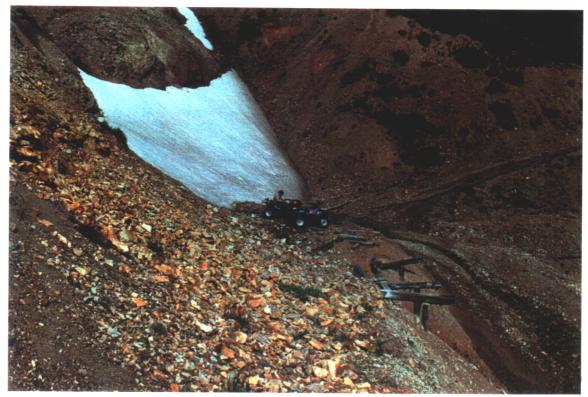
UPPER WASTE ROCK DUMP AND GULLY

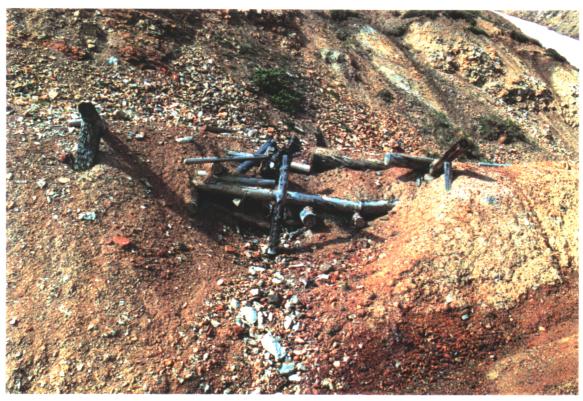
COLLAPSED ADIT

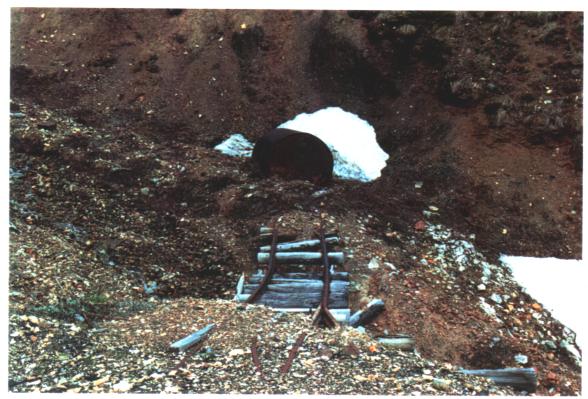
The only remaining infrastructure at this site is one empty metal tank (approximately 2000 litres), less than 50m of rail and track, various pieces of metal waste including barrels, pipe, tin cans and general purpose refuse that has been dumped or washed down the gully below the lower adit. Some wood waste is also scattered around the site.

Railway track once used by ore cars is still in place extending from inside the lower exploration adit to the waste dump. Once outside the adit, the track extends to the edge of the waste dump.

TRACK AND TANK AT LOWER ADIT

If a waste clean-up program is implemented in the area, it is recommended that the metal waste be gathered and removed from the site. At the same time, the remaining wood waste should be piled and burned in an acceptable location. This work should be considered a **LOW** priority at this location.

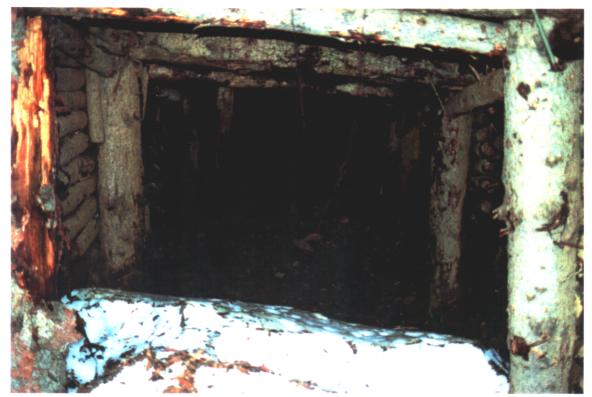
INTERIOR OF LOWER ADIT

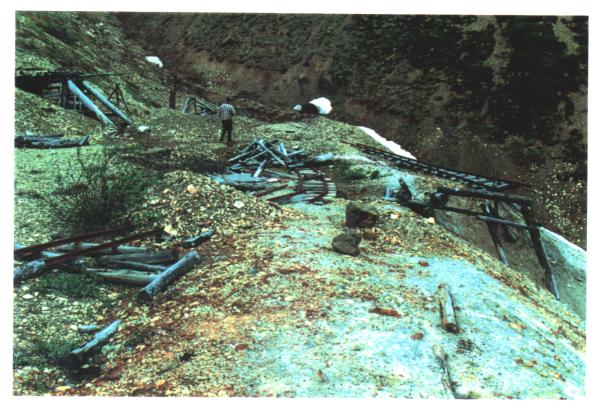
LOWER ADIT, WASTE DUMP, AND ADJACENT GULLY

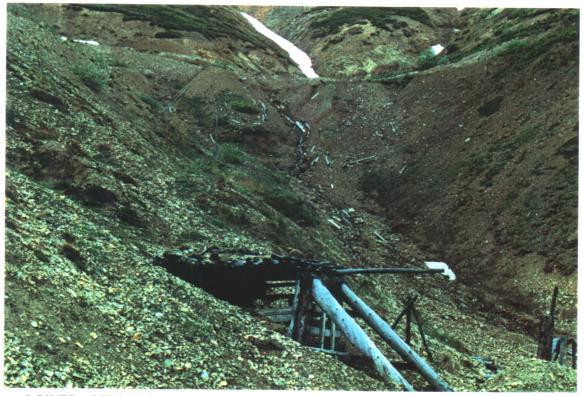
LOWER ADIT LOOKING UPSLOPE (NOTE WASTE IN GULLY FROM UPPER ADIT)

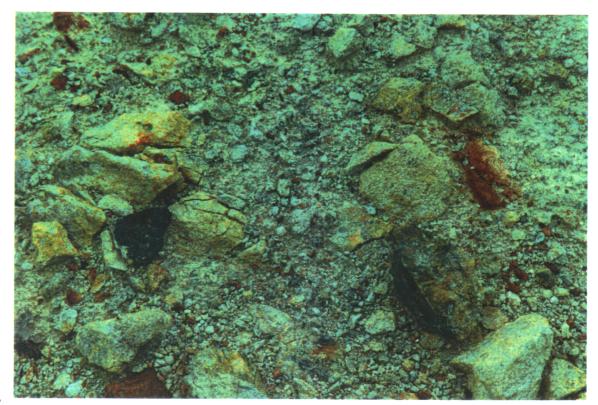
SULPHIDES IN LOWER WASTE ROCK DUMP

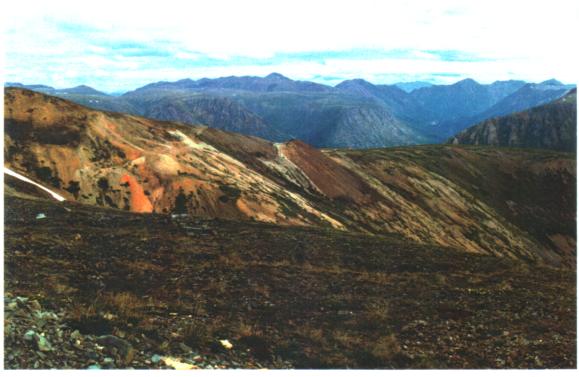
TRENCHING

Across the gully, trails have been extended on the plateau to the west. These trails extend approximately 5km across this plateau to a variety of trench and drill sites. One specific area of trenching has been left with large piles of excavated material.

The road development and trenching is situated in an area on the top of a mountain that is made up of weathered bedrock, is very dry, and supports very little vegetation cover. Very little revegetation appears to have taken place since the road construction and trenching was completed.

Damage to the vegetative cover appears to be the only significant impact to the area because of the all the drill access roads and trenching completed in the area. There is little evidence that erosion, slope failures, contamination of water courses, etc. have been caused from the past activity.

Site remediation, if it was considered would consist of reshaping cut slopes to blend with the natural slopes, refilling trenches, and attempting to revegetate this work once it was completed. However attempting to complete this work is expected to be very costly and delay any natural recovery that has started. The benefits to attempting this kind of expensive remediation program in this remote area are not evident. This work should be considered as a **VERY LOW** priority.

Revegetating roads, drill sites, and trenching sites is considered a **LOW** priority for this area.
