ASSESSMENT REPORT

105D-02-2

BIG THING

**OCTOBER, 1993**

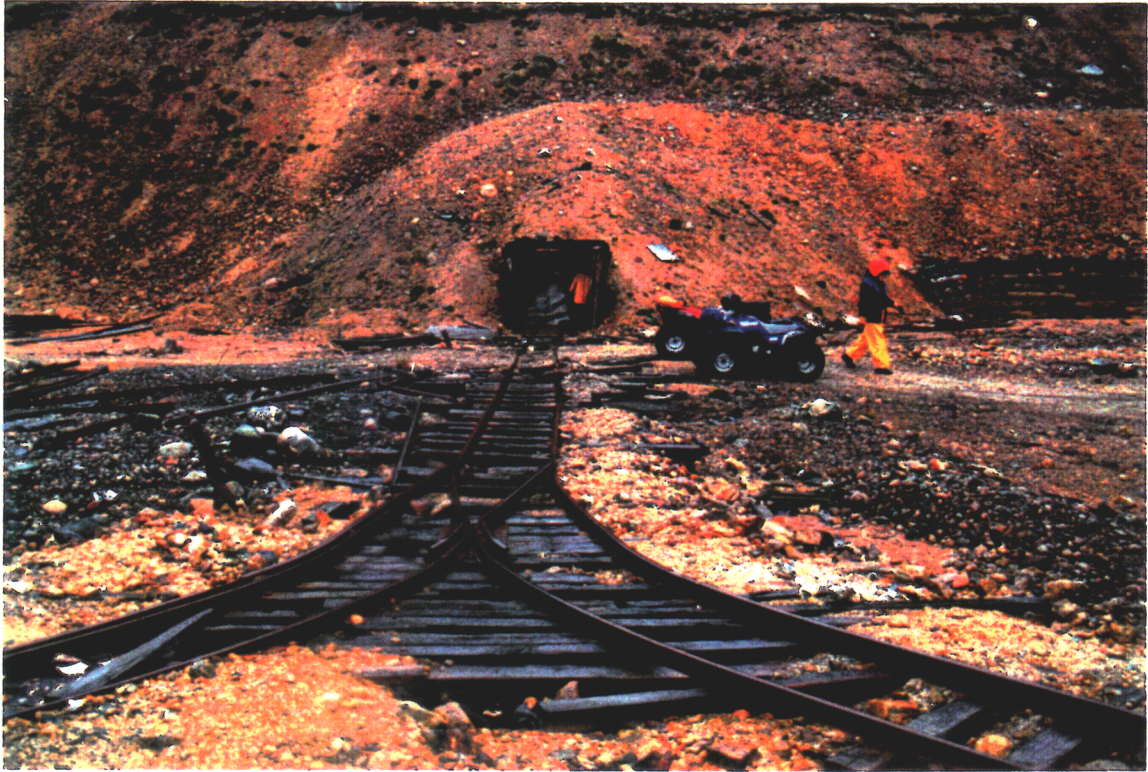
An open mine adit, first developed in 1965, remains at the site. At the time of inspection on 1993/06/21 the entrance to the adit was filled with snow. Ice was slowly melting from the adit and water was flowing from the entrance. The entrance to the adit is accessible to the public.

1. ENTRANCE TO MINE ADIT

The mine adit is unsecured and open to the public. Because this site is accessible by road and close to populated areas (Whitehorse and Carcross), the open adit should be considered a safety hazard. The adit should be sealed to prevent the public from entering it. If the adit is left unsecured a potentially **HIGH** level of risk remains for an accident to occur.

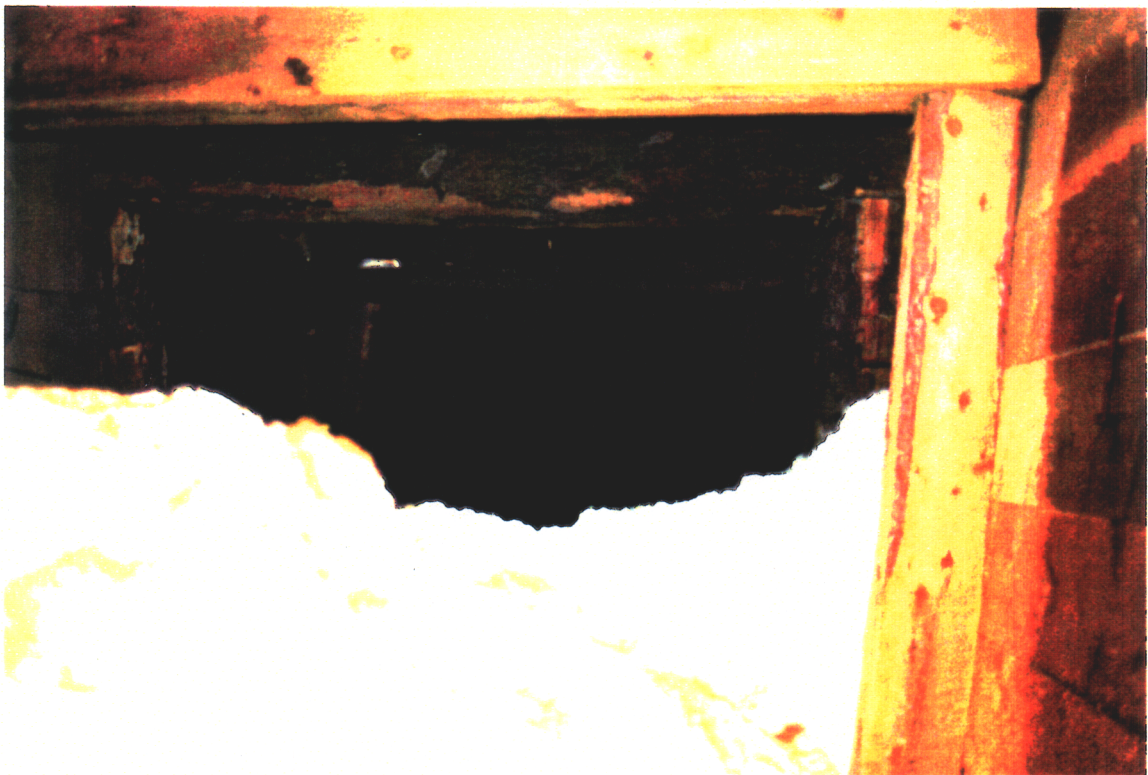
2. INSIDE MINE ADIT

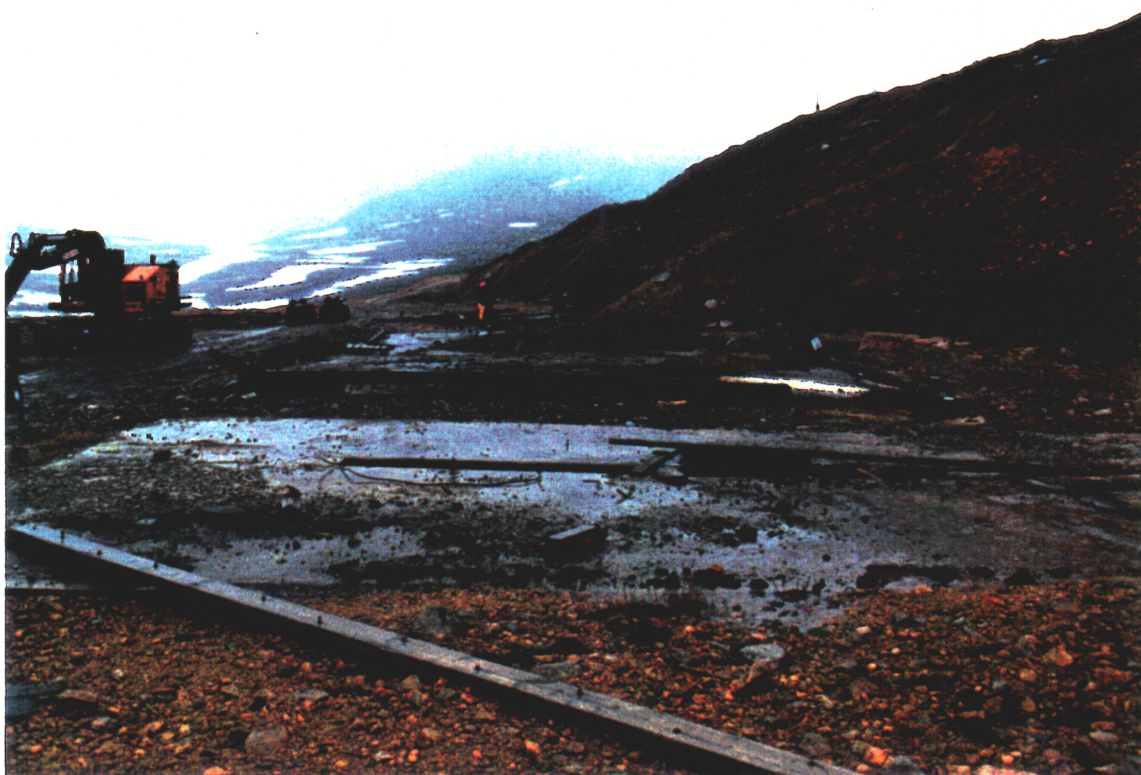
Concrete foundations and floor slabs remain from a 272 tonne mill constructed in 1967. These foundations, from two separate buildings measuring 9.1x24.4m and 6.1x9.1m, are located directly to the east of the adit. Railway track is embedded in the floor slab closest to the adit. The concrete appears sound and in reasonably good condition.

A large tracked excavator is on-site. This excavator does not appear to be in working order and may have been abandoned.

3. MILL FOUNDATIONS AND EXCAVATOR

The concrete mill foundations are not considered a serious environmental hazard and should be left in place. Attempting to remove them will be costly, create further disturbance, and require disposal to another area. Any loose metal waste on-site should be collected and removed from the site if a clean-up program is initiated.

Ownership of the excavator should be confirmed. Once ownership is verified the excavator should be removed from the site.

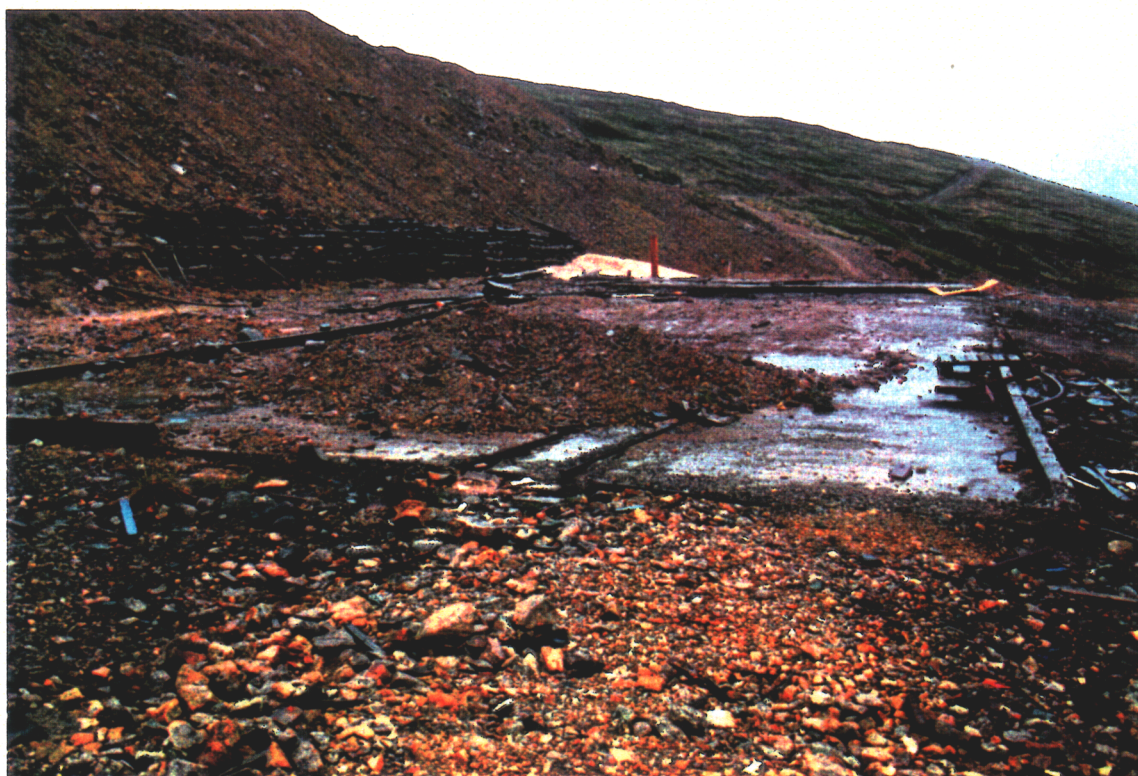
4. MILL FOUNDATIONS

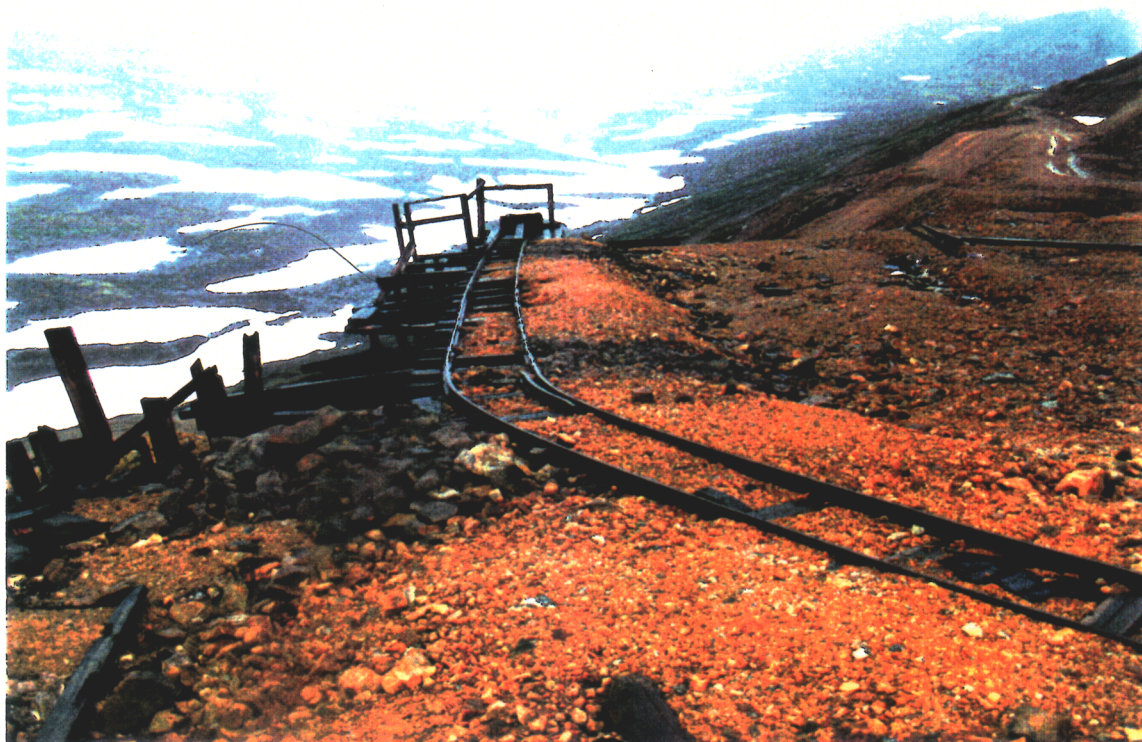
Railway track once used by ore cars is still in place extending from inside the mine to the waste dump. Once outside the adit, the track extends in opposite directions, one going to the waste area, and the other going to the loadout. The track extending to the waste area is constructed on a wooden trestle for approximately 60-80m. This trestle was constructed using local timber, is old, decaying, and is starting to collapse. This structure is not safe and should be considered a hazard. The track extending to the loadout area is constructed on waste rock and is supported on a wooden retaining structure approximately 10m high. This retaining structure is old, decaying, and is also beginning to collapse from the weight of the retained backfill. This situation is expected to worsen with time and should be considered unsafe.

5. TRACK TO LOADOUT AREA

The waste area has been developed by dumping the waste rock over the slope below the adit. This was developed by extending railway track from the adit to the edge of the slope and beyond with a trestle supporting the track. The trestle and loadout retaining structure were constructed with local untreated timber, are old, decaying, and unsafe. They should be posted as unsafe and dismantled as soon as possible.

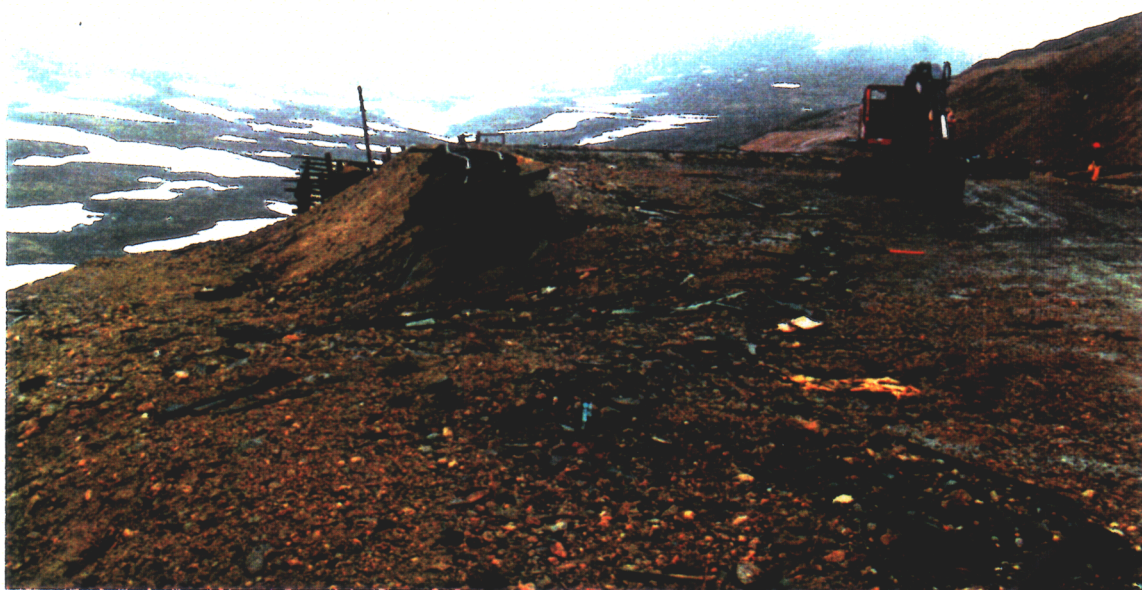
6. TRACK TO WASTE DUMP

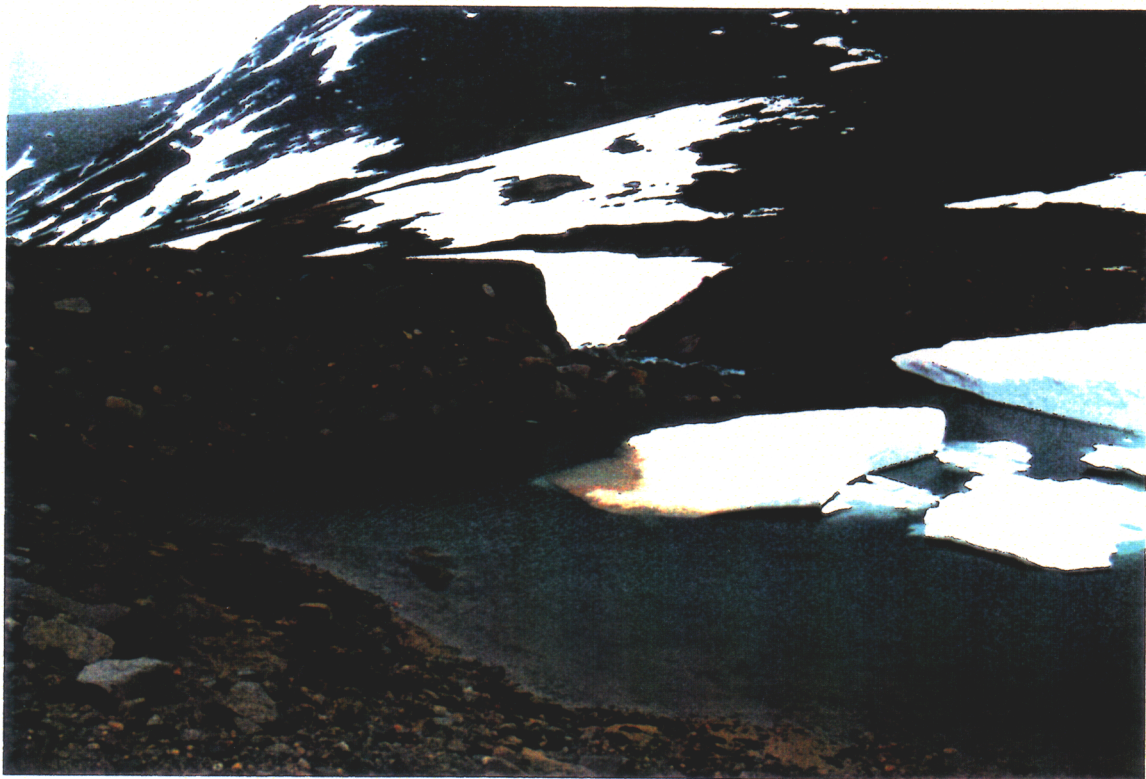
The dam across the creek appears to have been constructed using local granular fill and is between 2-3m high. An overflow pipe was installed within the top 0.5m of the dam. The dam has failed and the creek has re-established unconstricted flow through the middle of the dam. The material from the centre of the dam appears to have been eroded and washed downstream. There is no evidence to suggest that this dam was deliberately removed during any shut down phase of the mine as the remaining opening does not appear to have been machine excavated. If this did occur, above normal siltation would have taken place in the creek below the dam until the embankment was eroded to its present condition.

9. REMAINS OF DAM ACROSS BIG THING CREEK

- backsloping the eroded face of the dam on the creek sides to a 3:1 (horizontal:vertical) slope,
- removing the remaining culvert from the dam fill, and
- dismantling and burning the wooden pumphouse building.

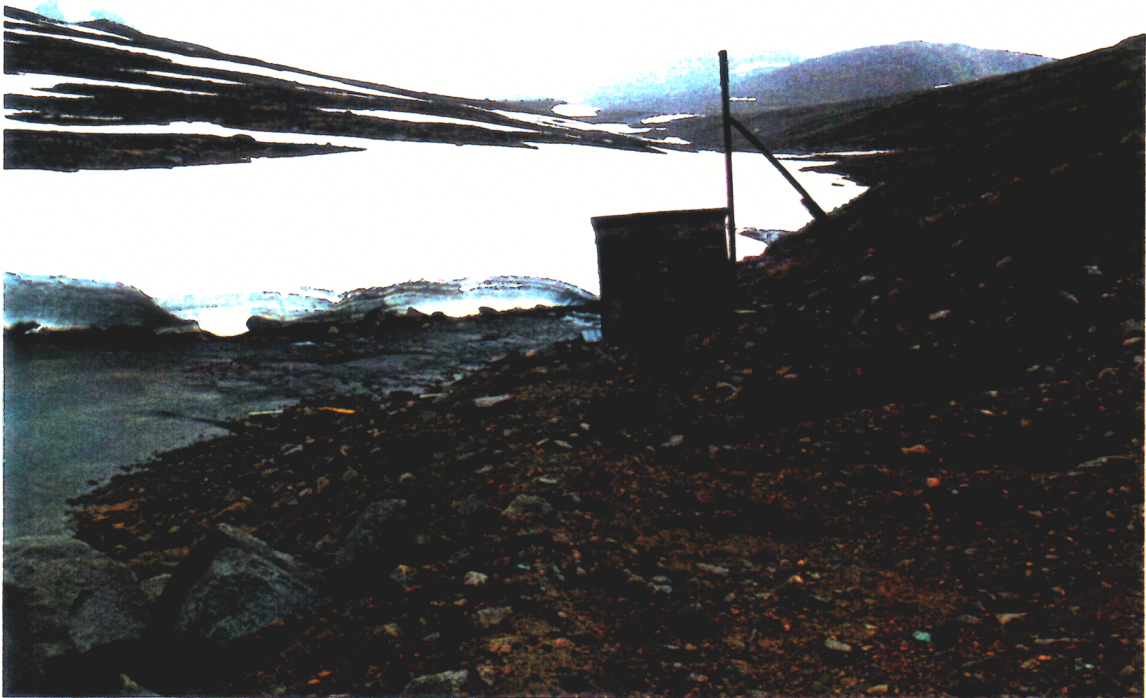
At one time, likely when the mill was in operation during 1968 and 1969, Big Thing Creek below the mine and mill site was dammed and a water storage reservoir was created. The water was likely pumped from a plywood pumphouse building measuring 3.0x3.0m on the north shore of the creek to the mine and mill site. The old pumphouse remains on the bank of Big Thing Creek, however no water pipe was found.

10. PUMPHOUSE ON BANK OF BIG THING CREEK

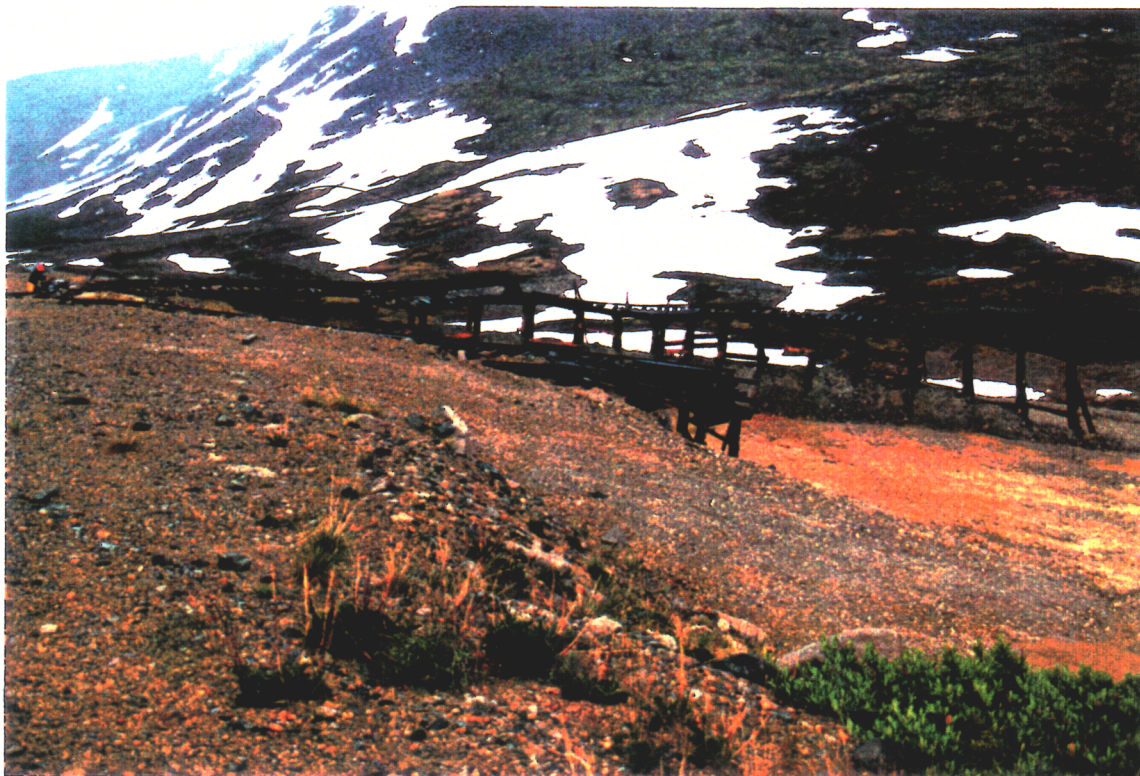
7. TRESTLE INTO WASTE DUMP

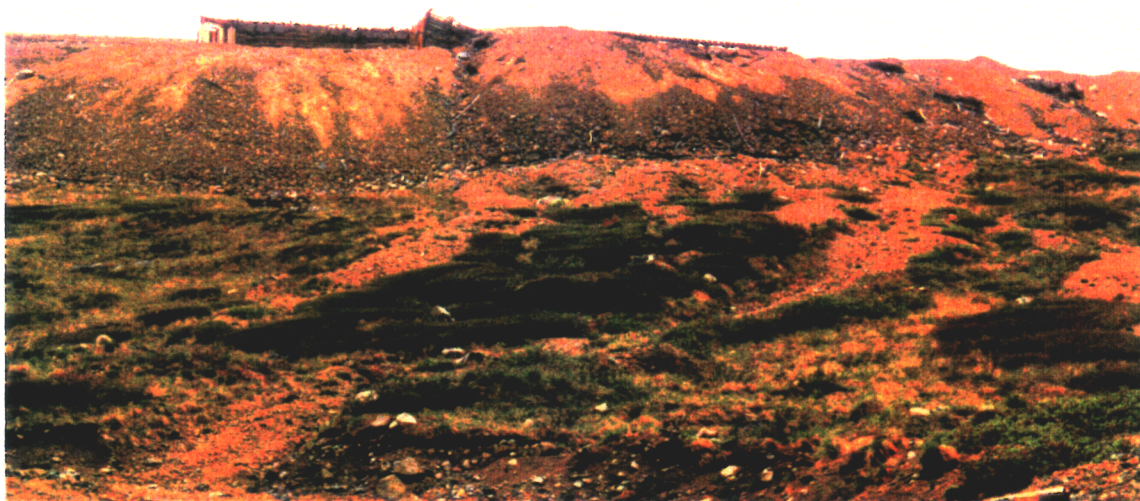
The waste rock has been dumped and is sitting at its natural angle of repose. It is unlikely that this waste rock will cause any additional slope instability. Revegetation of this waste material as well as areas where trenching occurred is not practical as the material is dry and void of organics needed to support vegetative growth. Further disturbance of this material will disturb any natural revegetation that is taking place.

8. LOADOUT (LEFT) AND WASTE ROCK DUMP (RIGHT)
