ASSESSMENT REPORT

105F-07-1

STORMY

DIAND TECHNICAL SERVICES

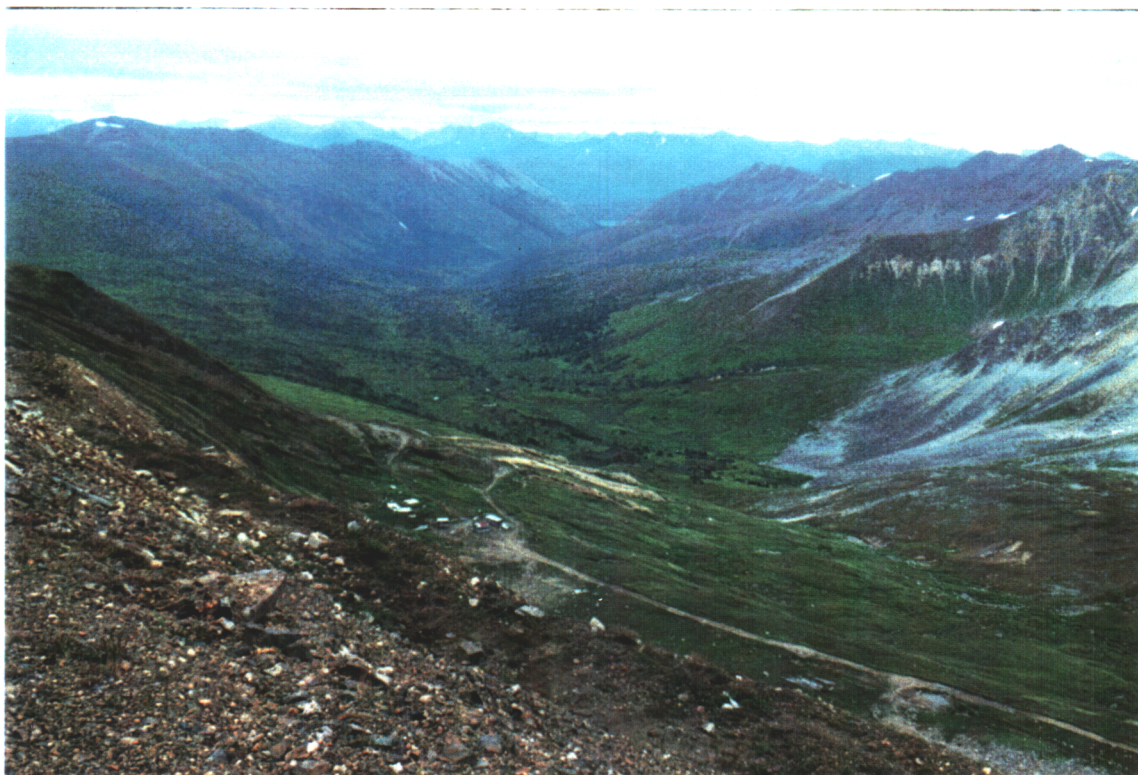
CAMP SITE FROM ADIT LOCATION

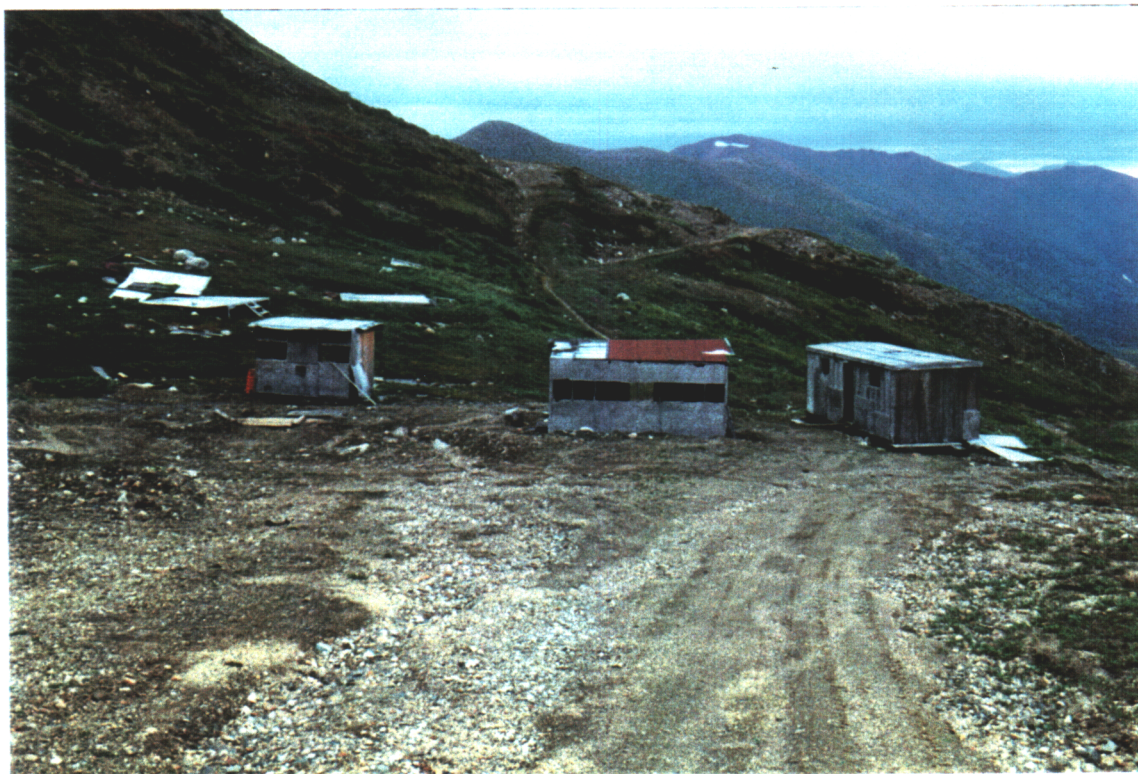
- plywood clad wood frame building, measuring 3.1x7.3m, once used as a cooking facility.
- plywood clad wood frame building, measuring 4.9x4.9m, used to store approximately 8.5 cubic metres of core.
- plywood clad wood frame building, measuring 2.4x3.7m, once used for showers.
- 2 wooden tent frame bases, each measuring 4.3x4.9m.

BUILDINGS AT CAMP SITE

The remaining part of the camp does not provide significant environmental hazard to the area. The wooden buildings will continue to deteriorate and should be demolished and removed or burned, however they pose no real hazard to the surrounding environment. This is considered a **LOW** priority to improve the environment in this area.

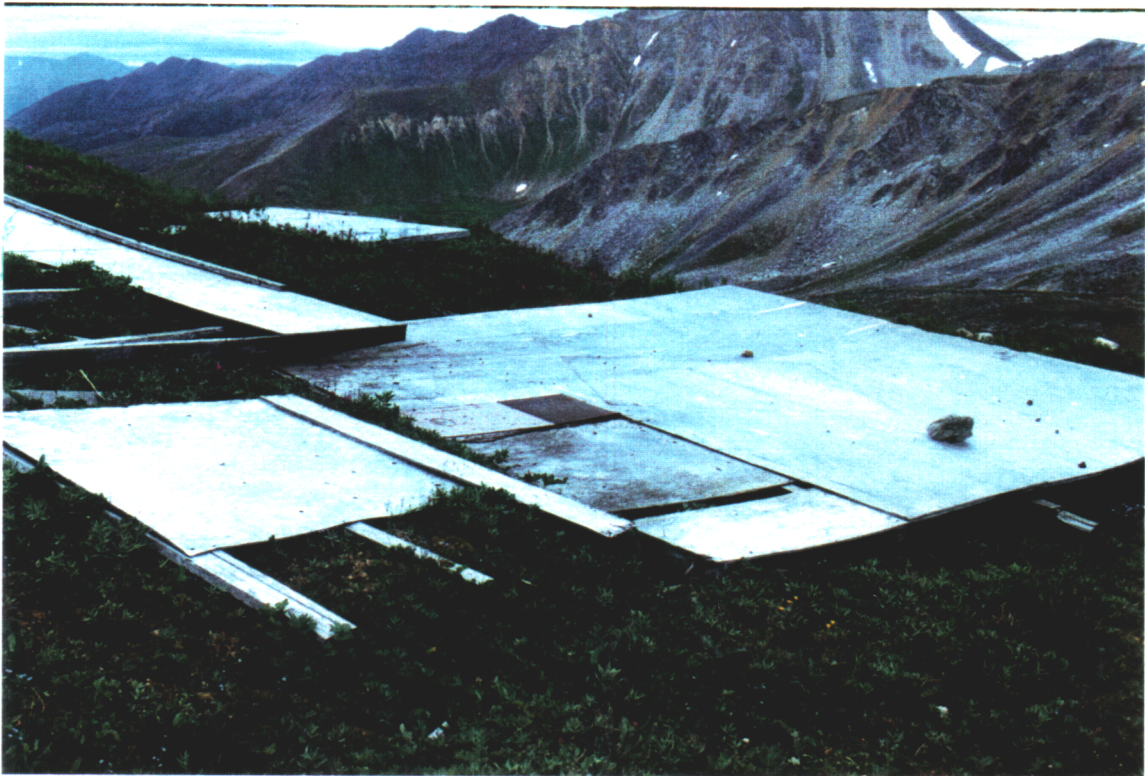
TENT FRAMES

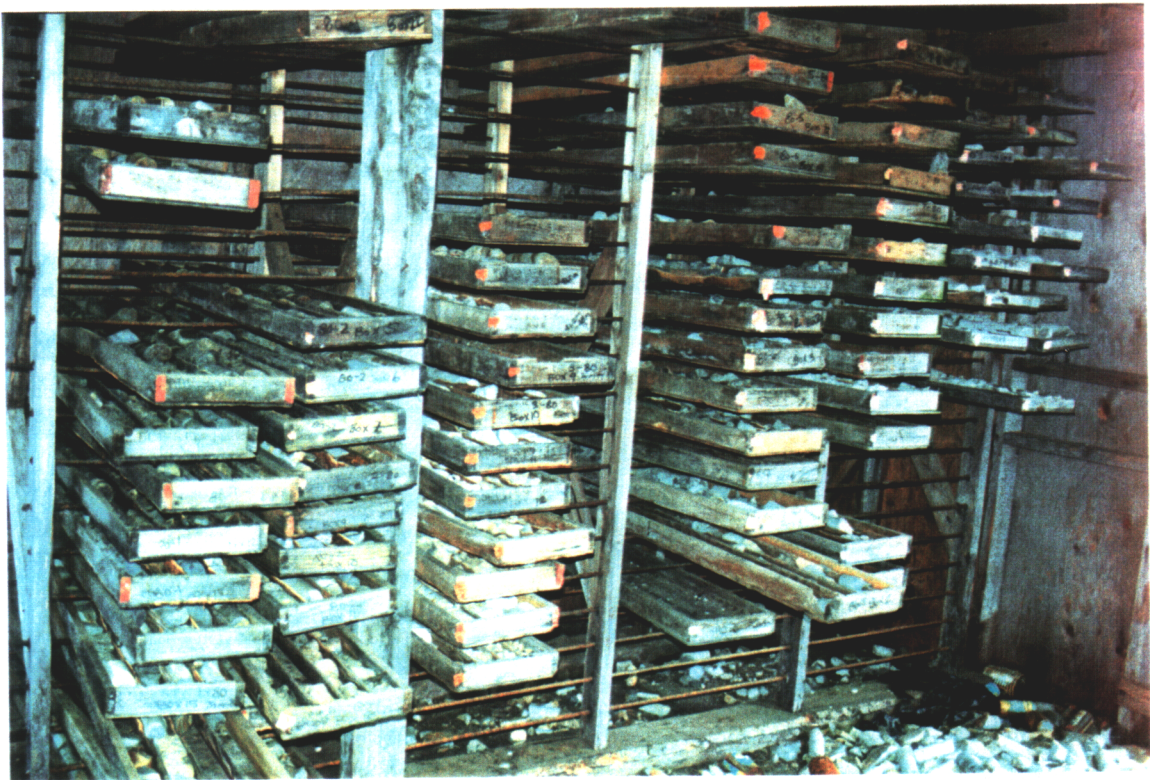
CORE

The remaining core appears to be quite old, has been scattered and will likely be difficult to recover with any accuracy. However, a qualified geologist would need to assess the possibility of recovering or accurately logging this core at this time.

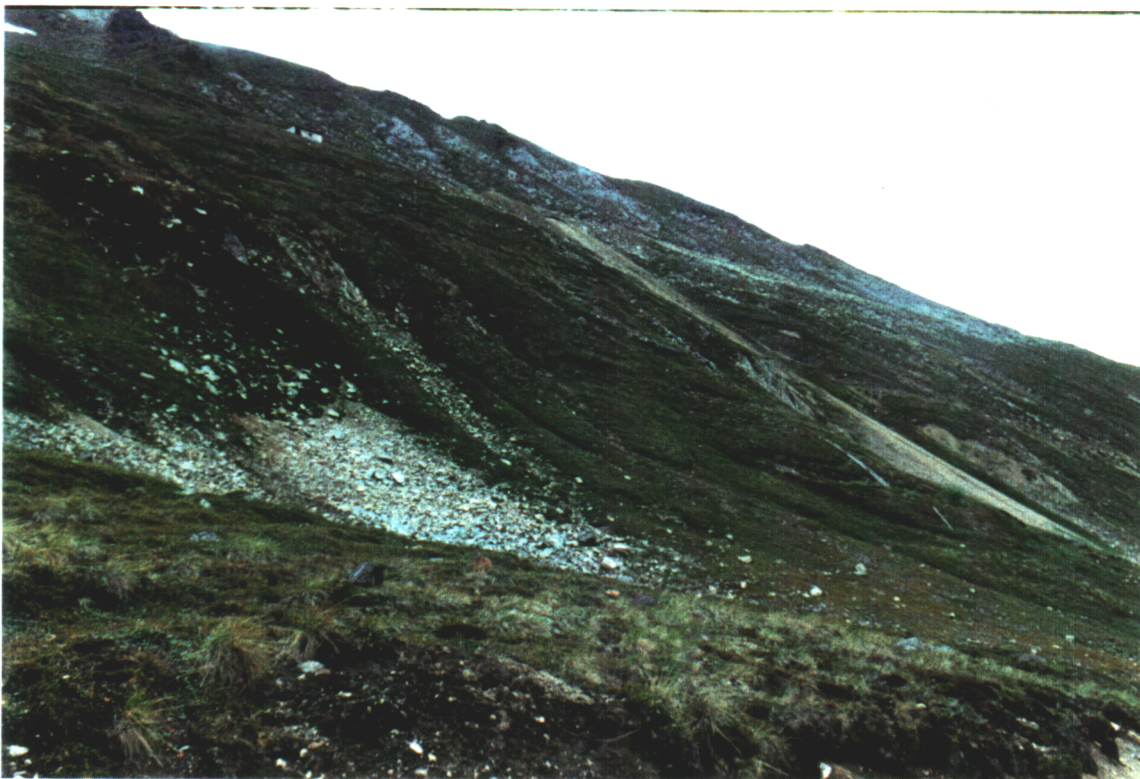
A relatively small amount of waste rock (less than 1000 cubic metres) was dumped over the steep bank in front of the entrance to the adit. This waste rock effectively blends in with the surrounding talus, and is not overly visible on the slope.

ADIT SITE

Site remediation of the waste rock is not considered practical and would not improve the environment without causing additional damage to the area. The revegetation that has started on the waste rock dump, the trench area, and the access road should not be damaged and allowed to regenerate naturally.

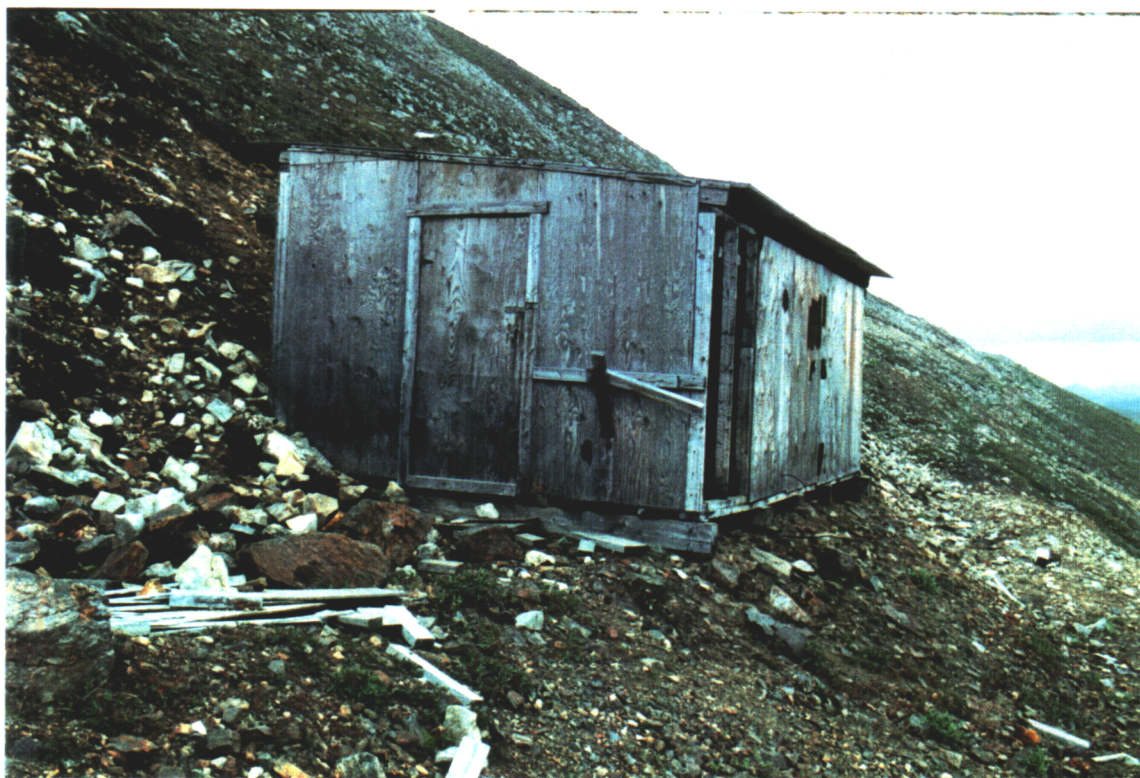
STORAGE BUILDING NEAR ADIT

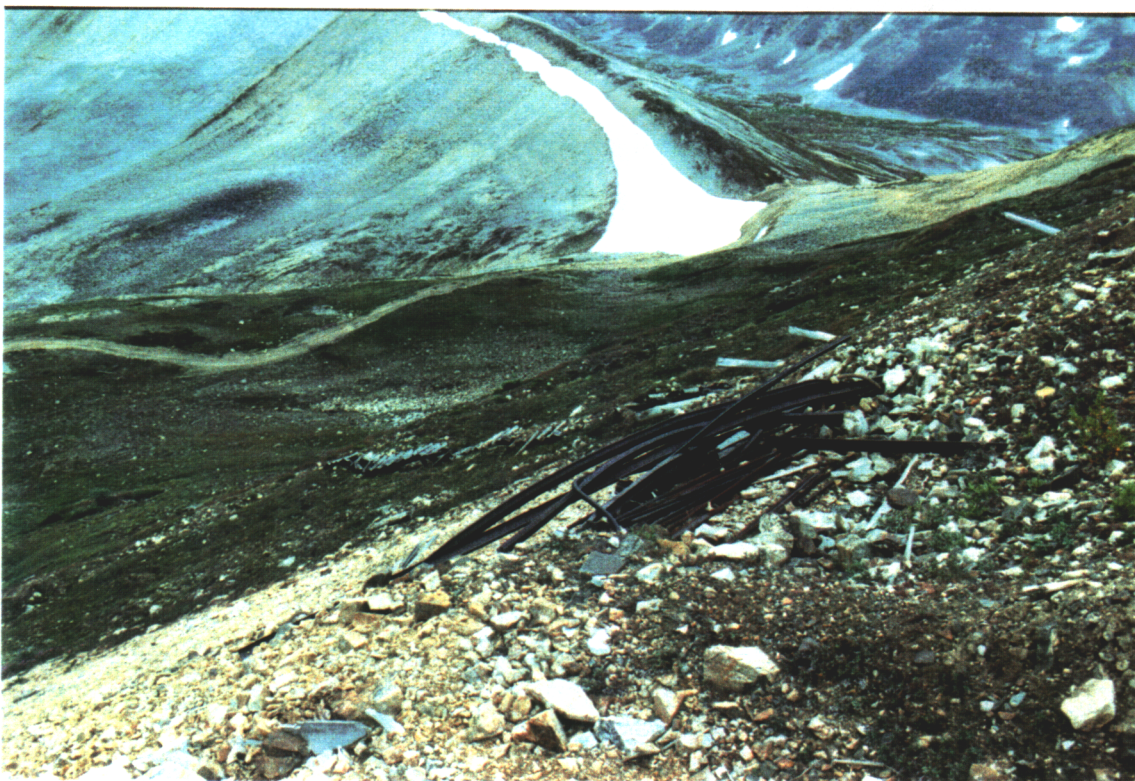
- plywood clad wood frame building, measuring 3.7x6.1m, used as a storage building.
- a pile of old rail, pipe, and 10 wooden timbers was located outside the entrance of the adit.

RAIL, PIPE, AND LAGGING AT ADIT

If a waste clean-up program is implemented in the area, it is recommended that the metal waste be gathered and removed from the site. At the same time, the remaining wood waste should be piled and burned in an acceptable location. This work should be considered a **LOW** priority at this location.

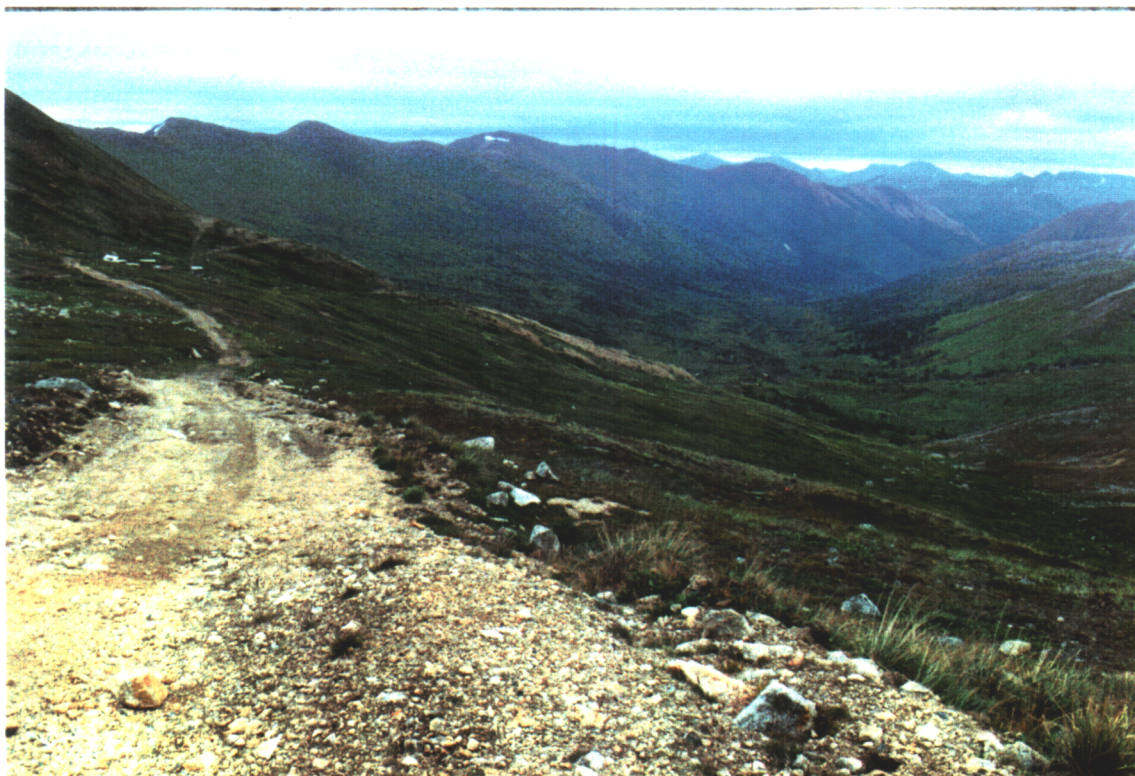
The once cleared right of way is overgrown with new vegetation except for a one lane trail that remains open due to local traffic. The road near the exploration site was constructed on a very steep, dry, but stable slope, leaving a visual impact from the "cut and fill" method of construction used. Remaining impact should only be visual which would be very expensive and initially cause more damage if repairs were initiated. This is not recommended.

ACCESS ROAD NEAR EXPLORATION SITE

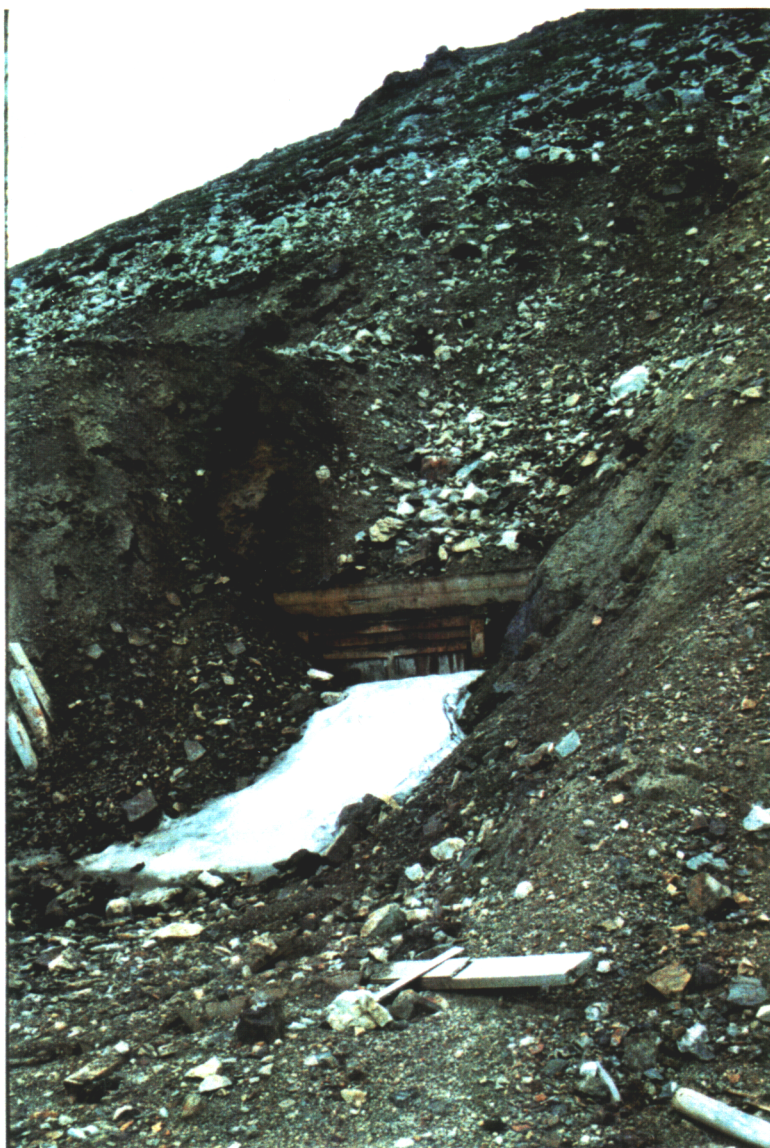
One adit was found which was partially blocked by snow. The upper half of the adit entrance was exposed which showed that it was well sealed with a solid wooden timber gated structure. The only seepage from the adit appears to be from snowmelt. No groundwater seepage was evident.

ADIT

As noted, the adit is well sealed, is effectively covered with snow year round, and does not appear to pose any concern for public safety. Nothing needs to be done to better secure this adit at this time.
