**ASSESSMENT REPORT**

**105H-07-1**

**CONGLOMERATE CREEK**

**DIAND TECHNICAL SERVICES**

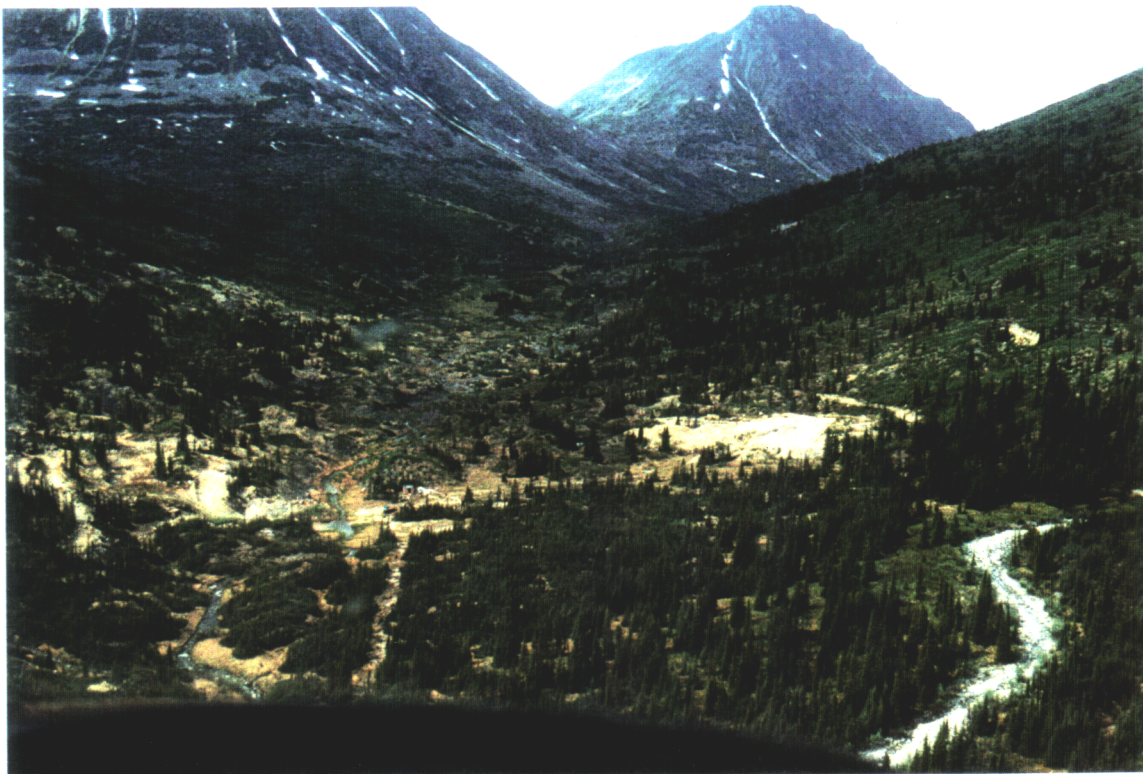
OVERALL VIEW OF SITE

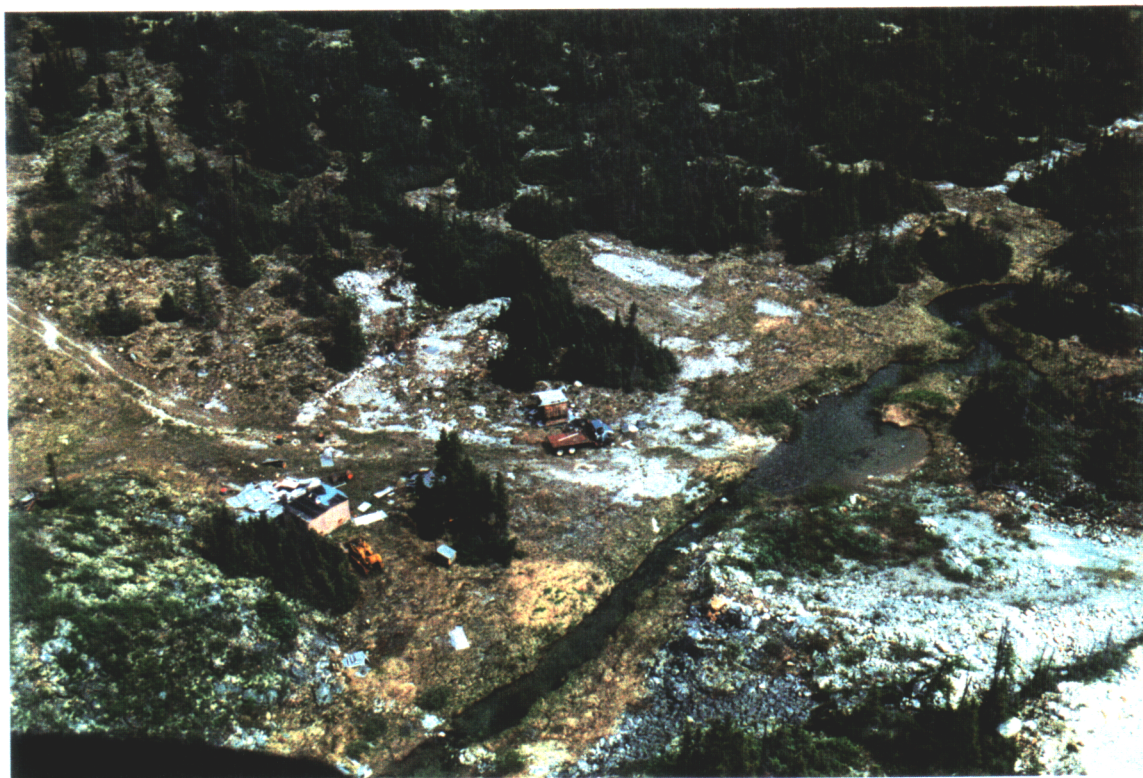
As noted above, the camp was not cleaned up when the exploration activity was finished; and equipment, core, barrels with some hydrocarbon product, buildings, and miscellaneous junk has been left behind.

CAMP SITE AND CONGLOMERATE CREEK

The highest priority for clean-up at the camp is considered to be the removal of the barrels from the area. Although the potential for any hydrocarbon spill is small, it still exists as long as these barrels remain on site.

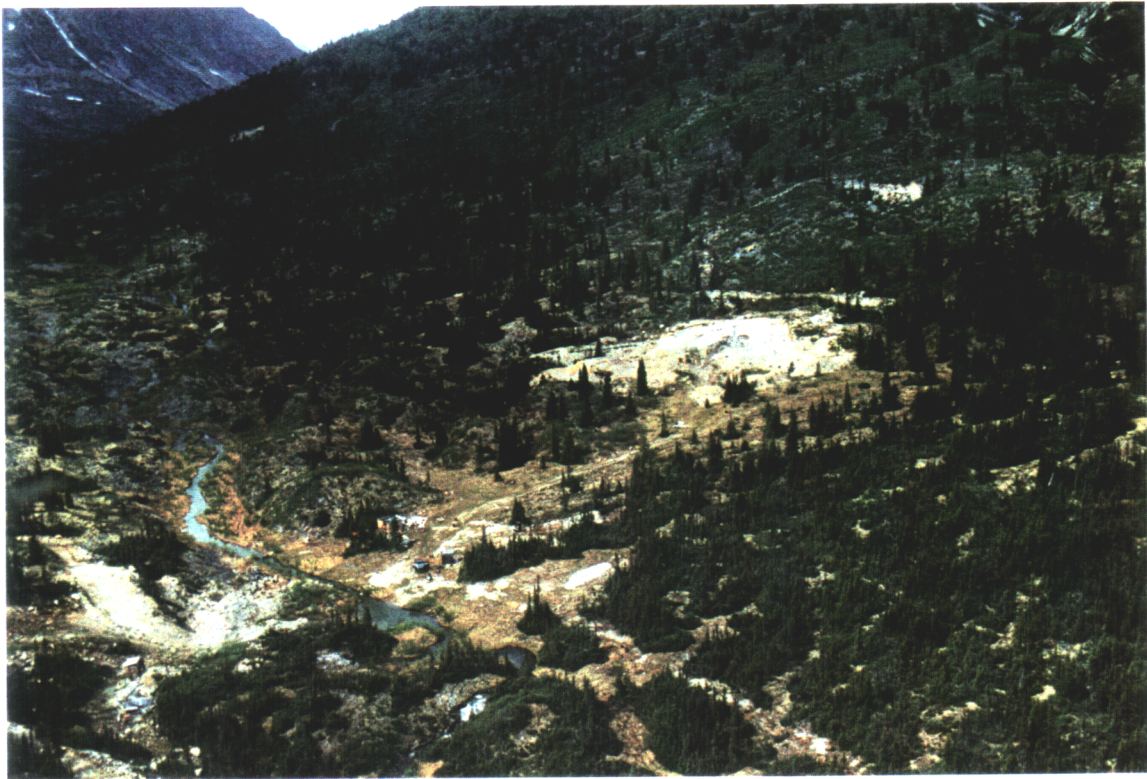
Trenching and stripping across this area has resulted in damage to the surficial soils and vegetation. Generally the soils across this moderately sloped area are very coarse and little surface erosion was evident. The creek flowing through the site was clear with no evidence of any recent siltation.

The roads generally follow the contours of the ground and little material has been cut or filled. The most significant damage from the road construction has been the removal of the vegetation. The only significant excavations have occurred from the trenching where piles of material have been left. Site remediation could include reshaping these excavation piles and attempting to revegetate any cleared areas. It is recommended that neither reshaping or revegetating be considered in this remote, very dry, and very harsh climate. Reshaping would only set back any natural recovery that has started and revegetating this site with very little organics that could not be tended is not likely to be very successful. The disturbed areas will eventually revegetate themselves from the local vegetation encroaching into the disturbed areas. This revegetation process is likely the only practical solution in an area that is extremely remote with a harsh climate.

EXPLORATION SITE

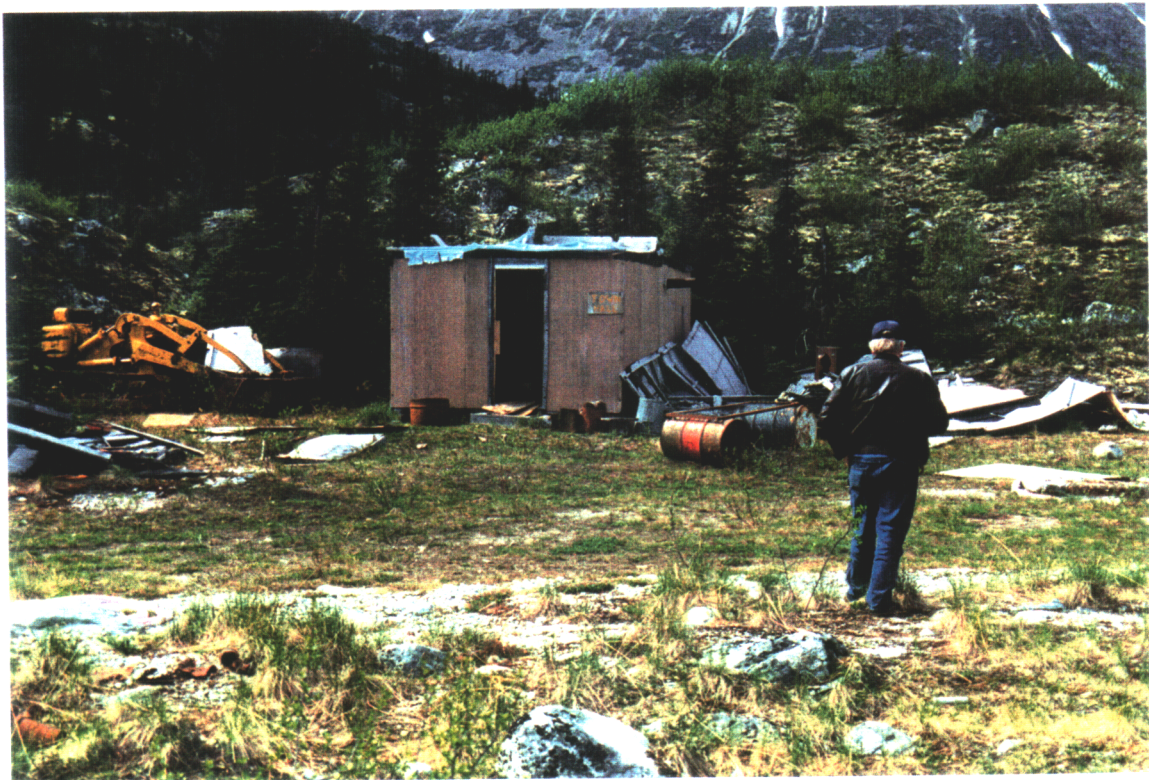
The two large pieces of equipment, the crawler tractor and the truck, are not in running condition and do not appear to be practically repairable. Removing these pieces of equipment would be costly as they would either have to be flown from the site in pieces,

The buildings left behind are deteriorating and have started collapsing. Although considered a **LOW** priority, it is recommended that these buildings along with any other lumber be stacked and burned in an appropriate manner and location.

CRAWLER TRACTOR AND CAMP BUILDING

or the road would have to be repaired and equipment mobilized to haul this equipment off the site. Although this equipment is unsightly, it is considered a **LOW** priority for clean-up. The other remaining material left on-site is also considered to be a **LOW** priority for cleaning up the site as they do not appear to be causing any significant ongoing environmental damage.

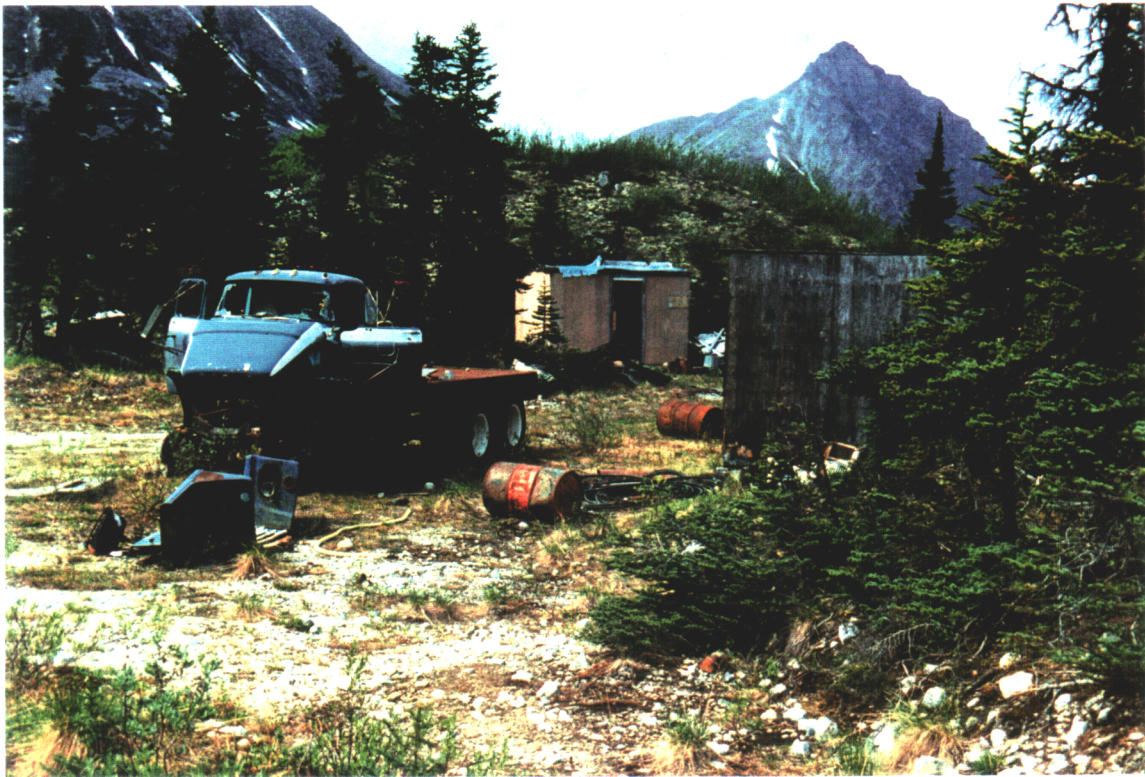
ABANDONED FLAT DECK TRUCK AND MISCELLANEOUS DEBRIS

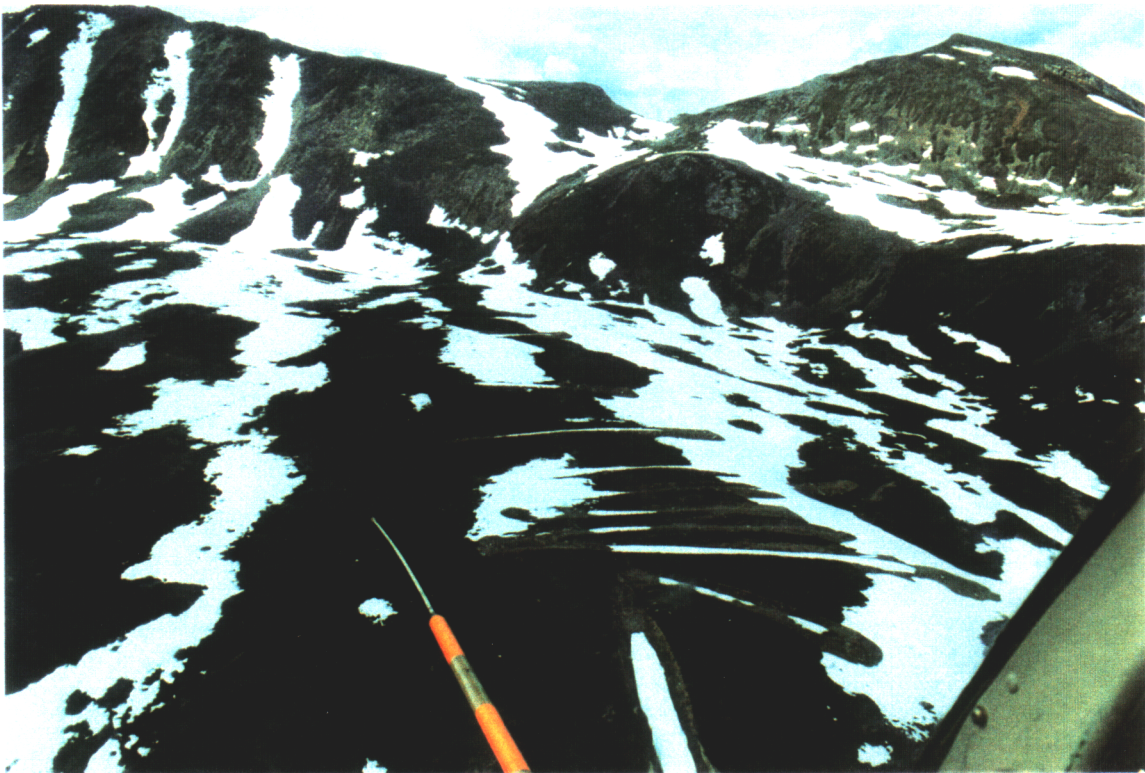
TRENCH SITE ABOVE CAMP
