ASSESSMENT REPORT

105M-14-4

FORMO

DIAND TECHNICAL SERVICES

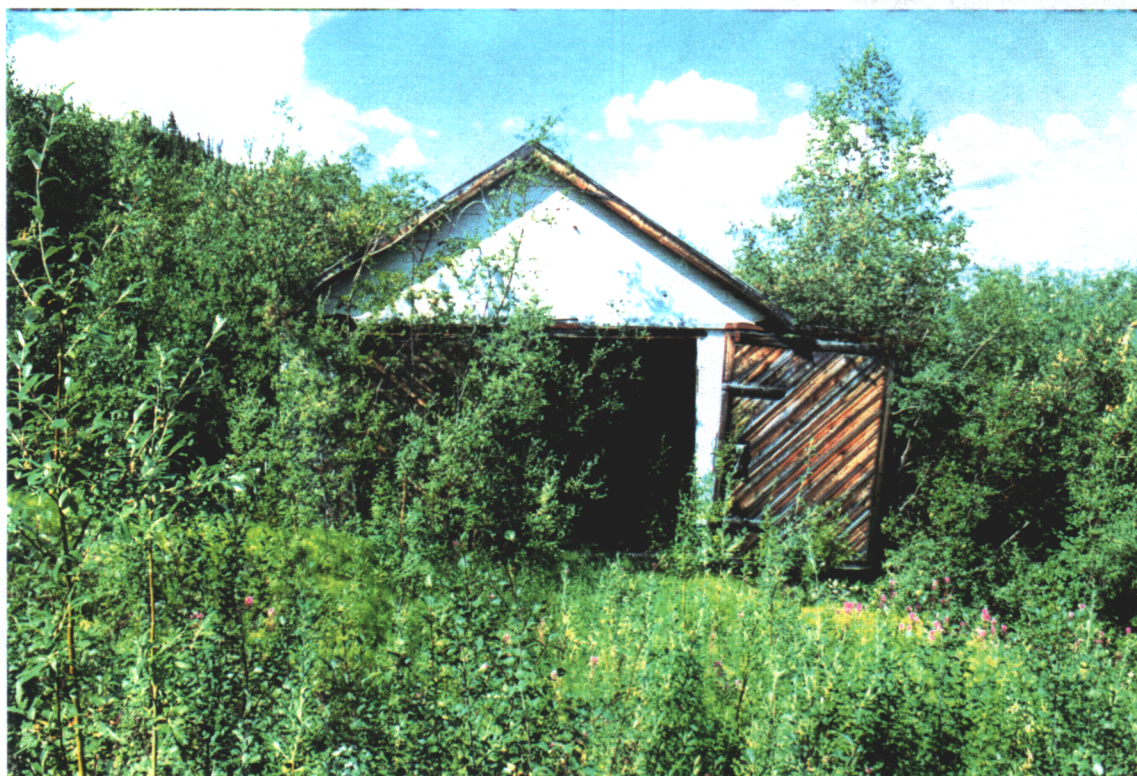
GARAGE/WAREHOUSE

The one old warehouse (or garage) is very old and deteriorating. It is expected that in a few years this structure will start to collapse caused by a combination of repetitive snow loading and weathering. It does not appear that the remaining core in this building is salvageable.

The one remaining building is deteriorating and vegetation is growing up close to it. This building does not appear to constitute an environmental liability at this time. In future, if this building deteriorates to the point where it is structurally unsafe, it may be considered a safety hazard and should then be removed. This building should be removed before an unsafe situation develops, however it is considered a **LOW** priority at this time. Setting a time to clean up this building should be determined from periodic inspections of the site.
