ASSESSMENT REPORT

105F-09-3

HOEY

DIAND TECHNICAL SERVICES

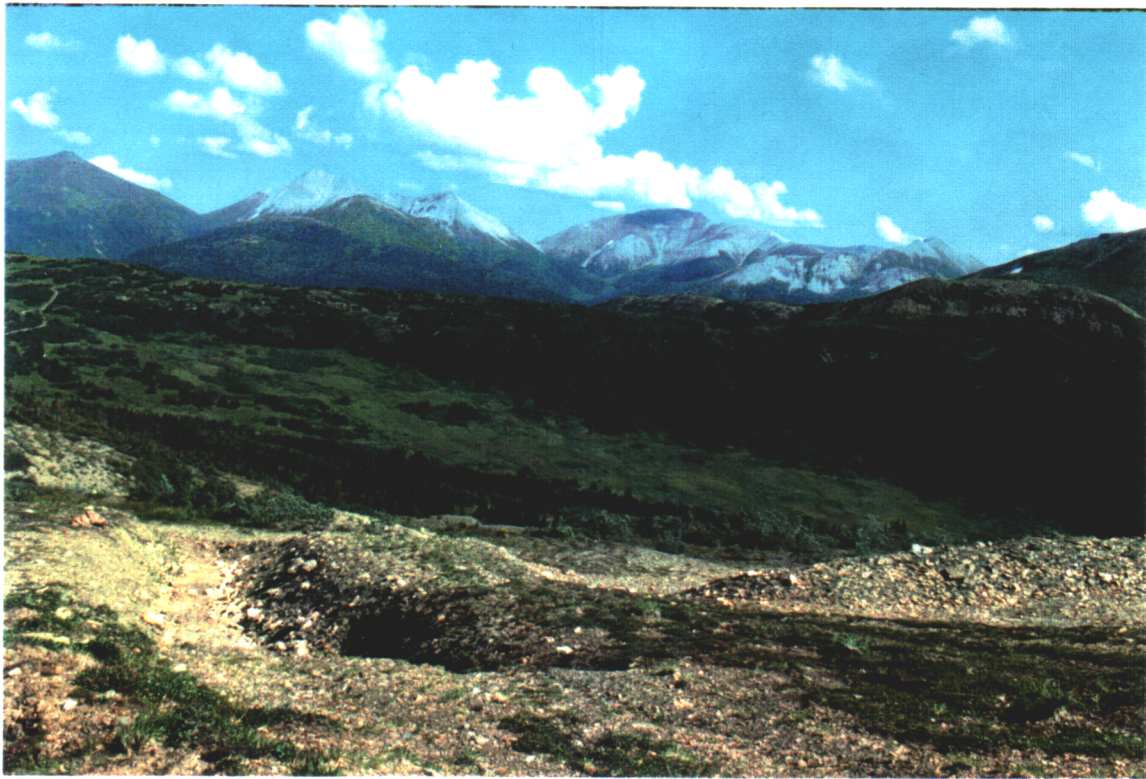
Trenching was conducted in the area approximately 30 years ago and these areas have overgrown with local vegetation. Partially overgrown piles from the trenching activity is the only remaining evidence from this work.

TRENCHING AND LOCAL TOPOGRAPHY

It is recommended that the trench areas not be disturbed, and allowed to continue the slow recovery that is underway.

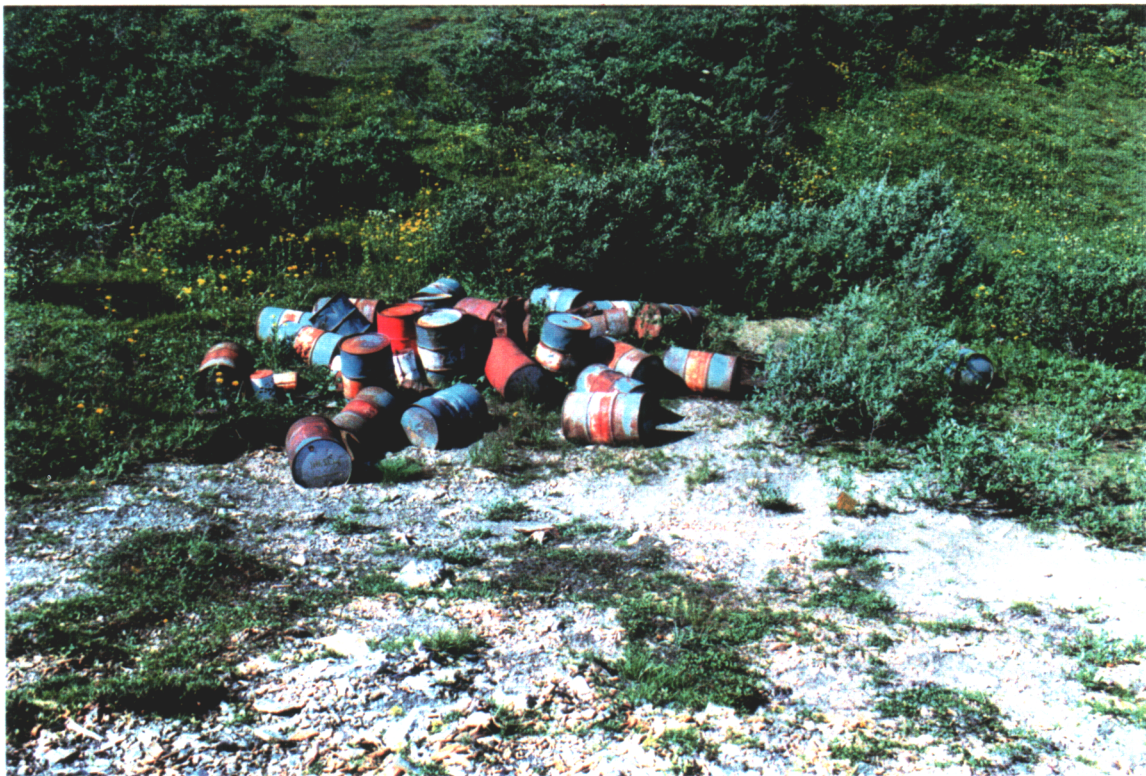
Between 1-2 kilometres south of the adits, remains of a tent camp was found with plywood walls and 27 very old 204 litre barrels. **Seven of these barrels are full of diesel fuel.** As well, a significant amount of trenching has been undertaken in the past. This trenching is not concentrated in one location, but is scattered across a fairly wide area along the network of trails.

The only potential significant impact at the old exploration camp is for the seven remaining barrels of fuel to leak or be punctured and damage the environment. This should be considered a **HIGH** priority for clean-up. All full and empty barrels should be removed from the site as soon as possible.

27 BARRELS (7 FULL) AT CAMP SITE

Overall, very little environmental damage was observed at this site, and it should be allowed to continue its natural recovery. However potential environmental damage could occur if the seven barrels of fuel leaked or was spilled. This fuel should be removed as soon as possible to eliminate the remaining hazard. This should be considered a **HIGH** priority.

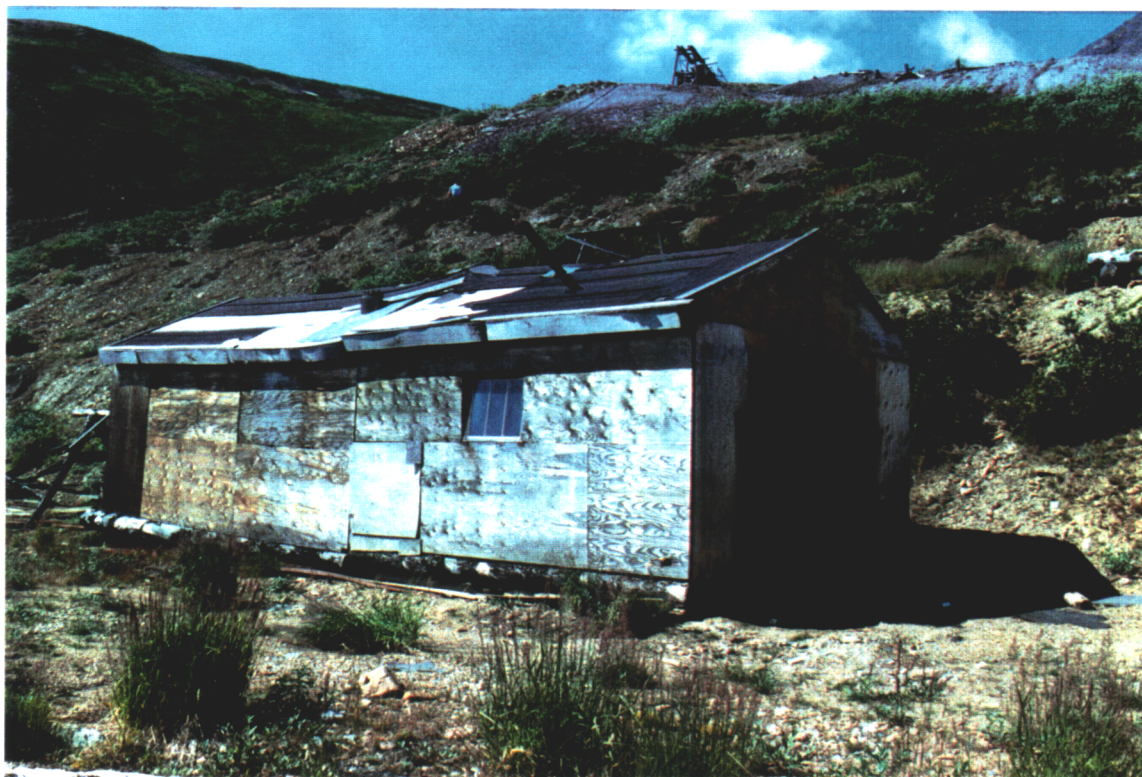
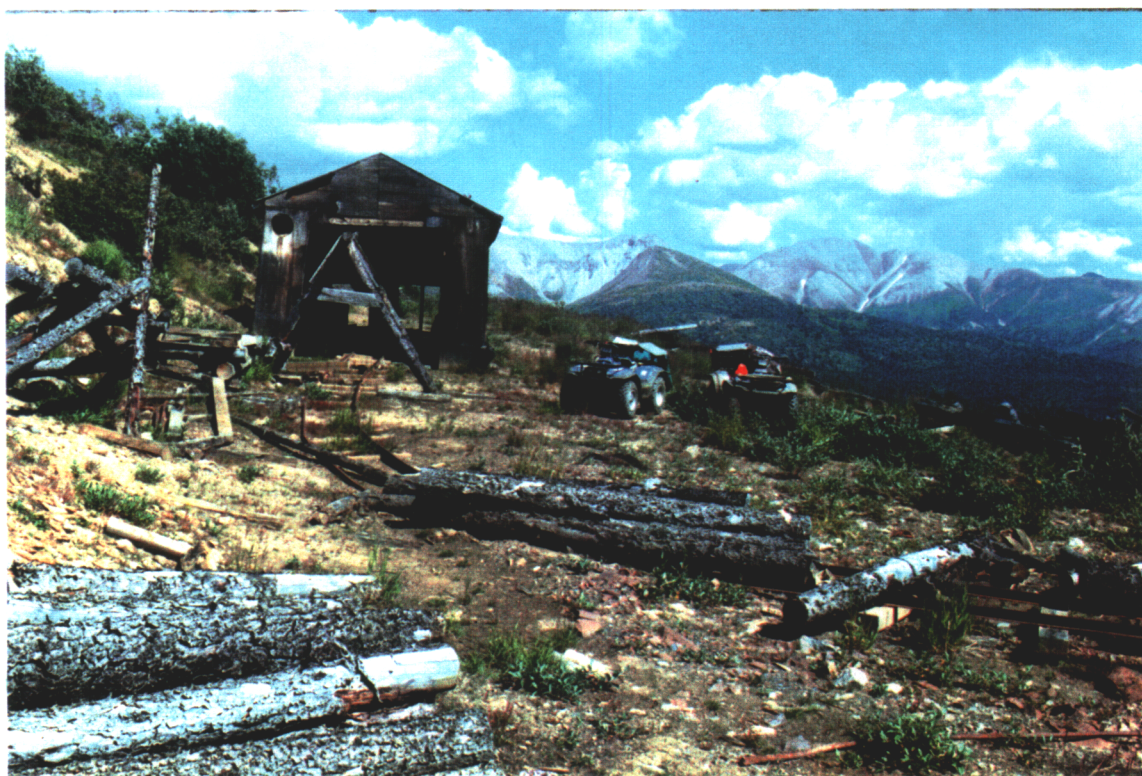
A 5x12m wood frame plywood clad building is located adjacent to the adit and appears to have been used as a workshop and warehouse.

WORKSHOP AT LOWER ADIT

Other surrounding infrastructure such as old rail and other metal waste can be gathered and removed from the site. This is considered a **LOW** priority and could be undertaken only if a general clean-up program is initiated in the area. Similarly, the storage building could be dismantled and removed, however this is considered a **LOW** priority as well.

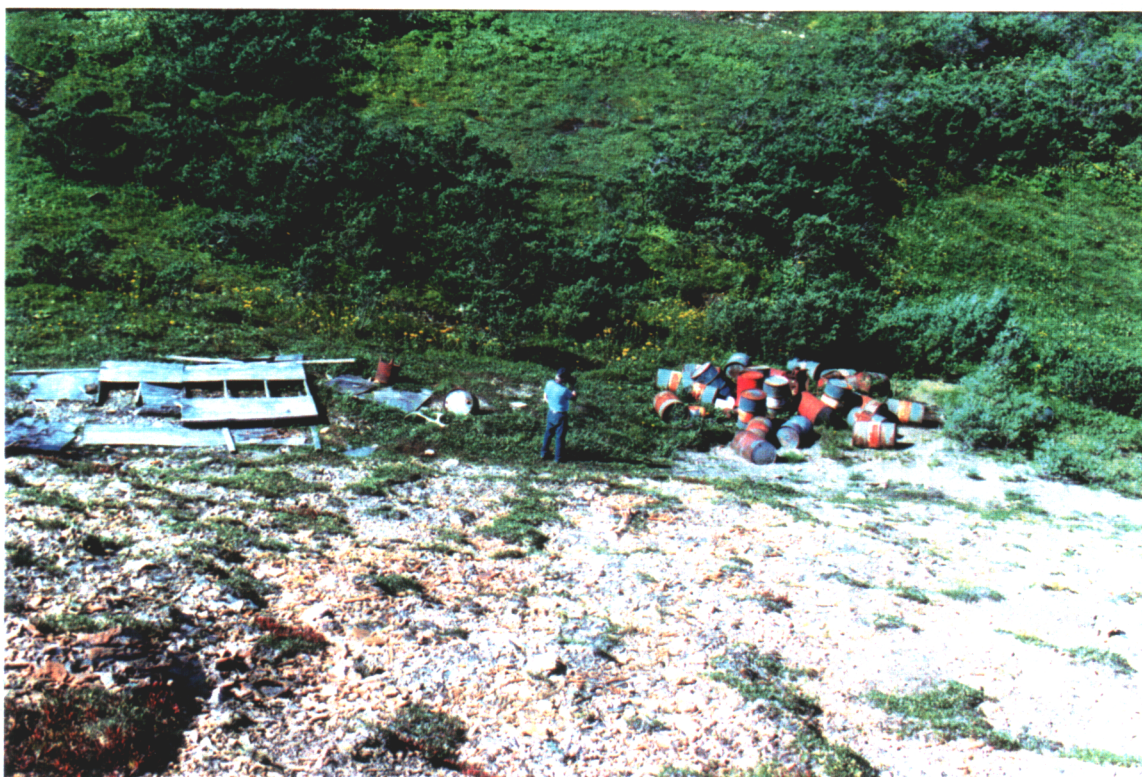
REMAINS OF CAMP AND BARREL SITE

The remaining wood waste could be piled and burned in an appropriate location, however this is considered a low priority.

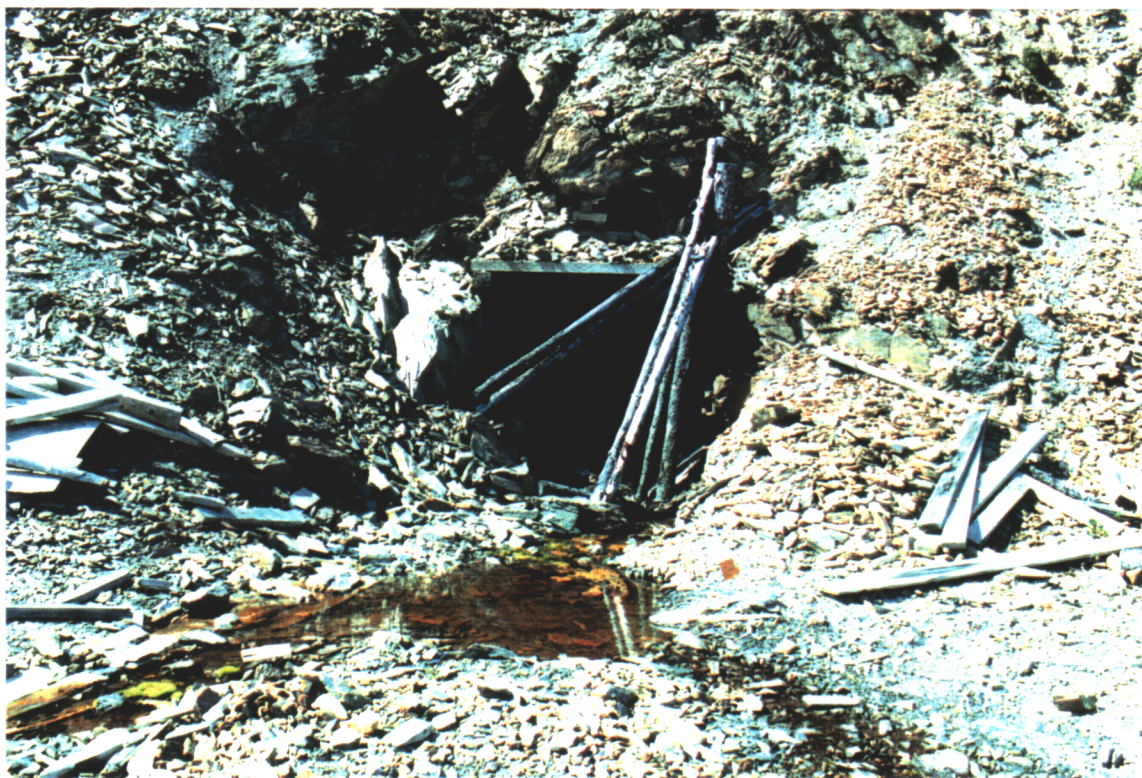
Up to 100 litres/minute of groundwater was flowing out of the adit at the time of inspection on 1993/07/30.

Both adits are open and are not sealed from public access.

LOWER ADIT

The entrances of the two old adits are unsecured and accessible to the public. These open adits pose a public safety hazard, and the entrances should be closed or sealed against possible entry.

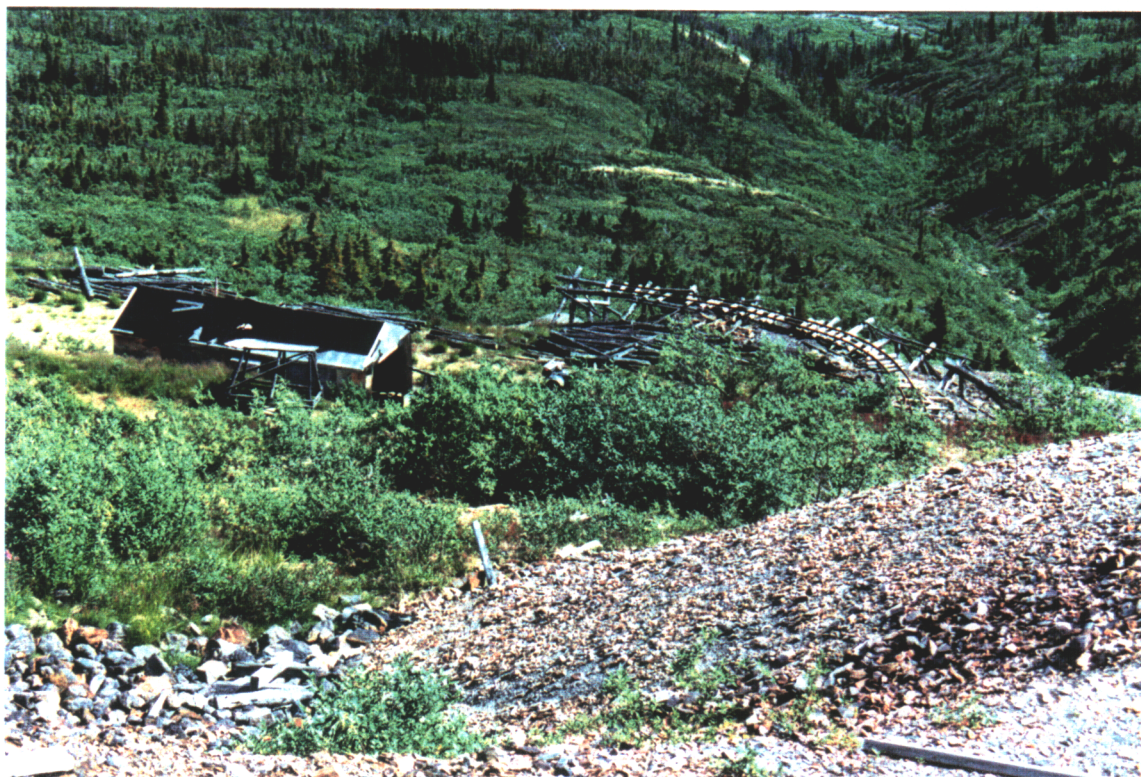
WORKSHOP AND RAIL TO WASTE DUMP AT LOWER ADIT

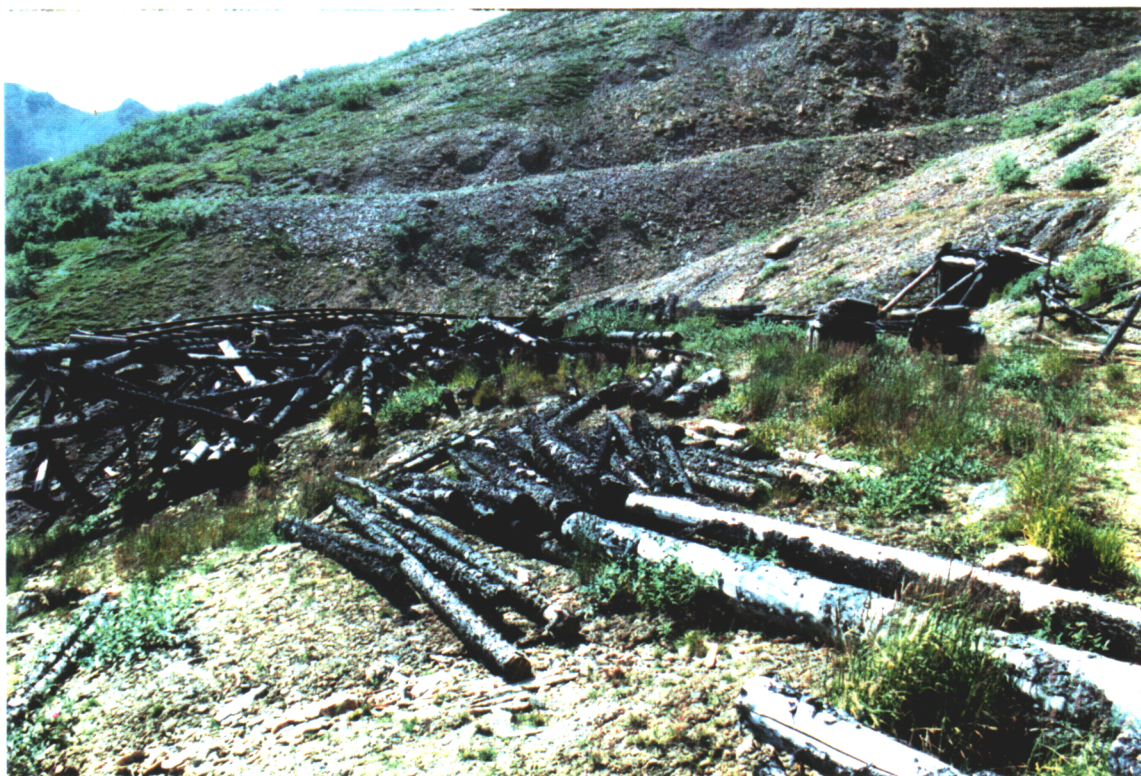
LOWER ADIT, LAGGING, AND RAIL TO WASTE DUMP

Lagging and any other wood waste should be piled and burned in an appropriate location if any clean-up program is undertaken.

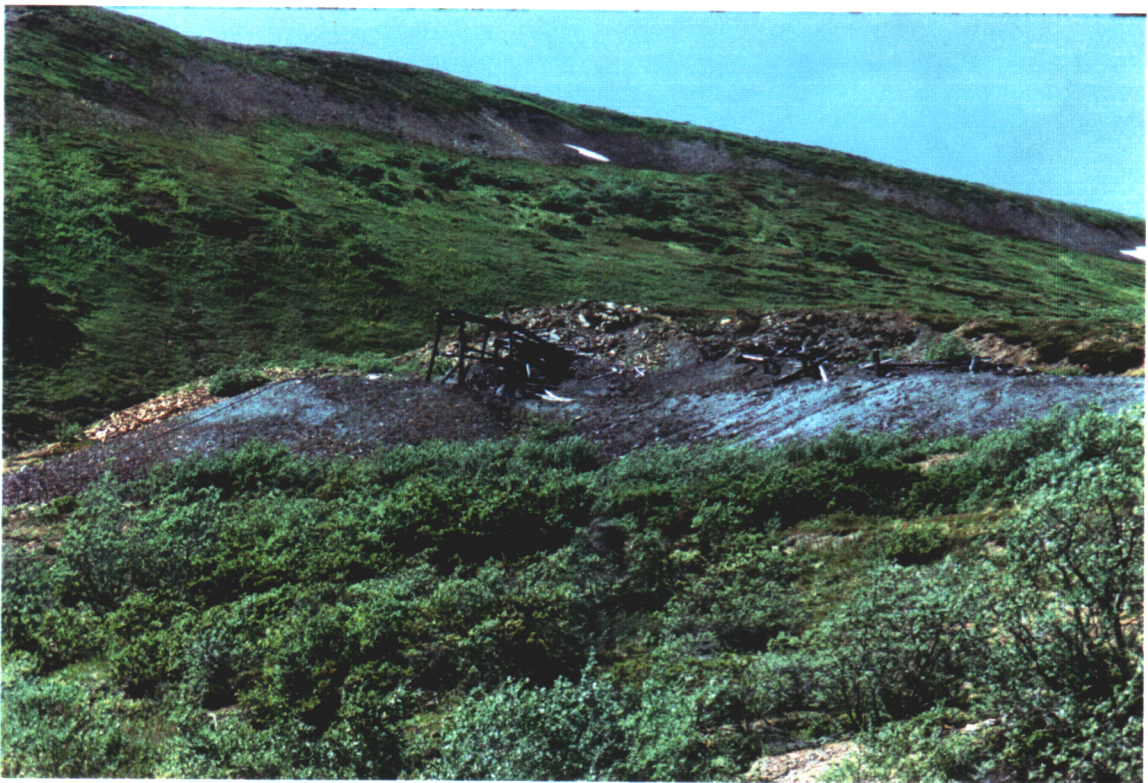
Rock waste has been dumped down the slope in front of the adits. This waste material is visible from quite far away but would be very difficult and costly to conceal or remove. Practically, the waste rock can only be left in place.

WASTE DUMP AT UPPER ADIT

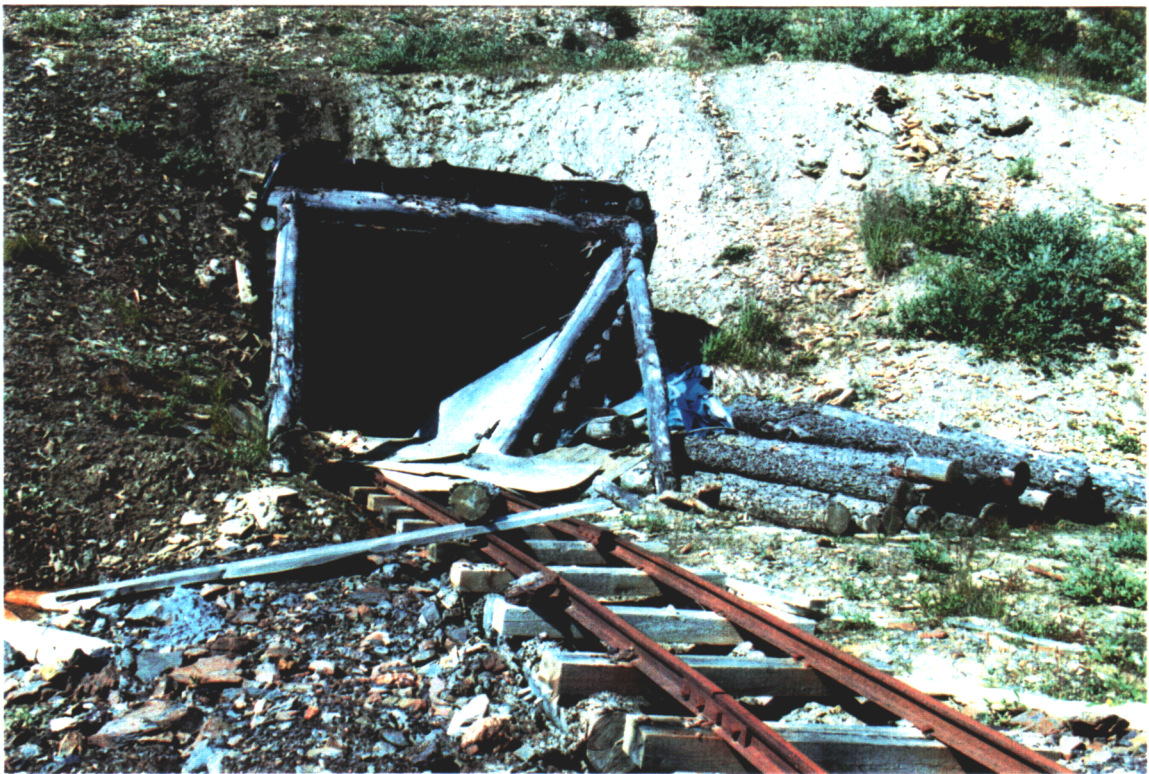
Approximately 25 litres/minute of groundwater was flowing out of the adit.

UPPER ADIT

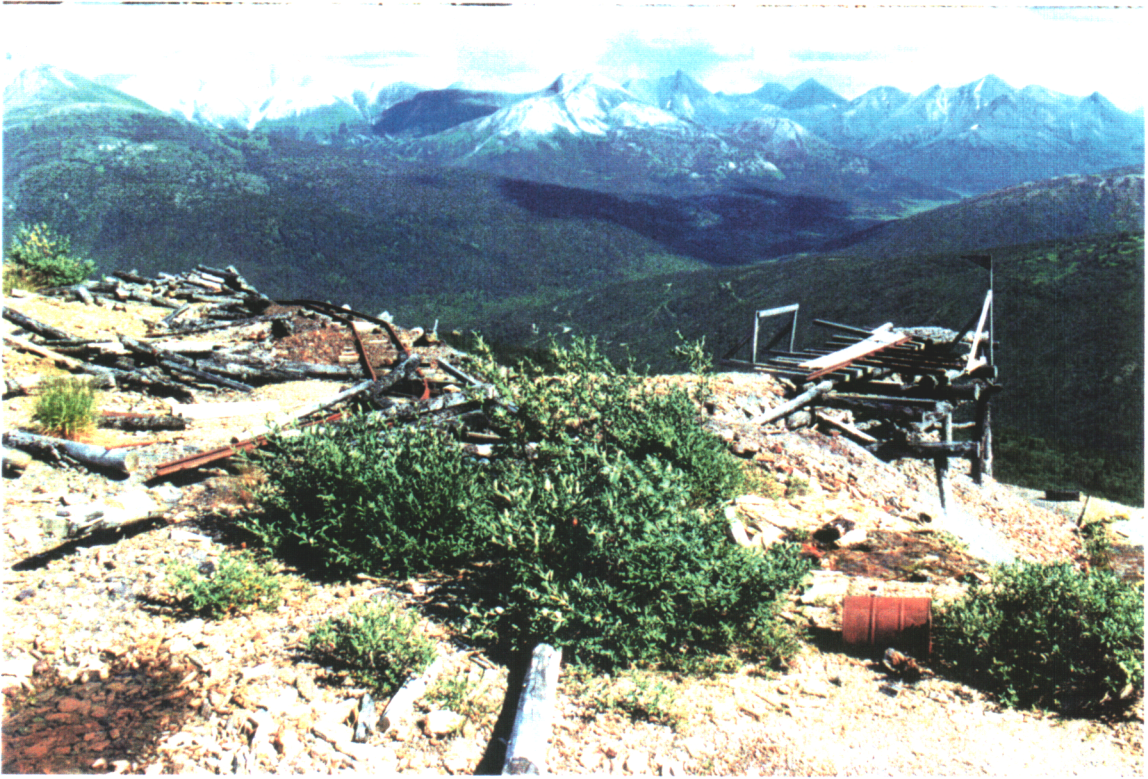
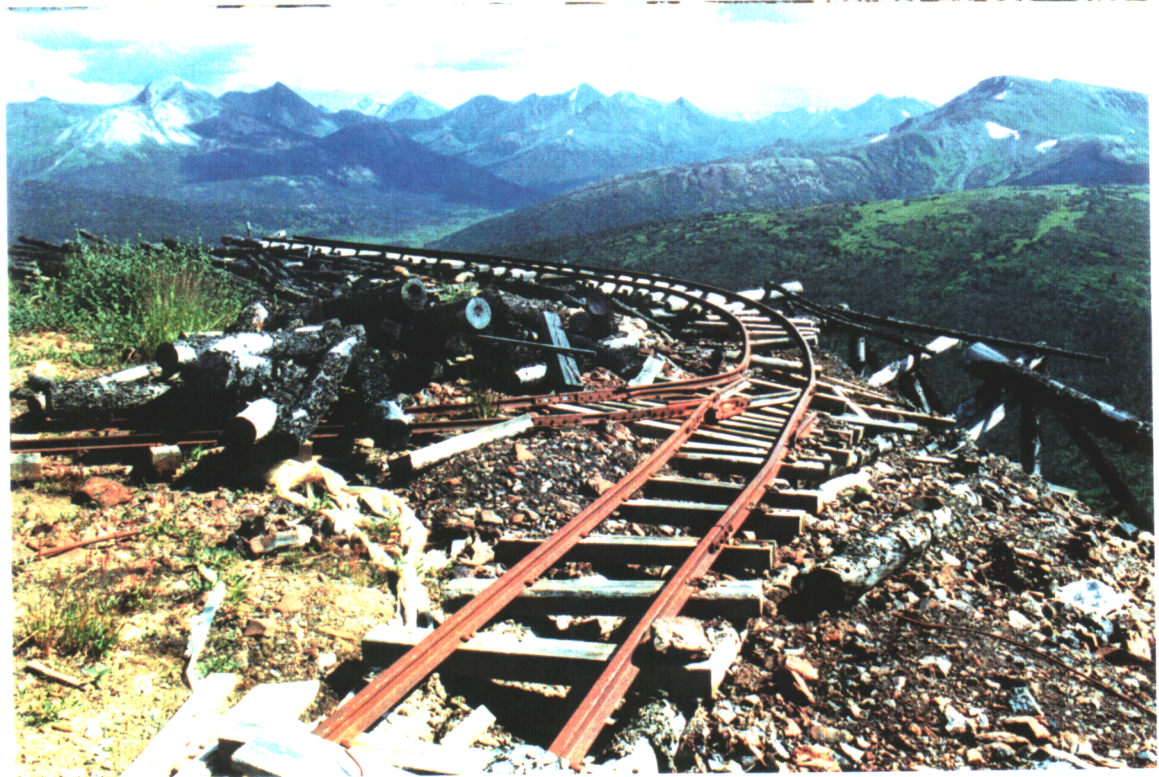
Remaining infrastructure consisted of approximately 60m of rail extending from the adit to a wooden trestle used to dump the waste rock down the slope. A pile of wooden lagging is also piled on-site.

RAIL TO WASTE DUMP FROM UPPER ADIT

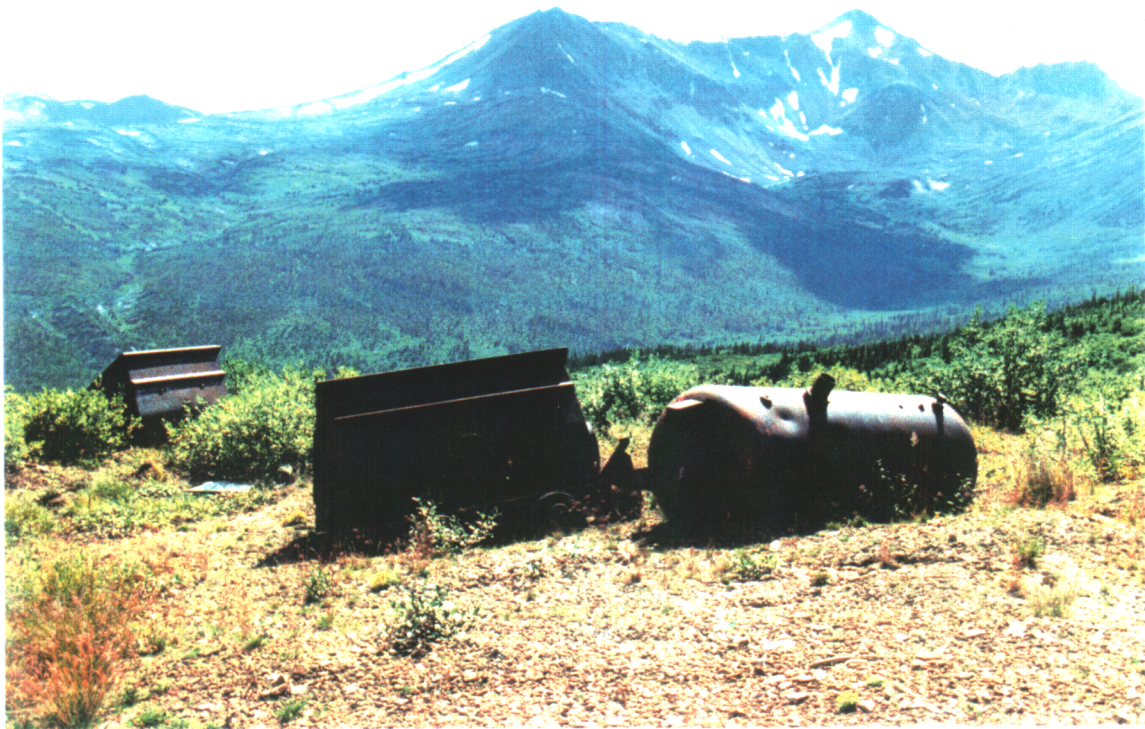
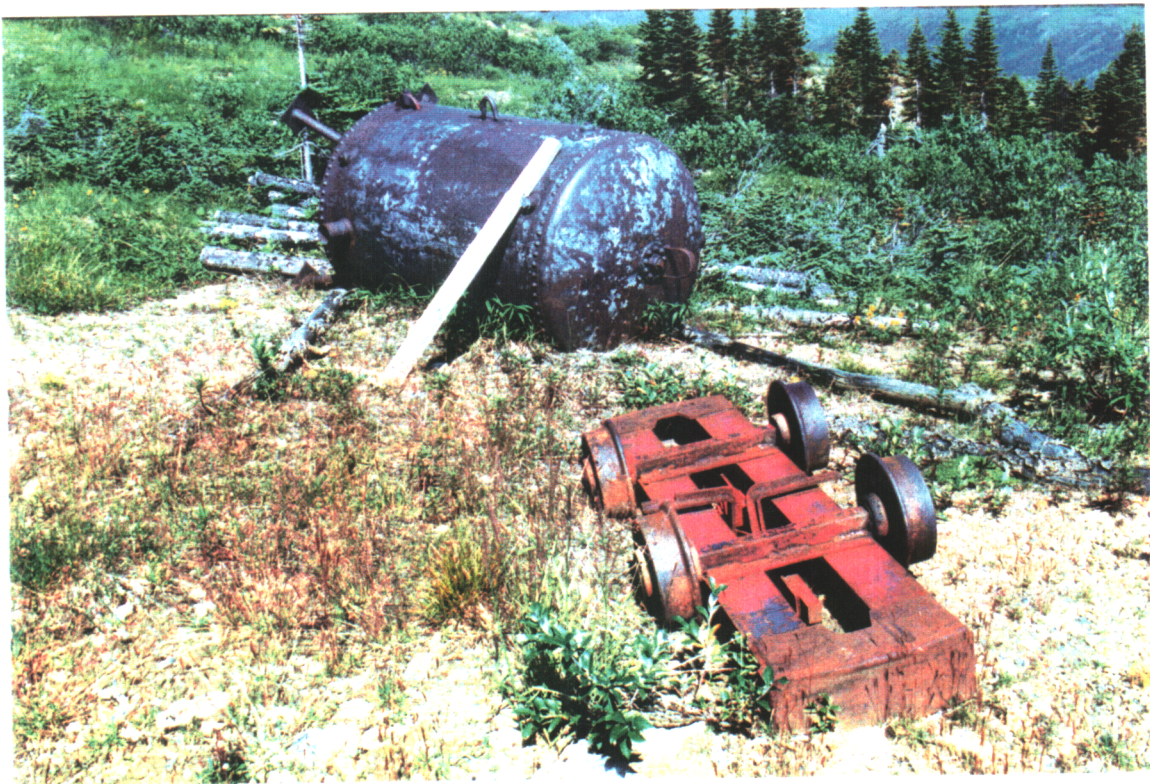
- approximately 120m of rail,
- a large pile of wooden lagging,
- 3 ore cars,
- 2 pressure vessels,
- one empty barrel.

ORE CARS AND PRESSURE VESSEL

PRESSURE VESSEL AND ORE CAR UNDERCARRIAGE
