ASSESSMENT REPORT

106D-08-1

KATHLEEN LAKE NORTH

DIAND TECHNICAL SERVICES

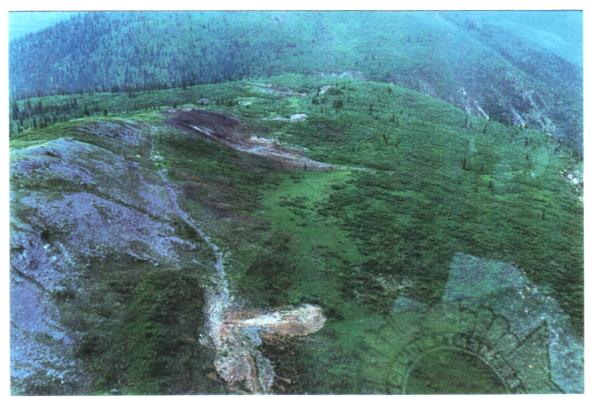
Exploration at this site has been limited to surface drilling and trenching. Extensive areas have been exposed from construction of exploration trails and trenching. No adits were constructed at this location.

Because the site is so high and dry the exploration trails and trenched areas have not revegetated naturally.

OVERALL VIEW OF SITE SHOWING TRENCHING

The exploration trails to the site are steep and narrow and constructed on coarse granular material. The area is dry with only some surface ravelling taking place. Revegetation on the road surface and "cut slopes" has started and will advance slowly. Leaving the area to recover naturally appears to be the only practical solution. Reshaping the drill roads to completely blend in to the natural landscape would be very costly and disturb any natural recovery that has occurred in the area, and is not recommended.

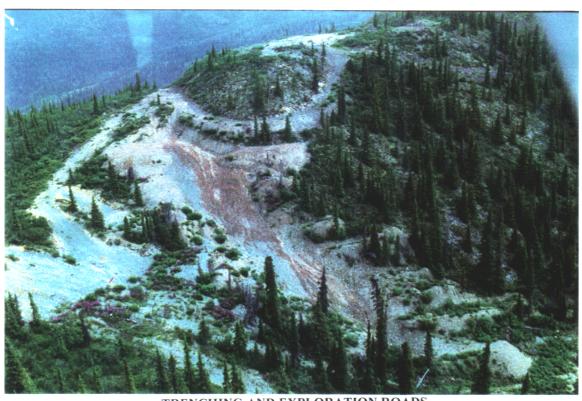
TRENCHING AND EXPLORATION ROADS

Revegetating roads and drill sites is considered a VERY LOW priority for this area.

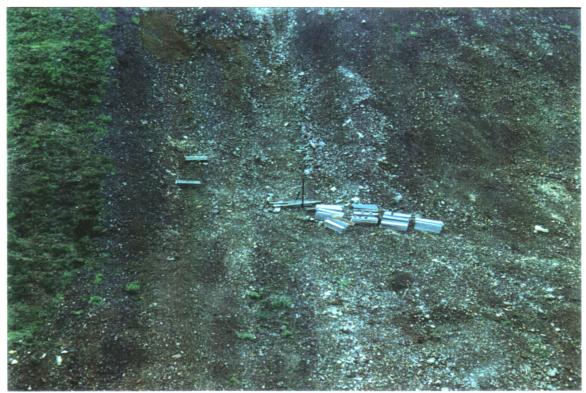
- 3 empty 204 litre fuel barrels,
- 30-40 core boxes.

CORE BOXES LEFT ON-SITE

If a waste clean-up program is ongoing in the area, it is recommended that the 3 barrels and core boxes be removed from the site. Recovery of these barrels and boxes will have to be completed using a helicopter as the site is not practically reached by road. This work should be considered a **LOW** priority at this location.

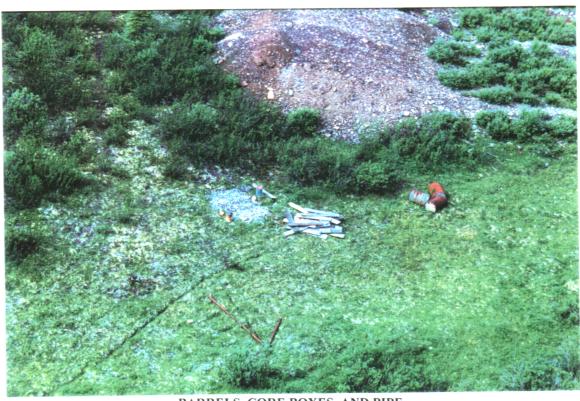
BARRELS, CORE BOXES, AND PIPE
