ASSESSMENT REPORT

105O-08-1

MACTUNG

DIAND TECHNICAL SERVICES

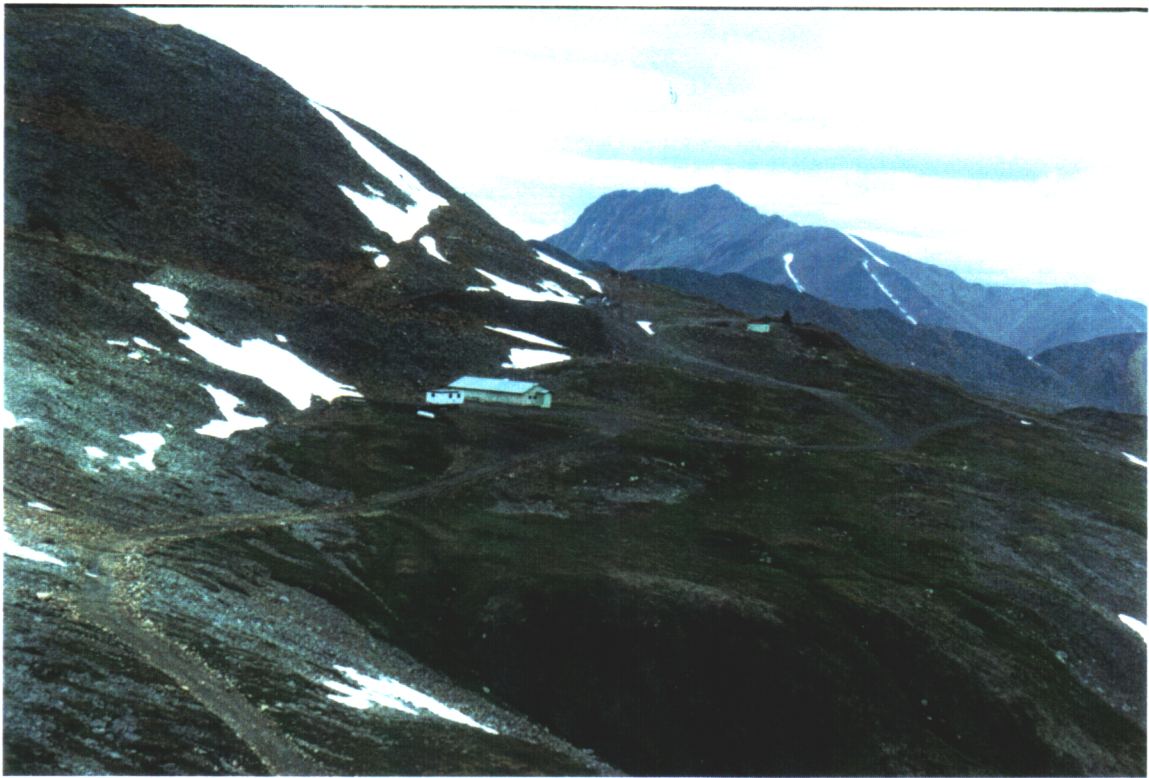
ACCESS TO EXPLORATION SITE

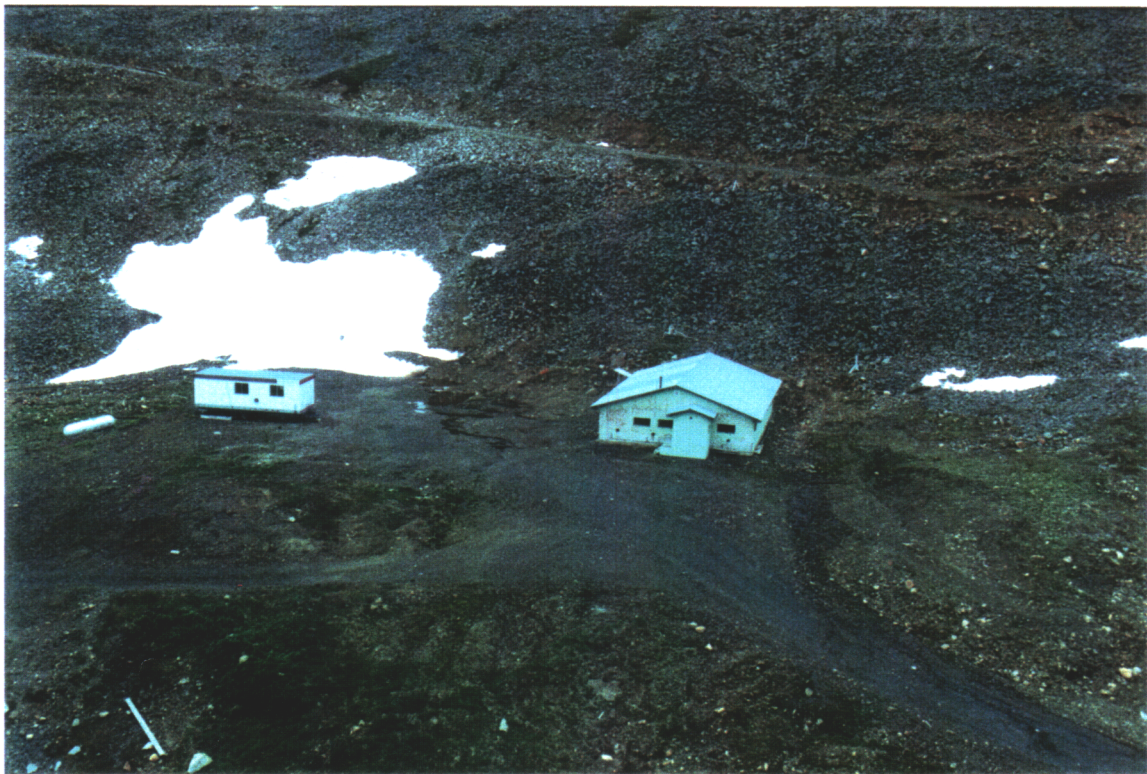
OFFICE TRAILER AND CORE STORAGE BUILDING

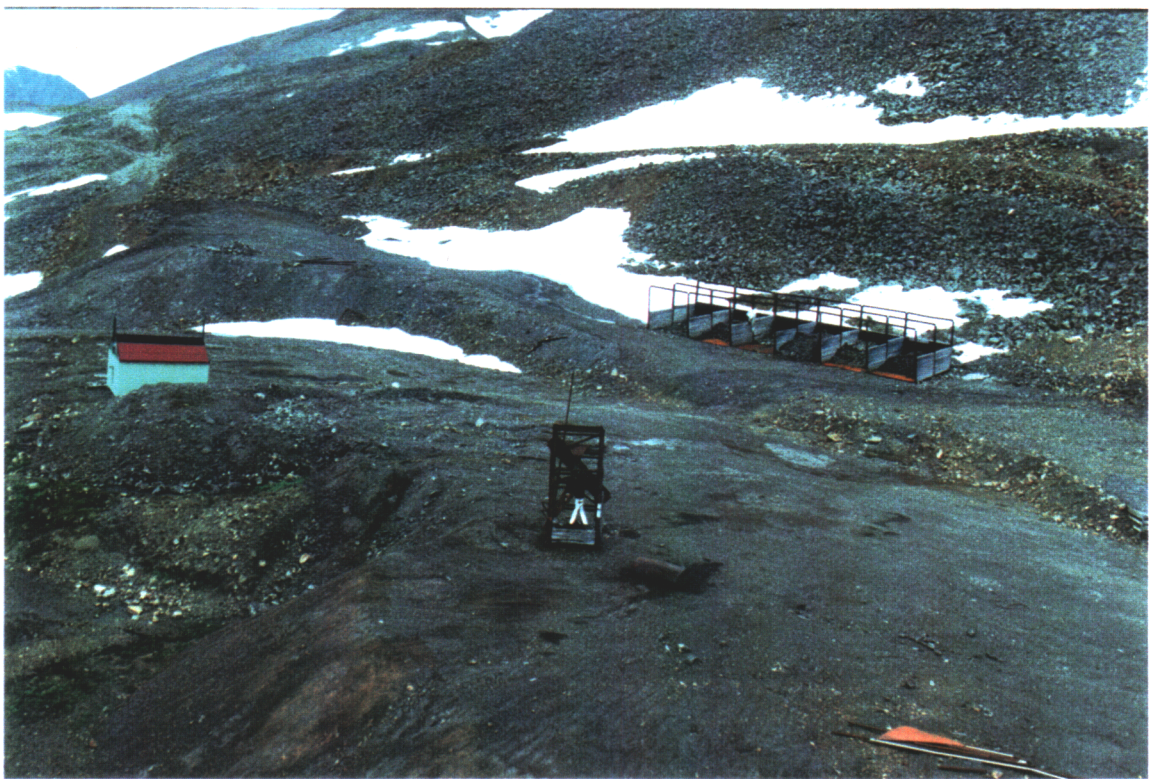
SAMPLING TOWER, ORE BINS, AND GENERATOR BUILDING

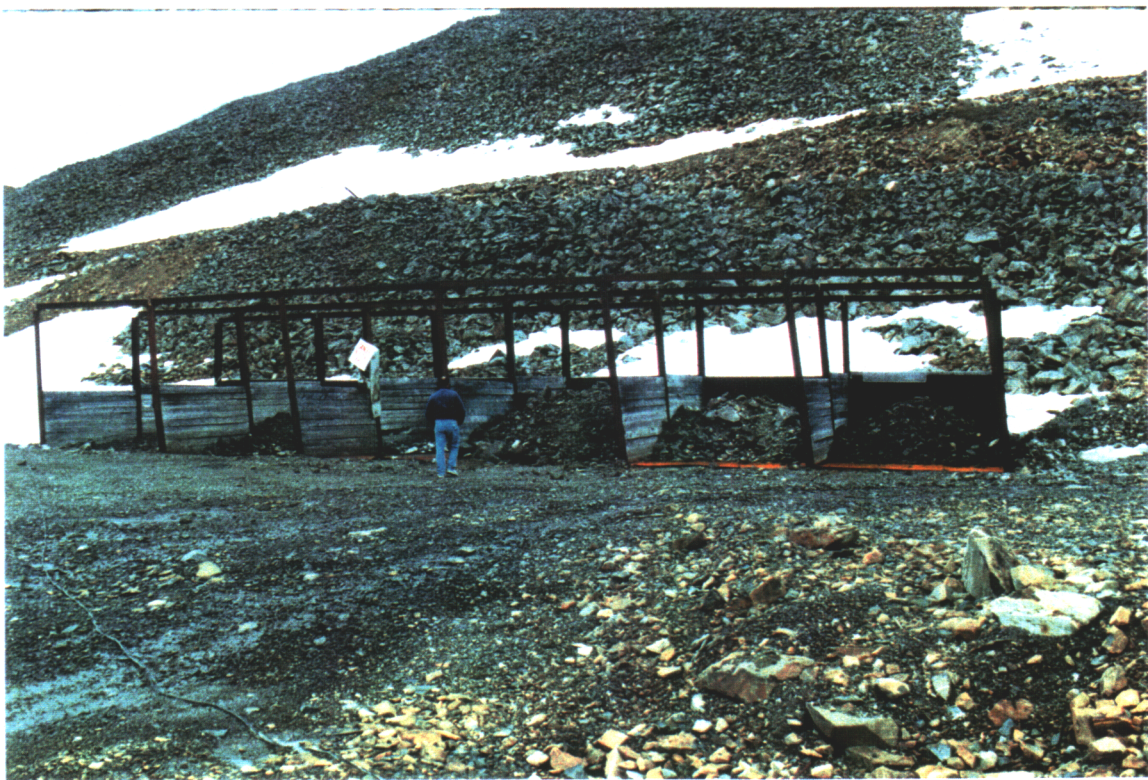
ORE STORAGE BINS

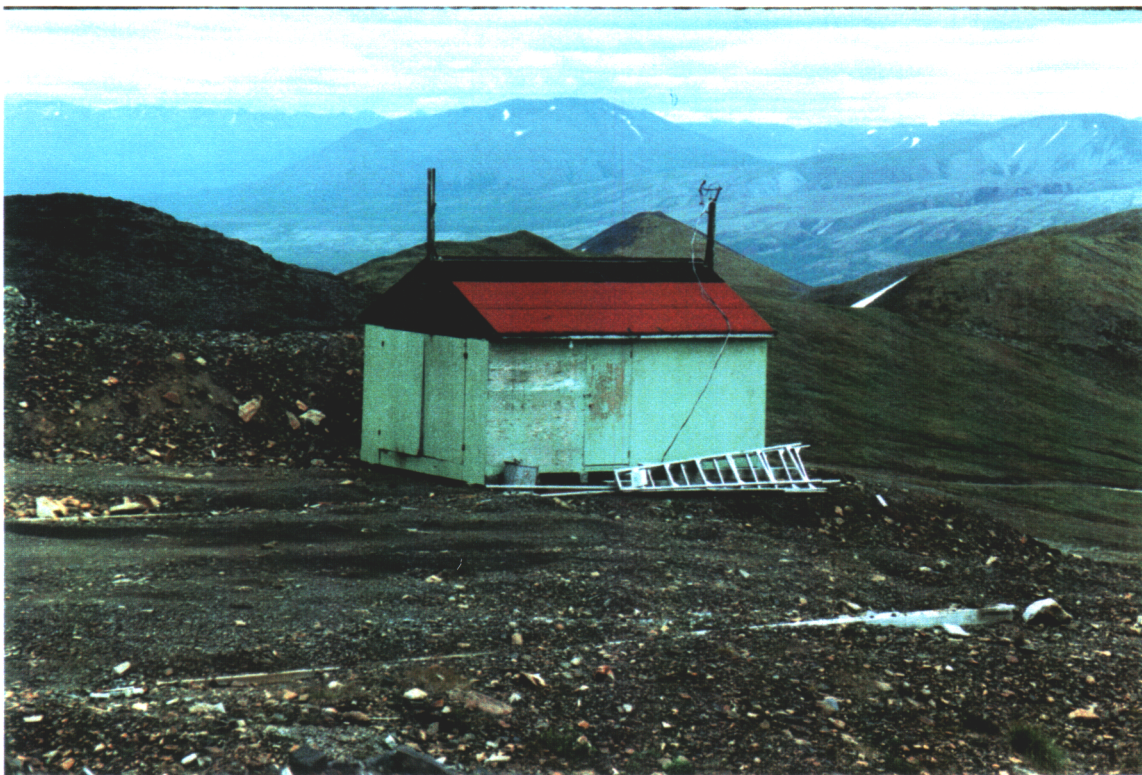
GENERATOR BUILDING

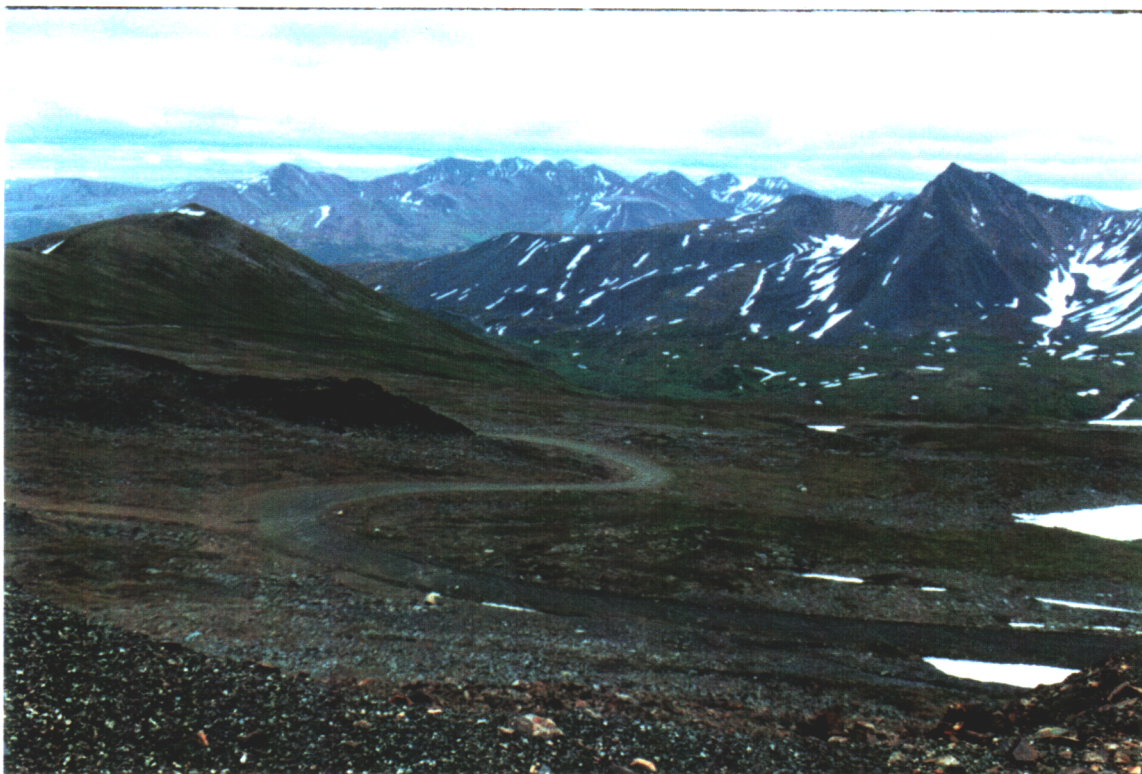
ACCESS ROAD FROM SITE
