ASSESSMENT REPORT

105M-14-9

PADDY

DIAND TECHNICAL SERVICES

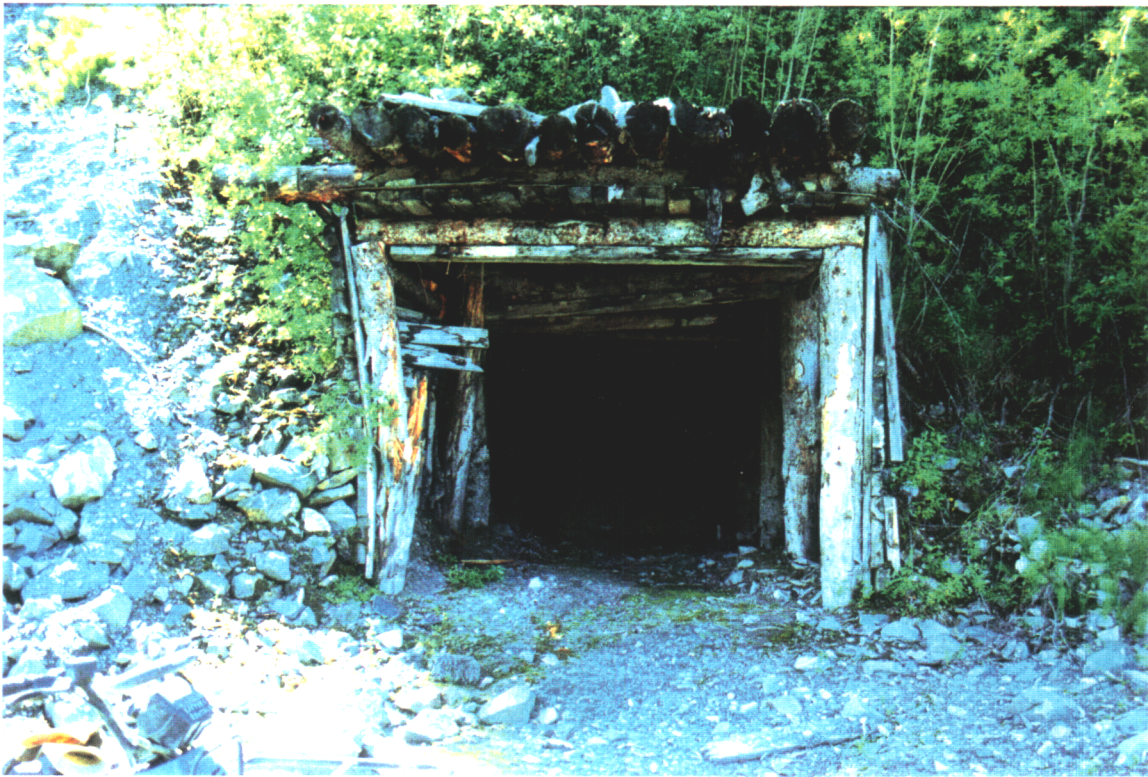
One adit was intact and open, supported at the entrance by locally cut timbers. This open adit is 10-15m above Christal Creek and had a waste area below it sloping to Christal Creek. This waste area measured approximately 40-50m long, was about 4m wide, and 3-5m thick.

The main concern at this site is considered to be the open adit accessible to the public. For safety reasons this adit should be sealed from the public to eliminate any risk of an accident occurring by anyone that could enter it.

OPEN ADIT

The open adit is considered a safety hazard and it is recommended that it be sealed securely so that it cannot be accessed by the public. This is considered a **HIGH** priority and this work should be completed as soon as possible.

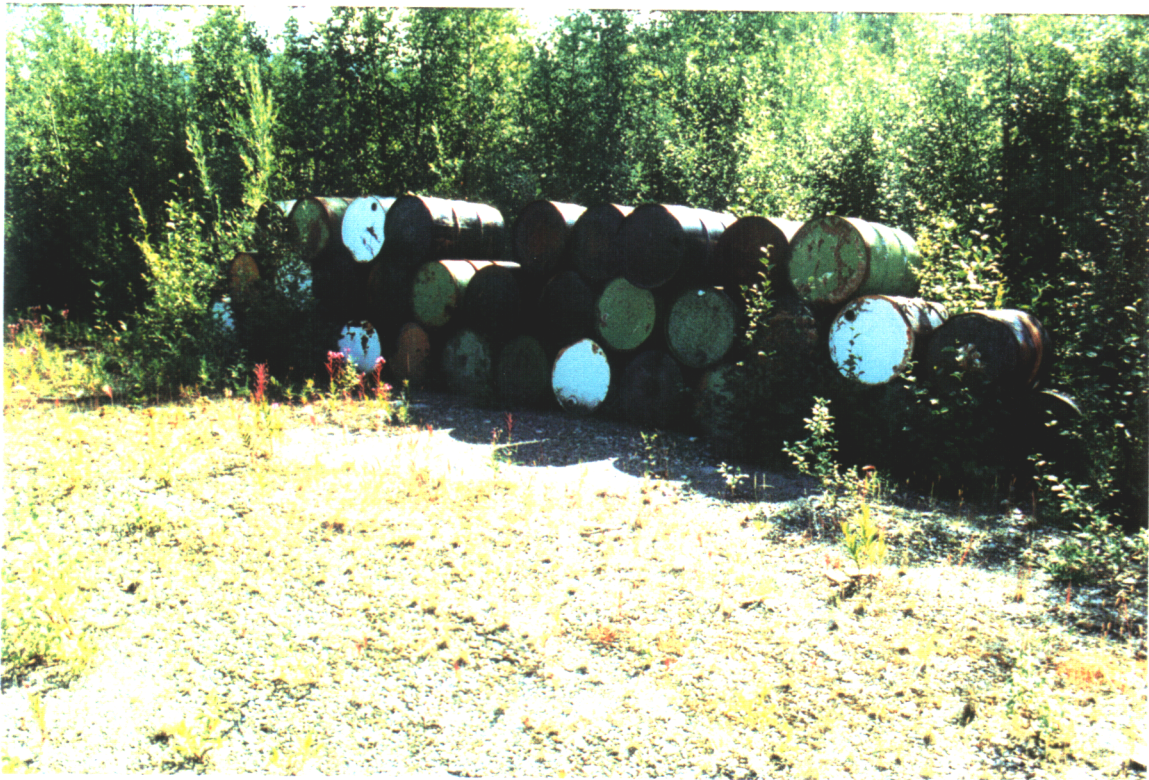
Thirty-five empty 204 litre barrels are stacked on a level area beginning to overgrow with willows. What appears as a hydrocarbon spill measures about 5x5m near the stack of empty barrels.

EMPTY BARRELS

Barrels, pipe, ore cars, and rail left on the site should be removed if a clean-up program is initiated in the area. As roads extend to the site clean-up of this material should be relatively easy to complete. Clean-up of this material is considered a **LOW** priority.

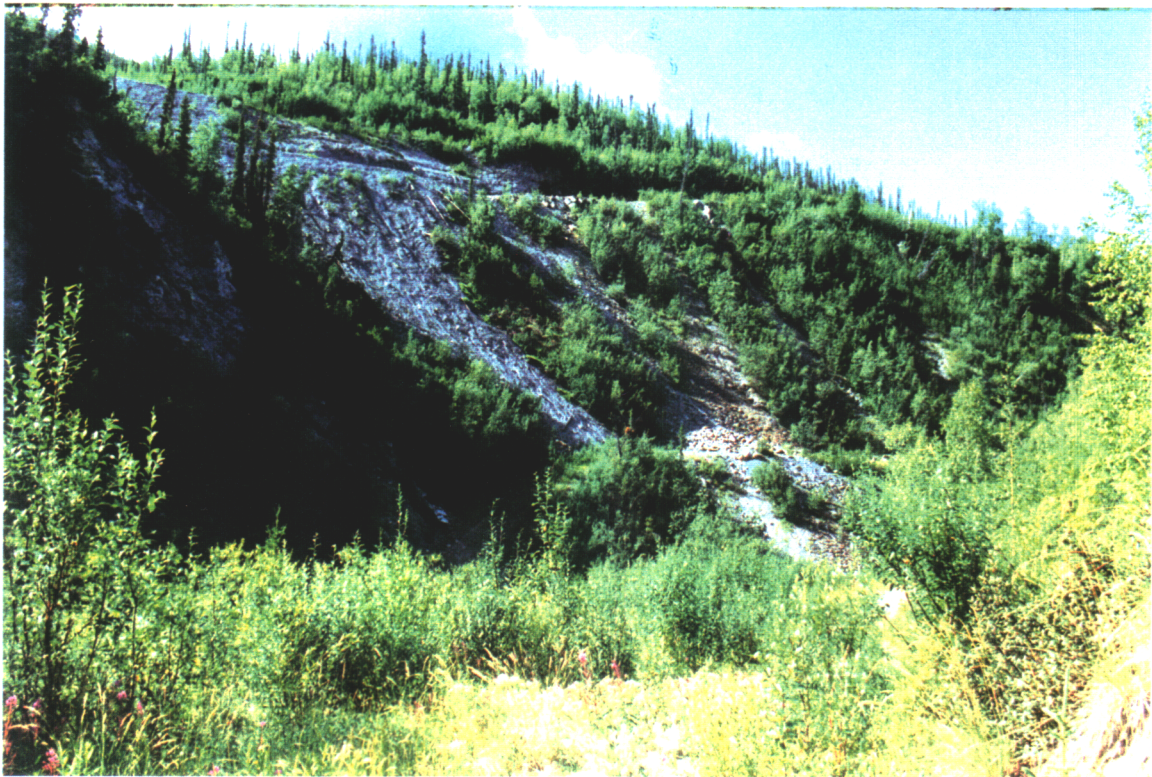
The substantial amount of trenching across this site has caused the most impact on the area. Several sites looking like "borrow pits" have been created, and in some cases material has been pushed down slopes resulting in erosion and some siltation into Christal Creek at some time in the past. However, most of the trenching has taken place a long time ago and is beginning to grow vegetation seeded from the adjacent trees, shrubs, and grasses. Attempting to regrade and reshape the trenched areas will cause additional damage to vegetation that is regrowing in once stripped areas. It is recommended that the trenched areas be left to allow the natural revegetation to continue.

WASTE DUMPED DOWN SLOPE (NOTE EROSION)

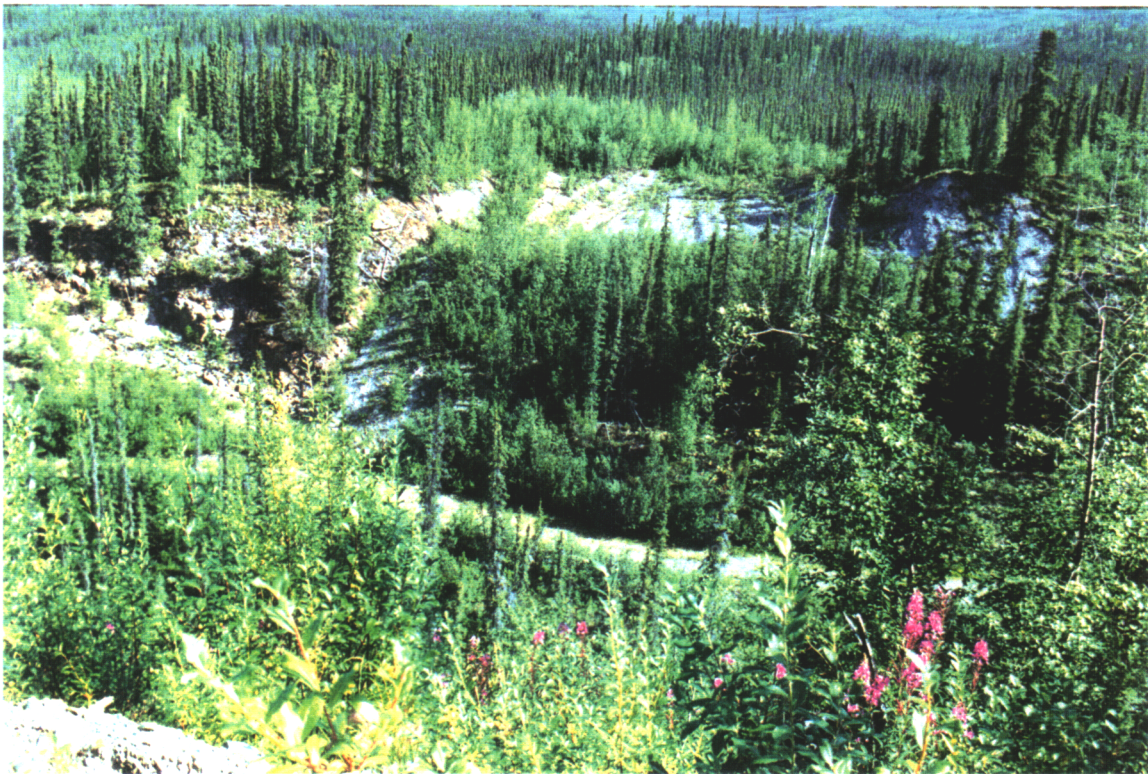
Trenching was completed at a number of places within the area, some of which was quite extensive. Some of the trenching was along the steep slopes above Christal Creek and it is quite likely that at the time this work was ongoing that some material sloughed into the creek. One of the areas of trenching appears to have excavated over an old adit.

The areas where roads have been constructed and trenching has been completed has left the most visible scarring on the landscape. This is considered to have had the most impact on the environment. Attempting to improve conditions that have been left will only cause additional damage in this northern environment that recovers very slowly. This is not recommended.

TRENCHED AREAS

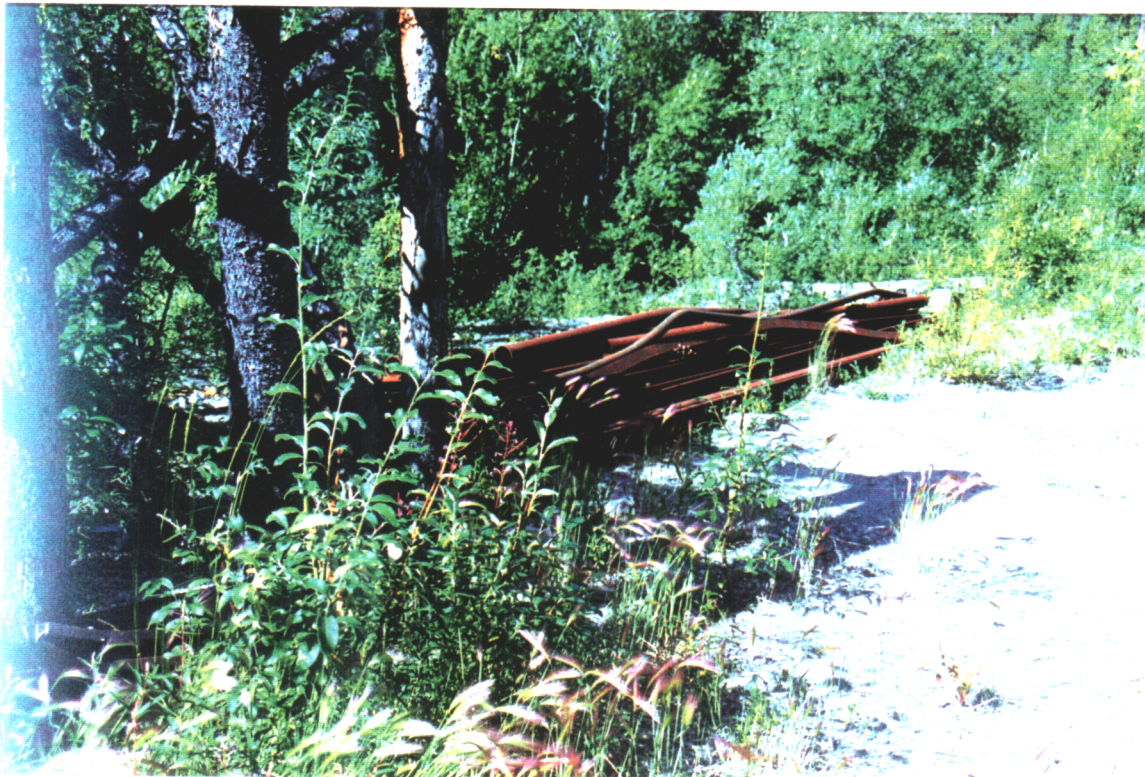
PIPE AND RAIL

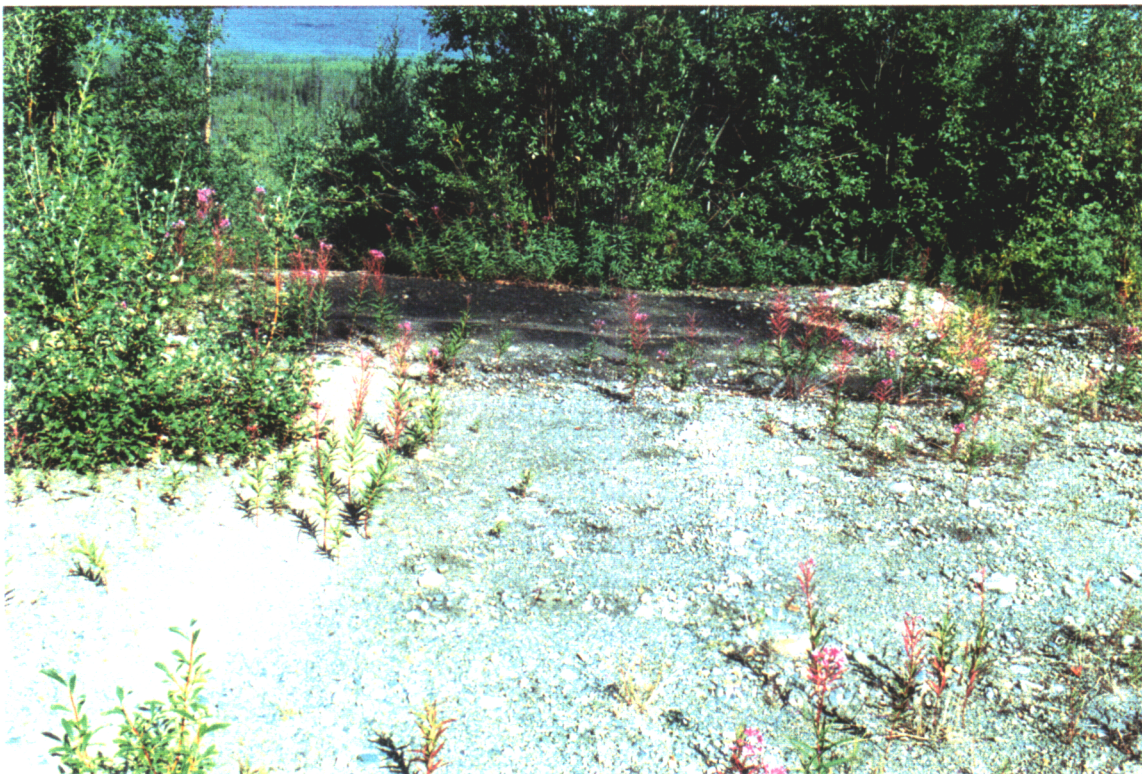
Vegetation is not growing on a small patch of ground that appears stained from a hydrocarbon spill near the barrel site. What appears as an old hydrocarbon spill should be confirmed. This can be completed by sampling and testing the surface soils to determine what is causing the staining. This is a very small area in a remote area and for this reason is not considered a high priority. However if clean-up is undertaken at this site, verifying what is suspected as a hydrocarbon spill should be completed. If this stained area is an ongoing environmental liability, then the extent of the problem can be defined with further testing, and a site remediation plan developed.

STAINED GROUND

What appears as a hydrocarbon spill should be confirmed to determine the extent of this potential environmental liability.

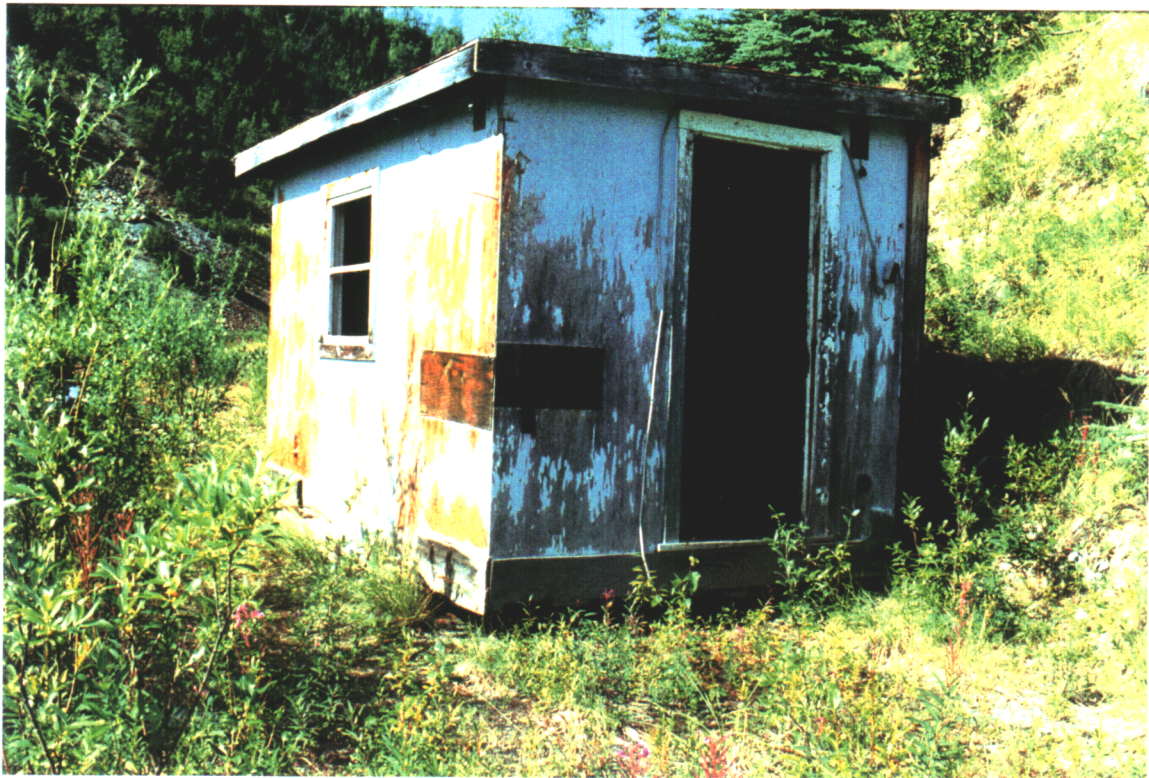
The one small warehouse is very old and deteriorating. This building is portable but is rotting and has very little residual value.

SMALL WAREHOUSE

The building left on-site is in poor condition and of little value. It is recommended that this building be disposed of at some time in the future. This is also considered a **LOW** priority.

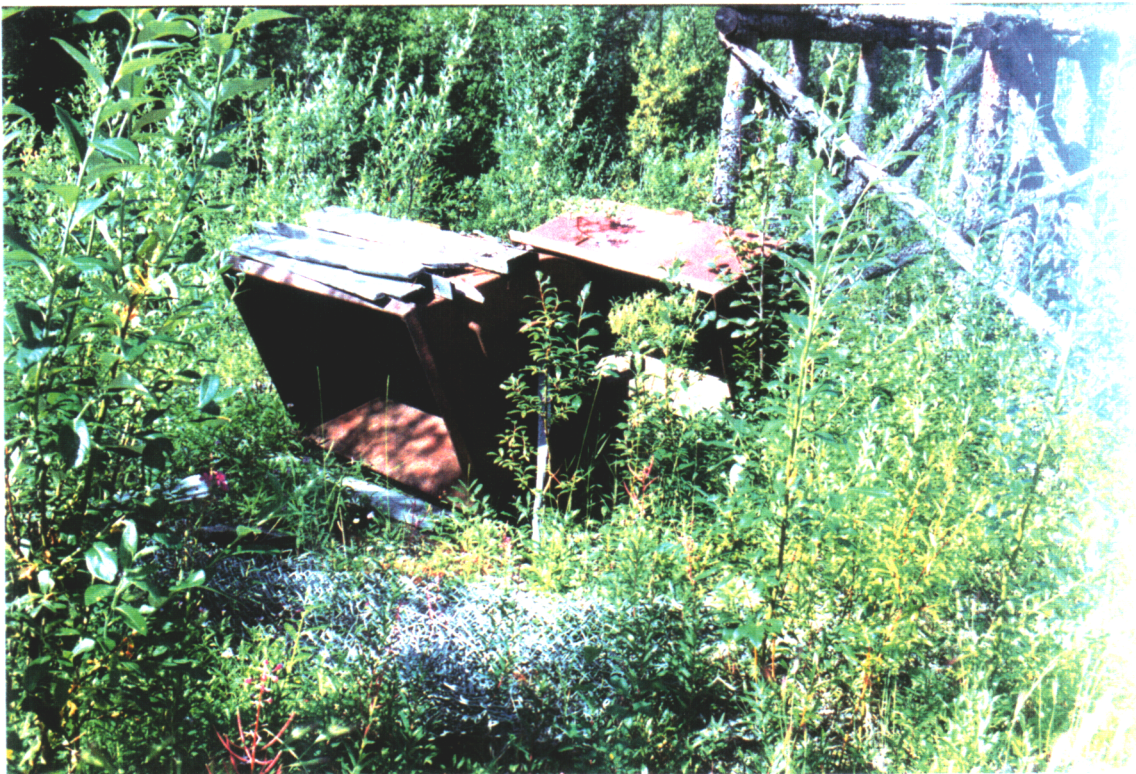
ORE CARS
