ASSESSMENT REPORT

105M-14-10

PAST WERNECKE

DIAND TECHNICAL SERVICES

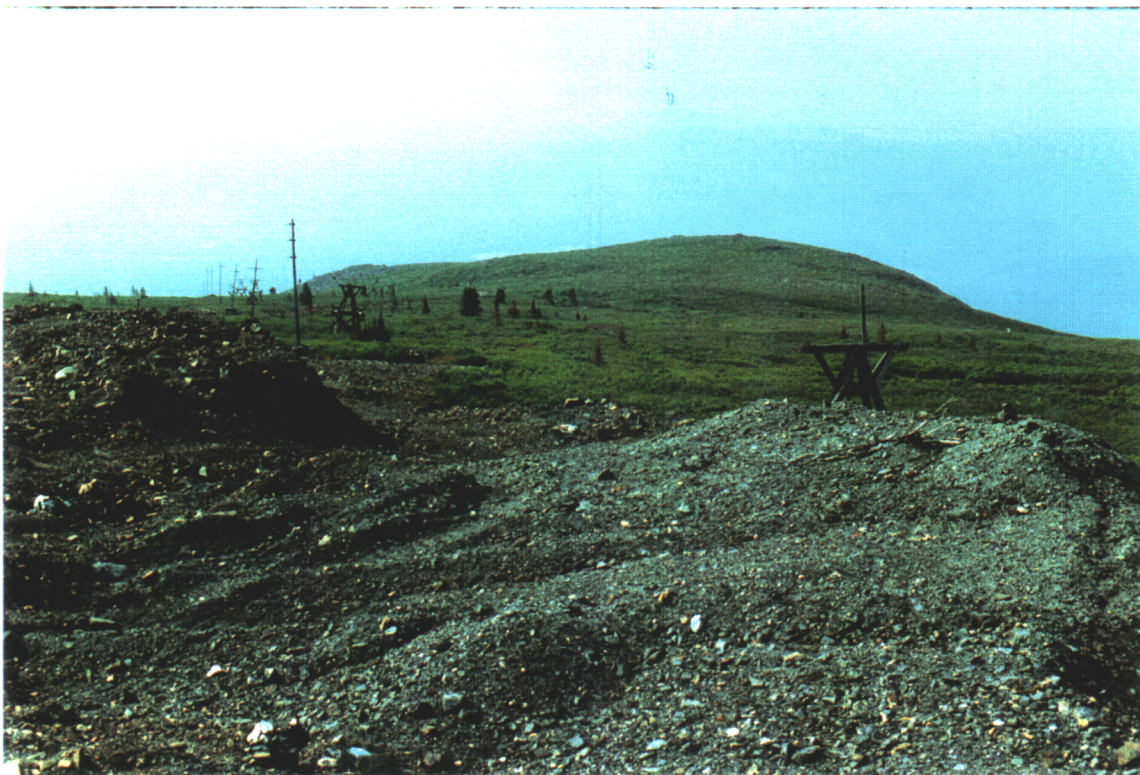
Ore from the exploration shaft was dumped out a chute from the mine shaft building and appears to have been cleared from the chute using a loader. The ore was likely loaded on trucks and hauled off-site for processing. The waste rock was placed approximately 50m downslope from the mineshaft.

WASTE ROCK DUMP, TRAMWAY TOWERS, AND POWER LINE

The powerline poles and the old tramway towers could be removed, however this would likely cause additional damage to the vegetation. It is recommended that these poles, wire, and towers be left to avoid further disturbance of the sensitive vegetation.

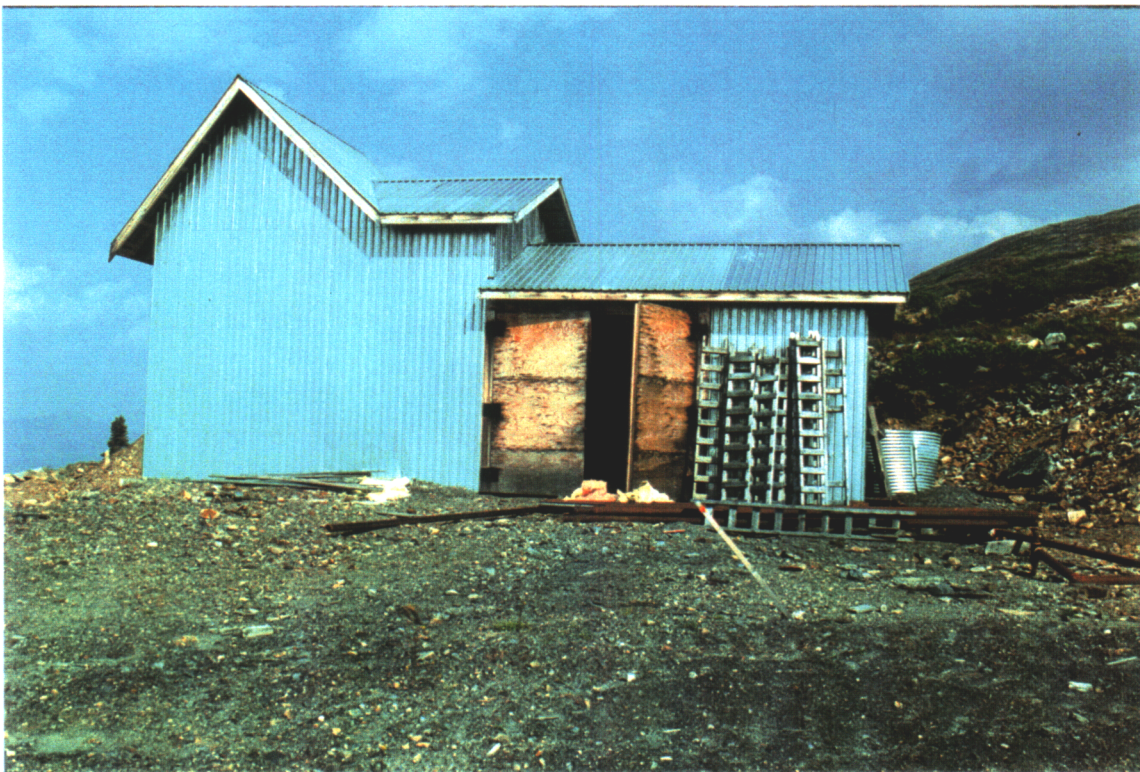
As noted above, the building over the exploration shaft is in good condition. This building appears to have been serviced by electrical power at one time as some electrical wiring is still in the building. Inside the building a large wooden frame has been constructed to support the removal of ore from the shaft.

BUILDING OVER SHAFT

The building covering the shaft is in good condition and should be left in place to protect entry from the shaft. The building should be properly sealed or locked to prevent any unauthorised entry. This is considered a **HIGH** priority and should be completed as soon as possible.

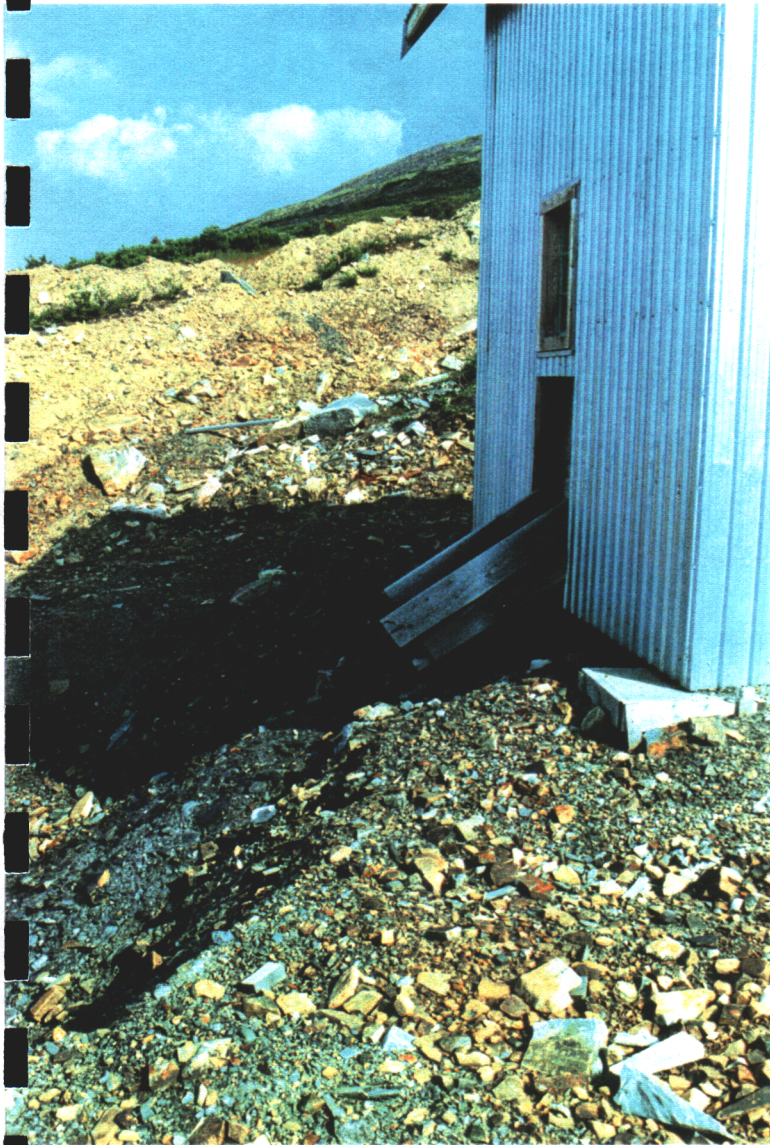
ORE CHUTE FROM BUILDING

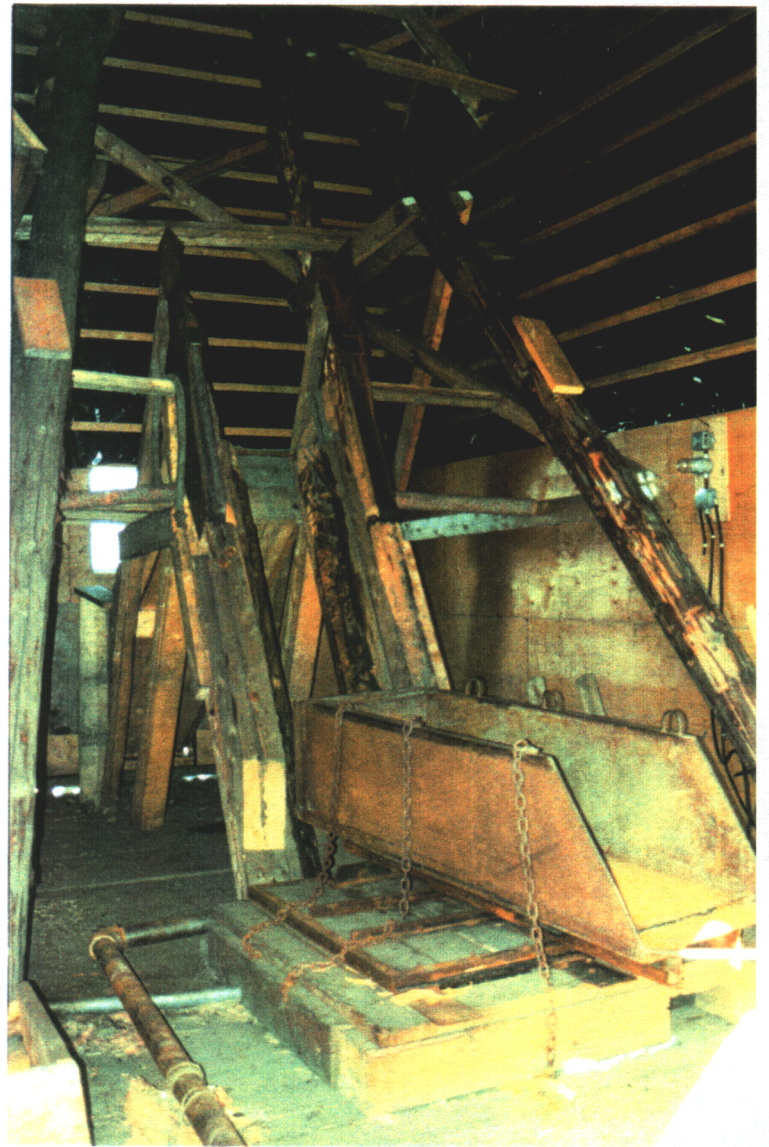
INTERIOR OF BUILDING

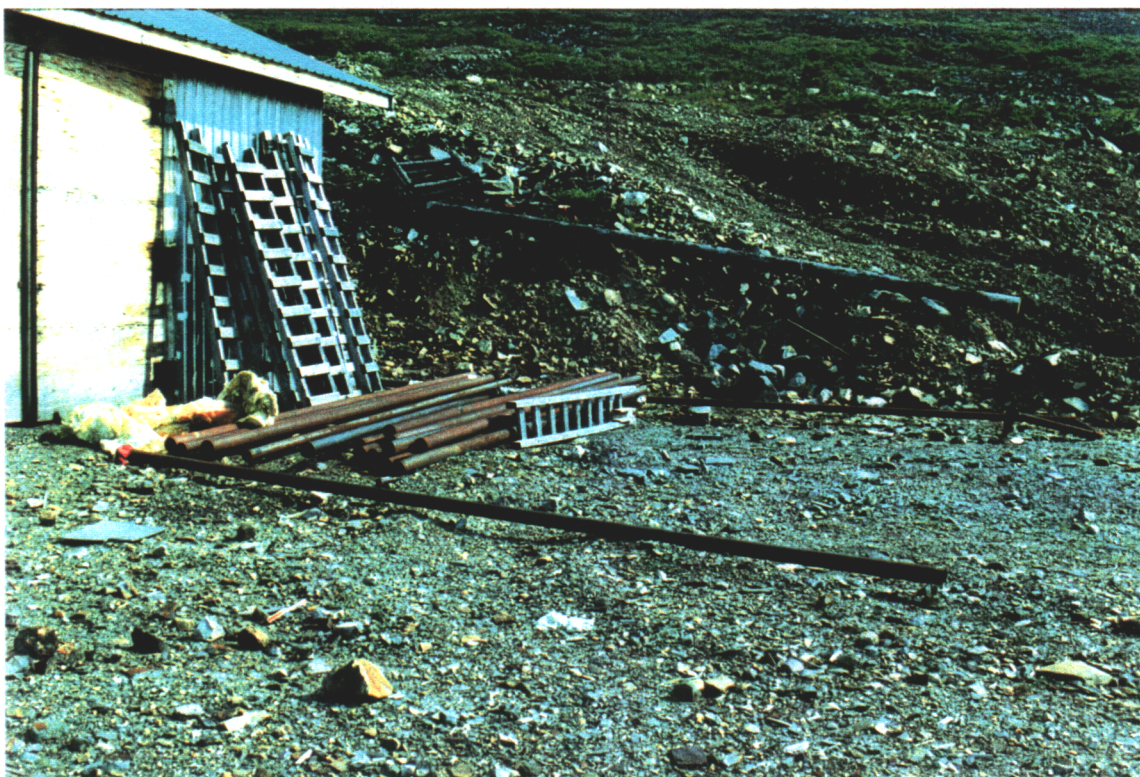
- 16 pieces of variable length pipe up to 6m long and 100mm diameter,
- 1 culvert collar,
- a few pieces of metal cladding,
- approximately 10 wooden ladders, and
- power poles and wooden tramline towers extending from the old community of Wernecke, a distance of approximately 2km.

PIPE AND LADDERS

The pipe, any other metal waste, and wood waste such as the ladders should be removed if a clean-up program is initiated in the area. As roads extend to the site clean-up of this material should be relatively easy to complete. However clean-up of this material is considered a **LOW** priority.
