**ASSESSMENT REPORT**

**105B-01-2**

**SILVER SEVEN**

**OCTOBER, 1993**

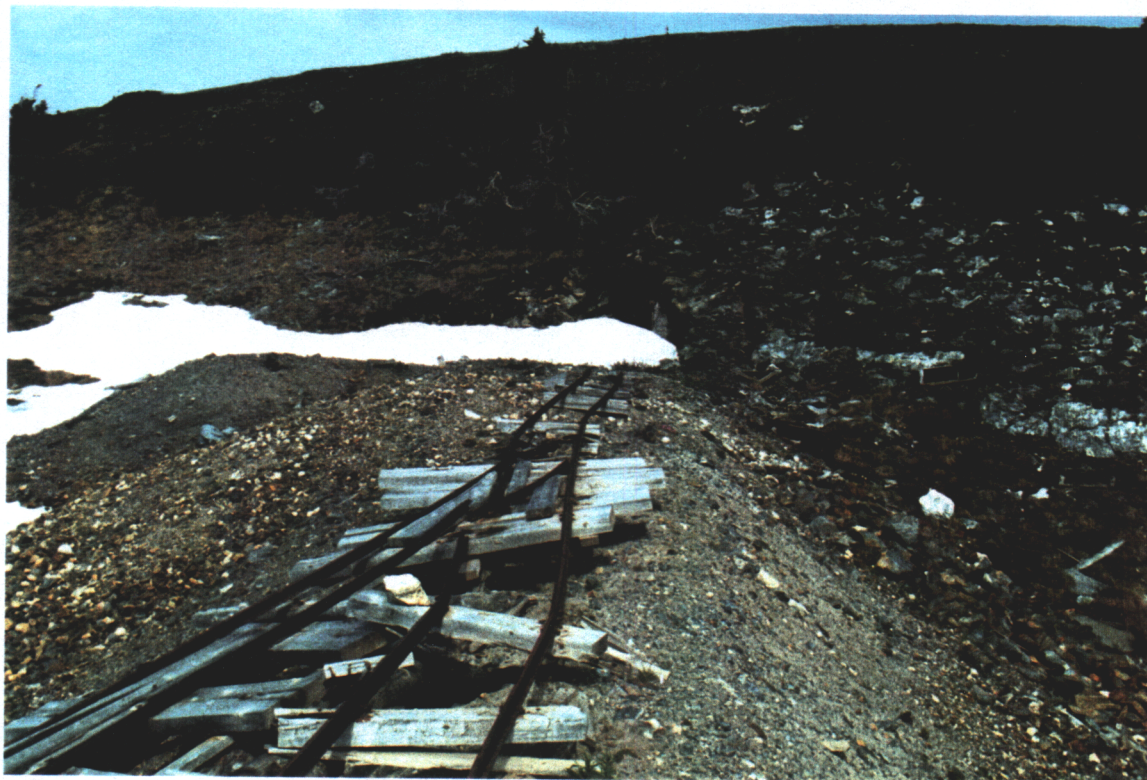
2. MINE ADIT AND RAIL

Rock Waste - The waste rock at the entrance to the adit consists of approximately 1000 cubic metres of steeply sloped material. Little can or needs to be done with this pile of rock. If a clean-up program is conducted the rails should be removed between the adit entrance and the end of the waste pile.

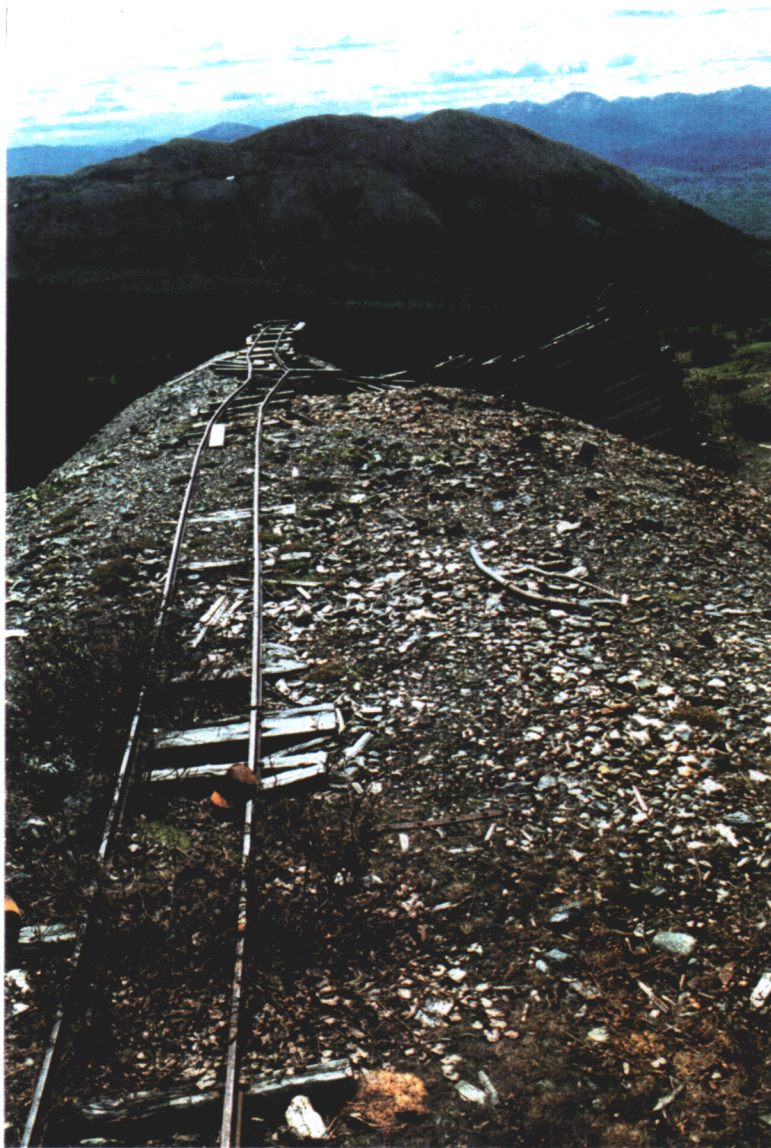
Loadout - The loadout outside the entrance to the adit is constructed of locally cut logs, measures 3x5m and is 3-5m high, is held together with wire cables, and is deteriorating and beginning to collapse. This poses a safety hazard if someone inadvertently climbs this structure causing it to collapse. If a clean-up program is conducted at this site, this structure should be knocked down or dismantled to eliminate any safety hazard.

3. WASTE DUMP AND LOADOUT

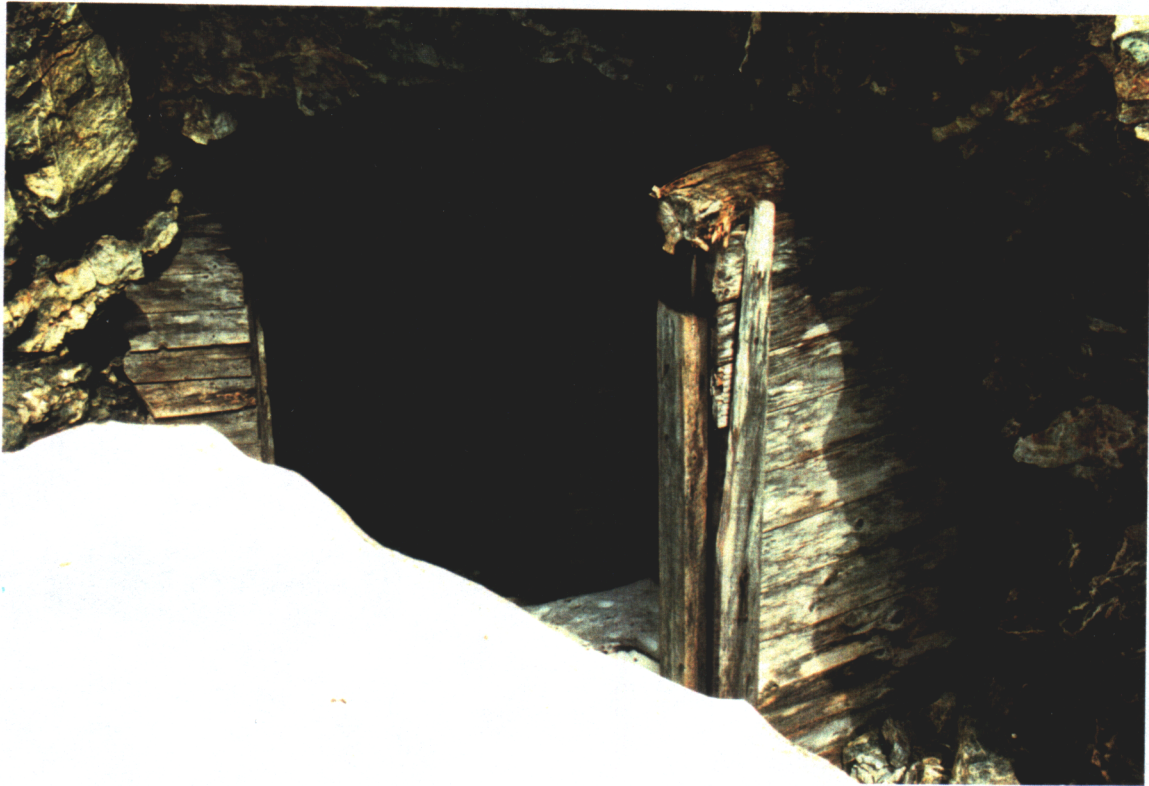
Mine Adit - The mine adit is open, the supporting timbers are old and weakening, and although remote, is accessible to the public. It is recommended that the adit be properly sealed or permanently covered.

4. OPEN ADIT

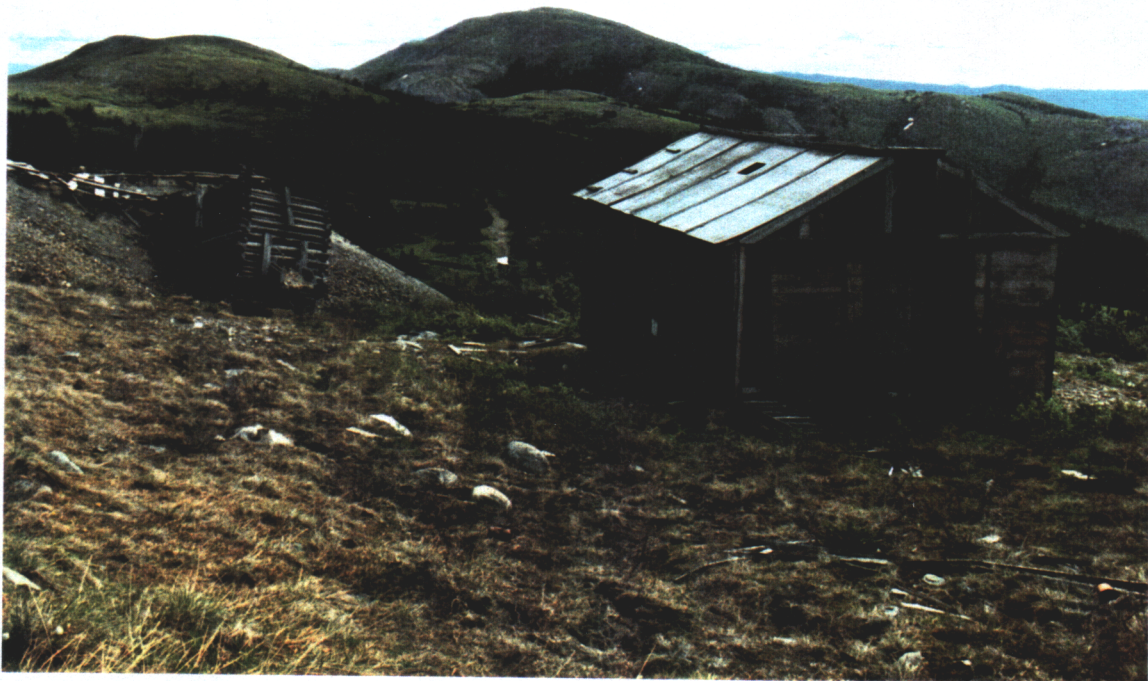
5. TOOL SHED AND LOADOUT

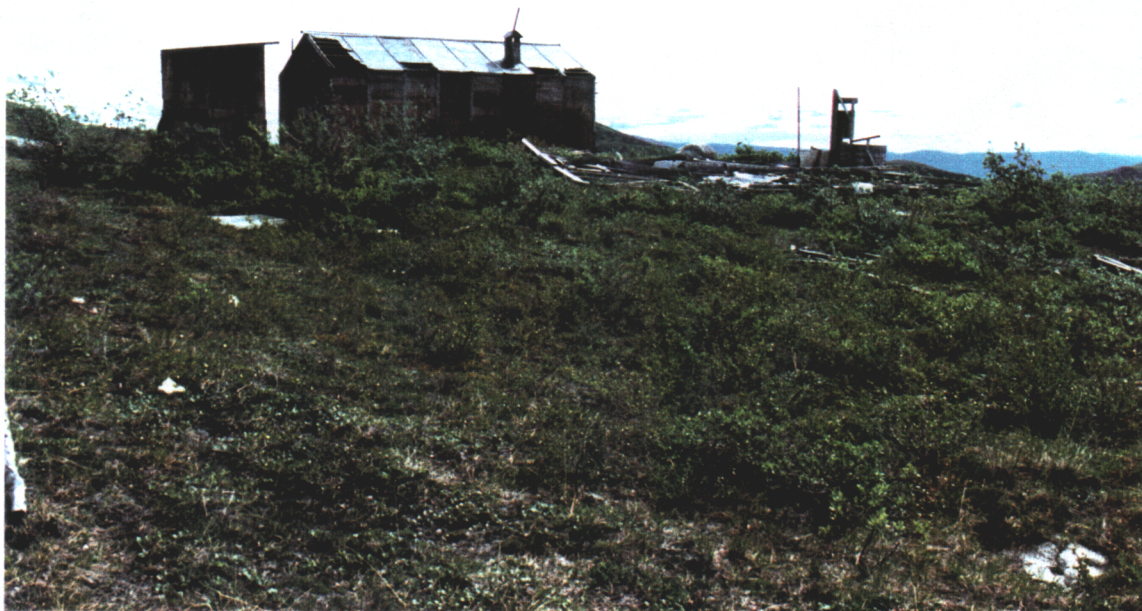
Mine Buildings - Three old plywood clad buildings, one that has already collapsed, remain at the site. These buildings are continuing to deteriorate from the weather and will eventually collapse. These structures are small and not expected to cause any environmental problem. It is recommended that if a site clean-up program is conducted at this site, the buildings should be piled and burned. However this is considered a low priority. No spilled or stored hydrocarbon products were found around the mine site.

6. COLLAPSED STORAGE BUILDING AND PLYWOOD CLAD BUILDING

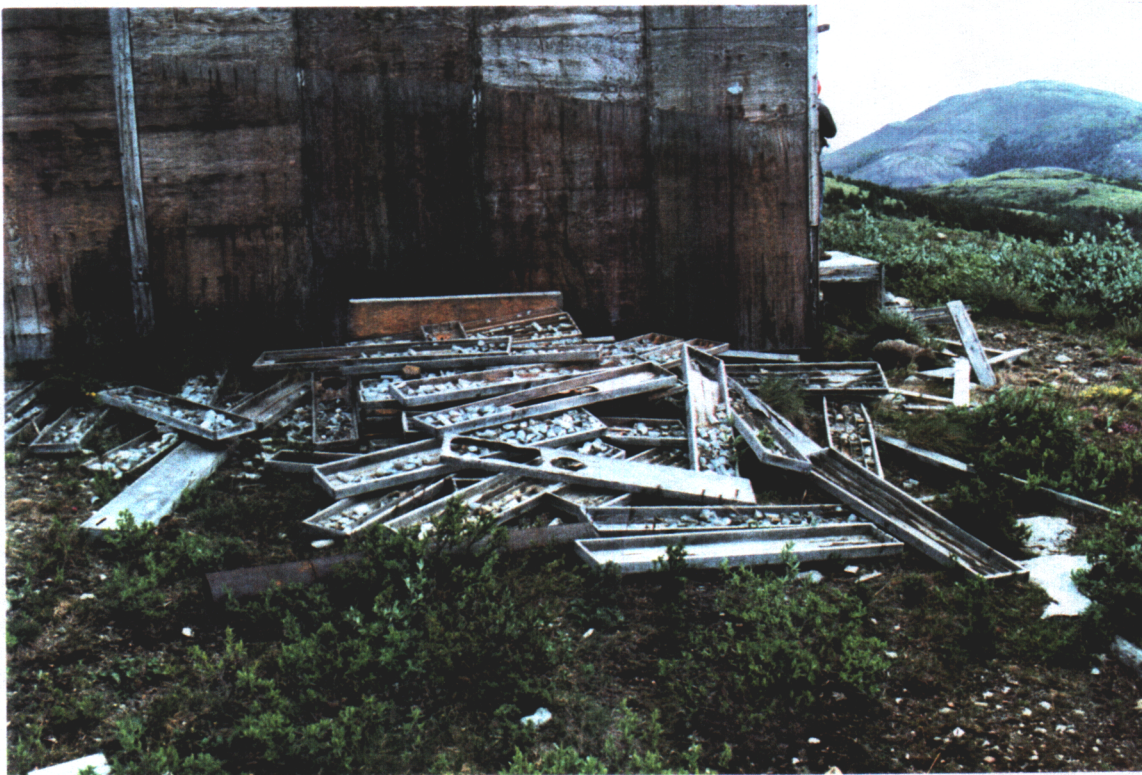
7. SPILLED ROCK CORE

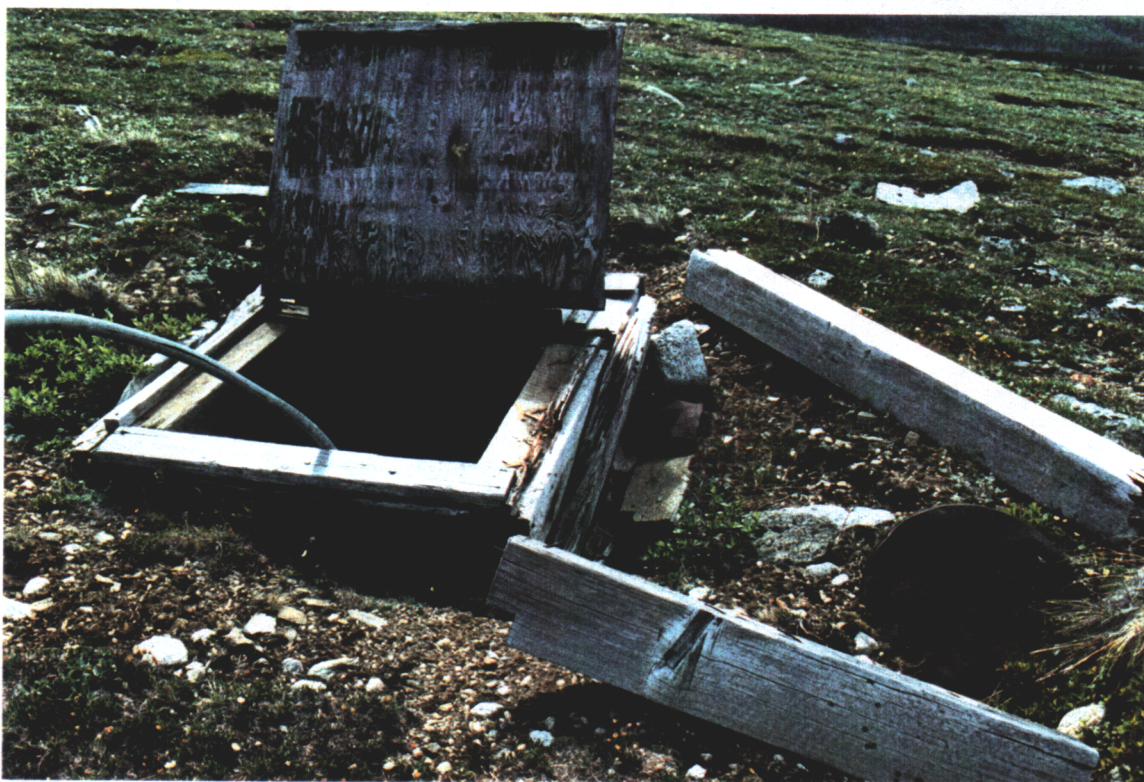
Raises and Vertical Shafts - Two unmarked shafts (raises) above the adit are still in place. One of the shafts is covered with an unlocked plywood door and the other shaft is open. As a precaution, the two shafts should be properly sealed to prevent anybody from entering them and possibly injuring themselves.

8. OPEN SHAFT WITH PLYWOOD COVER

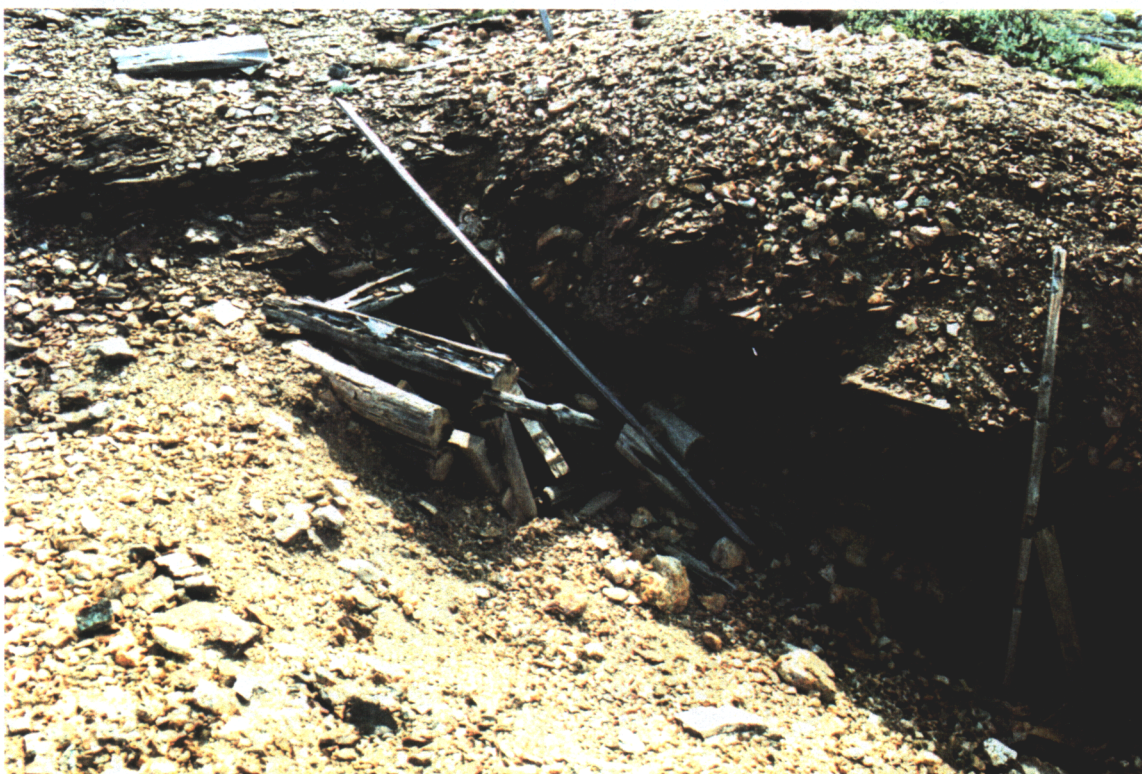
9. OPEN RAISE ABOVE ADIT

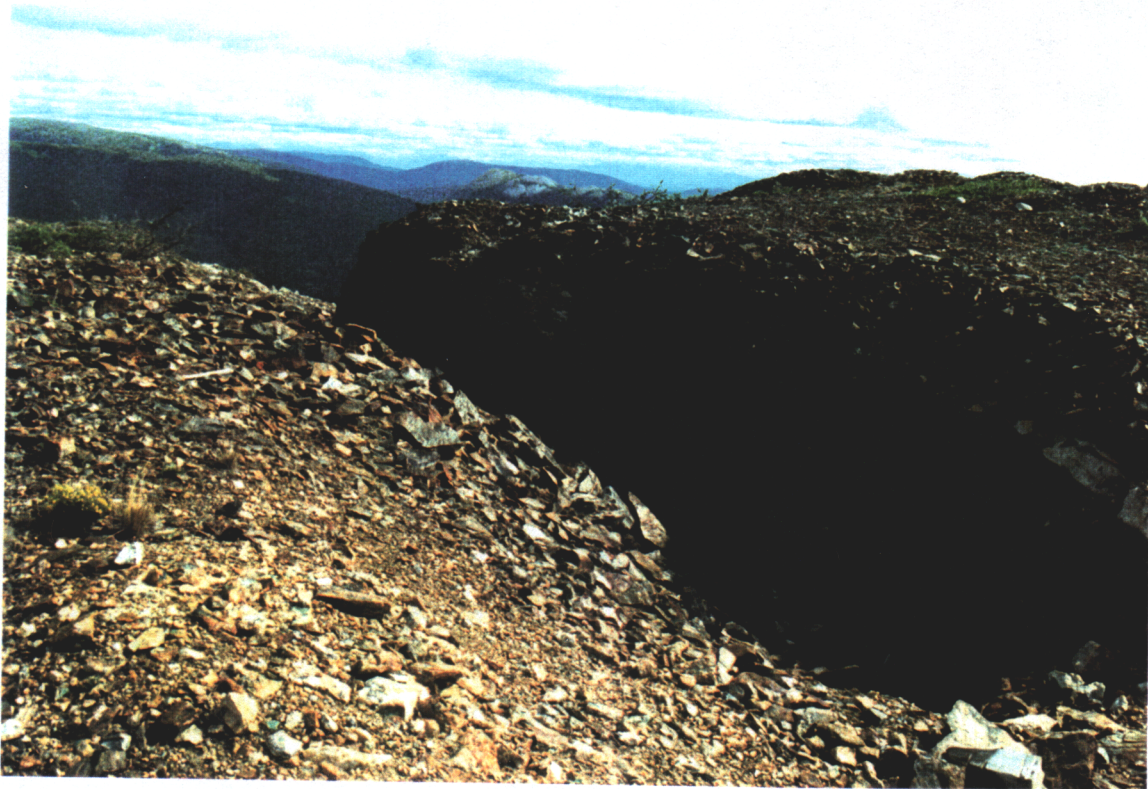
Trenching - The damage caused by the trenching conducted across this site is mainly aesthetic with damage to the vegetation and surface disturbance. The native material is weathered rock with few nutrients and is very slow to naturally revegetate. As the site is very remote with a harsh climate, natural revegetation is really the only practical solution. Because the material is naturally coarse the trenched areas are not showing any evidence of erosion. There are no streams in the area to be impacted from the mine site.

10. TRENCHING

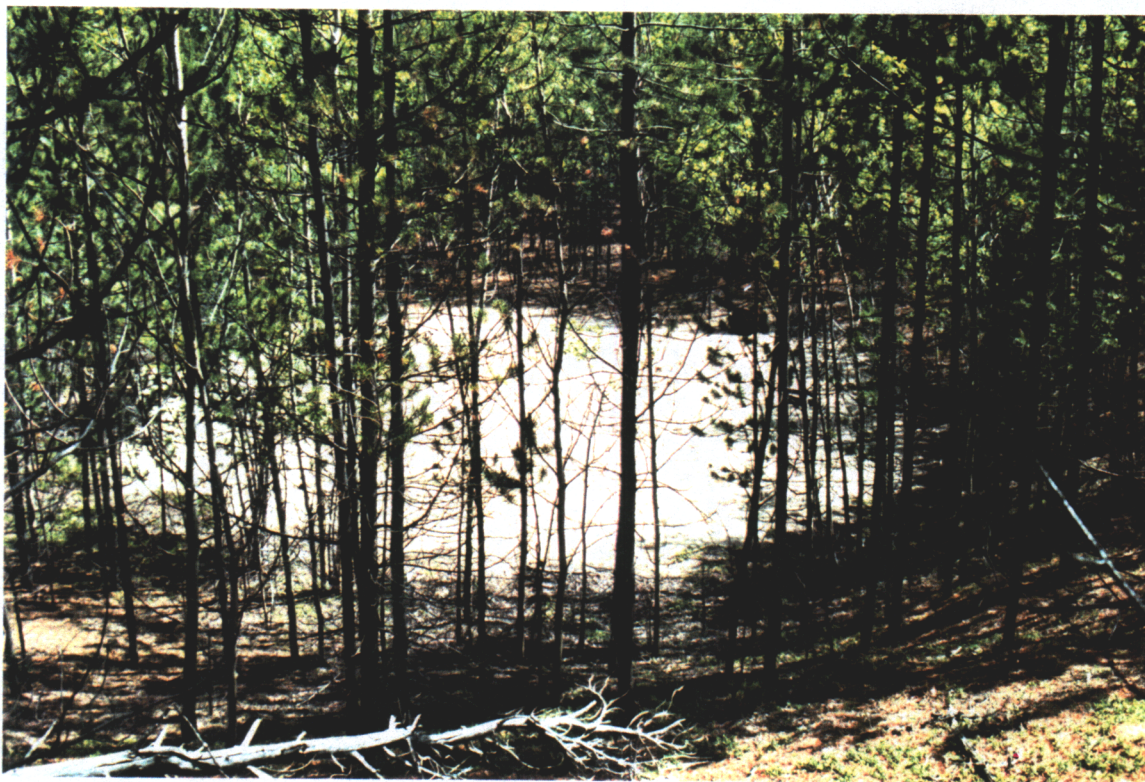
There is no remaining evidence, with the exception of an open trench close to the mill site, of how the tailings was moved from the mill to the tailings area downslope of the mill. However, one can speculate that tailings was deposited by gravity through either a pipe or flume. There is no evidence that any proper tailings structure was constructed. It appears that the tailings was simply dumped into the natural depression and any liquids either seeped into the soil or evaporated. The tailings, consisting of sand sized particles and covering an area 25-30m in diameter, is void of any vegetation after 40 years. Animal droppings were evident across the site indicating the tailings might be used as a "salt lick". The surrounding vegetation did not exhibit any obvious signs of distress at the time of inspection.

11. TAILINGS POND AND SURROUNDING VEGETATION

**It is recommended that the tailings and surrounding vegetation be sampled and analyzed for contaminants.** Soil sampling at and below the surface should be completed to determine if any contaminants leached into the surrounding soil. Although the site is not likely to be used by local or passing population, it is close to the Alaska Highway and also appears to be frequently used by animals which could be ingesting any residual contamination. Any testing should determine whether or not the tailings could have any adverse effects on the animal population in the area.

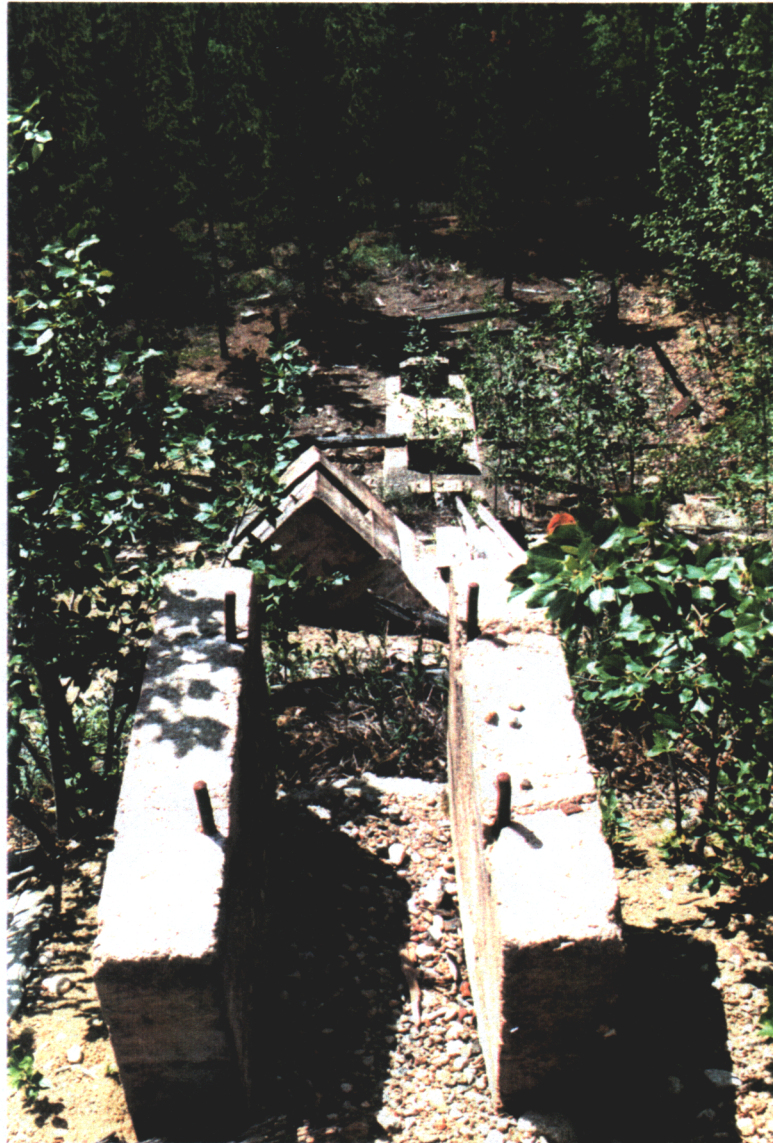
The only remains of the mill site are the concrete foundations and a few metal scraps. The mill appears to have burned down as some charred timbers were found near the concrete foundations. It is recommended that these foundations simply be left as they are. The vegetation has regrown around the mill site and little remains to be cleaned up.

12. MILL FOUNDATIONS

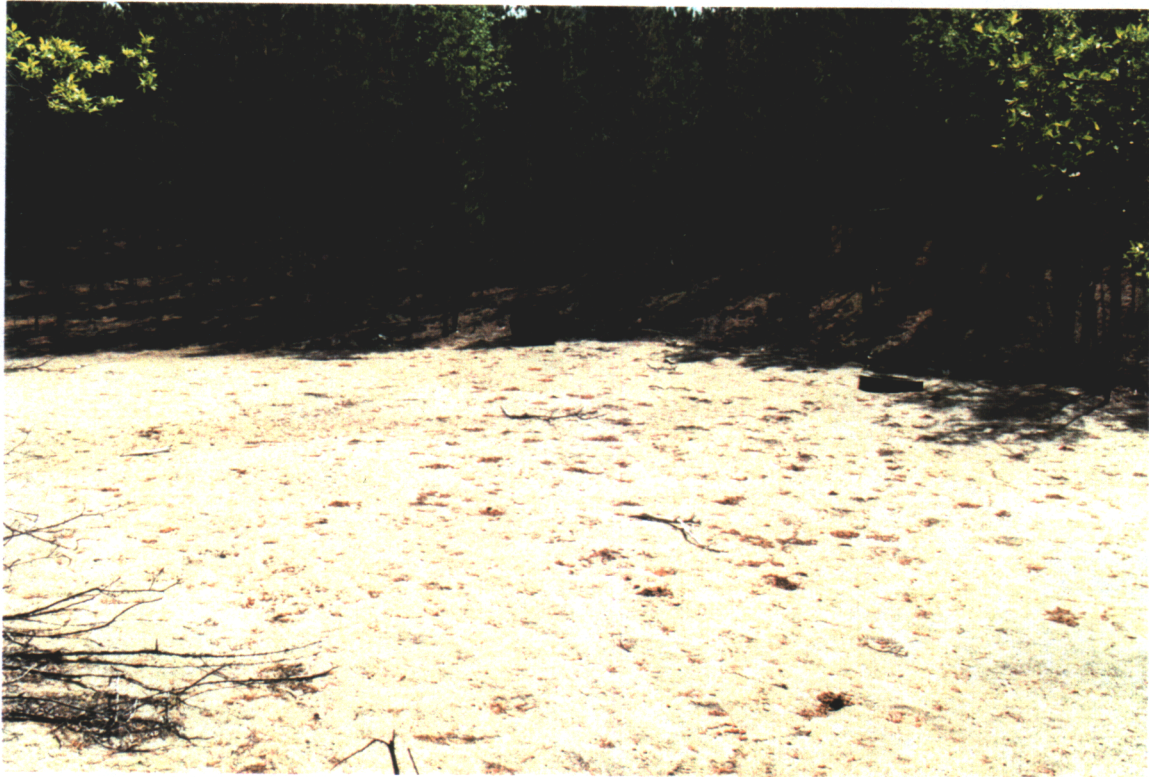
Ore from the underground mining was hauled over the rough, steep trail 8.2km from the mine to the mill. There is no remaining evidence that there was a proper (culvert or bridge) crossing of Boulder Creek. Remnants of infrastructure at the mill site includes concrete foundations from the mill and tailings contained in a natural depression below the mill site. According to the historical records milling took place between 1951-1953. **It is important to note that the tailings area is void of any vegetation after 40 years.**

13. TAILINGS POND

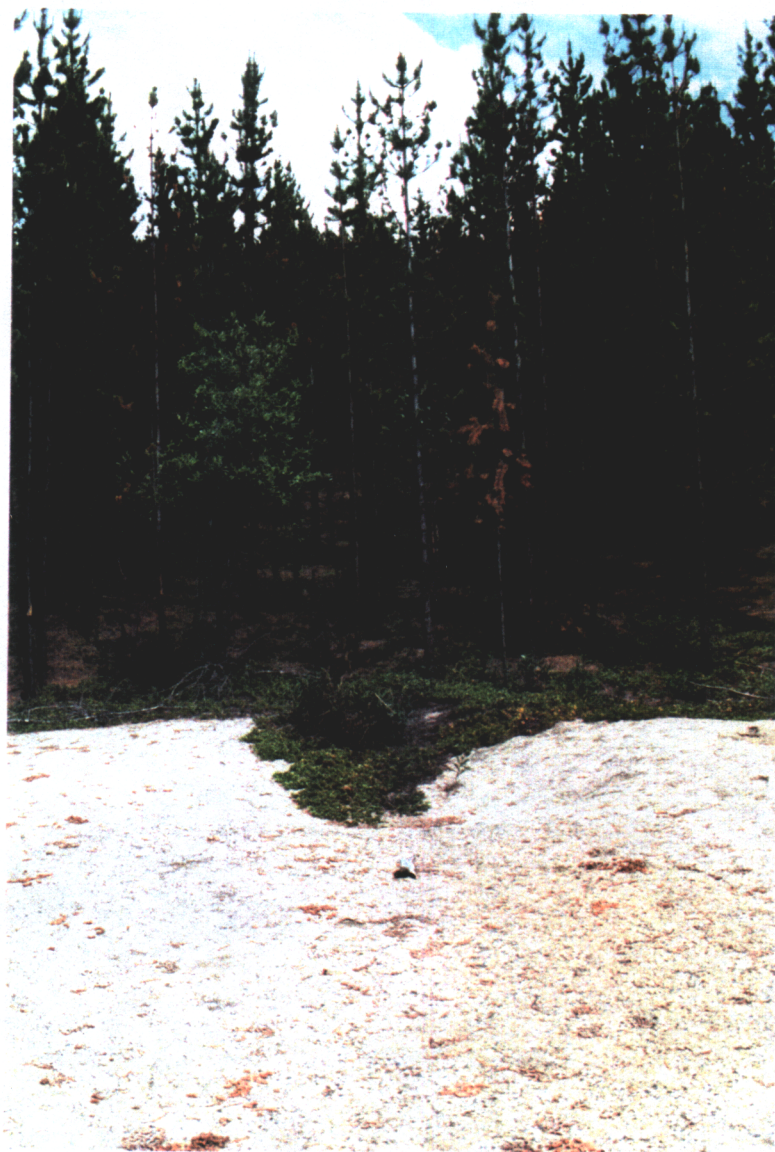
14. INLET TO TAILINGS POND
