**ASSESSMENT REPORT**

**116C-08-2**

**SOURDOUGH**

**DIAND TECHNICAL SERVICES**

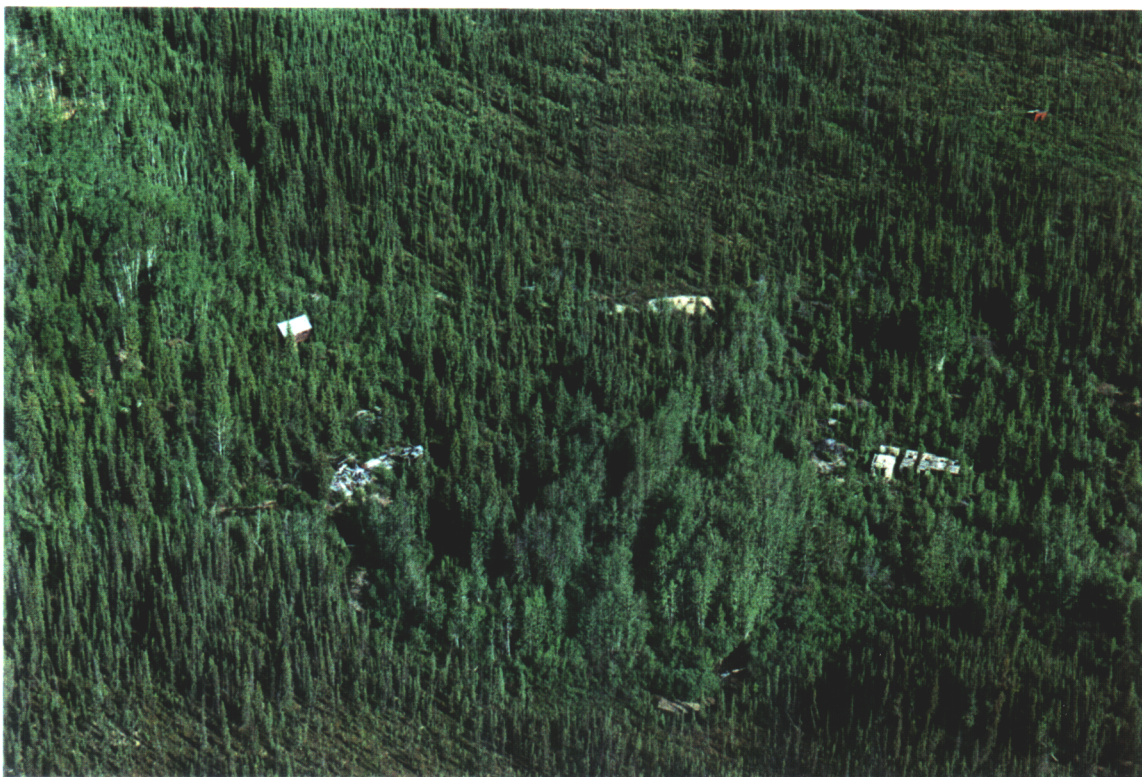
OVERVIEW OF SITE

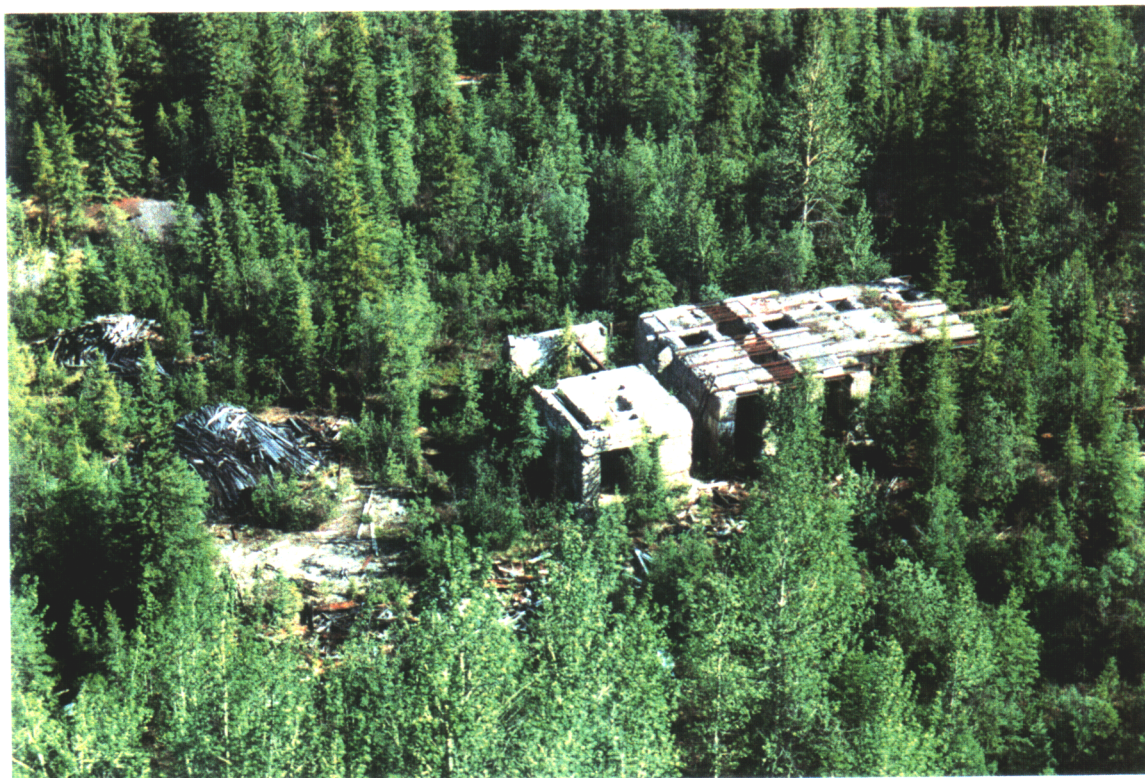
- 1) The old powerhouse is a concrete structure that is still standing but crumbling and is in an advanced state of decay.
- 2) Three wood frame wood clad structures including a warehouse, cookhouse, and one other building on the opposite side of the creek, have all collapsed.
- 3) The only standing wood structure is a two storey log residence that is leaning and is expected to collapse in the near future.

CONCRETE STRUCTURE

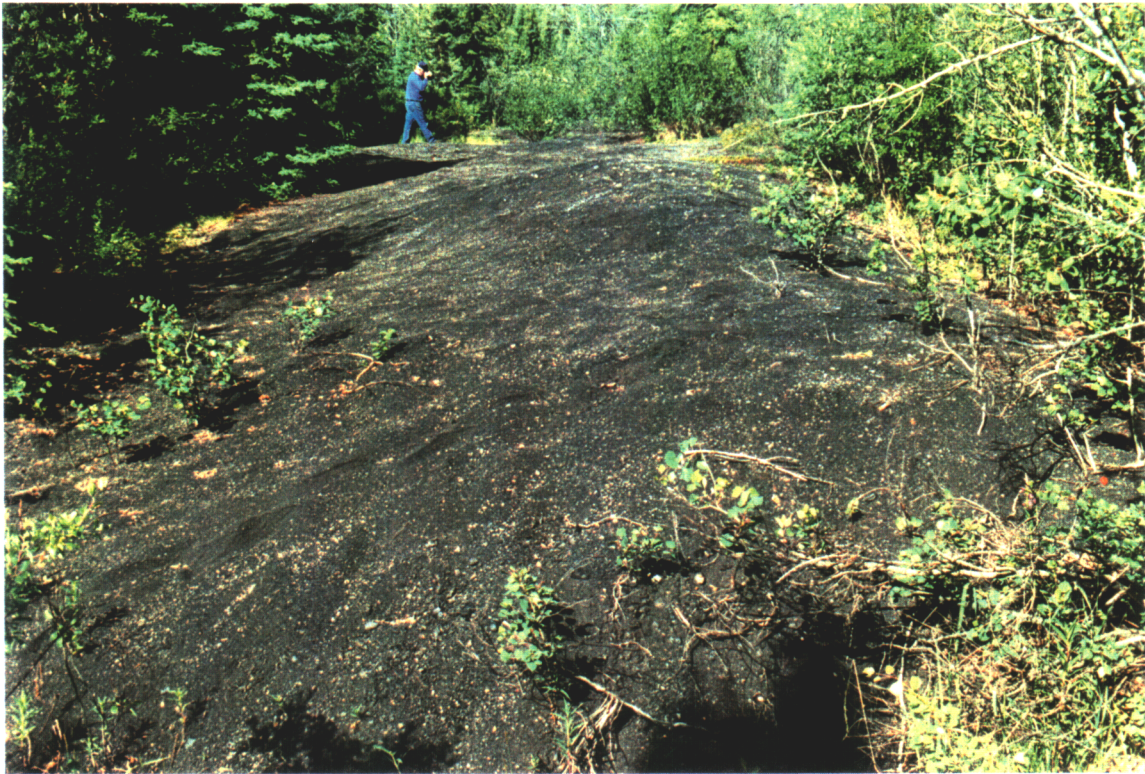
No open adits were found at the site at the time of inspection on 1993/06/29, however locations suspected of being adits were located. These adits have all collapsed. Small piles of coal 3-4m high along with a pile of ash are located near the old powerhouse.

PILES OF COAL

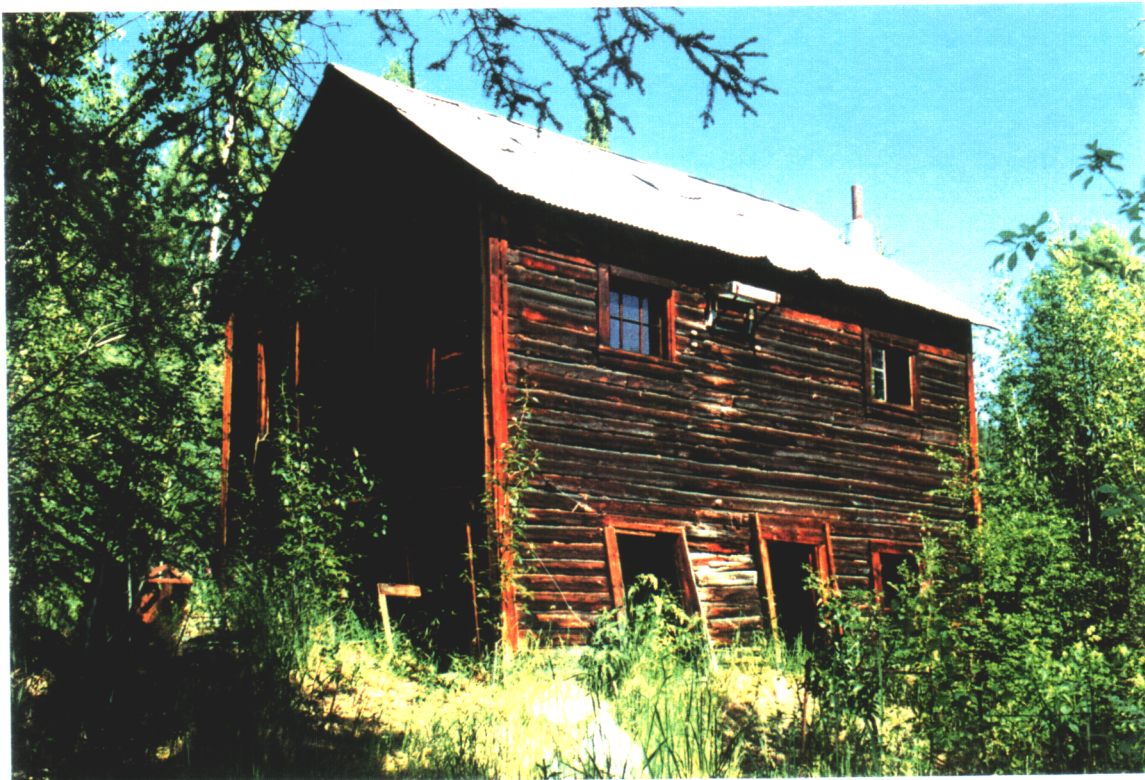
The standing log structure represents a public safety hazard because it is collapsing. It is recommended that the building be posted to warn anyone in the area that this building is unsafe to enter.

LOG RESIDENCE

Posting the one remaining log structure that it is now unsafe should be completed as soon as possible.

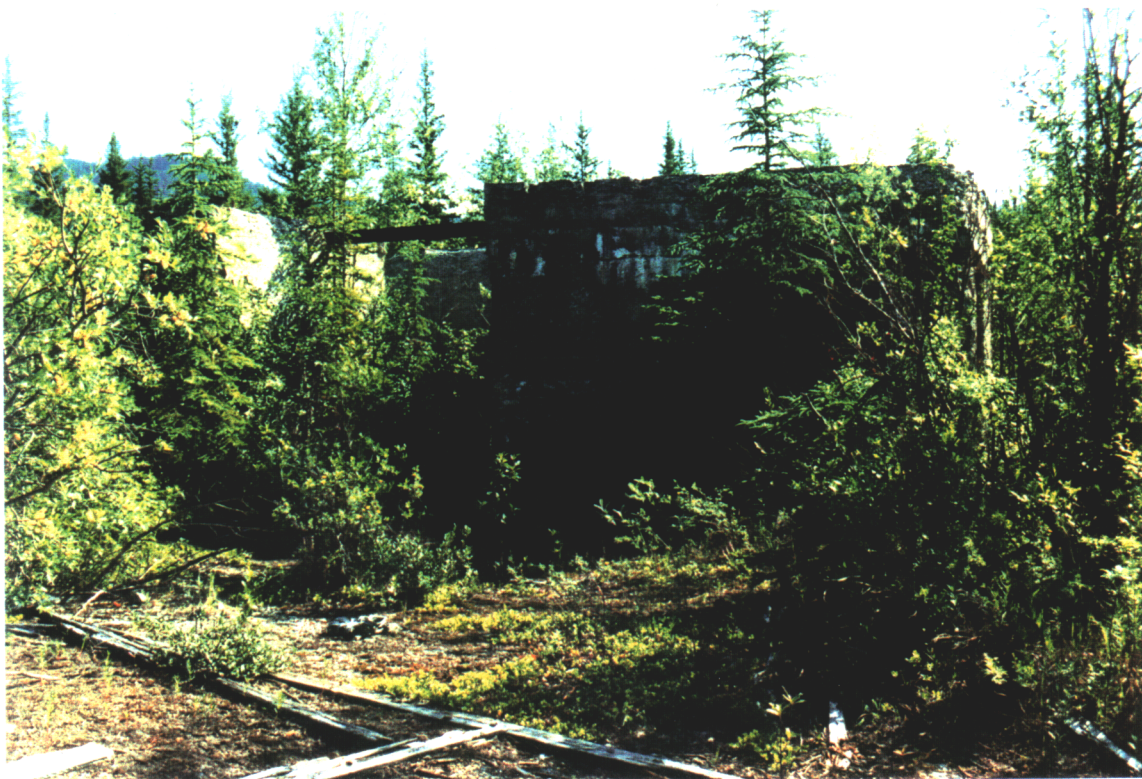
CONCRETE STRUCTURE

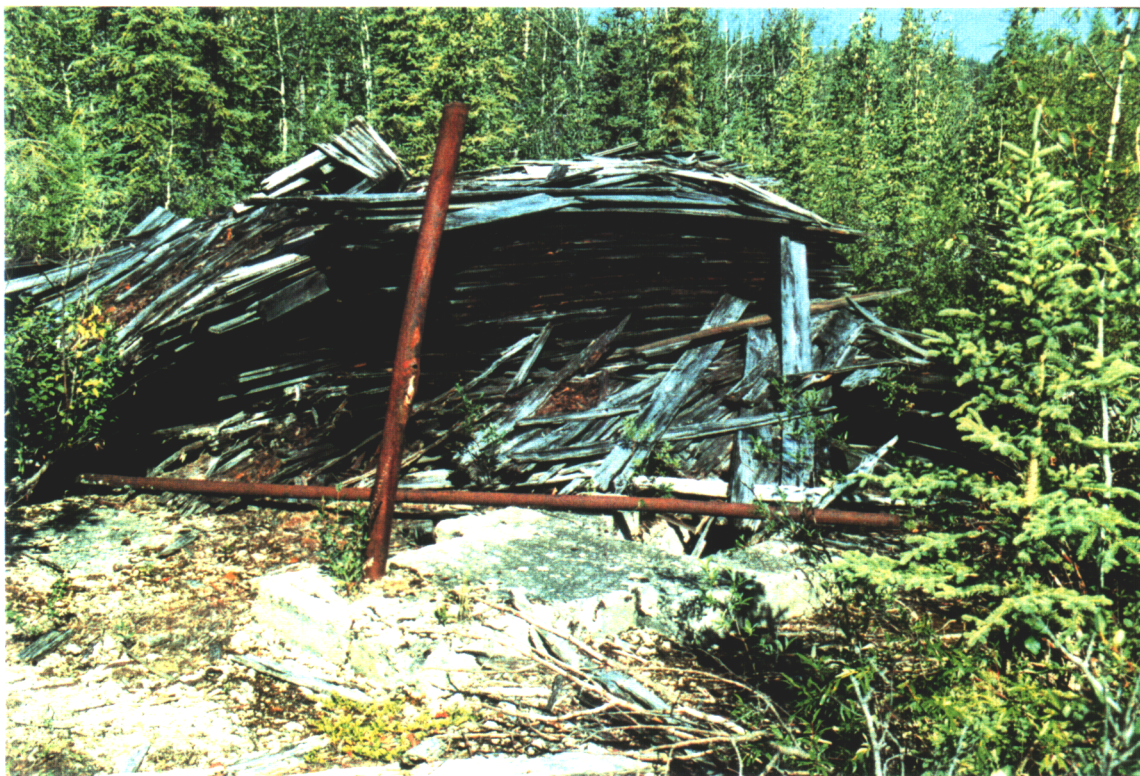
Other material found at the site includes boilers, cookstoves, barrels, pails, hand tools, pipe, bolts, bedframes, etc.

WOOD AND METAL WASTE

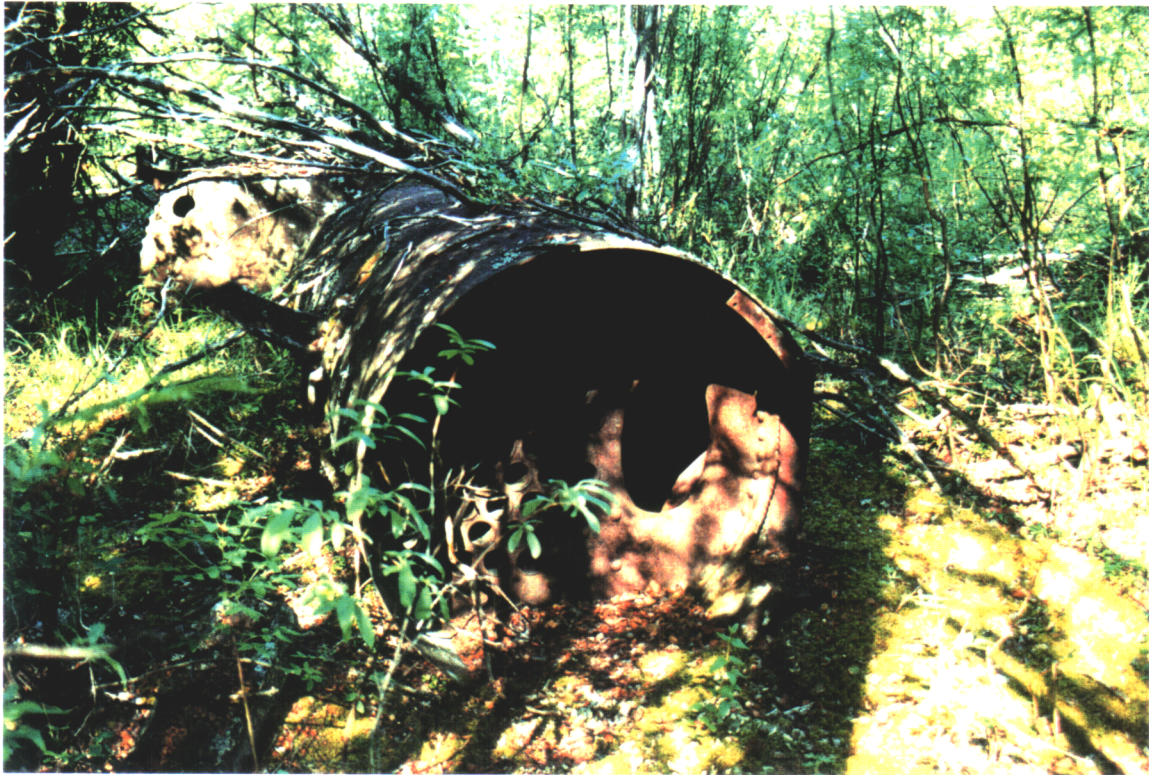
REMNANTS OF OLD BOILER

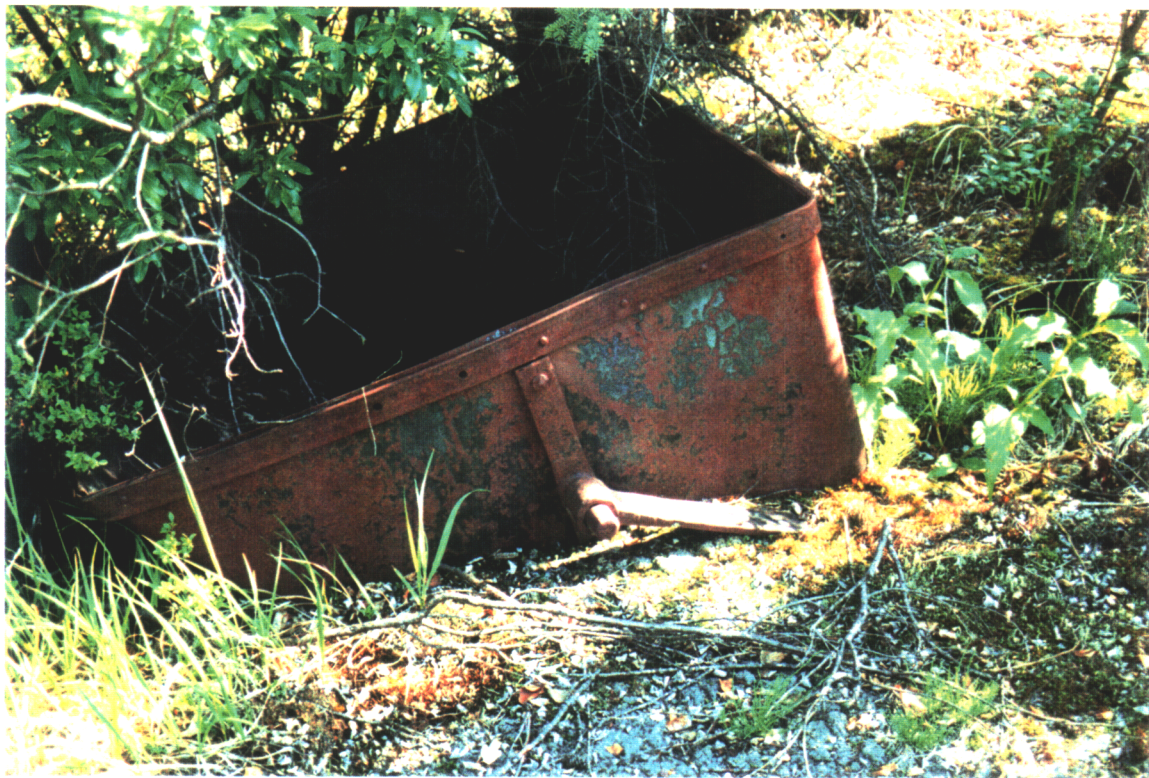
METAL BOX

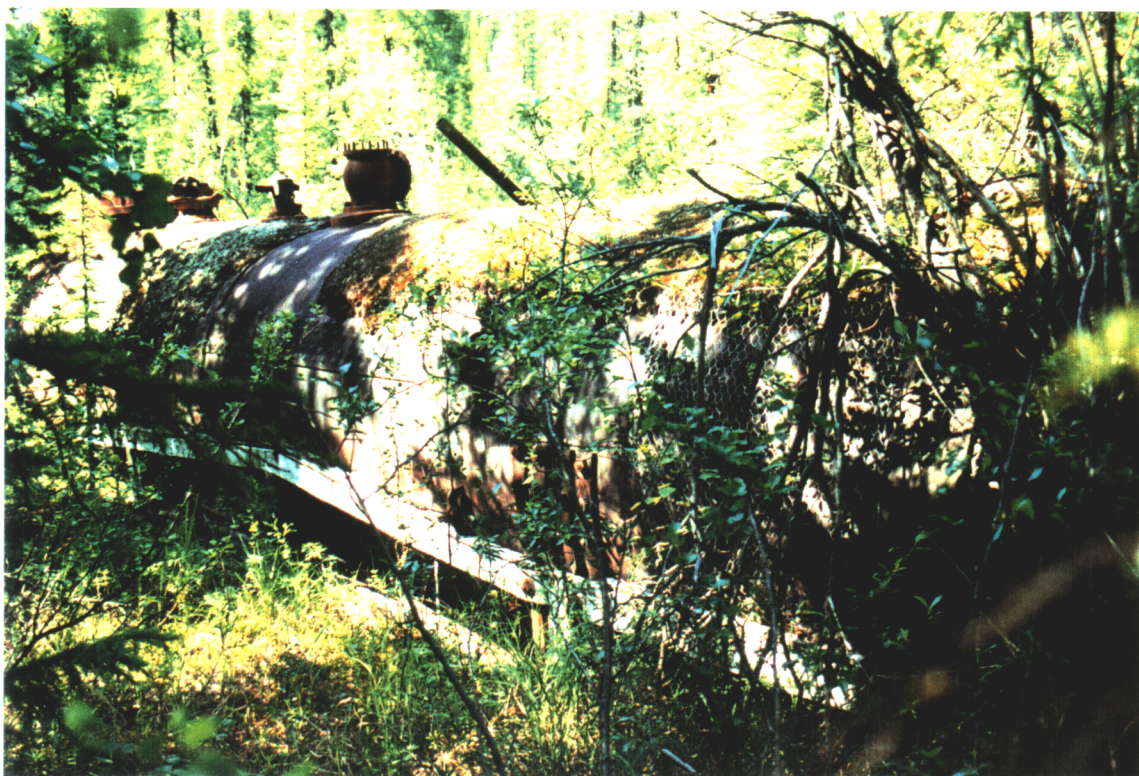
BOILERS

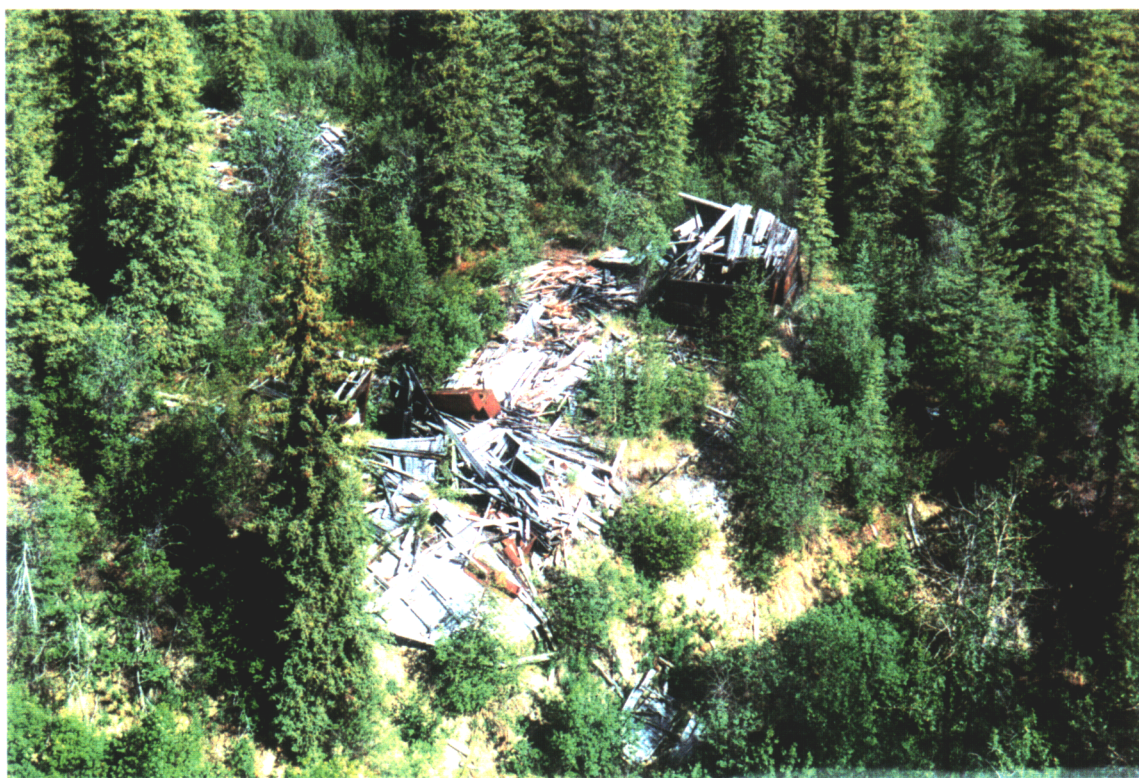
WOOD AND METAL WASTE
