ASSESSMENT REPORT

105G-03-1

**TINTINA**

PREPARED BY
DIAND TECHNICAL SERVICES

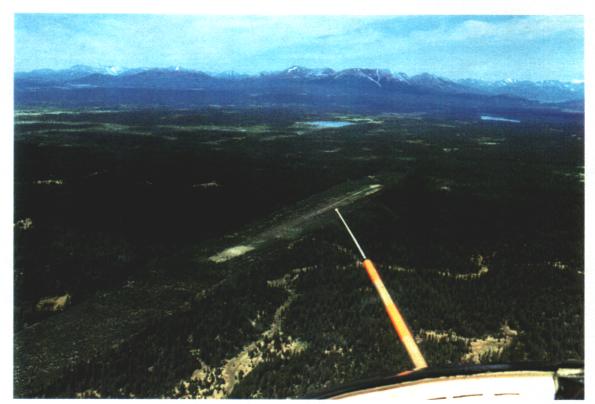
TINTINA AIRSTRIP

The site is remote and can be reached only by helicopter. An airstrip approximately 8 kilometres south of the site was constructed to service the mine exploration. Vegetation is now covering the airstrip, and if not now, will soon be too high to land fixed wing aircraft. A trail extends from the airstrip to the exploration site. According to records, a road was constructed from the Alaska Highway to the site, and pieces of this trail can be seen from the air. However it is obvious that this trail is impassable for vehicle traffic, appears overgrown, and has several large stream crossings between the site and the Alaska Highway.

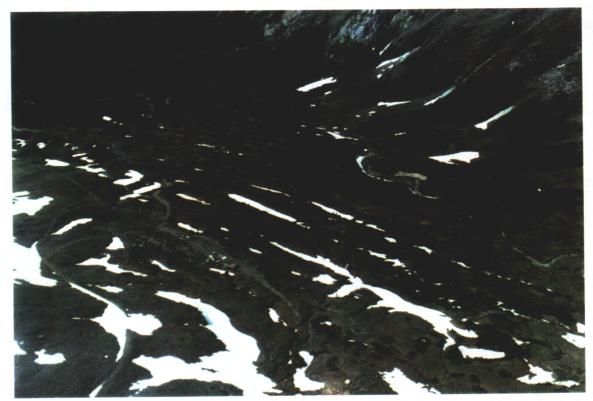
CAMP SITE

The wood structures at the site are beginning to show signs of deterioration which will only worsen with time. These buildings give a visual impact to the environment in this very remote location. It is recommended that these buildings be left untouched unless there is a clean-up program initiated in the area for **LOW** priority sites. If any clean-up is initiated for these buildings the work will need to include;

- cataloguing all worthwhile rock core,
- removing or disposing of the core according to Geological Services recommendations,
- removing all contents from the buildings and disposing in an acceptable way,
- dismantling all structures, piling all wood materials, and burning all wood waste according to acceptable practise, and
- removing all unburned waste from the site.

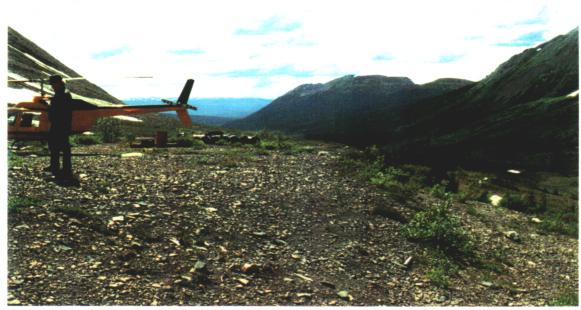
The twelve remaining barrels of diesel and one remaining barrel of gasoline could potentially leak or be spilled and damage the environment. Removal or disposal of these hydrocarbon products and barrels should be considered a **HIGH** priority.

FUEL BARRELS BEHIND HELICOPTER

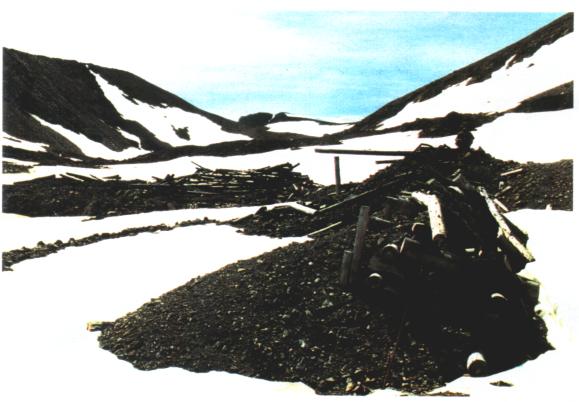
Waste rock has been dumped outside the adit entrance on a gently sloping area. This deposition was completed from ore cars on rails extending from the adit. The rail and track, less than 100m in length, is still in place along with a large pile of locally cut wooden lagging stacked in the same area as the waste rock.

The waste rock from the adit does not appear to have been milled or refined and does not appear to be an environmental hazard. This waste rock should be left alone.

END OF WASTE DUMP, LAGGING ON LEFT

The rail and track to the adit should be removed from the site if a clean-up program is initiated in the area, however this is considered a **LOW** priority. If a clean-up program is initiated for the site, the wooden lagging should also be burned.

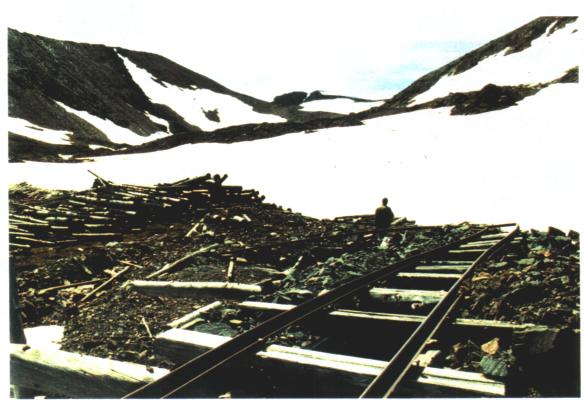
RAIL FROM ADIT, LAGGING ON LEFT
