ASSESSMENT REPORT

105M-14-11

WERNECKE

FEBRUARY, 1994

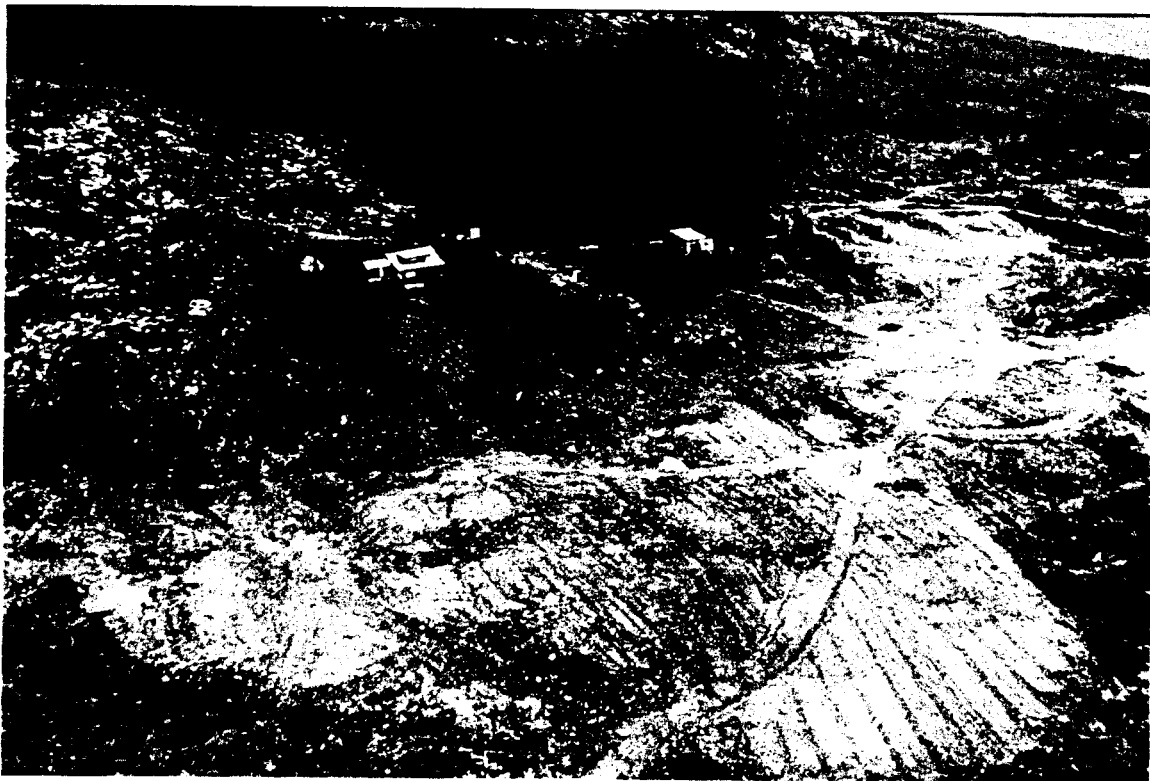
OVERALL VIEW OF WERNECKE TOWN SITE AND MINE SITE

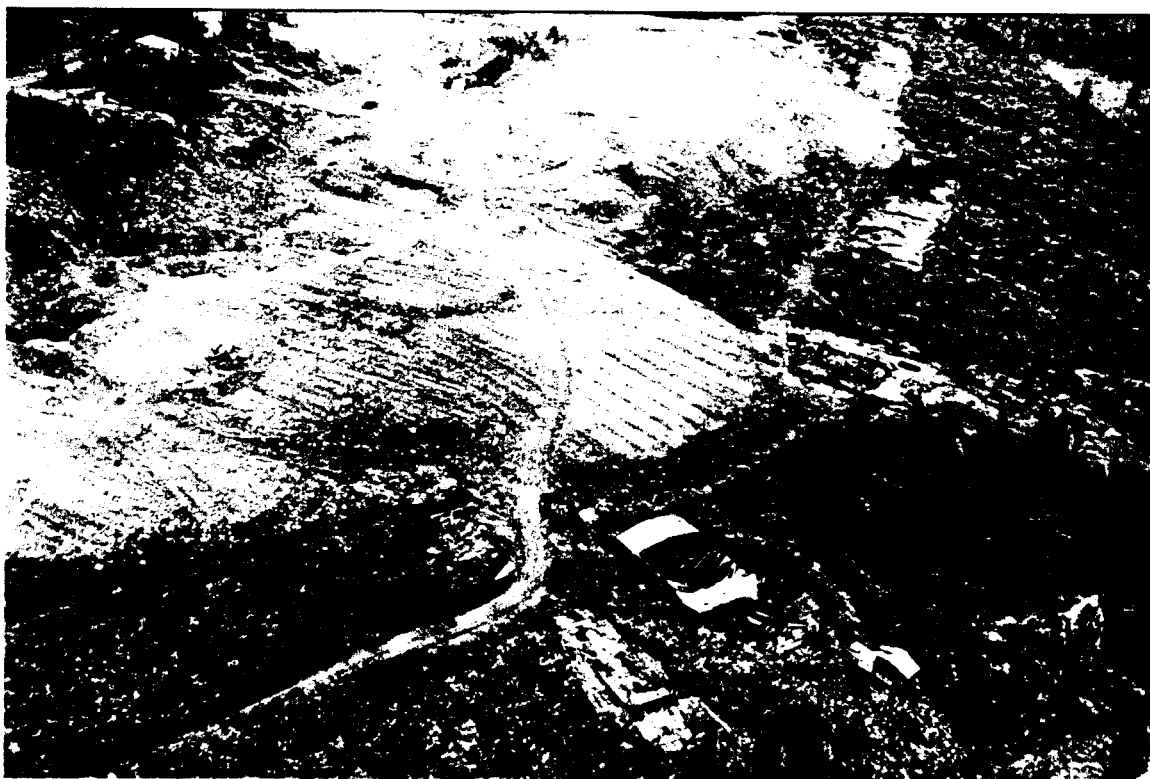
The waste piles surrounding the site appear to have been flattened and pushed downslope. Most of the lower part of the site is void of much vegetation.

OVERALL VIEW OF LOWER PART OF MINE SITE

The trenching in the area has been completed and left in good condition. No large piles have been left and the site has been flattened and levelled. Complete remediation would require revegetating the worked areas, however this is not considered practical at this site because of its remoteness, dry climate, and poor soil conditions for growing.

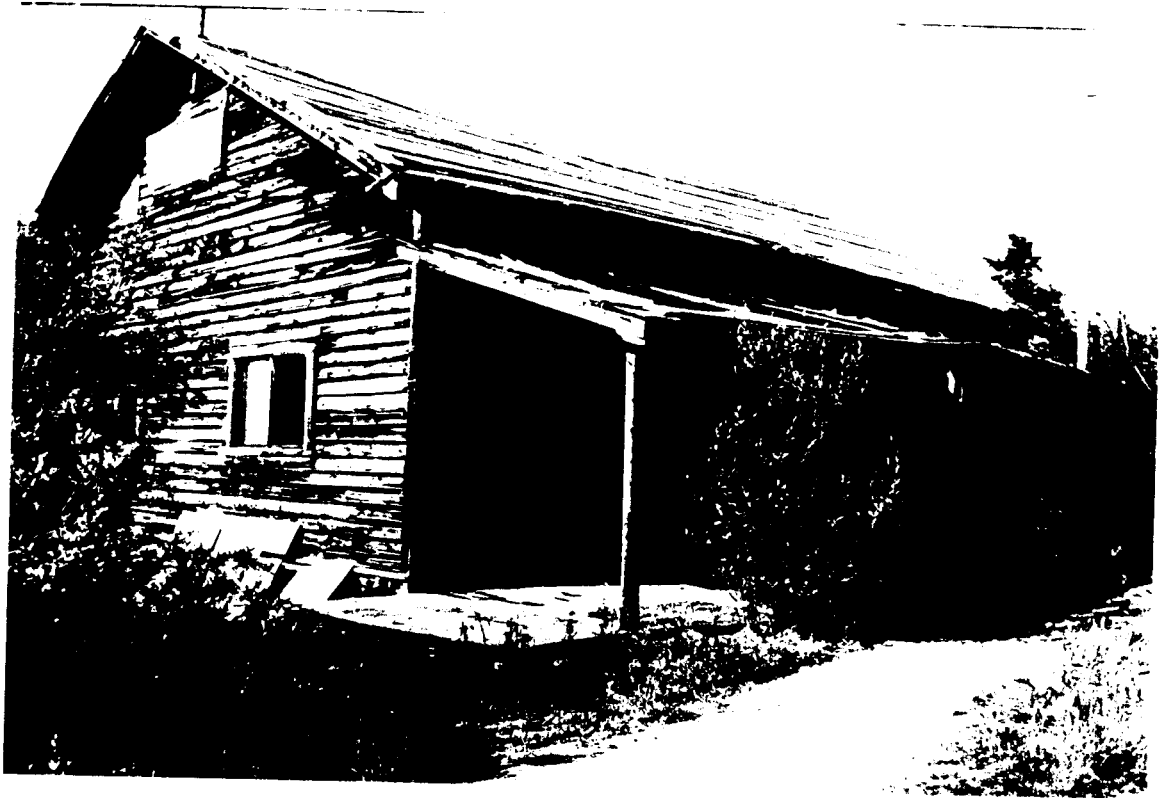
The buildings at this site are all old, decaying, and many are collapsed. The least deteriorated building was a wood frame one and one half storey house that appears to have been occupied in recent years by geological exploration crews or campers. The building measures 15x16m and contains a few wood bedframes and tables.

HOUSE

If the buildings or remains are considered to be of historical significance then they should be left to serve that purpose. It should be understood that these buildings will continue to deteriorate and become unsafe (or may already be unsafe) and a safety hazard. If at some time in the future protecting these structures no longer is considered essential then the site could be cleaned up by removing any remaining structures and collecting all metal and other material and removing it from the site. However, this would be considered a **LOW** priority.

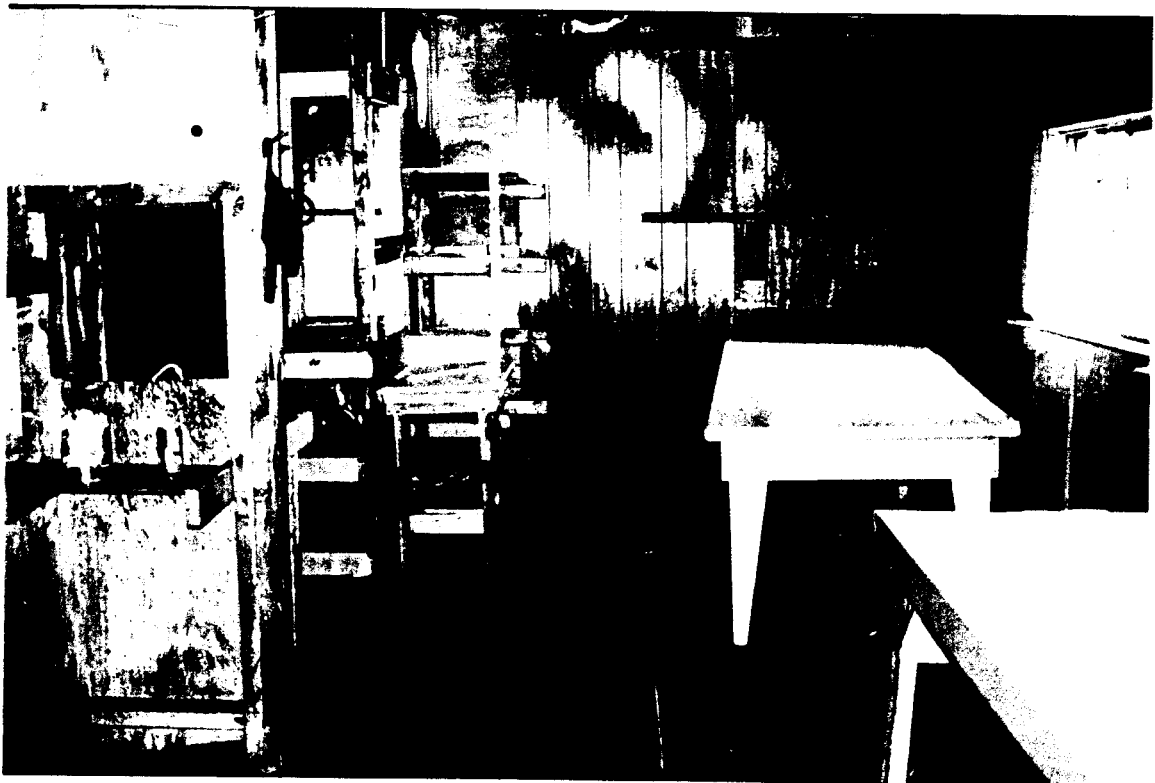
INTERIOR OF HOUSE

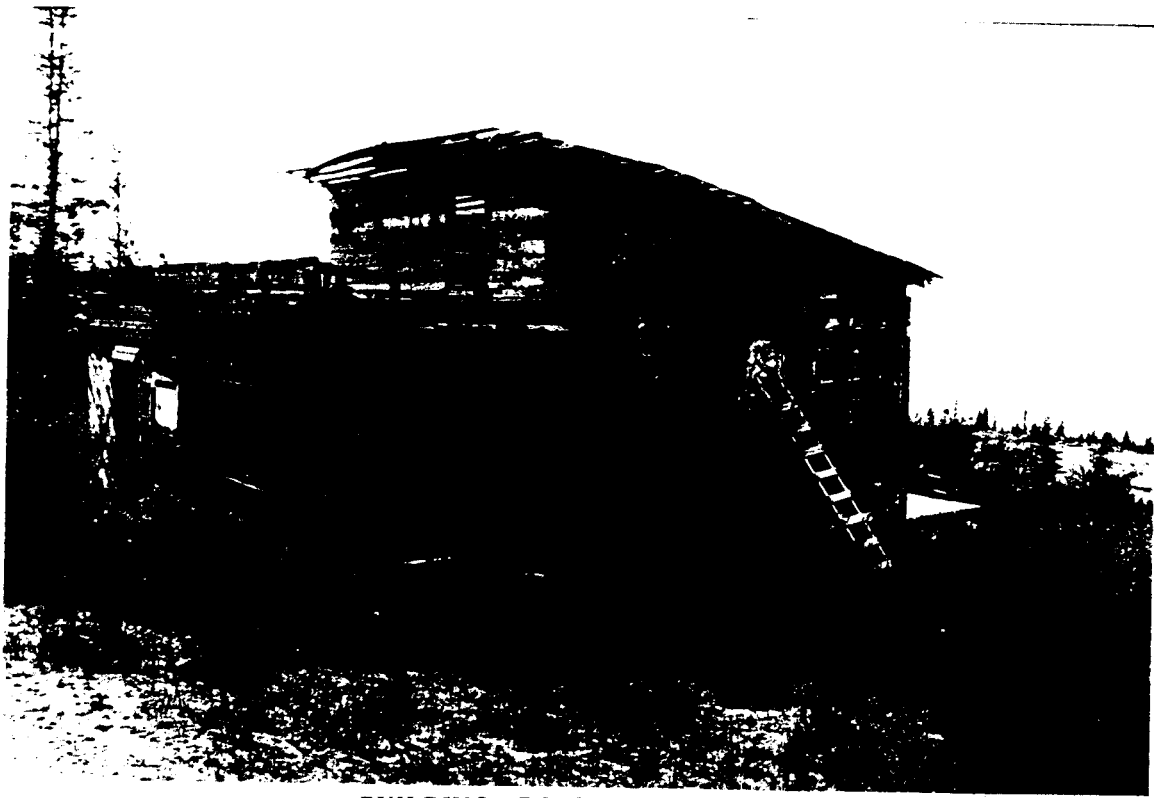
- 3x4m wood frame used for a sauna,
- 4x5m wood frame shed containing a large amount of stove pipe,
- an outhouse,
- 6x10m wood frame building used as a residence. This building is in very poor condition and is beginning to collapse,
- 11x24m collapsed log and wood frame structure with an arch roof.

BUILDING ADJACENT TO HOUSE

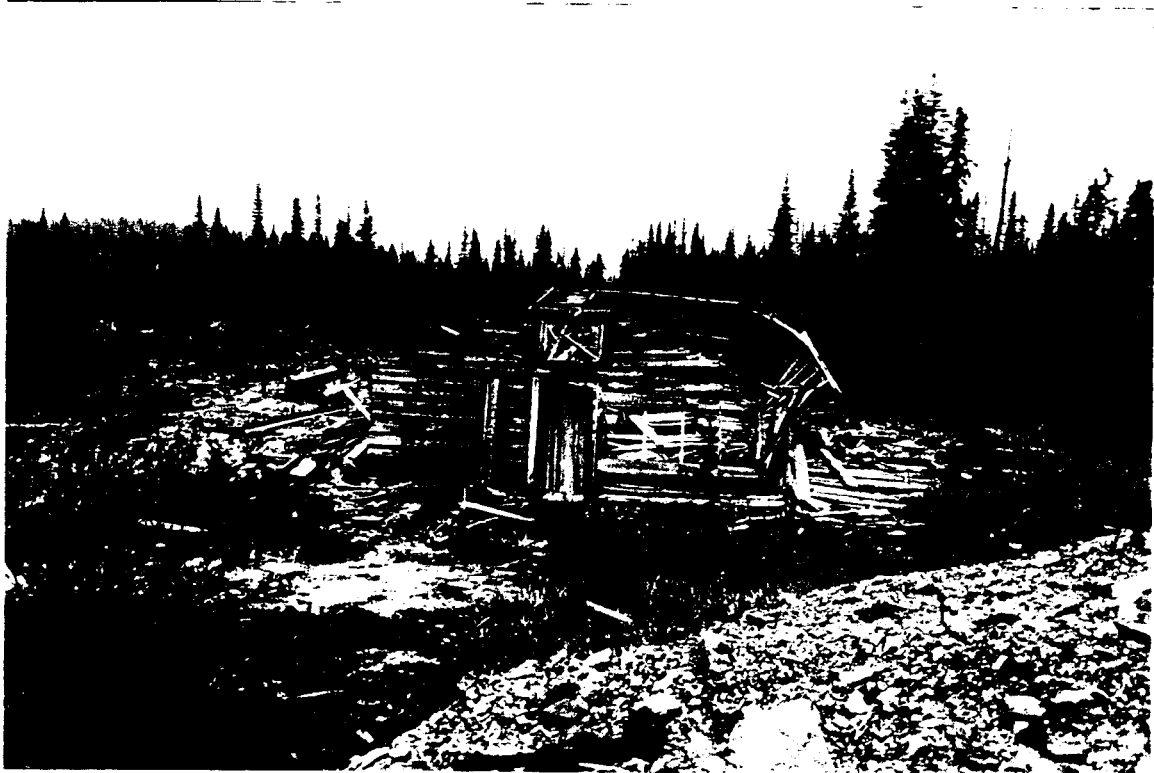
COLLAPSED WAREHOUSE

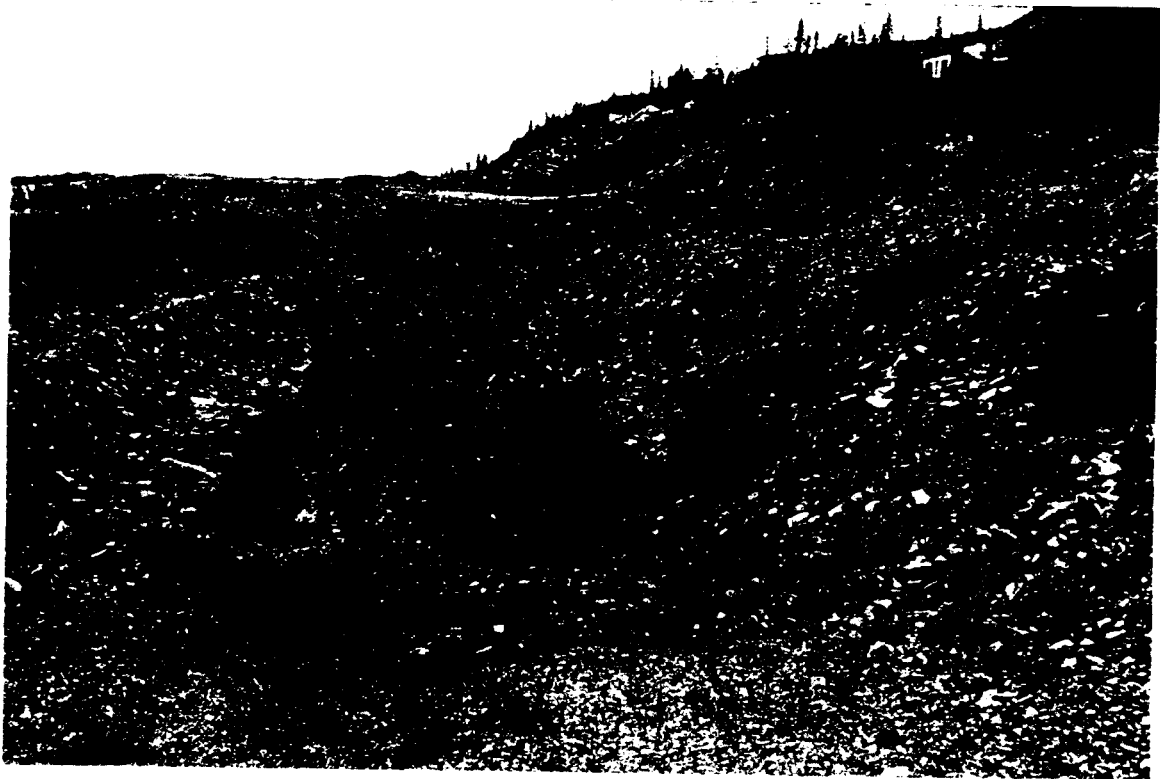
OPEN PIT

The biggest concern at this site is the extremely unsafe unmarked open hole located in the center of this site. Because this hole is unmarked it would be very easy to drive or walk into this hole and sustain serious injury or result in loss of life. It is recommended that this hole be fenced off and posted to warn anyone of the potential danger. This is considered a **VERY HIGH** priority. The sides of any open pits should also be clearly marked and posted to warn anyone of the potential hazard.

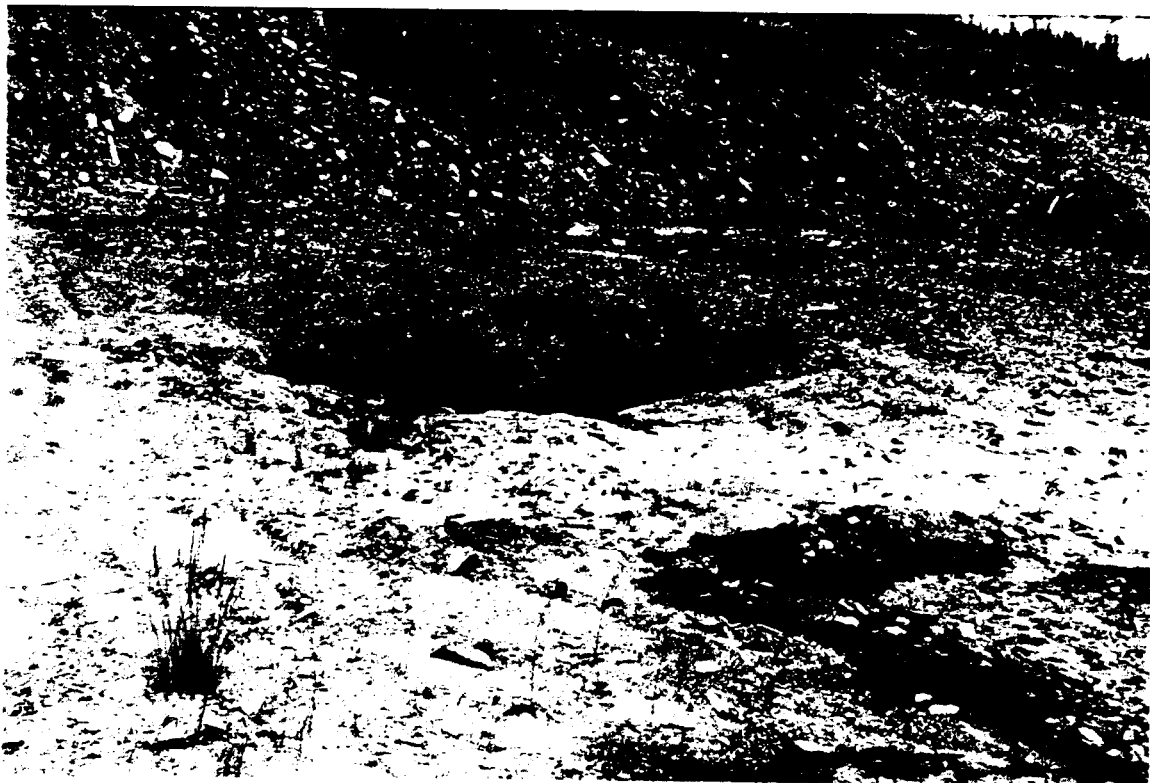
According to the vegetation cover it appears that the trenching activity actually occurred over a number of separate time periods. This is evident as parts of the site are starting to be covered with newer vegetation. The surface exploration and trenching covers an area at least 800x600m with an open pit situated in the centre of the site. The open pit in the centre of the site is approximately 10-15m deep. **Within 100m north of the open pit an unmarked hole was observed. The depth of this hole could not safely be measured and is not known.**

UNMARKED OPEN HOLE

The major concern at this site is the open hole that has been left unmarked and unprotected. This is considered a **VERY HIGH** priority to warn the public against this safety hazard and to secure the site by fencing off the area around this hole. The site should also be posted to warn of any other potentially hazardous situations such as getting too close to the headwall of the open pit or entering unsafe buildings.

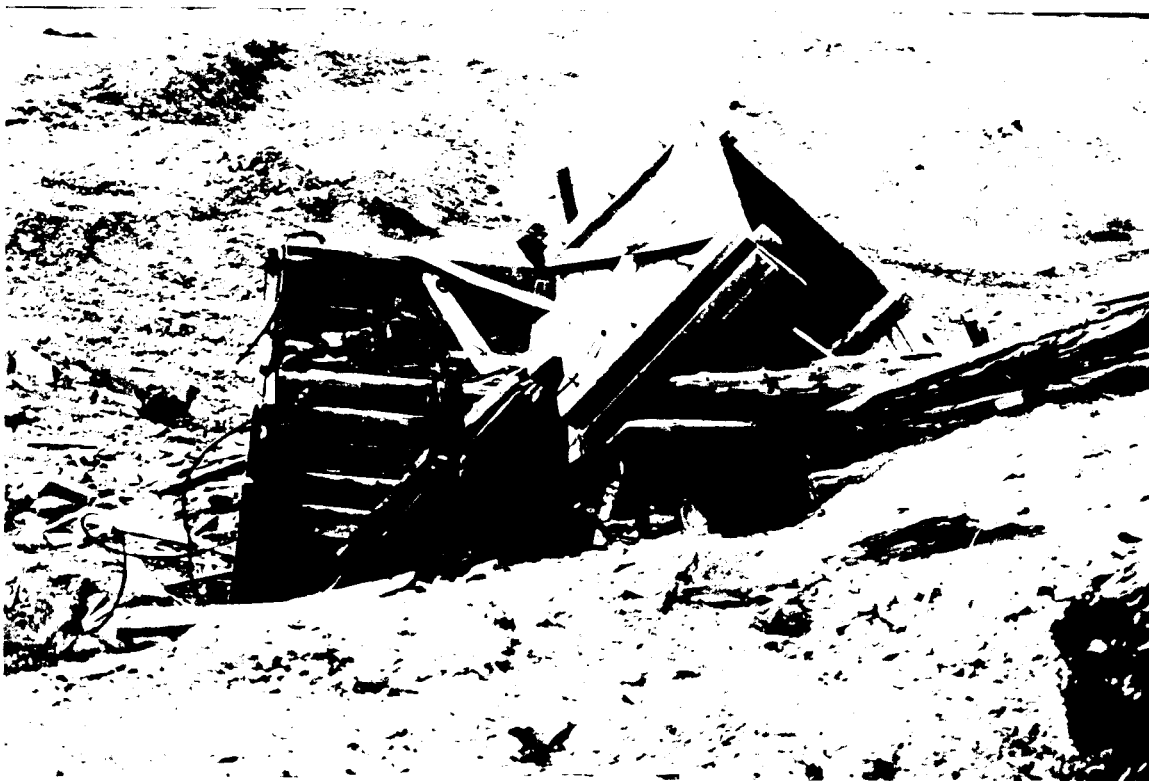
Foundations for other buildings were still evident , however no structures were completely standing. Some other material was found on-site, most notably the remains of a boiler with metal exhaust stack. A variety of pieces of metal junk were found inside the remains of the arch building. Little else was found on-site.

WASTE ON SITE
