**PHASE II ENVIRONMENTAL ASSESSMENT
OF THE
CANALASK
ABANDONED MINE SITE**
prepared for:

Action on Waste Program
Indian and Northern Affairs Canada

Environmental Services
Public Works and Government Services Canada

February 1997

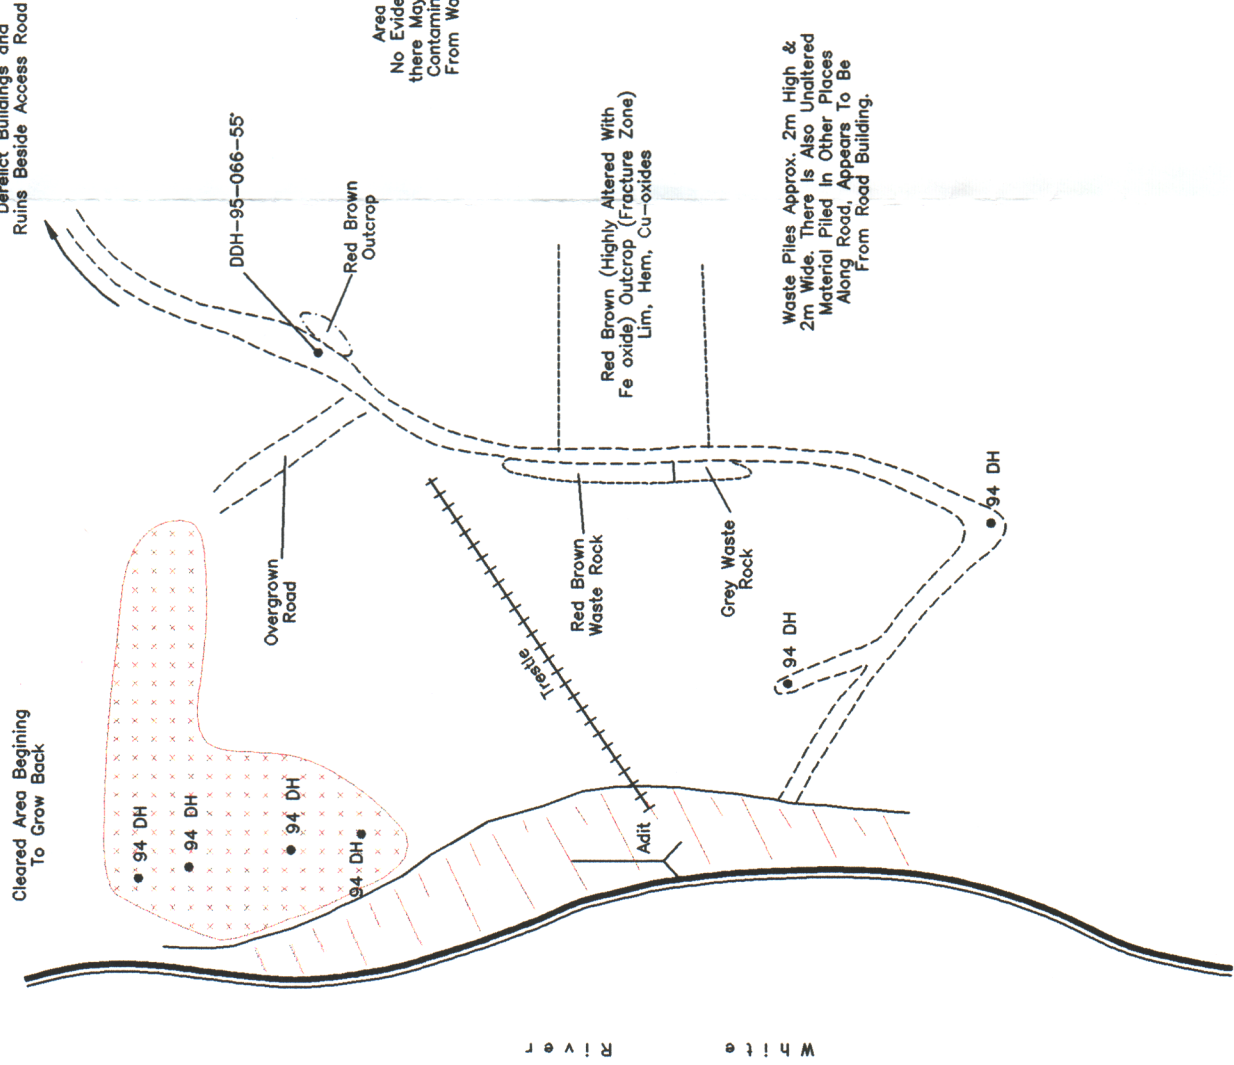
Area is Dry, No Seeps. No Evidence Of ARD. Although there May Be Some Intermittent Contamination Of Soluble Salts From Waste & Outcrop During High Rainfall.

Red Brown (Highly Altered With Fe oxide) Outcrop (Fracture Zone) Lim, Hem, Cu-oxides

Waste Piles Approx. 2m High & 2m Wide. There is Also Unaltered Material Piled In Other Places Along Road. Appears To Be From Road Building.

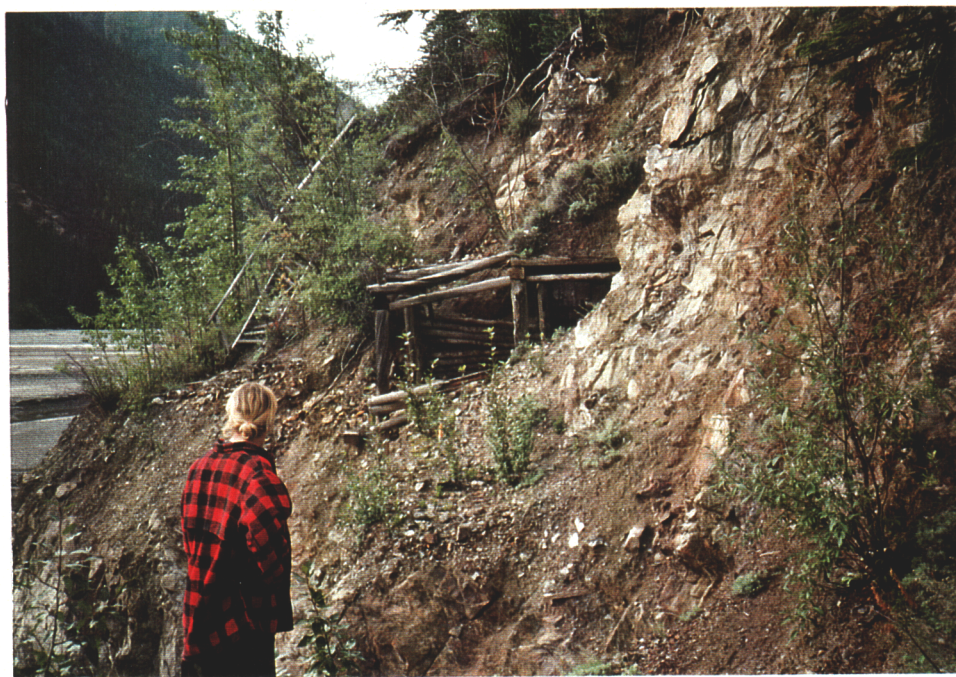
The portal opening or mine adit measures 2 m high by 1.5 m wide and is located on the face of the eastern bank of the White River. The adit is constructed of wood beams and 2 inch by 4 inch lumber. Some of the beams that had provided a roof over the adit entrance have fallen away, possibly due to rock slides, and others are missing. A wire mesh screen was installed over the entrance of the adit to restrict access, but the screen has been cut. A sign reading "danger keep out" has also been installed at the entrance. the bank above and beside the adit entrance appears to be unstable, consisting of loose shale and rock outcropping. The adit entrance is only accessible by traversing the cliff face. The stairs that provided access in the past are no longer safe.

Photo 4. Adit opening located on the bank of the White River. Staircase leading to the adit is visible behind shrubs to the left of the adit.

Recommendation 1. Assuming no further site development, the mine portal or adit opening should be sealed by blasting. Charges can be placed by drilling from above. Experienced blasters should be retained to minimize potentially land slides entering the White River and endangering workers above the adit.

Prior to closing the adit, the potential for the presence of hazardous materials should be evaluated only if the adit can be entered into safely.

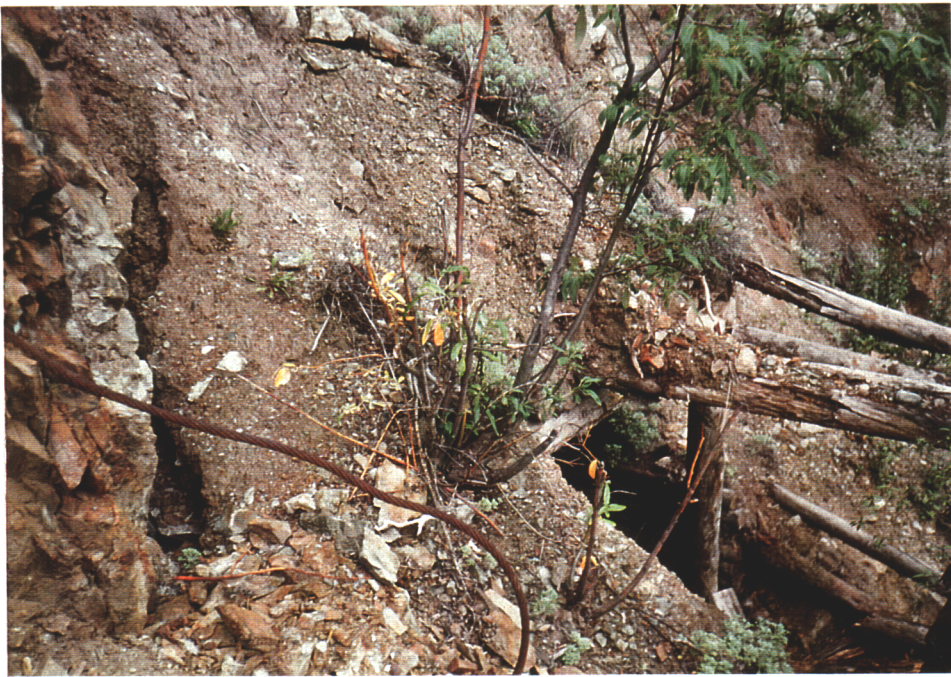
Photo 5. Bank area above adit opening. Note loose shale material on bank.

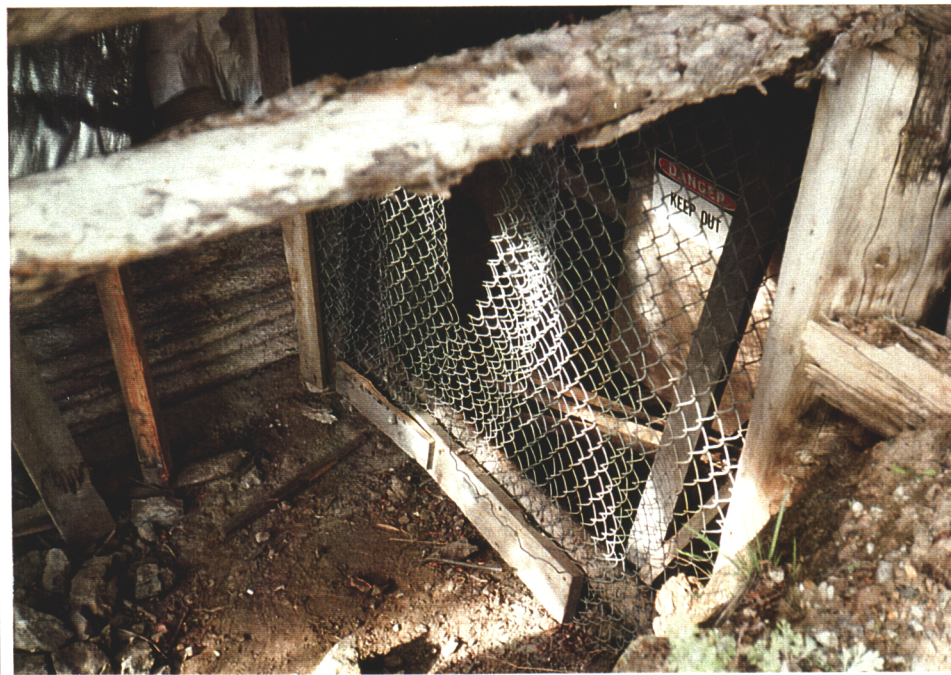
Access to the underground workings is still possible but highly dangerous, and therefore may pose a hazard to human safety. The small shed that has not collapsed is highly unstable and therefore is of concern from a health and safety point of view.

Photo 6. Adit entrance has been screened off and sign posted warning of danger, keep out. Note screen has been cut to allow access.

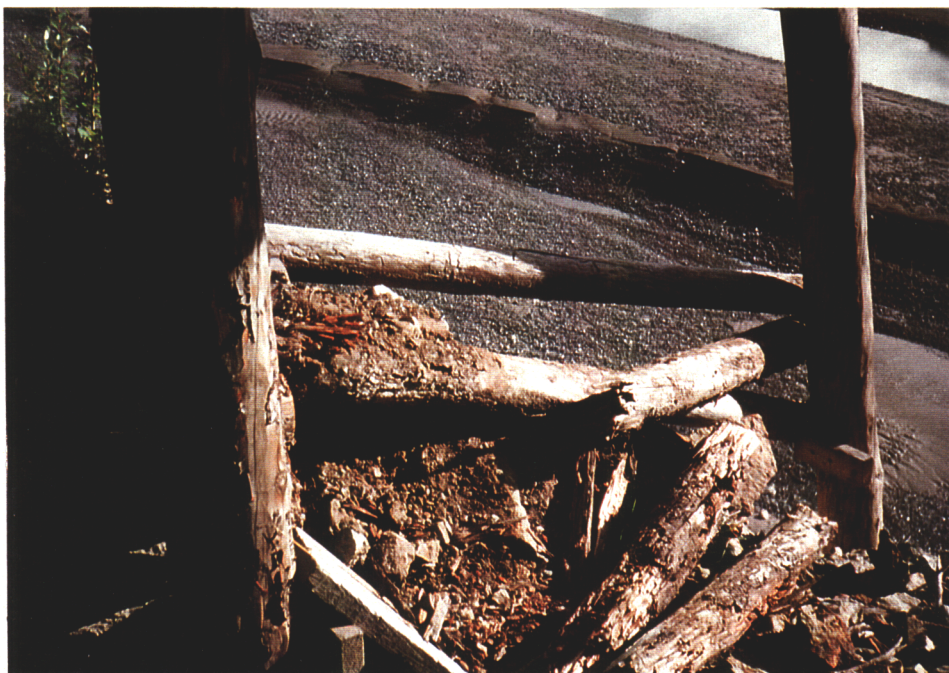
Photo 7. Timbers supporting the adit are in poor condition.

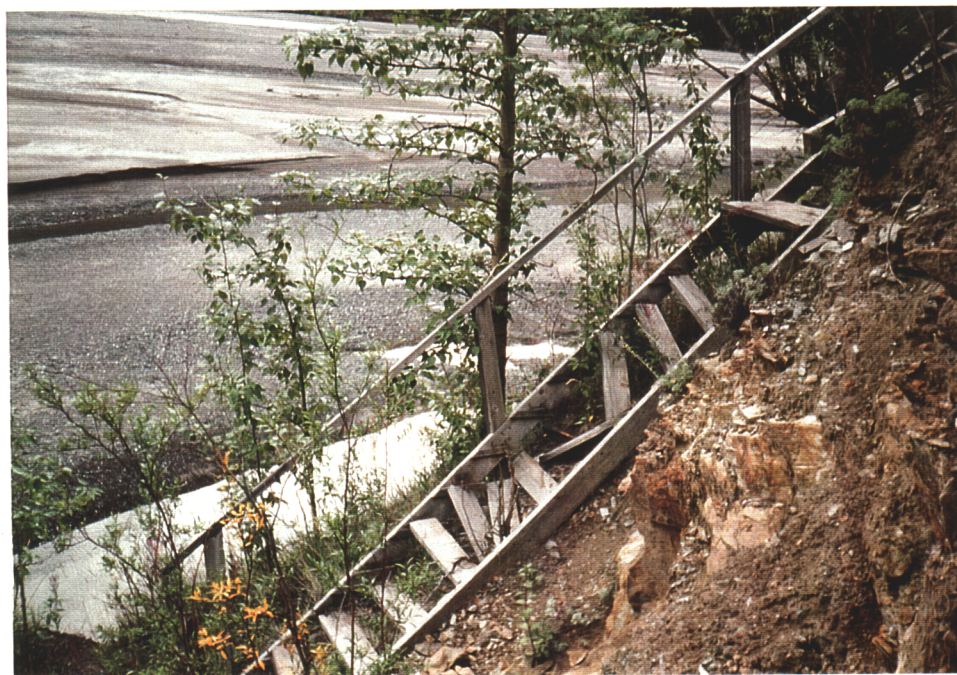
There is also a wooden staircase on the bank leading to the mouth of the adit. The staircase is in extremely poor condition with several of the stairs, as well as portions of the railing, missing. The remnants of a wooden trellis is located on the bank above the adit opening. Like the stairs, this structure is in extremely poor condition and has been overgrown with

Photo 8. The staircase leading to the adit is in disrepair and is very unsafe.

Recommendation 2. Piles of wood debris should be sorted and all hazardous objects such as nails and sharp objects should be removed and properly disposed of off site. All combustible material including the wooden staircase leading to the entrance to the adit and the wood frame building should be dismantled and/or demolished, stockpiled and burnt under controlled conditions.

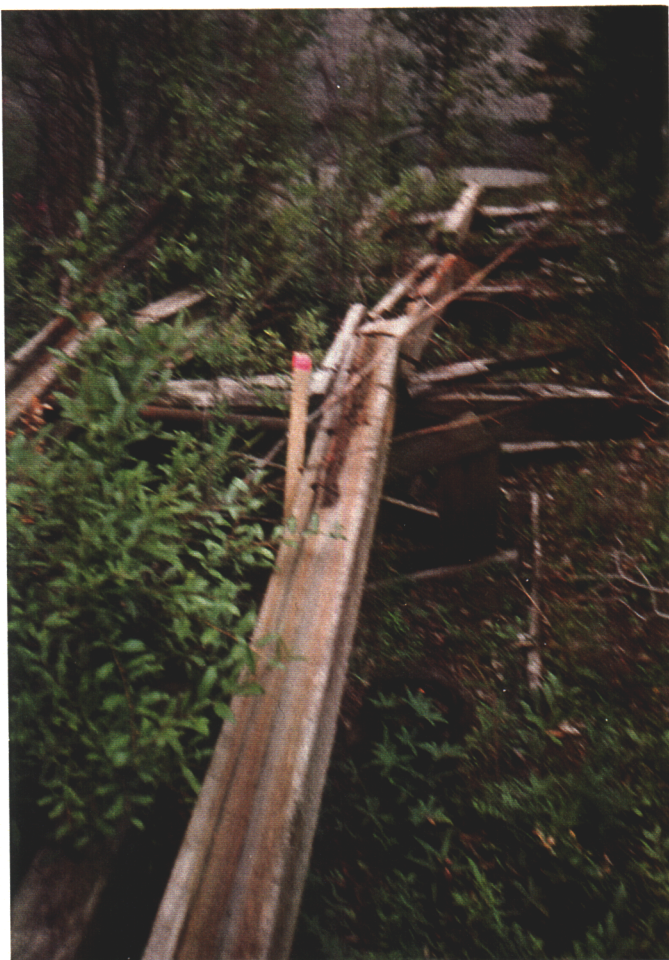
Photo 9. Wooden trestle running up bank above the adit.

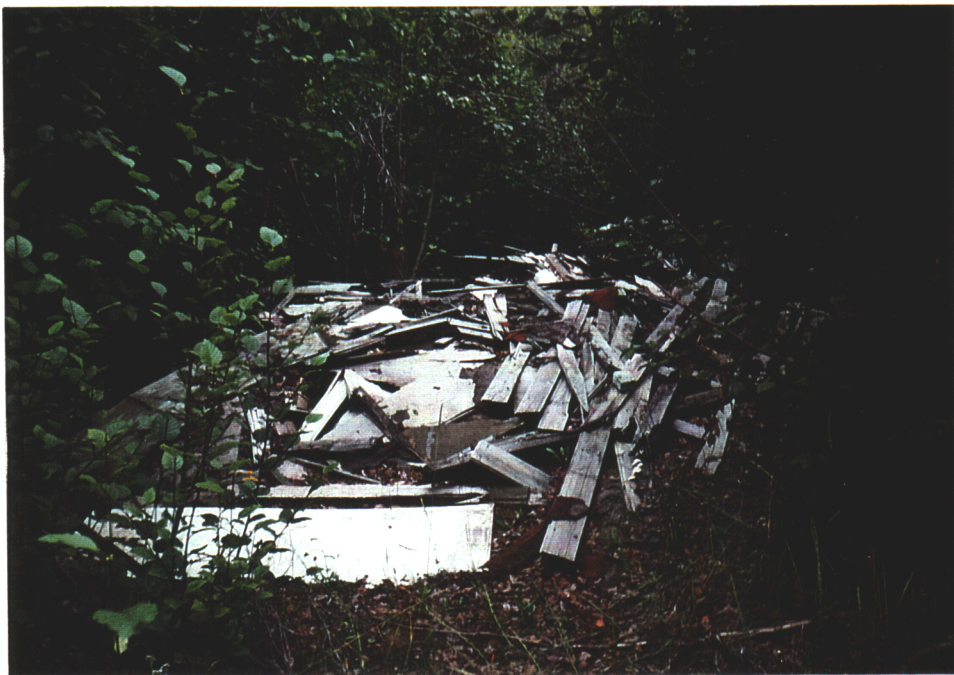
Photo 10. Demolished building in the wooden area on bank above the adit area.

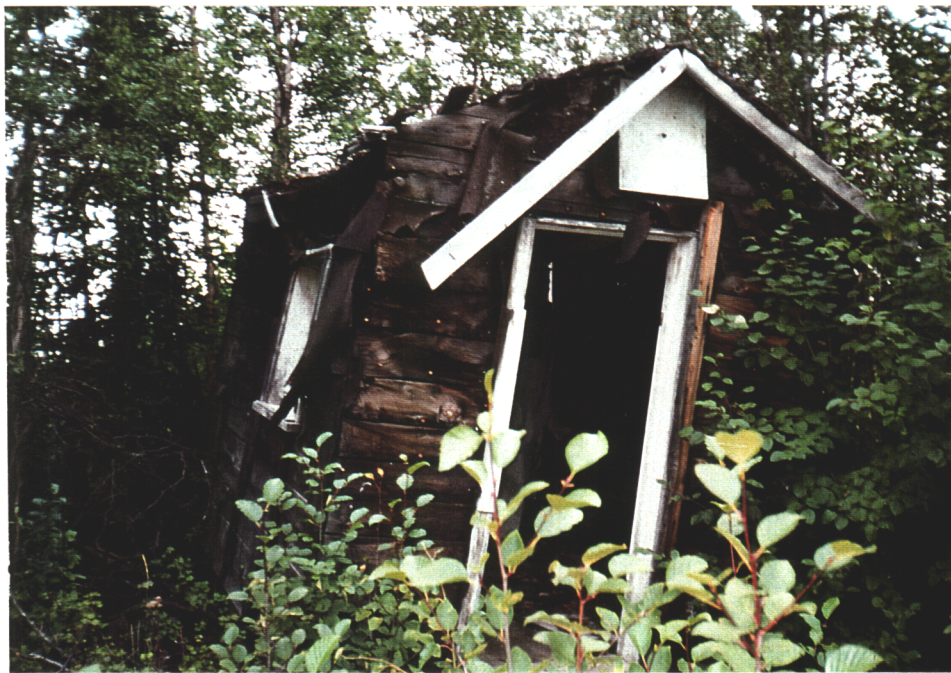
All building structures with the exception of one small wooden shed have been demolished. Two debris piles, from the demolition of these structures, have been left in a wooded area adjacent to an open area beside the access road. This area where the mine site buildings were located is higher up off the bank of the White river and above the adit or working area of the mine. The shed has been significantly damaged and is in very poor structural condition.

Photo 11. Damaged building at fringe of open area along side access road. In same general area as building debris shown in photo 10.

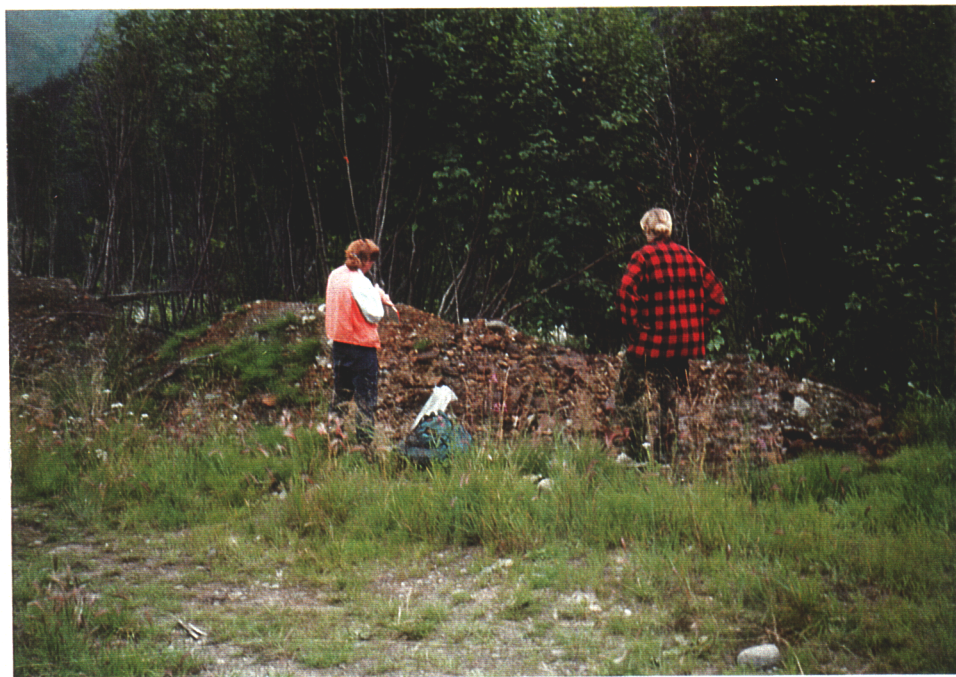
Results of ABA tests suggest that the waste rock at the Canalask property is potentially acid-producing and contains high concentrations of soluble oxidation products. However, no seeps or evidence of seepage were observed from the piles, and since they are so small, the potential for significant environmental effects is unlikely.

Photo 12. Waste Rock pile along side mine access road.

Recommendation 3. Should further development occur on the site, regulatory agencies should ensure that an acid drainage prevention plan is developed which includes detailed measures for handling and disposal/management of mineralized waste rock.
