**PHASE II ENVIRONMENTAL ASSESSMENT
OF THE
GOLD HILL**

ABANDONED MINE SITE

Environmental Services
Public Works and Government Services Canada

March, 1997

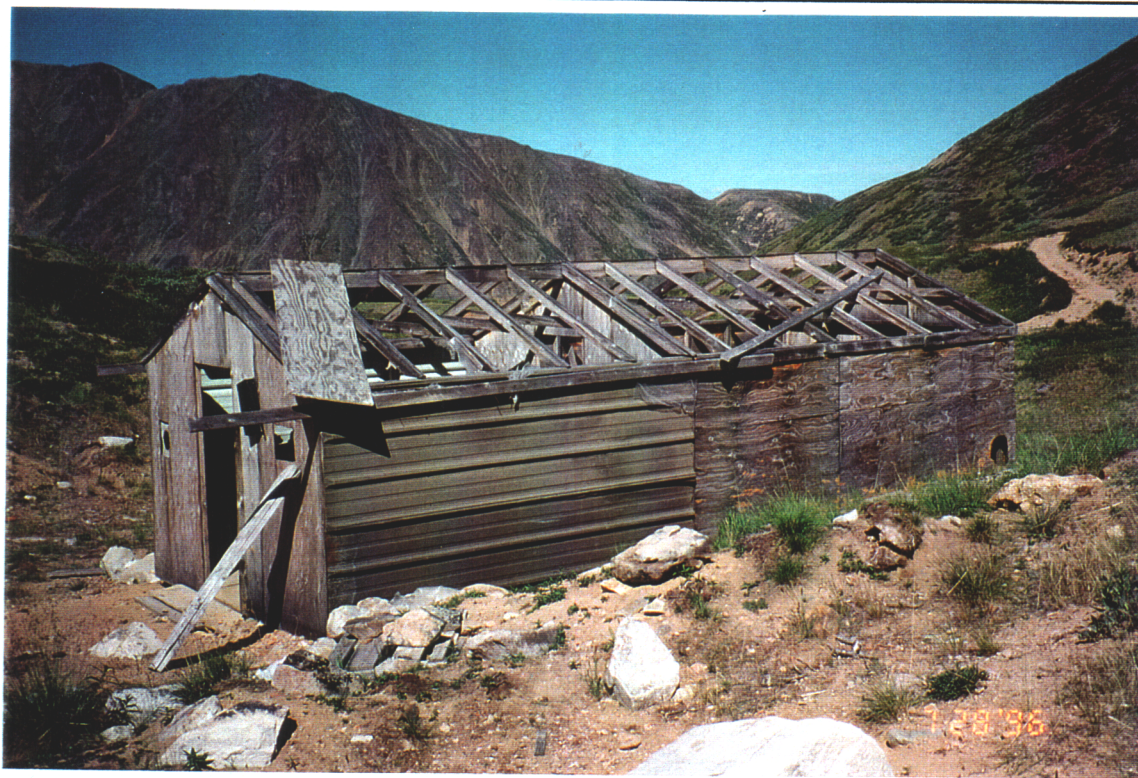
Inventoried Material	Location	Comments
~10 m x 3 m bldg.	bottom of northwest valley	wood frame with some aluminum siding; poor condition
wood outhouse	bottom of northwest valley	plywood construction; destroyed

Photo # 1 - Deteriorating Shack on Site

It is recommended that the buildings be demolished and burned and the ashes buried on site for aesthetic reasons.

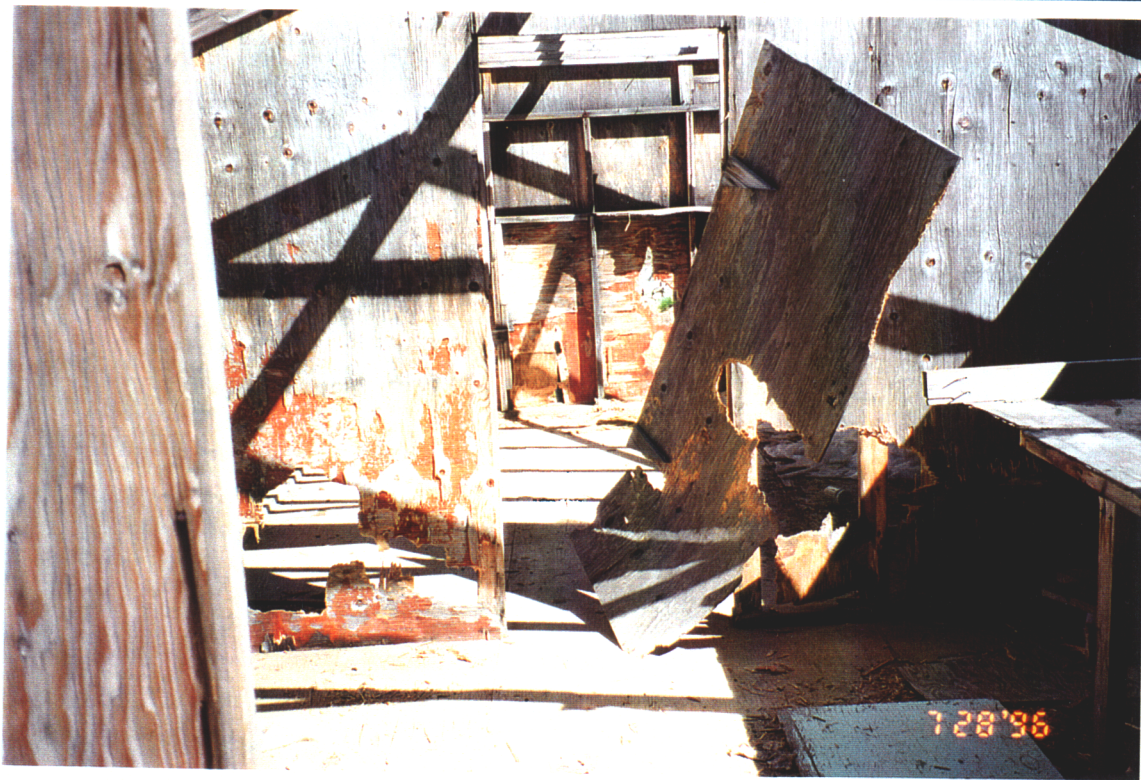
Photo # 2 - Interior of Shack

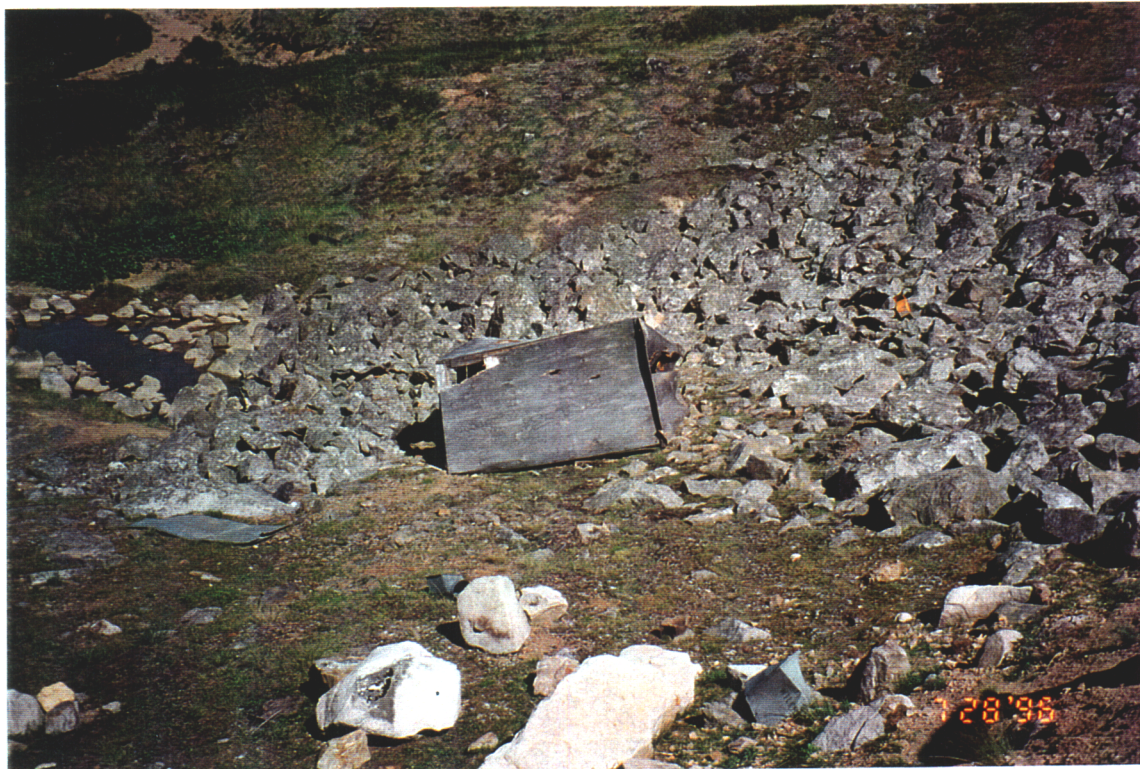
Photo # 3 - Miscellaneous Wood Debris

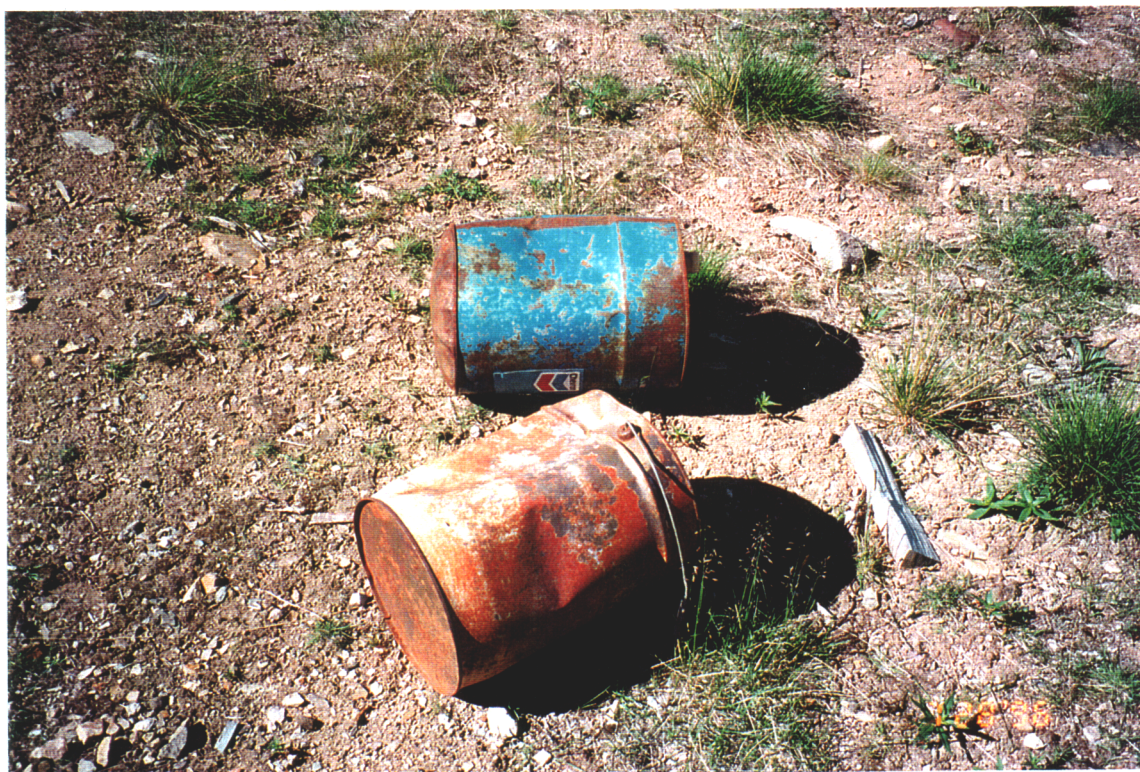
Photo # 4 - Barrels to be Collected

It is recommended that metal site debris, including portions of the building and domestic waste, be collected and transported off site for aesthetic reasons. The debris can be collected using locally available labour.

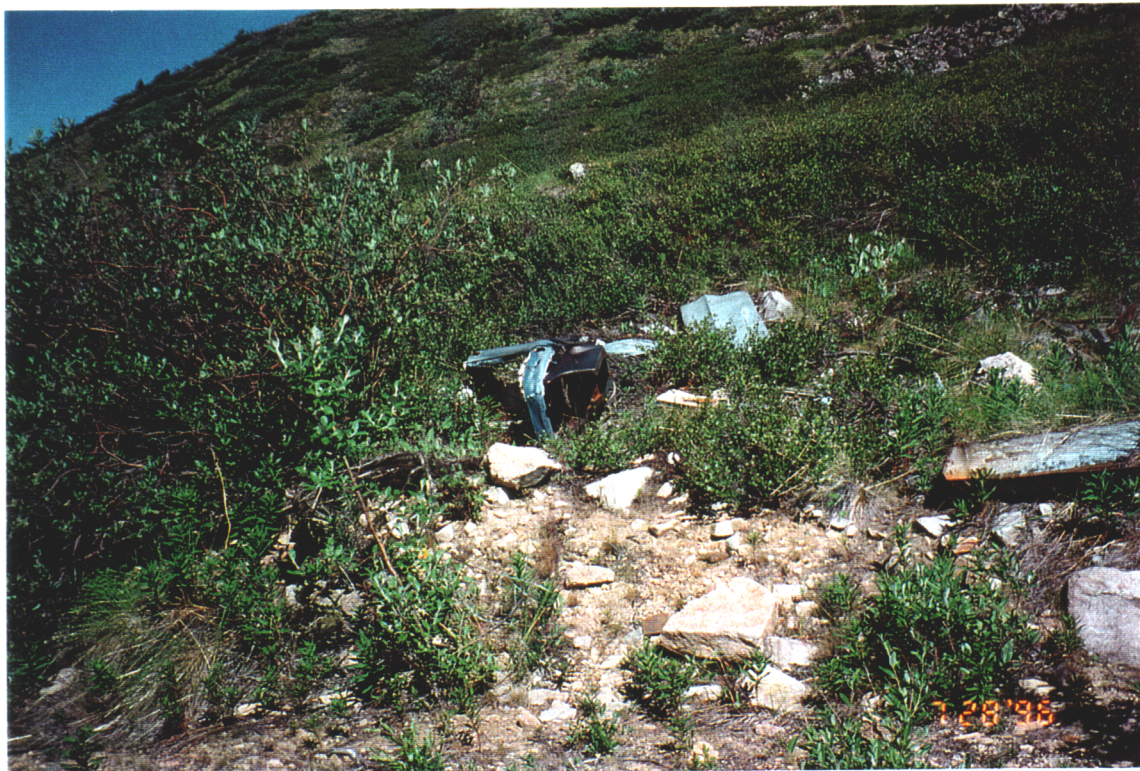
Waste Material	Number/ Volume	Location
2 empty pails	23¢ each	adjacent to buildings
miscellaneous domestic waste	< 5 m ³	adjacent to buildings

Photo # 5 - Miscellaneous Metal Debris

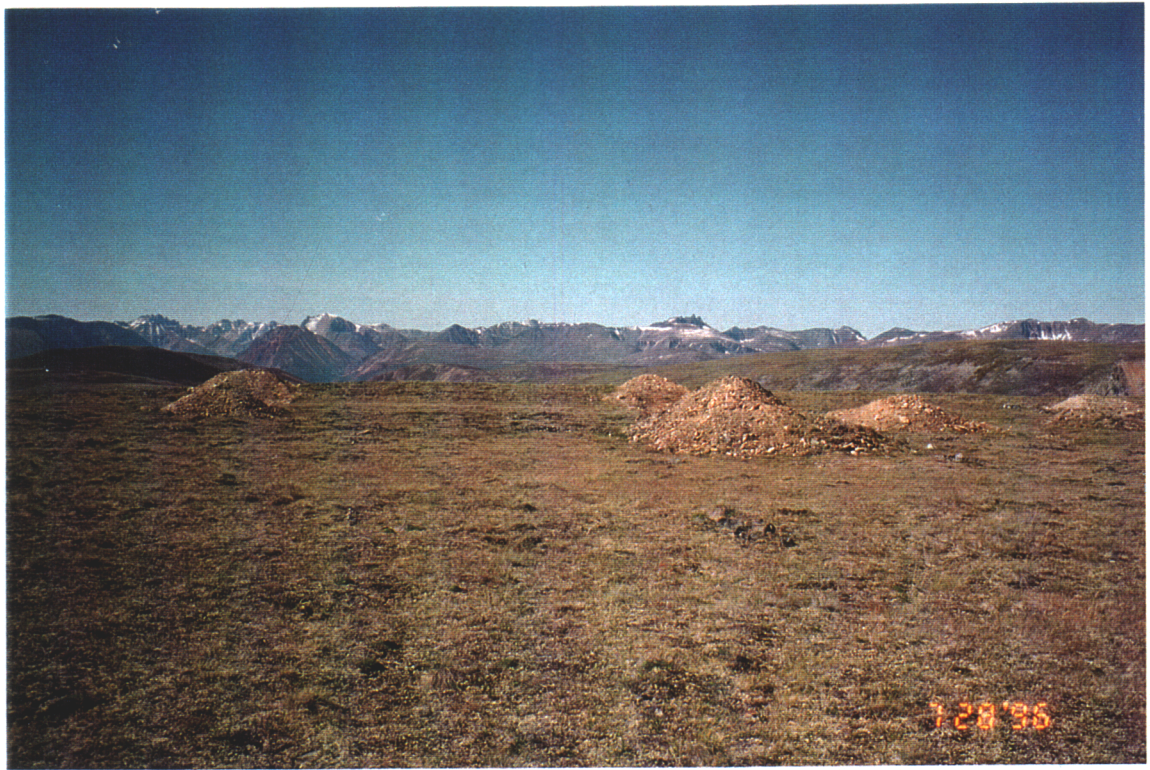
No indication of underground development work was found during the site assessment. Evidence of extensive surface trenching, circa 1910, was observed on the north side of Gold Hill. These trenches have sloughed in since that time and approximately 50% of the disturbed area is now fully revegetated. The site resembled a reclaimed alluvial mining area more than a hard rock mine site. The more recent trenching is located a short distance to the west of the old workings.

It is apparent from the site observations that the recent disturbances caused by trenching on the site will be non-detectable to the general public within 80 years if no reclamation work is undertaken on the site.

Photo # 7 - Trenching on top of Mountain
