PHASE II ENVIRONMENTAL ASSESSMENT OF THE LEGAL TENDER

ABANDONED MINE SITE

Action on Waste Program
Indian and Northern Affairs Canada

Environmental Services
Public Works and Government Services Canada

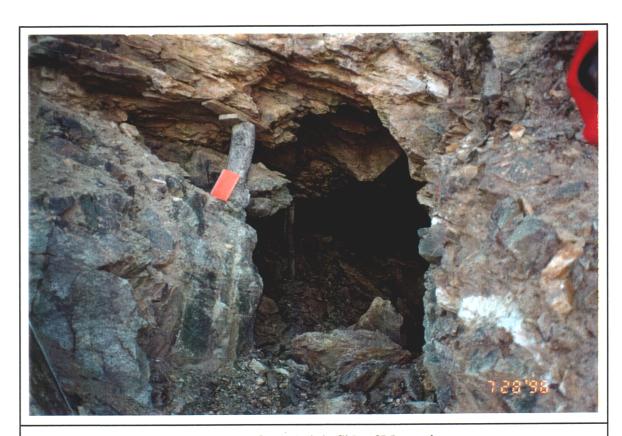
The portal is 2 m (6.5 ft) high by 1 m (3.5 ft) wide and access to the workings are not restricted, other than by its precarious location between avalanche shoots on the side of a mountain. The underground workings themselves appear to be relatively stable compared to the surrounding terrain. A description of the mine opening is presented in Table 3.

The mine adit remains open, however, the health and safety risk associated with the open adit is out-weighed by the risk associated with accessing the site. The site is not readily detectible from Watson River and is not expected to attract the attention of tourists.

Photo #1 - Open Adit in Side of Mountain

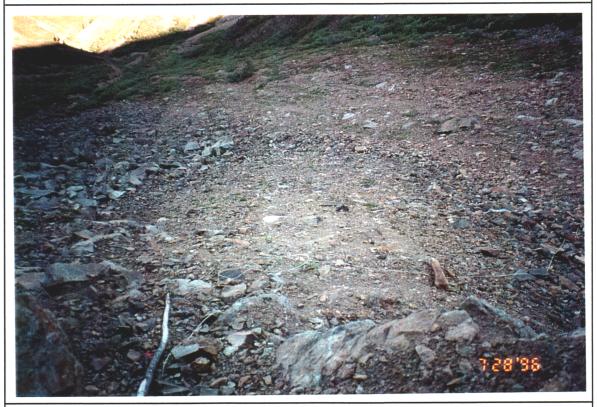
Approximately 175 tonnes (190 tons) of waste rock would have been produced from the underground workings, based on the dimensions observed and a specific gravity of 2.65. A thin layer of waste rock is located below the portal along the slope. Quartz rich waste rock has been piled in a small pile to the west of the adit and represents approximately 25% of the waste observed.

Photo #2 - Scree Slope below Adit

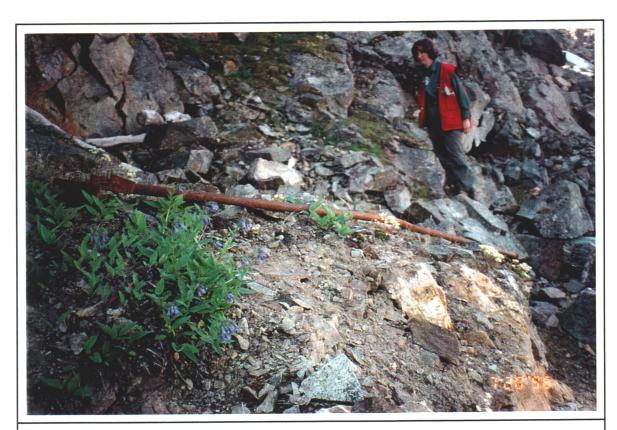
The only materials noted at the site included a 4 m length of metal pipe and a small wooden box.

Photo #3 - Wood and Metal Debris at Adit

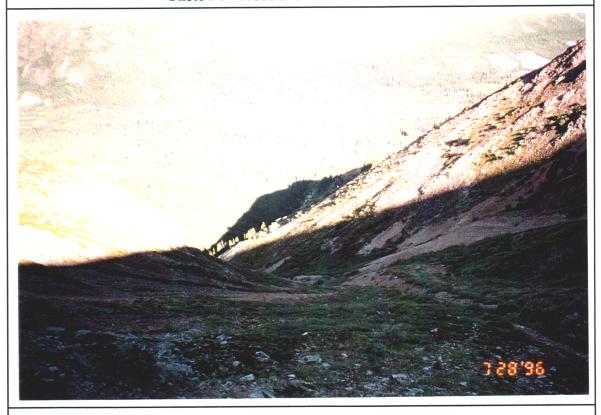
Photo #4 - Steep Slope below Adit

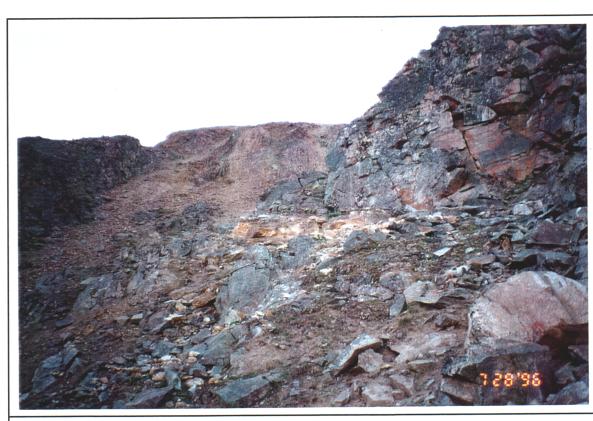
The site is located on the northwest side of Mineral Hill. The valley northwest of the site drops steeply towards the forested area surrounding the broad valley floor surrounding Watson River. The slope on either side above the mine site is a steep rocky slope with two avalanche pathways converging below the site. Directly above the adit is a large outcrop of overhanging rock.

Photo #5 - Unstable Rocky Slope above Adit
