PHASE III ENVIRONMENTAL ASSESSMENT OF THE ARCTIC GOLD & SILVER

MILL AND TAILINGS IMPOUNDMENT

prepared for:
Waste Program
Indian and Northern Affairs Canada
Whitehorse, Yukon

March, 1998

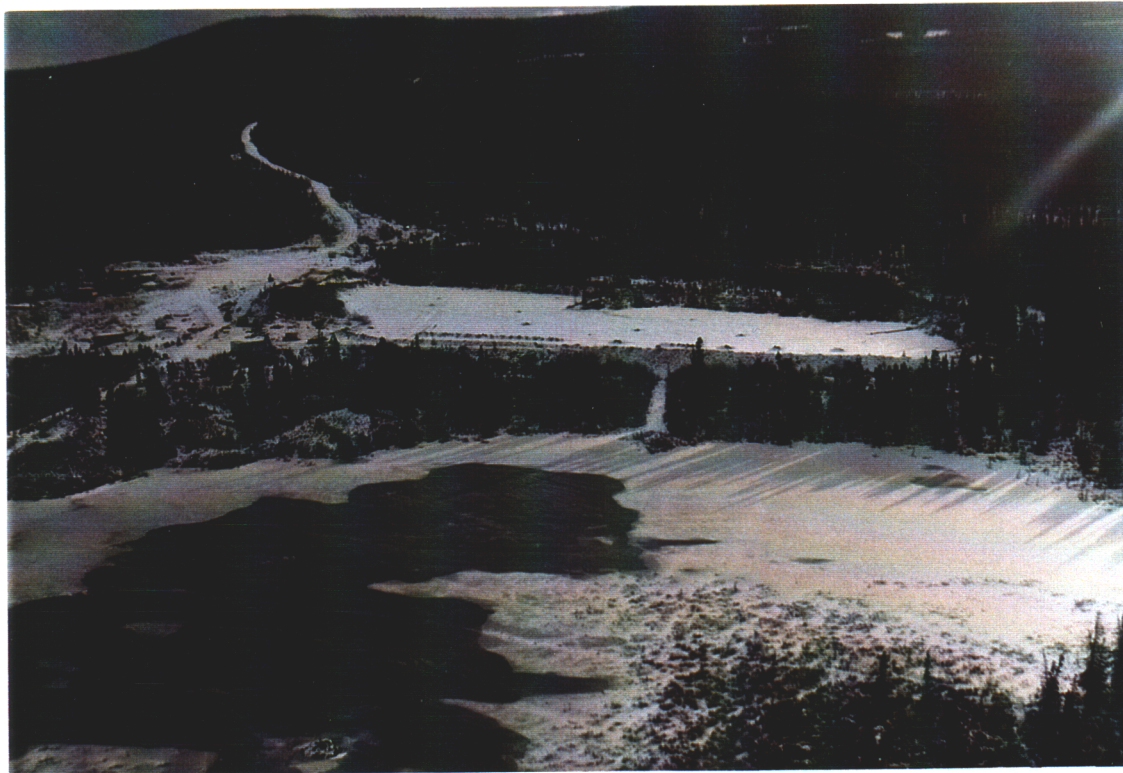
Drainage from a corroded pipe directed through the tailings dam flows westwards downstream along the ground surface for about 20 metres before entering the unnamed lake. The source of this seepage is unknown but is believed to be primarily precipitation which infiltrates through the tailings. It is possible that upstream groundwater is contributing to this seepage.

Photo# 1: Aerial View of the Tailings Impoundment and Drainage to Lake

Action should be taken to reduce or eliminate drainage from the tailings. A low permeability cover should be placed on the pile to reduce infiltration. The cover should be contoured to shed water and ensure that precipitation does not pond on the pile surface. Although there was no evidence of seepage or impact to the surrounding soil from the small ore piles, these piles should be removed. If the tailings are to be reclaimed, the simplest solution would be to dispose of the waste on the tailings before the tailings are covered. Metal rich sediment deposited in the small lake, as well as material deposited along the seepage drainage path between the impoundment and the lake, should be excavated and placed on the impoundment before covering.

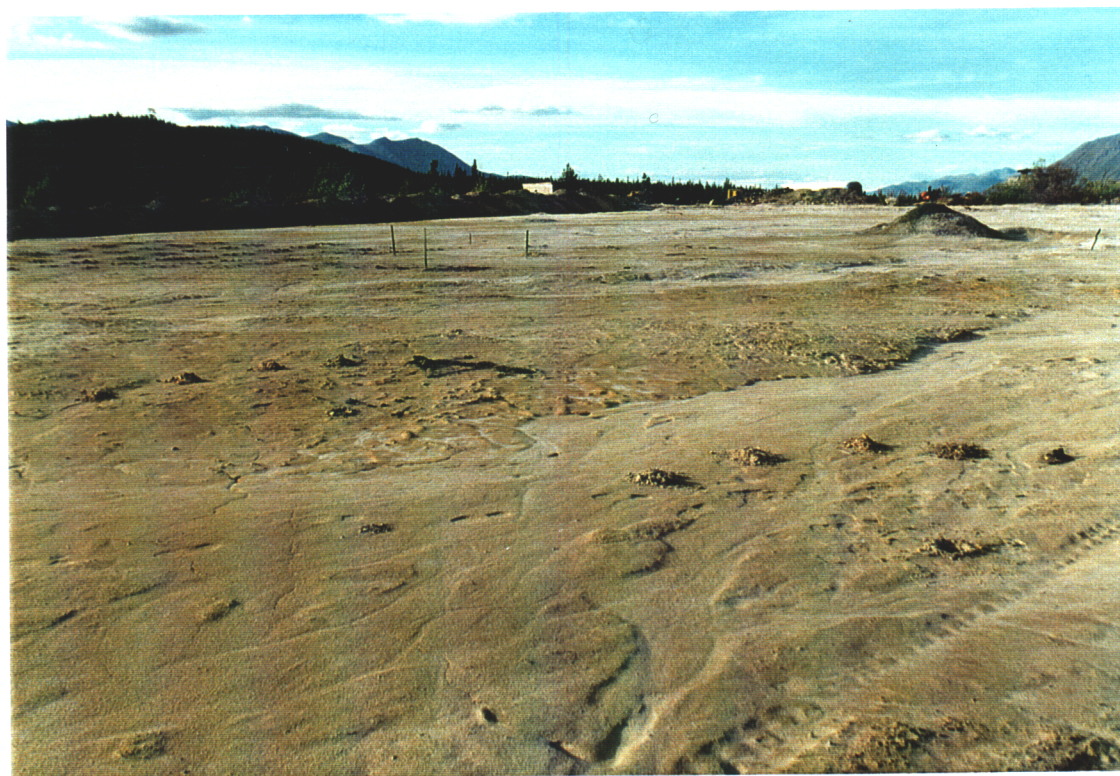
Iron oxide staining resulting from oxidation of iron sulphides was visible in places on the tailings surface. In addition, the bed along which the tailings solutions drain between the tailings embankment and the lake is coated with dark red iron oxide precipitates. Seepage from the tailings impoundment was not seen at any other location.

Photo# 2: Tailings Surface looking North West (note oxidation)

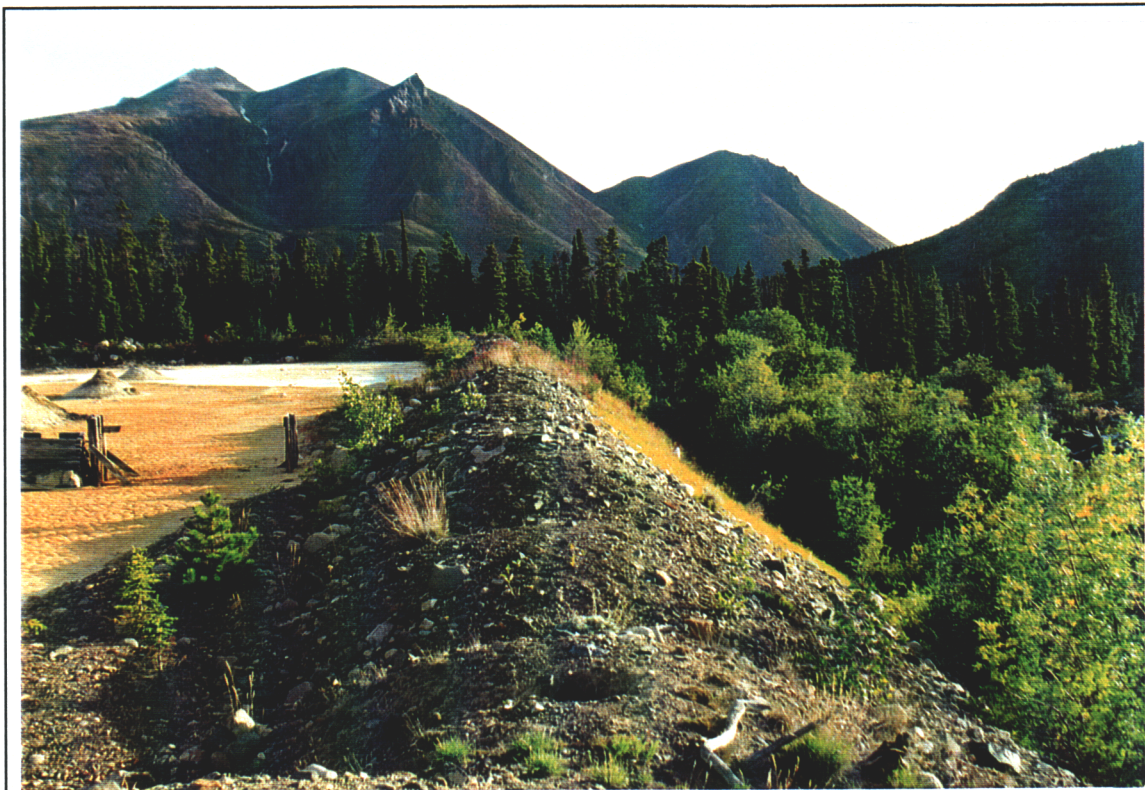
Photo# 3: Berm - West End

It is recommended that berm repairs be made to restrict further lateral migration of the tailings from the breached section of the berm and to provide enhanced stability to the west section of the berm. The load-out ramp should be leveled and used as berm/cover material. This can be done in conjunction with the reclamation work done on the tailings.

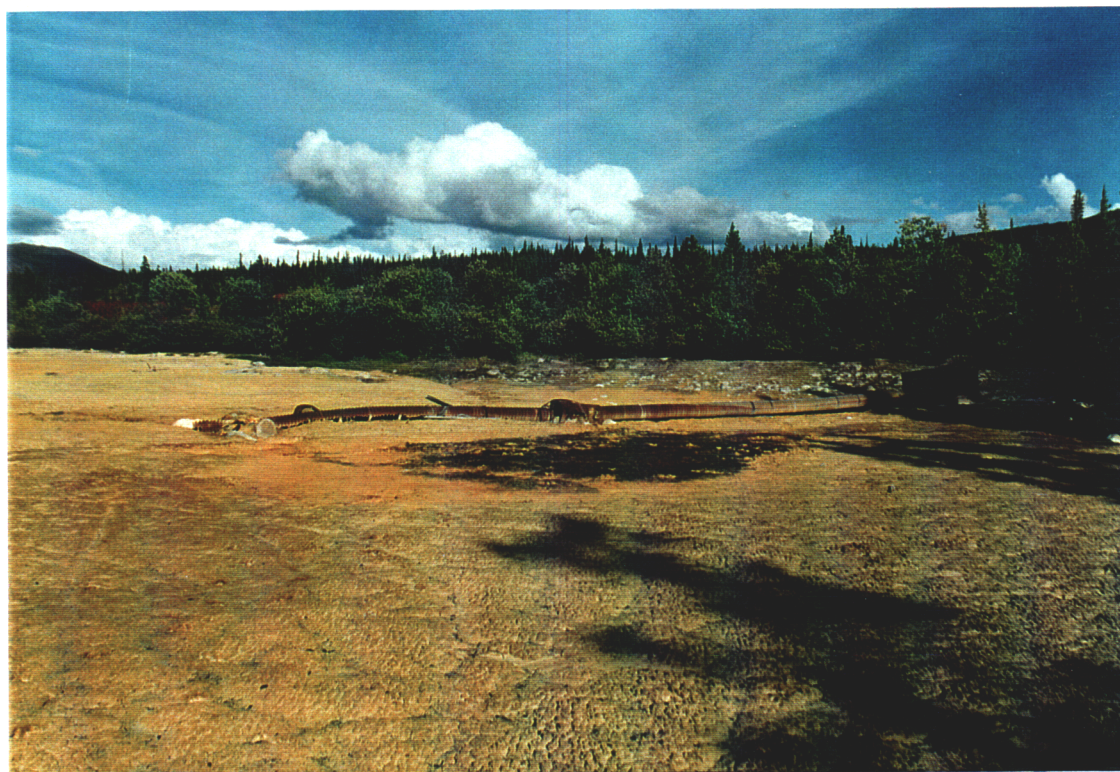
A portion of the pipe exiting the smaller water collection box was left exposed to the air and has corroded and, in some places, completely dissolved. Drainage collected in the deeper structure is piped through the tailings dam and released on the face of the tailings embankment. This seepage travels along the ground surface for approximately 20 metres before entering the adjacent small lake. See Drawing 1 for site details.

Photo# 4: Decant Pipe (note low lying wet area)

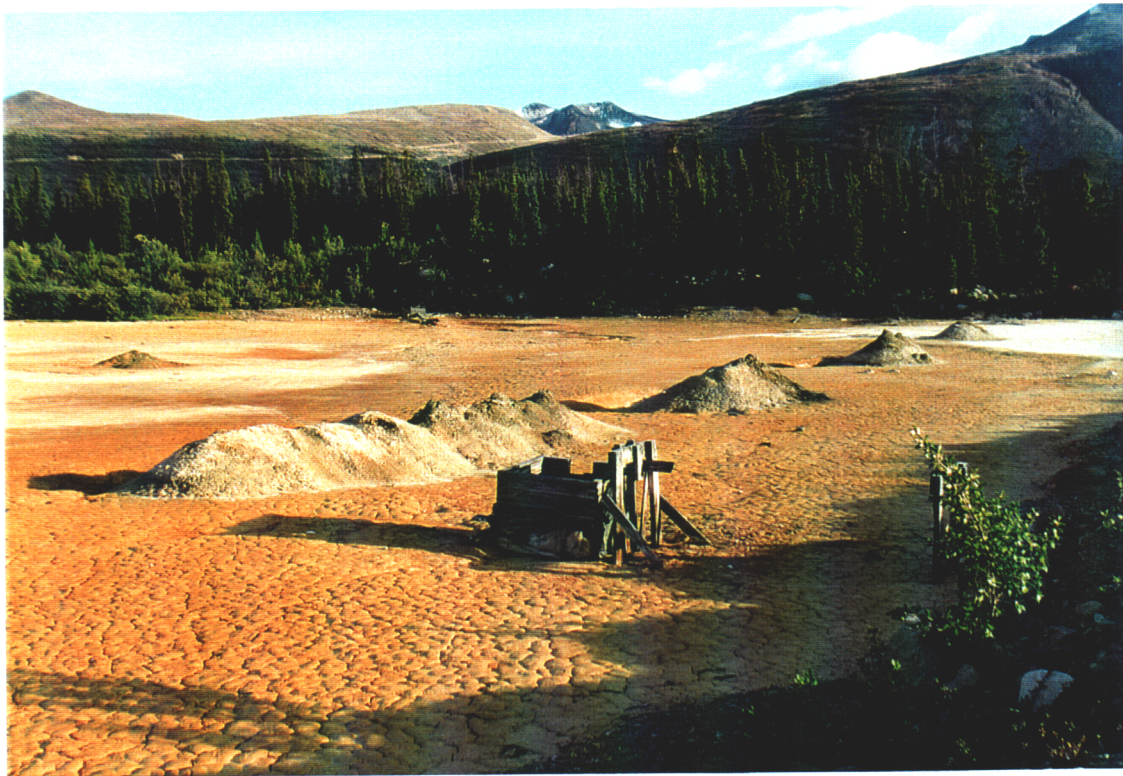
Photo# 5: Drainage Decant Box

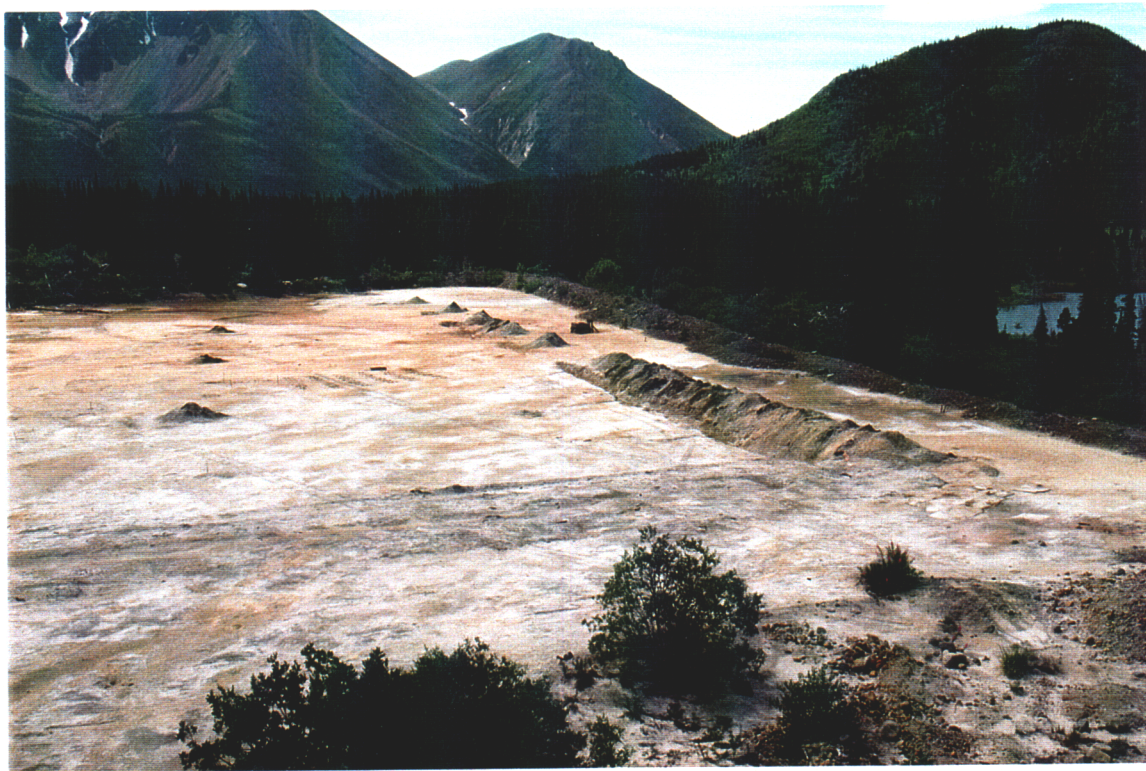
Photo# 6: West End of Tailings Impoundment

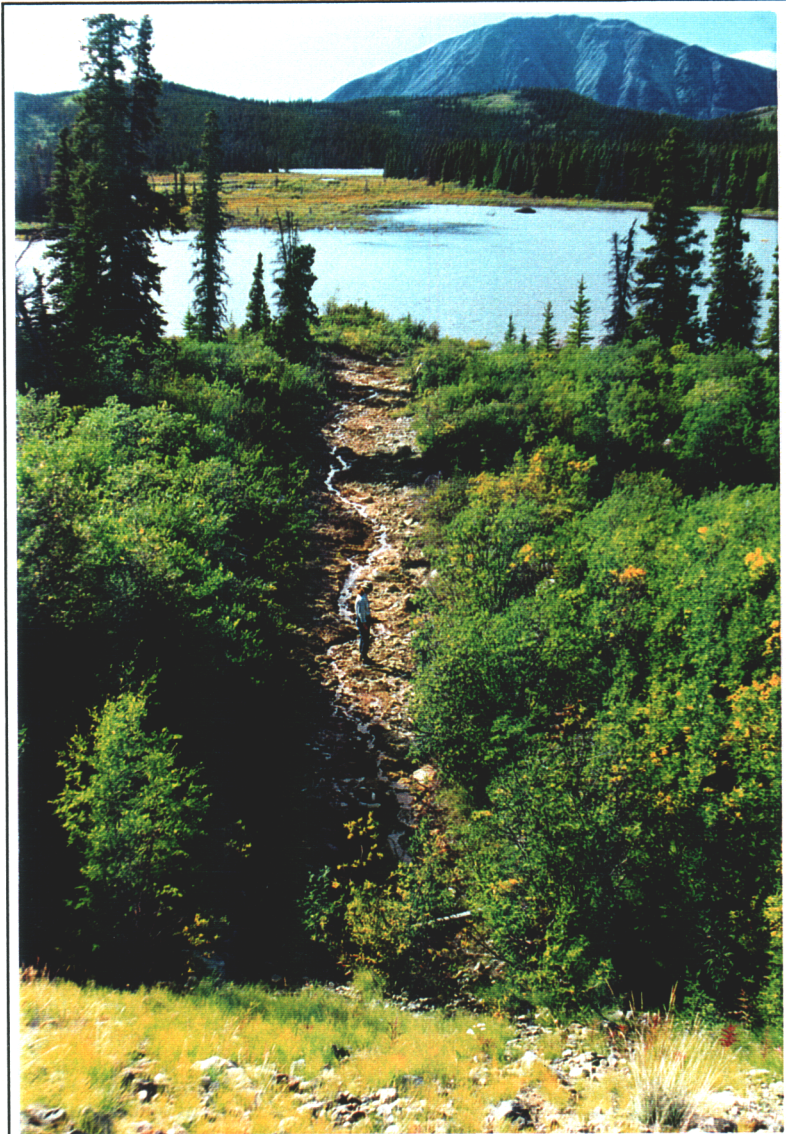
Photo# 7: Drainage Trench to Lake

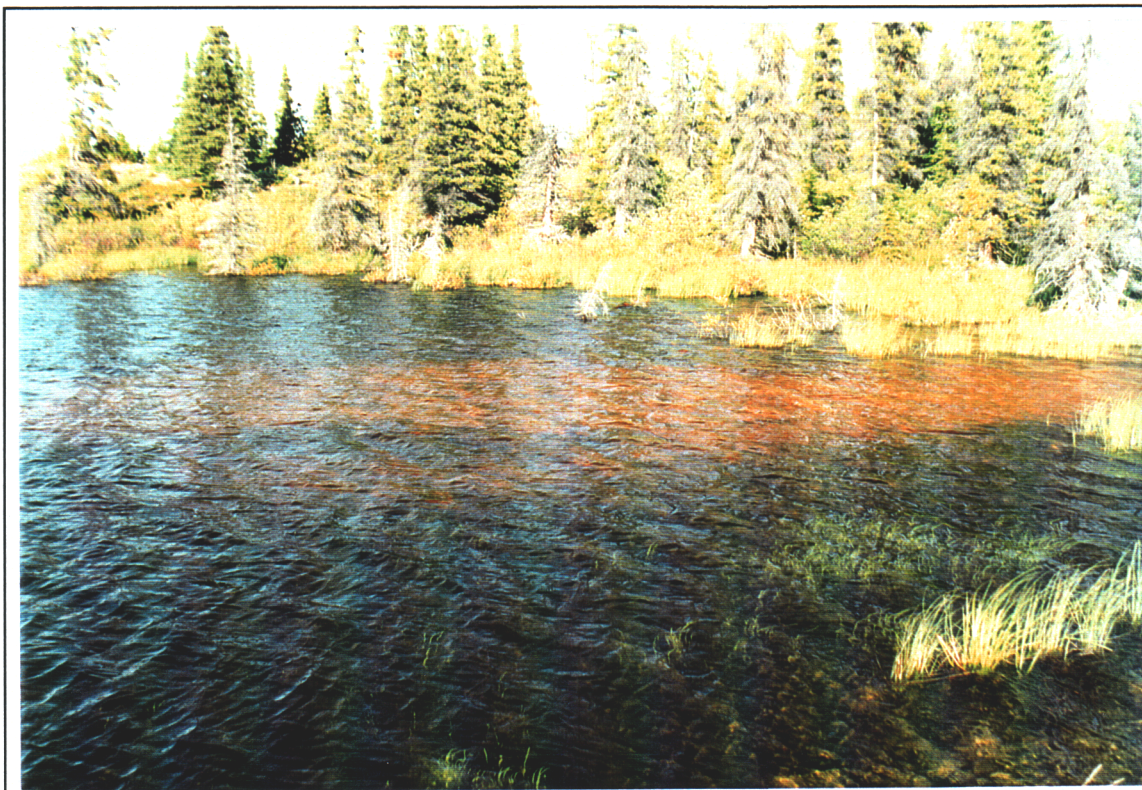
Photo# 8: Tailings in Lake

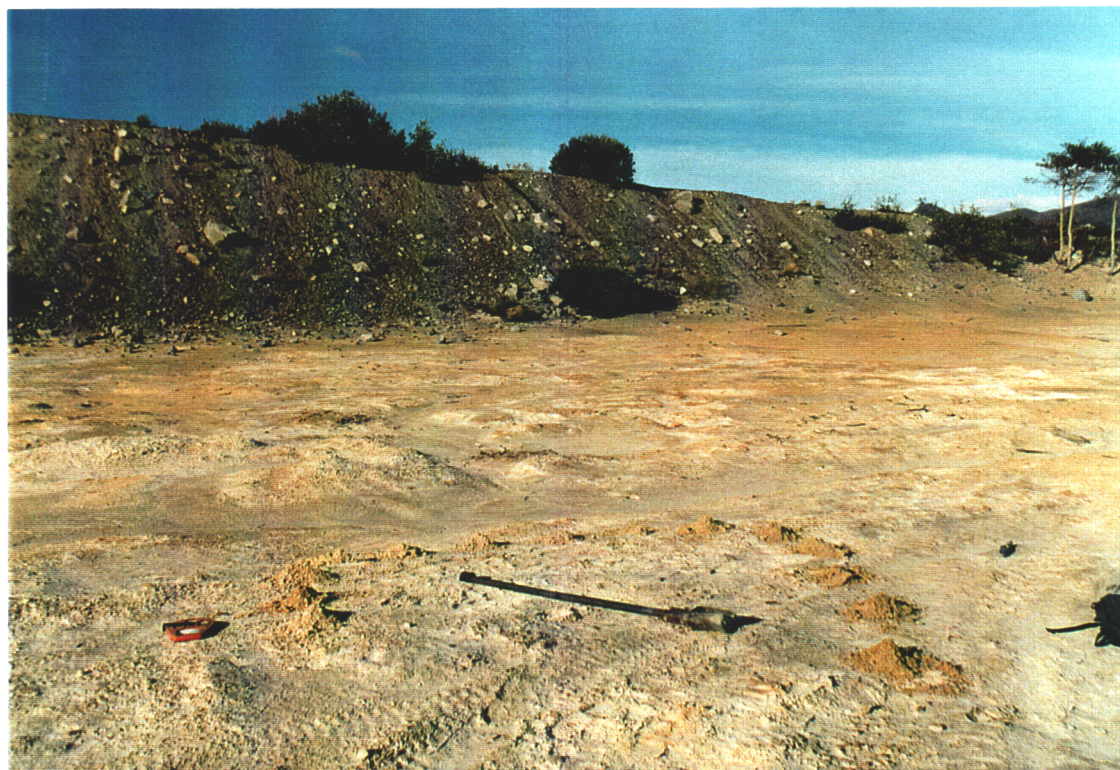
Photo# 9: Tailings Sampling Profile; South End of Loadout Ramp

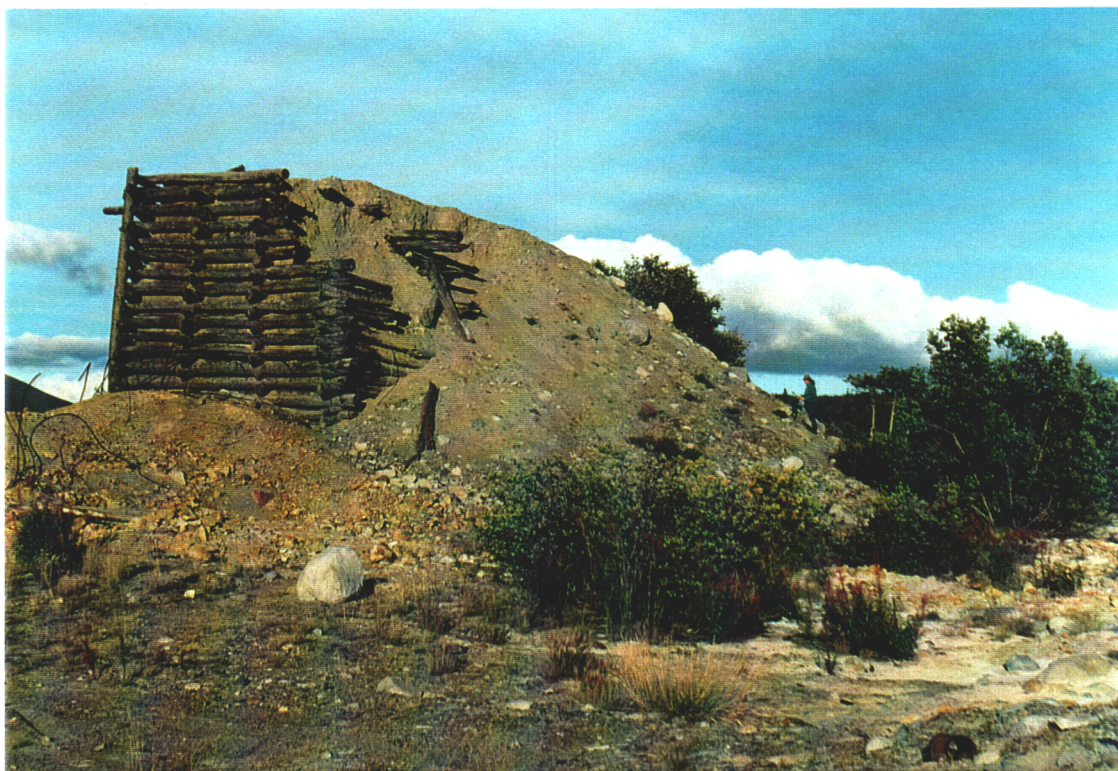
The load-out ramp at the north end of the impoundment shows signs of decay in the log cribbing supporting the west face.

Photo# 10: Log Cribbing at West End of Loadout Ramp

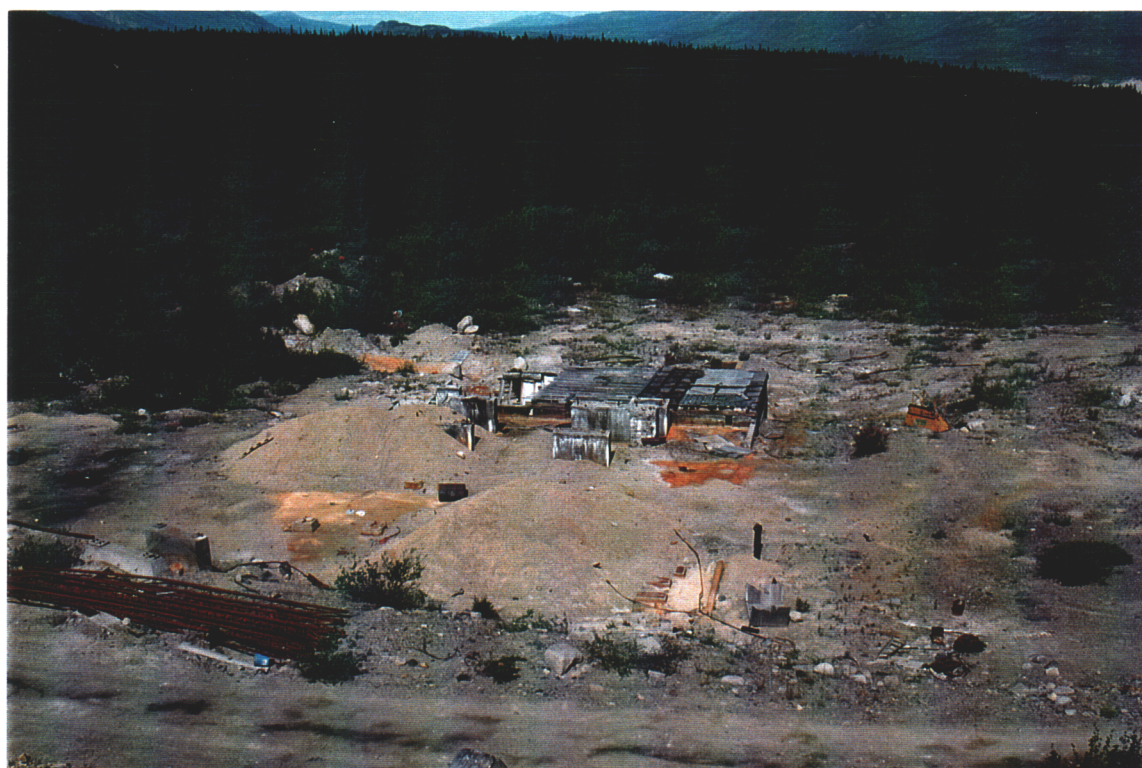
Photo# 11: Mill Site Foundation and Ore Piles

It is recommended that the mill foundations and pillars be demolished to grade and possibly buried on-site. The building be demolished and burned on site. The wood waste can be burned and metal should be collected and disposed at a suitable nearby landfill. The loadout facilities should be dozed and the areas restored to the original slopes by dozing. The trailer should be relocated and salvaged by a local interested party. These activities can be accomplished using locally available resources and labour.

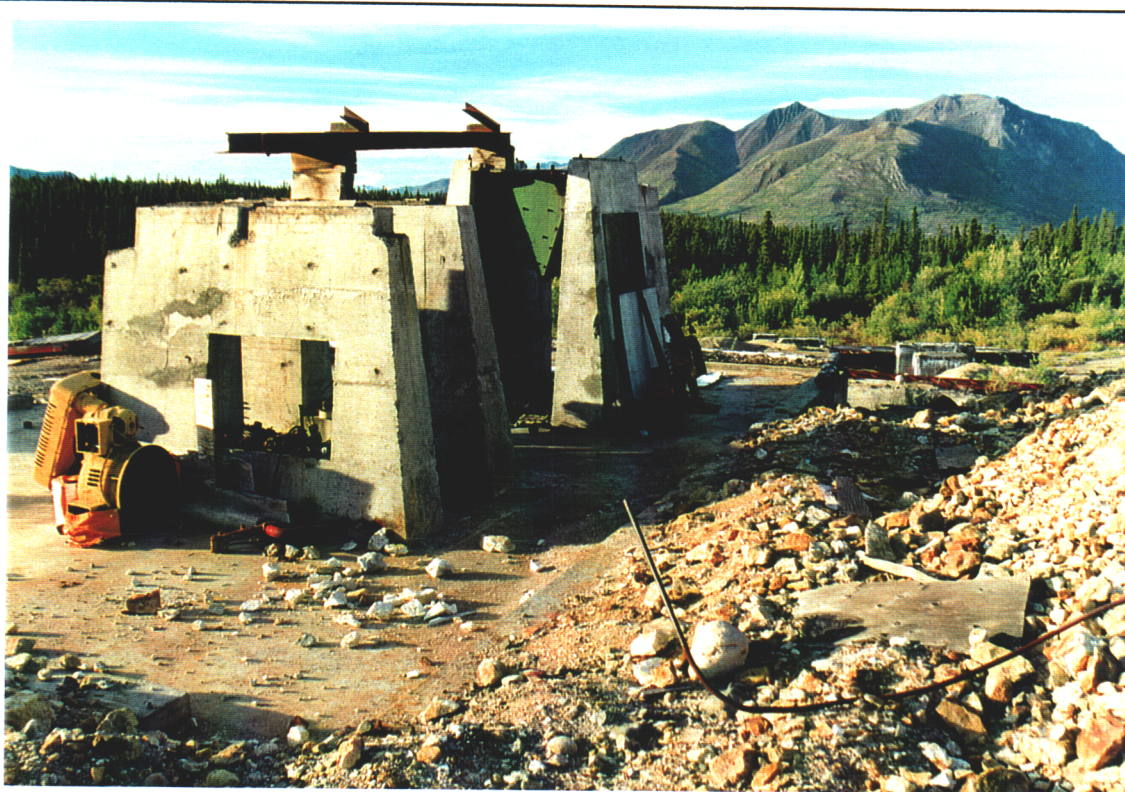
Numerous pieces of abandoned equipment lay scattered throughout the site. As well, foundations, wooden structures and concrete pillars lie exposed.

Photo# 12: Concrete Pillars on Foundation

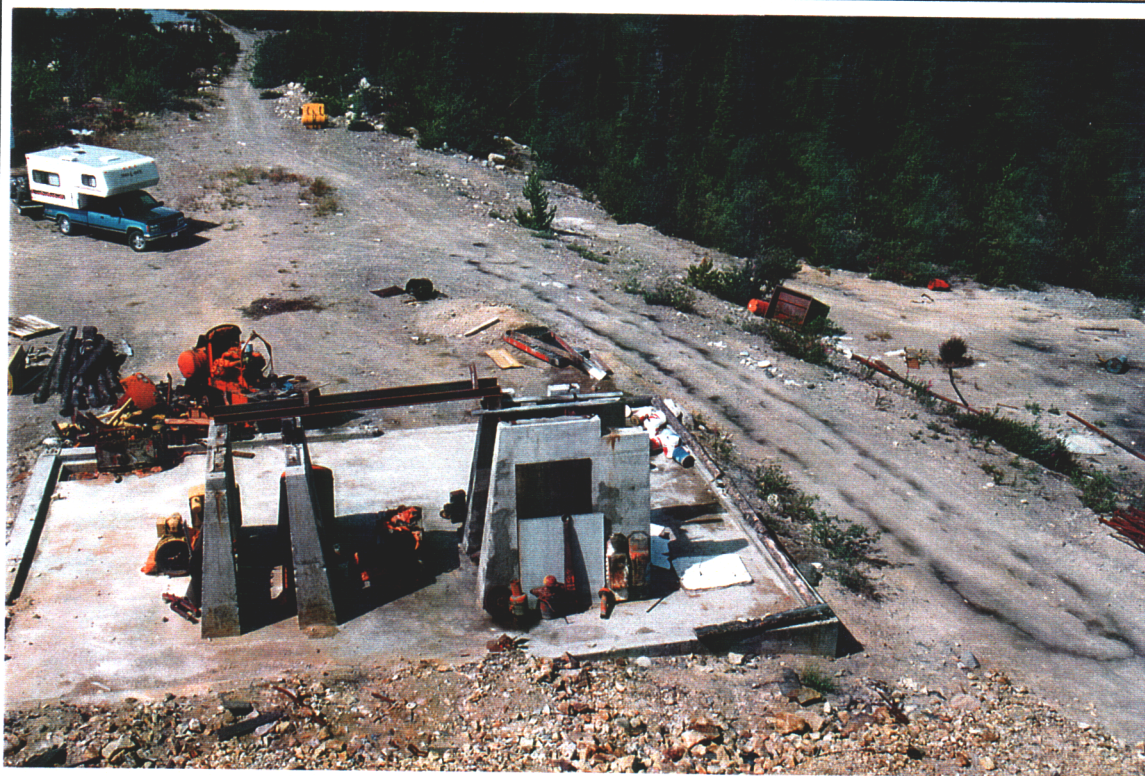
Aesthetic concerns arise from the range of infrastructure, equipment and debris, both metal and wood, noted throughout the site, particularly the mill foundations, concrete pillars, heavy equipment, trailer and wooden structures.

Photo# 13: Mill Foundation and Debris

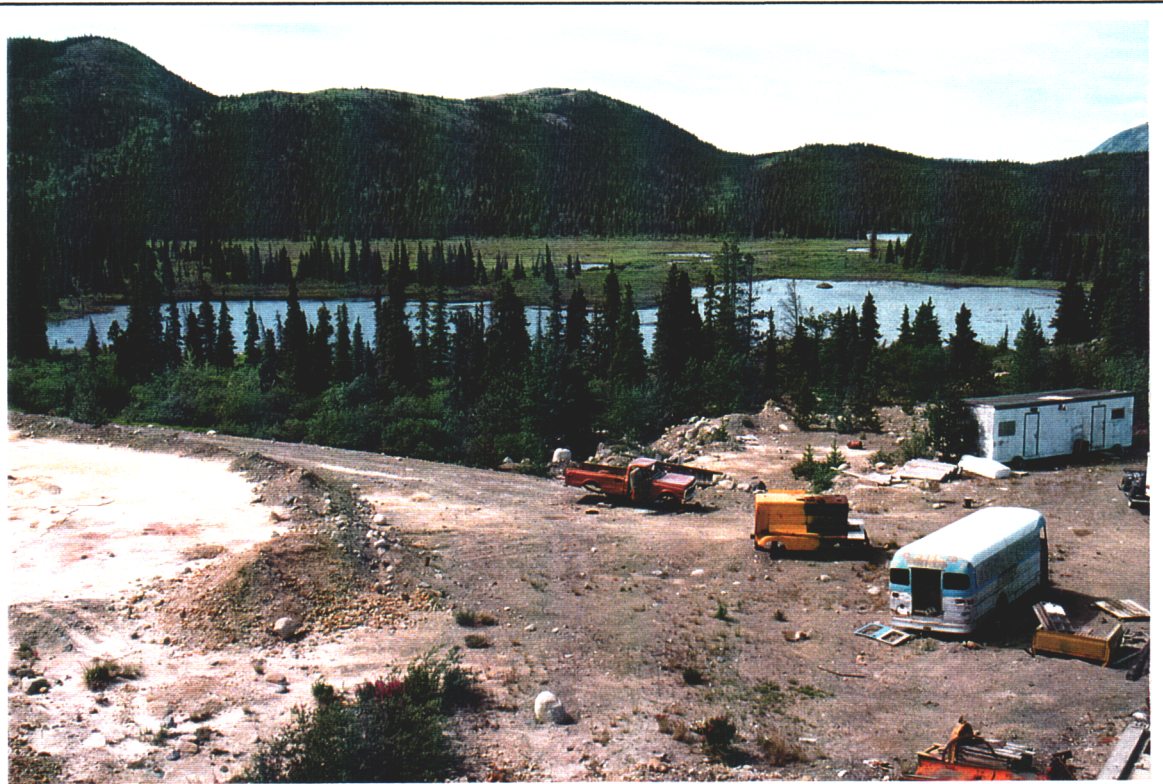
Photo# 14: Derelict Vehicles, Equipment and Trailer
