**Phase III ENVIRONMENTAL ASSESSMENT**

**PADDY MINE SITE**

**Final Report**

June 1998

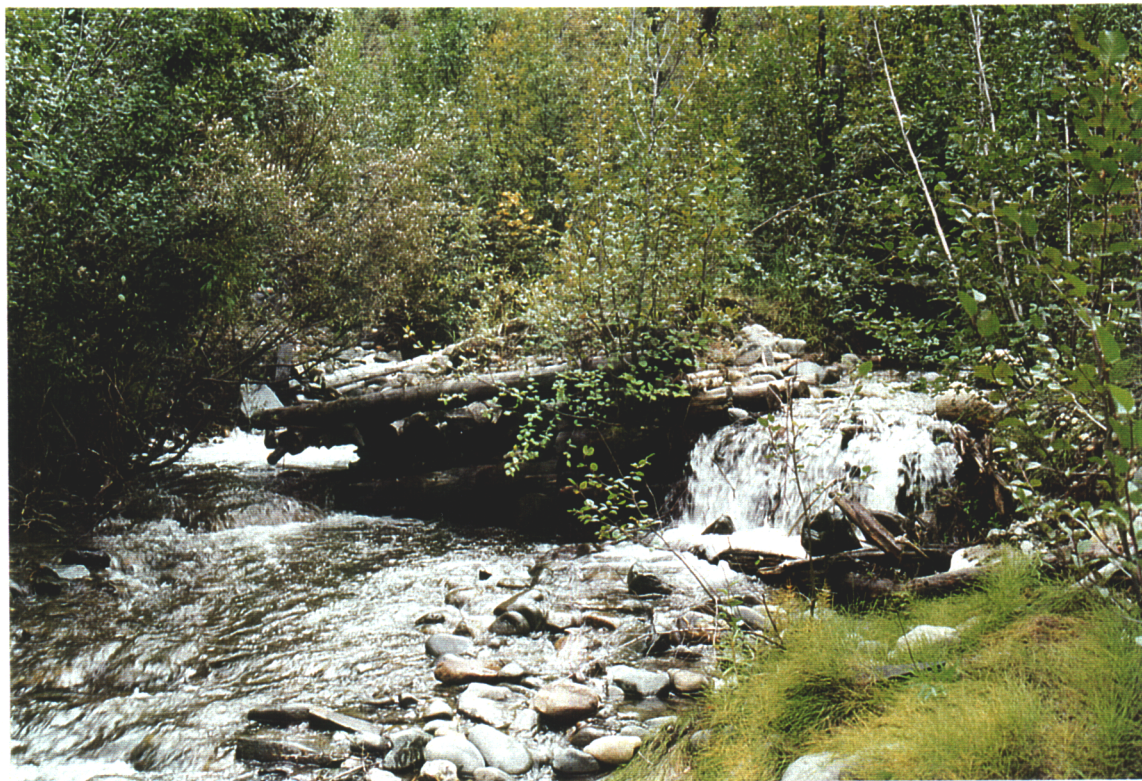
Photo 1. Collapsed bridge approximately 600 m downstream from adit.

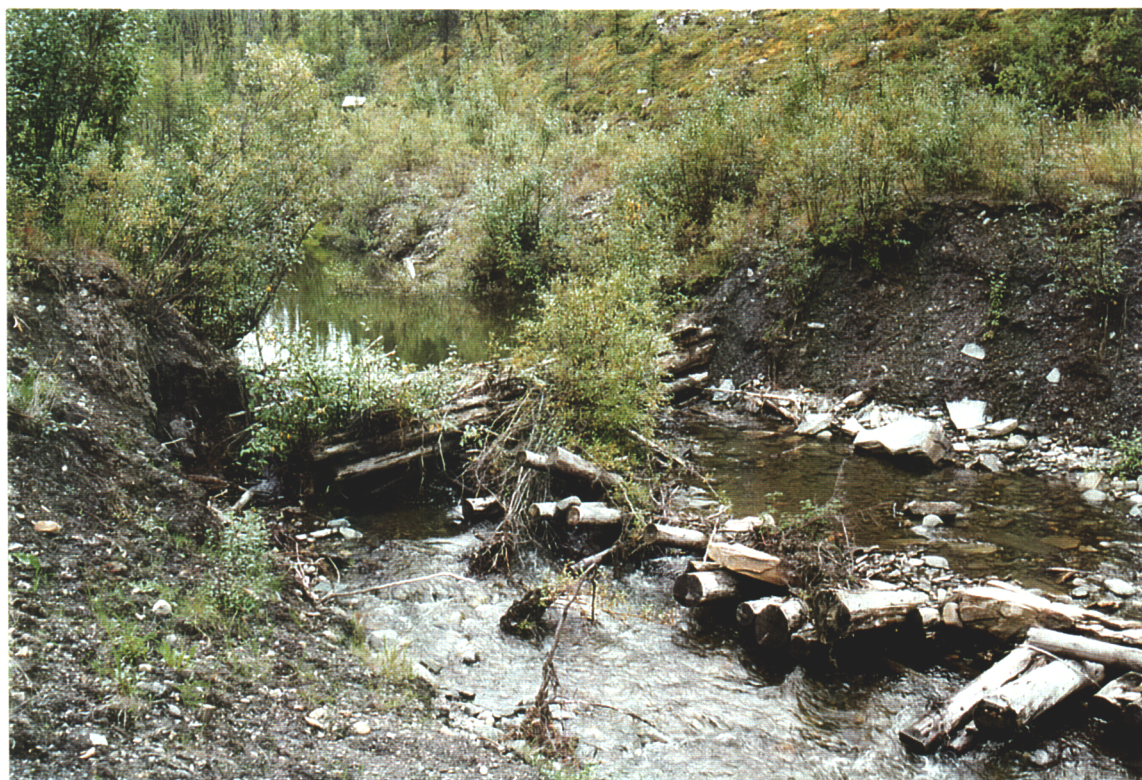
Photo 2. Collapsed bridge upstream from adit. Note ponded water behind cross-stream beams indicating partial flow blockage.

- Recommendation 1.** To prevent further movement of waste rock material into Christal Creek, gabion baskets or other physical barrier should be placed at the toe of the waste rock slope.
- Recommendation 2.** The collapsed bridge upstream from the adit should be demolished. Bridge materials and jammed logs should be removed to improve fish passage through the canyon area.

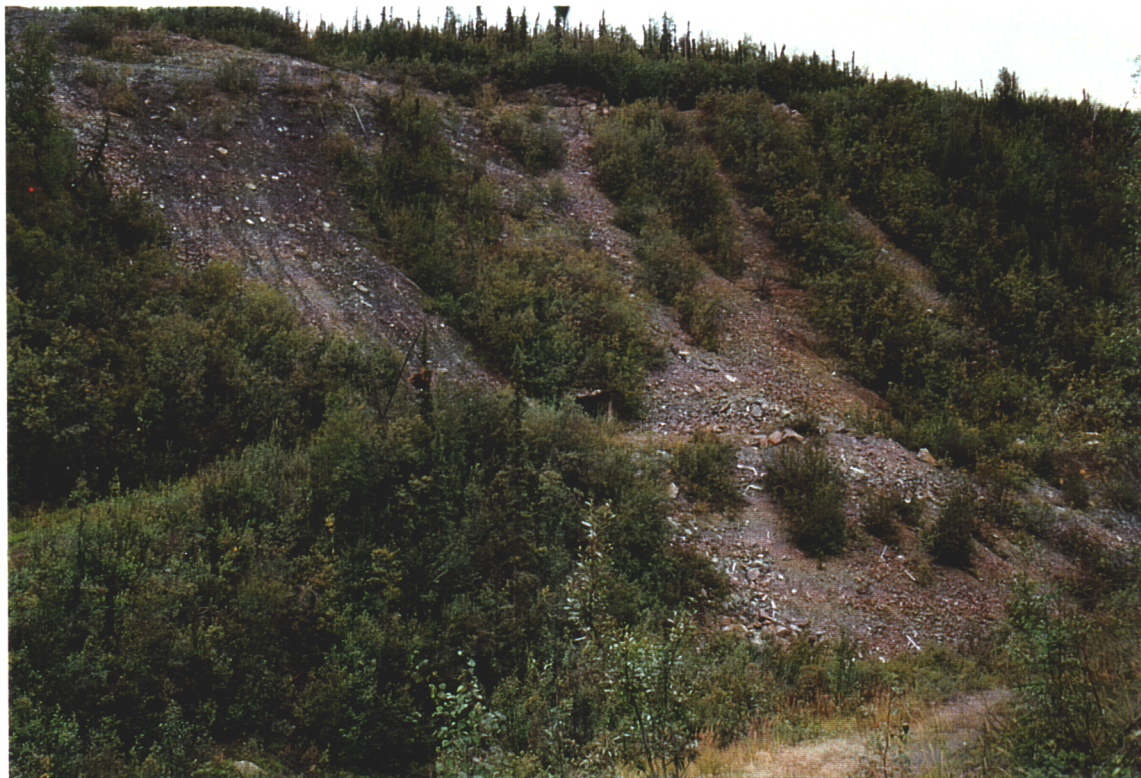
Waste rock along the south canyon slope near the adit consisted of alternating lobes of fine grained, slightly pulverized schist rock and course grained quartzite rock. The slope angles of the waste rock material approached  $38^{\circ}$  due to the naturally steep slope of the canyon wall. During the site visit, it appeared that mass wasting at this site was restricted to gradual surface movement as there was no evidence of translational slip failure or more extensive slides of this nature. There were signs of slumping and creep at the upper road and western most waste rock lobe. In the

upper road area, some slumping has occurred at the top of the waste rock slope. There was no visual evidence of past deep seated failures along the waste rock slope. At the westernmost waste rock lobe, some slump failure appears to have occurred within the schist-based waste rock mass.

Photo 3. Paddy waste rock slope. Upper Road is visible at top left of photo; adit is visible at center of photo.

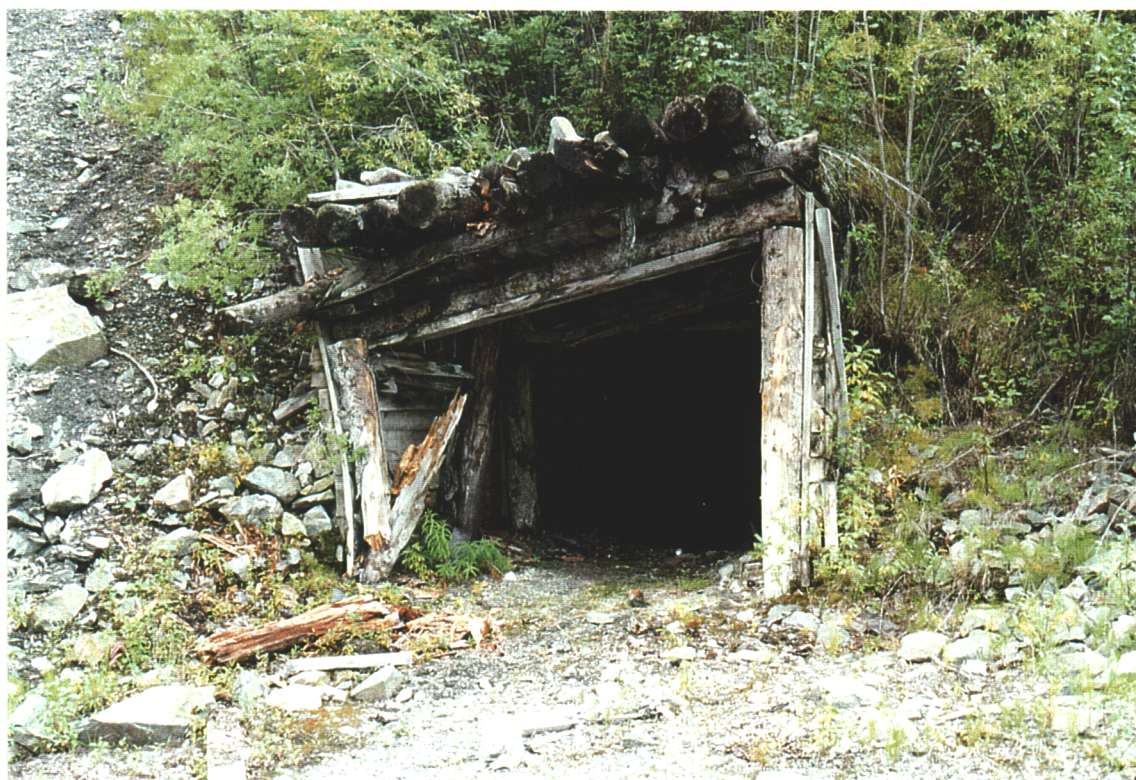
Photo 4. Paddy mine adit.

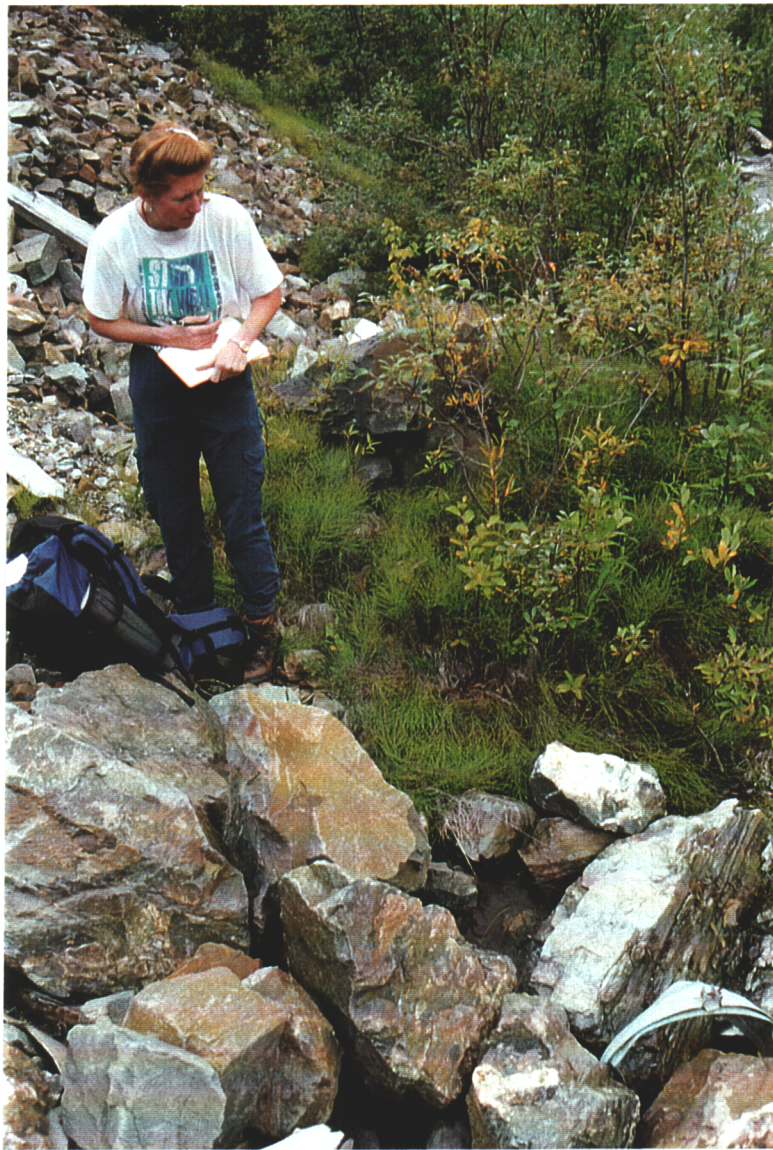
In August 1997, seepage from the main waste rock pile was less than 1 L/min. On both the August 1996 and August 1997 sampling dates, the seep had a pH of approximately 7.7 and sulphate concentration between 459 mg/L and 502 mg/L. Zinc was above the CCME criterion for freshwater aquatic life in August 1996, while cadmium, copper, and zinc concentrations were above the criterion during August 1997. Concentrations of copper and zinc probably reflect the presence of freibergite and sphalerite in local rock; however, the cadmium source is unknown. No seepage was observed during October 1997 or April 1998.

Photo 5. Toe of waste rock slope near Christal Creek. Waste rock seep is visible at lower center of photo.

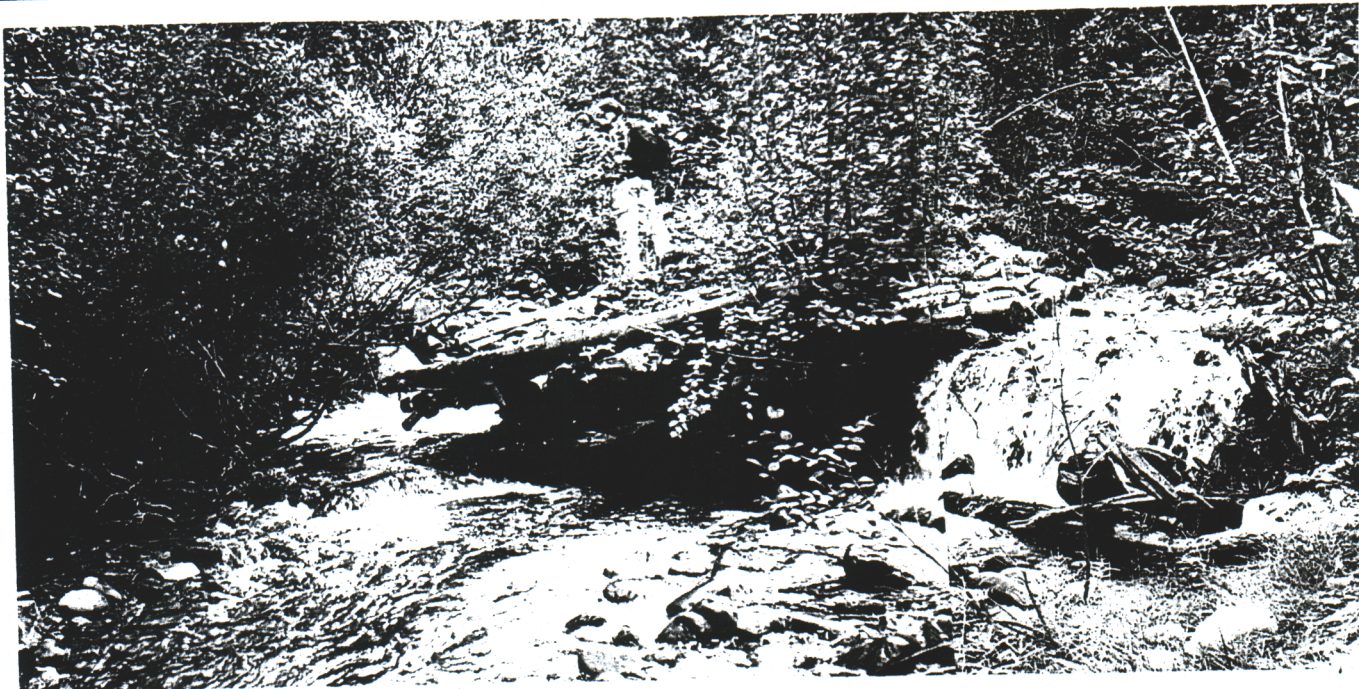
Photo #PA1: Bridge#1 collapsed into creek. Note log crib construction with earthen fill; note approximately 0.5 m drop in water level at right side of creek.

In the areas of the two bridges, it appears that the failure has resulted from the erosion of the bridge abutments over time, causing each bridge to collapse into the creek. The abutments and bridges themselves were constructed of log cribbing with earthen fill and were clearly not capable of withstanding large fluctuations in the creek flow or water elevations. As a result, the supports at either side of the bridge were eroded away, eventually causing the bridge to collapse into the creek. As seen in Photo PA1, the collapsed bridge #1 does not seriously impede the flow of Christal Creek since channels have been developed on either side of the bridge. There is an approximately 0.5 m drop in elevation of water level at the right side (west) and an approximately 0.3 m drop at the left side. Based on visual observation, it does not appear that the collapsed bridge #1 would pose a threat to the fisheries resource of Christal Creek.

Since the restoration work will involve a significant amount of machinery crossing the creek at failed bridges #1 and #2, these areas will have to be rehabilitated with corrugated steel pipe culverts covered with earth fill. This will serve as a temporary bridge during the construction and could be subsequently removed to restrict other users from the area. Site access will also require some grading of the road approximately 175 m west of failed bridge #1 where a short length of the road was intentionally destroyed to prevent vehicular passage.

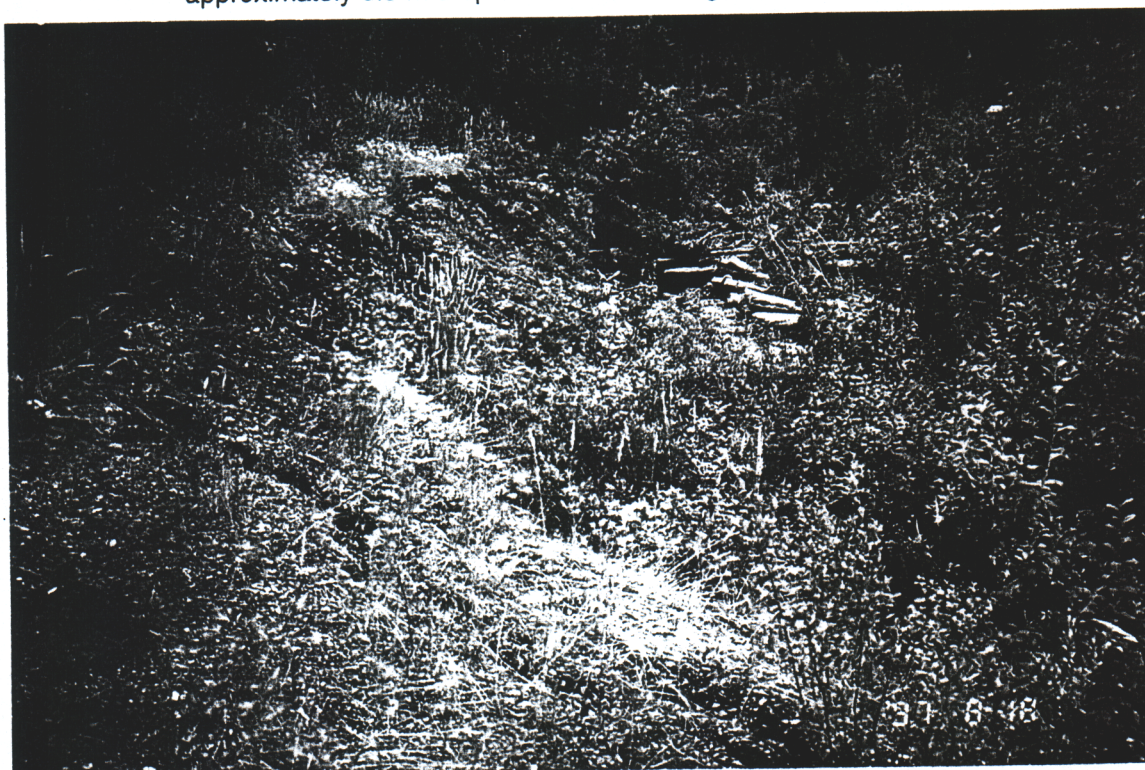
Photo #PA2: Note slump failures along north bank of creek just down stream of collapsed bridge #2.

The collapsed bridge #2 closer to the adit is more seriously impeding the flow of Christal Creek. The bridge appeared to dam the creek, causing a change in water elevation of approximately 0.6 m and creating a log jam at the upstream end. There was seepage through the collapsed bridge at various locations which allowed the creek to maintain flow downstream. Based on visual observation, the collapsed bridge #2 could represent a hindrance to the fisheries resource of Christal Creek. However, with little fisheries information available for this particular creek, the extent of this impact cannot be reasonably assessed. With this in mind, it is considered to be more effective to actually remove the obstruction in order to alleviate the problem rather than to engage in an assessment of the impact to the fisheries resource.

The collapsed bridge #2, which is the further east of the two, has severely impeded the flow of the creek and caused log jams and similar disturbances to the creek. This bridge should be demolished and the debris should be removed from the creek and buried in the immediate area. This work could be accomplished with a Caterpillar 225 backhoe or similar with a thumb attachment on the bucket to facilitate debris removal from the creek. Access to the collapsed bridge could be accomplished via the road leading from the gravel pit on the Hanson Lakes Road as shown on Drawing 12953-1.

2. In the areas of the two bridges, it appears that the failure has resulted from the erosion of the bridge abutments over time, causing each bridge to collapse into the creek. Collapsed bridge #1 does not seriously impede the flow of Christal Creek since channels have been developed on either side of the bridge. The collapsed bridge closer to the adit (#2) is more seriously impeding the flow of Christal Creek. In order to alleviate potential negative impacts on the fisheries resource in Christal Creek, the collapsed bridge #2 should be demolished.

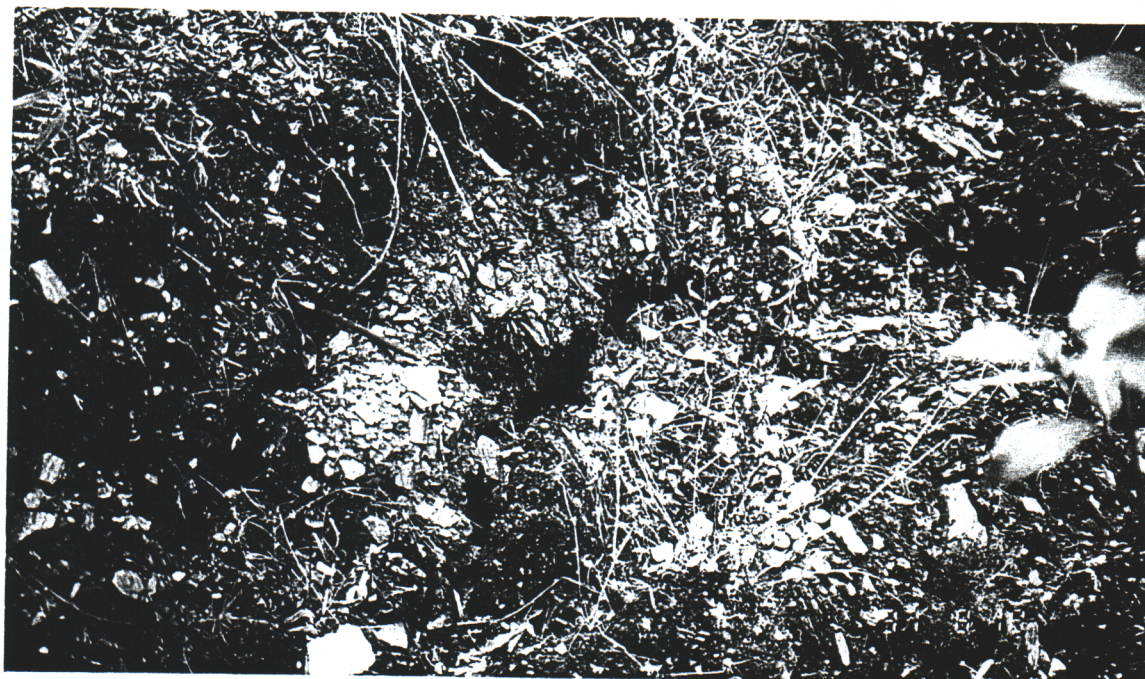
From this, it is envisioned that future slope failures along the lower road would involve a series of slumping events of soil into and subsequent erosion by the creek. The erosion of the slumped material undermines the toe of the newly formed slope which in turn causes further slumping. This cycle is typically repeated until sufficient slumping has occurred such that a natural slope angle for the fine grained material is realized. Based on the height of the road above the creek, it does not appear that the volume of material at each particular slumping event would greatly impede the flow of the creek. Rather, the slumping and subsequent erosion will affect the creek by slightly increasing the sediment loading over a period of several years. It cannot be estimated with reasonable accuracy whether this increase in sediment loading would adversely impact the fisheries resource of this creek.

Photo #PA3: Evidence of slump failure along lower road. Movement due to eventual stabilization of loose fill material placed at excessive slope angles and without compactive effort.

1. In regards to the lower road, it appears that the failures have been primarily due to slope angles which are in excess of the maximum angle of repose for such a fine grained, schistose-based silty sand soil. In order to prevent further slumping of the soil along the lower road into Christal Creek, some grading work will be necessary at various locations along the road to achieve a final slope of 2.5H:1V.

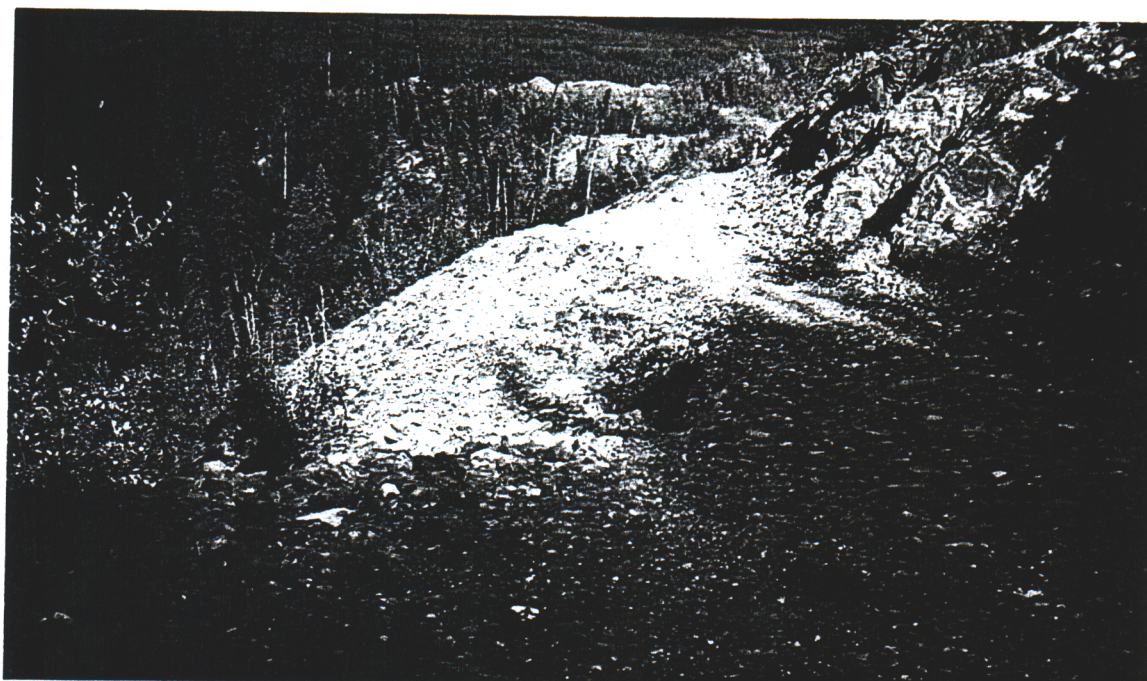
Photo #PA4: Looking east along upper road near waste rock dump. Note slumping of road, extension cracks due to natural slope stabilization.

There were signs of slumping and creep at the upper road and western most waste rock lobe as indicated on Drawing 12953-3 and in Photo PA4. In the case of the upper road area, some slumping has occurred at the top of the waste rock slope. As seen on the particle size analysis of Sample Paddy 1 which was retrieved from this area, the sample was composed of sand and gravel sizes, with some silt. The material was schist based, with a fines content of close to 20%, and appeared to be placed in a relatively loose state. These collective factors are most likely the cause of the slump in this area. Namely, the relatively high fines content and platy, graphitic schist nature translates to relatively low shear strength characteristics of the waste rock material. The loose nature of the material also has lead to slumping due to the decrease in void spaces and corresponding consolidation of the waste rock mass. There was no visual evidence of past deep seated failures along the waste rock slope. Such a failure would most definitely adversely impact Christal Creek.
