Phase III Environmental Assessment

Venus Mine Site

Interim Report

March 1998

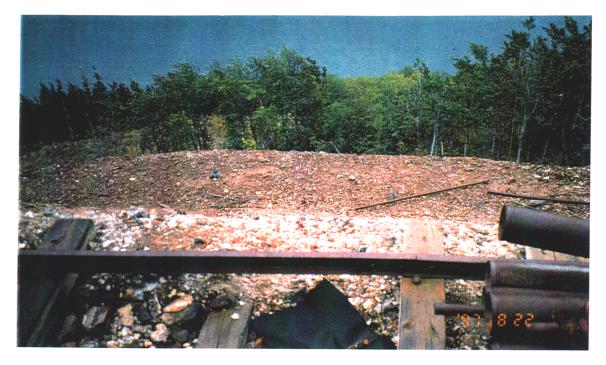
There were no signs of tension cracks near the top of the slope or bulging at the toe which would suggest slope movements. Rather, the extent of downslope movements has been restricted to near surface sloughing from disturbances such as avalanches and other slides. This is particularly evident at the south portion of the waste rock pile where surface sloughage has undermined the tracks leading from Adit 1 as seen in Drawing 12953-11. The presence of two horizontal benches downslope of the waste rock has restrained the surface sloughing from extending further down the slope. It does not appear that significant mass wasting has occurred in the area of Adit 1 as there were no observed failures related to the waste rock pile in this area.

Photo #V1: Looking east down slope from adjacent to shack at north portion of area near adit 1. Note lower benches of waste rock and of access road. Note fallen pipes.

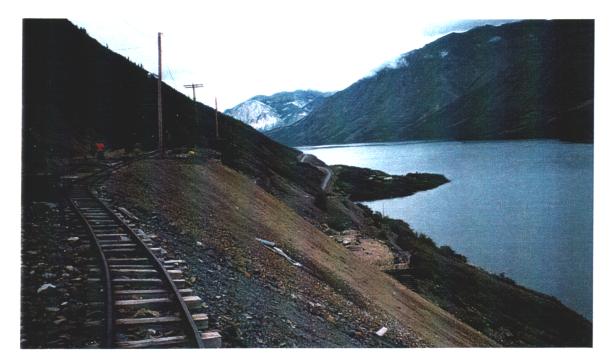
Photo #V2: Looking north along tracks at area of adit 2. Note culvert along waste rock pile s slope; note lower retaining wall built of log cribbing.

The most significant feature in the area of Adit 2 was the presence of relatively unstable retaining walls along the waste rock slope. These are illustrated in plan drawing 12953-12 and profile 12953-13 as well as in photos #V3 and #V4. Of particular note were the two retaining walls built in series along the waste rock pile slope shown as section B-B on drawings 12953-12 and 12953-13. These have been constructed with log cribbing and have shown natural degradation over their 25 or more year existence. With respect to the lower wall, the log cribbing itself showed some natural decay and there were some failures noted at the joints along the edges. There was also extensive sloughing of the waste rock behind the wall and tension cracks parallel to the wall. As the integrity of the wall and waste rock mass is undermined by natural decay and slight movements, a sudden failure may eventually occur leading to a large mass of waste rock mobilizing downslope. This could occur if the joints along the cribbing continue to fail to the point where the waste rock begins to deform and the strength within the remaining cribbing support is insufficient to restrain the waste rock mass from

- 1. In regards to the two retaining walls located in the area of Adit 2, it is recommended to intentionally fail these structures to reduce the risk of a future impact on the South Klondike Highway. This could be accomplished by implementing option 1 which involves constructing a catchment area to restrain the fallen waste rock from extending to the highway during the demolition. The fallen waste rock would be moved from the catchment area in a stepwise fashion and hauled to a suitable disposal site within a close proximity to the Venus Mine Site. A second option to demolish these retaining walls would involve relocating the material behind the retaining wall to the bench area near adit 2. As requested, Class 'D' cost estimates to an accuracy of +/- 25% has been prepared and is enclosed under separate cover.

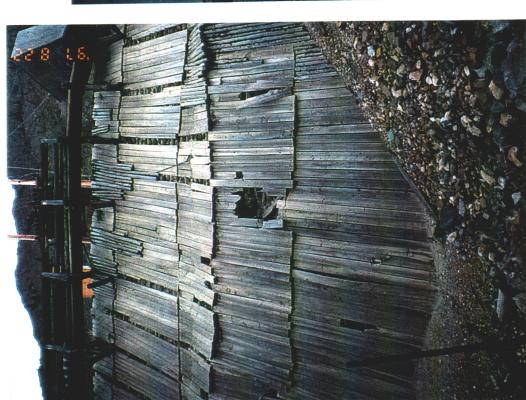
With respect to the upper retaining wall, the log cribbing did not appear to have decayed nearly as much as the lower wall. This is most likely due to the apparently coarse, free draining nature of the waste rock which was retained by this wall as compared to the finer grained material of the lower wall. This free draining nature of the waste rock has ensured a dry environment immediately surrounding the log cribbing which has retarded natural biological decay. There were no noticable failures of the cribbing joints or evidence of movement within the material behind the wall. Although this retaining wall is subject to natural decay and would eventually exhibit more active failure in the future, the affect of the lower wall on the instability of the upper wall is considered to be more significant. If such a failure of the lower wall was to occur, this could undermine the toe support of the upper wall which may result in failure and downslope mobilization of waste rock from the upper wall. However, the rate of this failure is uncertain. The maximum volume of waste rock restrained by the upper wall is estimated at between 1300 m³ and 1500 m³. The mobilization of this amount of rock would likely impact the South Klondike Highway below since the slope angle remains in excess of 28° to 30° along the run-out path and there is not sufficient retention capabilities of the lower benches to restrain such a volume of rock from mobilizing down to the highway.

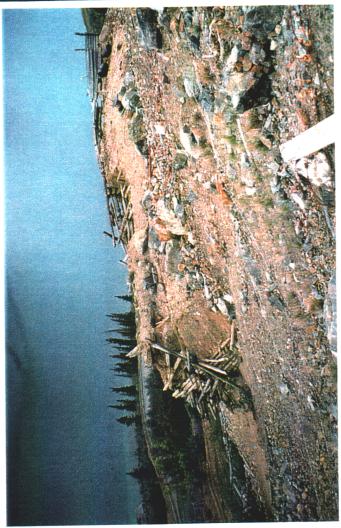
Photo #V4:

waste rock material; note poor condition of log cribbing supports. Looking south east at lower retaining wall. Note sloughing of
