**FINAL REPORT
ASSESSMENT OF REMEDIAL MEASURES FOR
ARCTIC GOLD & SILVER TAILINGS SITE**

THE ARTIC GOLD & SILVER WORKING GROUP

STEFFEN ROBERTSON AND KIRSTEN (CANADA) INC.
Suite 800, 580 Hornby Street
Vancouver, B.C. V6C 3B6
Tel: (604) 681-4196 • Fax: (604) 687-5532
E-mail: vancouver@srk.com Web site: www.srk.com

FEBRUARY, 1999

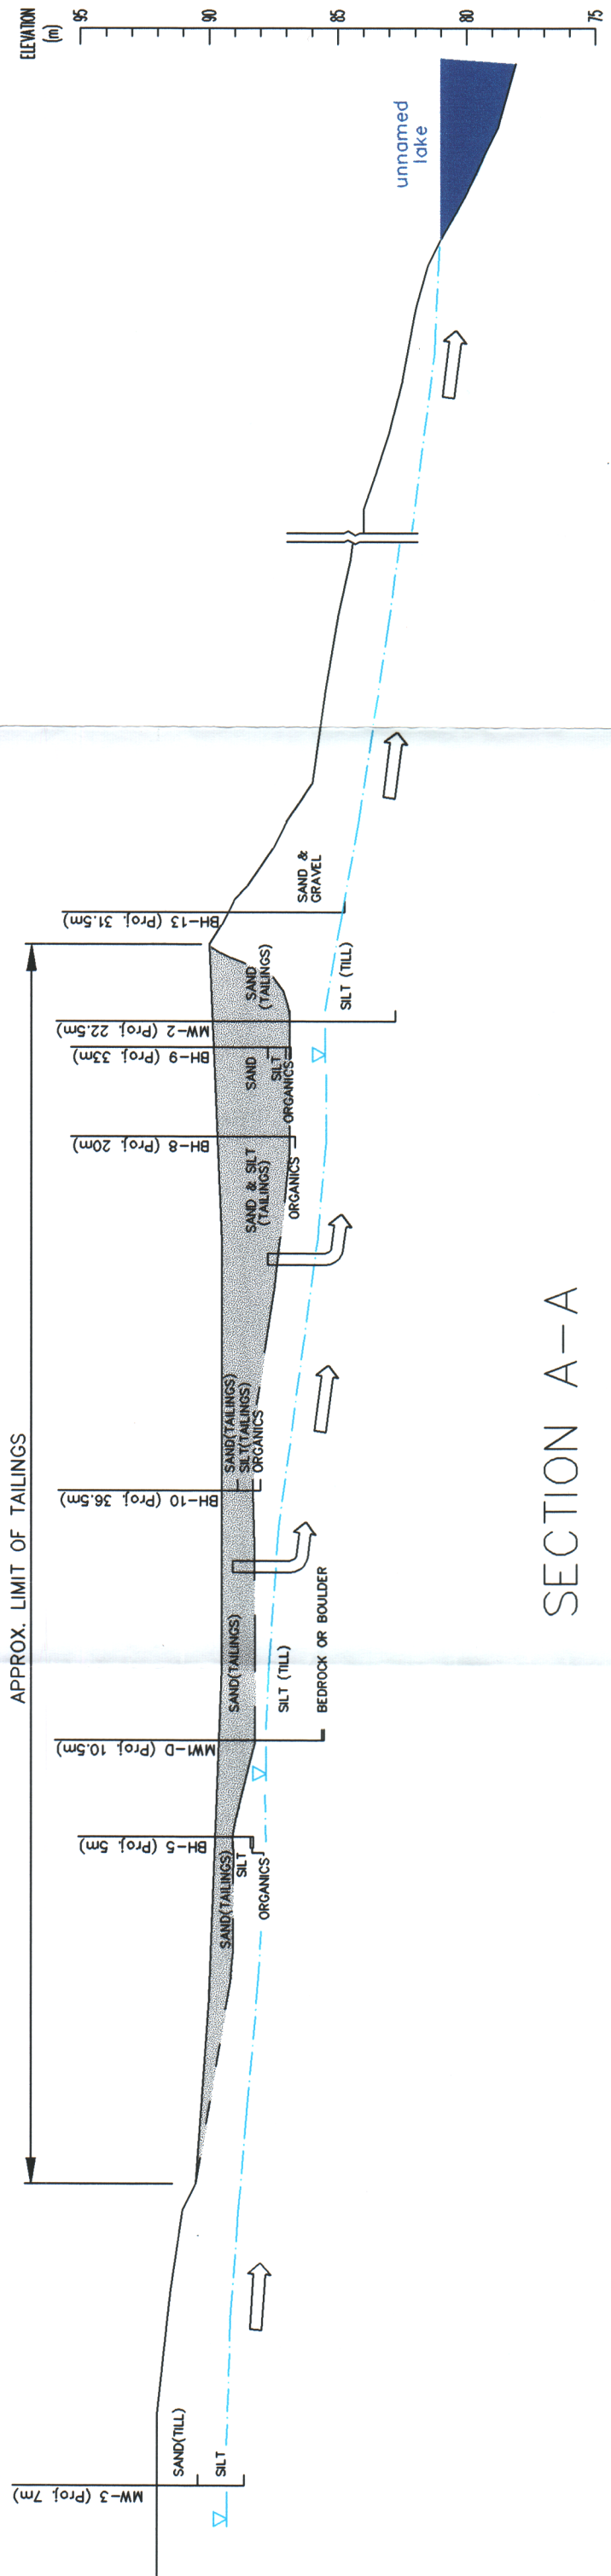
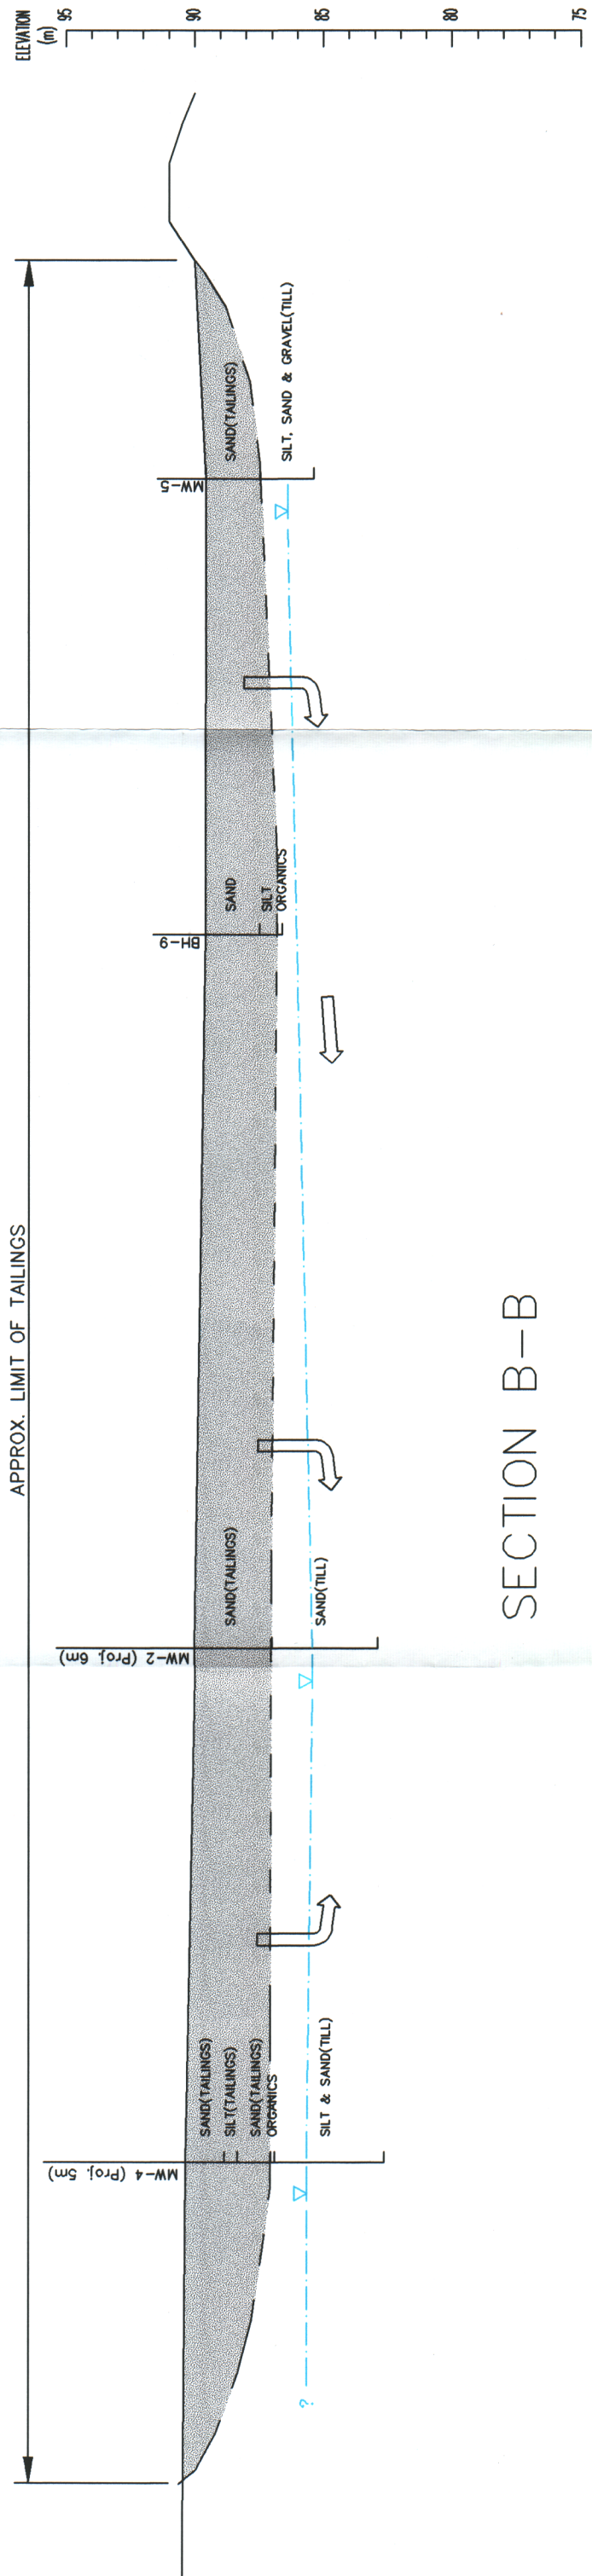
STEFFEN ROBERTSON AND KIRSTEN <i>Consulting Engineers</i>	ARCTIC GOLD AND SILVER			
	SECTION A-A AND B-B			
	PROJECT NO. 1CP001.07.01	DATE DEC. 1998	APPROVED	FIGURE 2.3
PUBLIC WORKS AND GOVERNMENT SERVICES CANADA

The groundwater table was below the tailings at all points measured (Figure 2.3). Currently, therefore, there is no evidence of groundwater passing through the tailings from the upgradient side. Hence there is no need for additional groundwater or surface water diversions. The water table may rise in spring, but due to the low permeabilities of the tailings and foundation soils, it is unlikely that significant horizontal flow through the tailings would result.

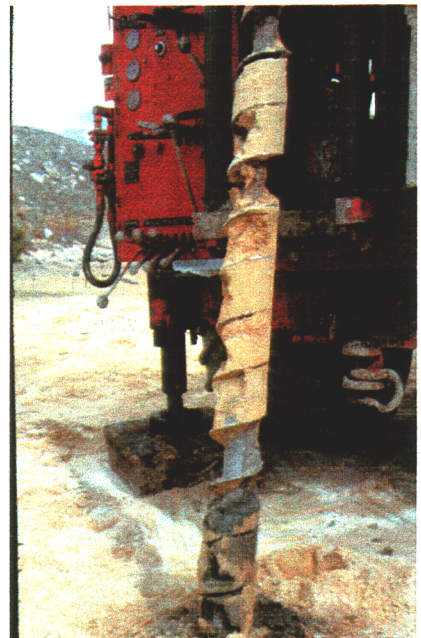
Photo 1: Tailings profile.

- Ten boreholes were advanced to characterize the depth and characteristics of the tailings material. The tailings consisted of two layers distinguished by the extent of oxidation (as evidenced by the characteristic rust colour associated with the ferric hydroxide presence in the tailings). As seen in Photo 1, the profile of the tailings consisted of an upper surface layer of more oxidized (beige) sand material with an underlying stratum of less oxidized (dark grey) silt and sand material.

- The upper surface layer consisted primarily of fine sand sizes and was damp to moist with moisture contents typically in the order of 10% to 15%. As seen in the representative particle size gradations for samples 2 and 16 in Appendix B, there is over 90% fine sand material in the upper tailings material.

- The lower tailings stratum consisted of finer soil sizes and was moist to wet with moisture contents ranging from 30% to 40%. Refer to samples 8 and 11 in Appendix B for representative particle size gradations of this material. Fines content ranged from 15% to 90% in those samples tested. As could be expected, the higher fines content observed

with increased depth of tailings corresponded to higher moisture contents (due to the higher field capacity) and a lesser degree of oxidation.

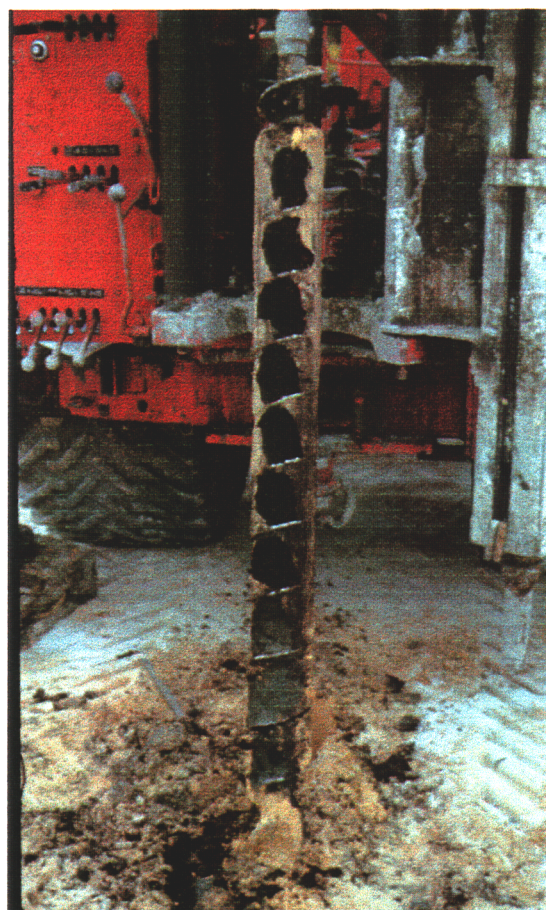
Photo 2. Underlying organics and till.

- As seen in Photo 2, the tailings ended at a distinct organic layer. The organic material was wet, dark brown, and partially decayed. The organic layer was underlain by a dense silt, sand, and gravel soil which was inferred to consist of native morrainal till.

- There was oversize material within the till matrix which made drilling very difficult. Refusal in the till occurred in all deeper boreholes, with depths of refusal ranging from 1.5 m to 7.7 m and an average depth of 4.6 m.

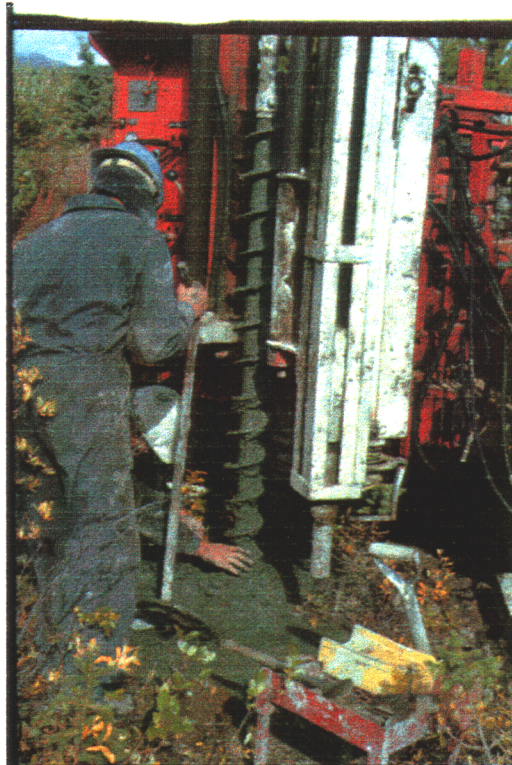
Photo 3. Location of MW6

- To assist in the evaluation of ground water flow and water quality outside of the tailings impoundment area, monitors 13563-MW3 and 13563-MW6 were installed. Based on the topography of the site and on an interpretation of drainage features from aerial photos, the locations were inferred as being hydraulically upgradient of the tailings area. This assumption was validated by on-site calculations using accurate survey data of monitors 13563-MW1 through -MW4 provided by Underhill Geomatics Ltd. on 98/8/31. The horizontal direction of ground water flow was determined to be toward the west, roughly in a direction parallel to monitors 13563-MW1D and -MW2. As seen on the well installation details, monitor 13563-MW6 was constructed for piezometric measurements only. It is noted that the static water level at -MW6 was very close to the existing ground surface, with extensive free water observed while removing the solid stem augers (see Photo 3).

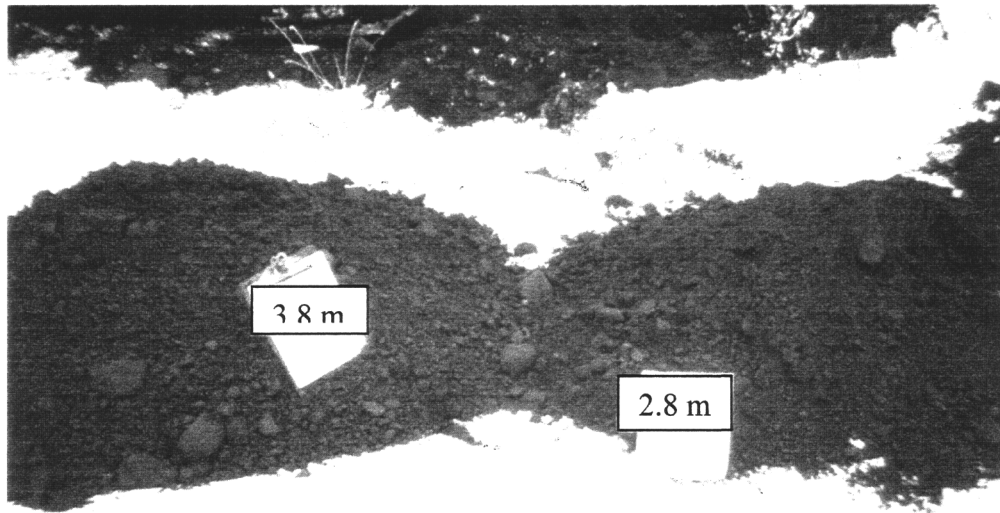
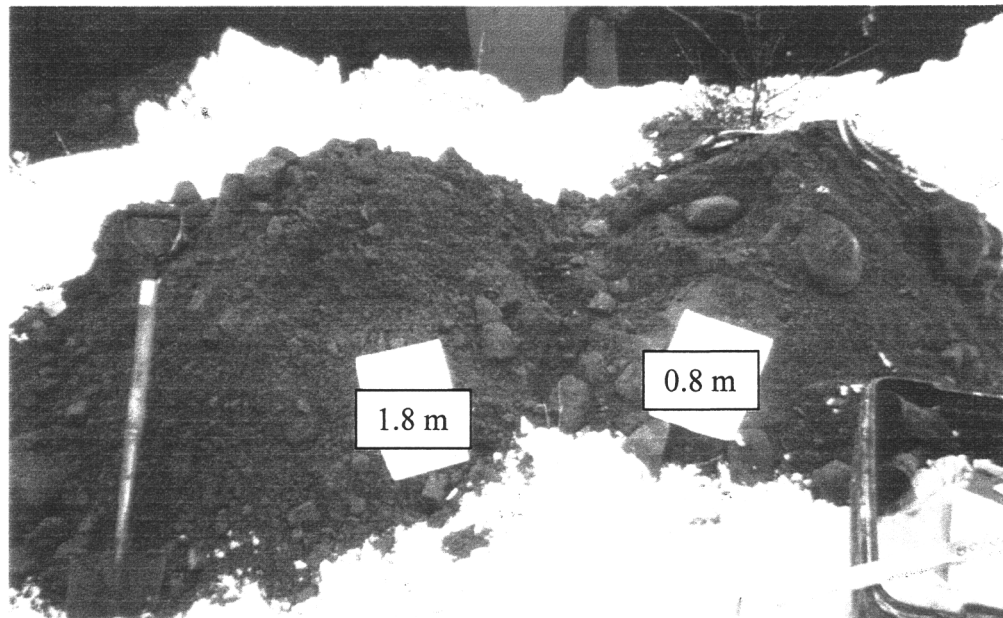
Photos 3 and 4. Soil piles from samples at varying depths at 13563-TP4

- As seen in the above table, the till is composed primarily of sand and gravel sizes, with an average fines content of approximately 15%. As well, the soil matrix consisted of approximately 5% cobbles by volume to a maximum diameter of 300 mm. A photographic documentation of the typical soils encountered is shown in Photos 3 and 4, following.

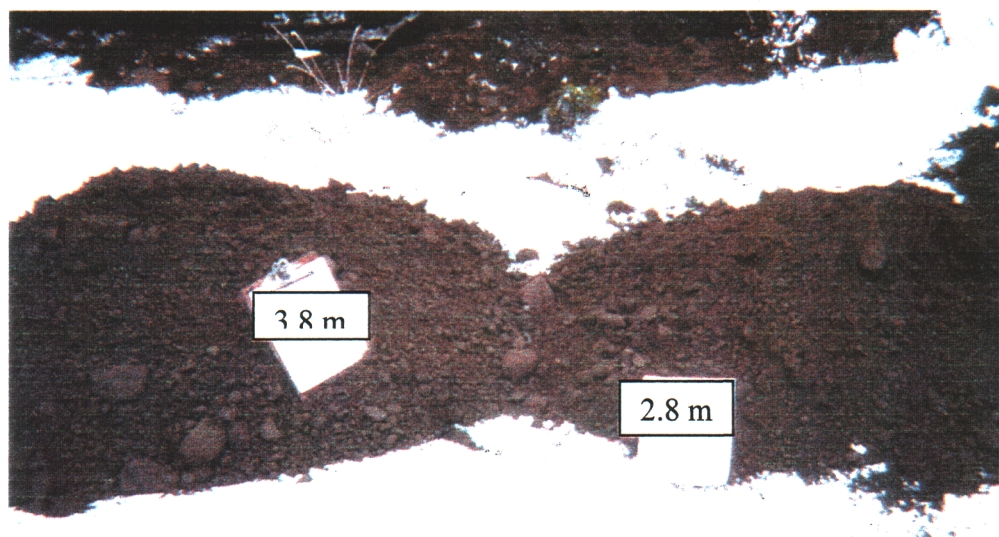
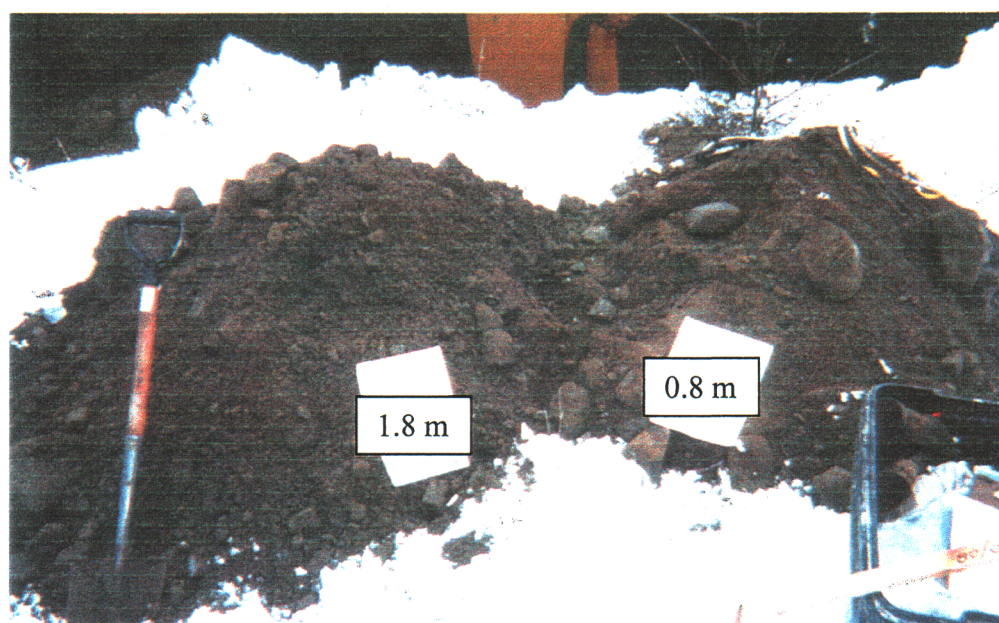
Photos 3 and 4. Soil piles from samples at varying depths at 13563-TP4

- As seen in the above table, the till is composed primarily of sand and gravel sizes, with an average fines content of approximately 15%. As well, the soil matrix consisted of approximately 5% cobbles by volume to a maximum diameter of 300 mm. A photographic documentation of the typical soils encountered is shown in Photos 3 and 4, following.
