# INDIAN AND NORTHERN AFFAIRS CANADA WASTE MANAGEMENT PROGRAM

## SÄ DENA HES MINE

### ENVIRONMENTAL BASELINE AND GEOTECHNICAL EVALUATION REPORT

April 2000  
G1776

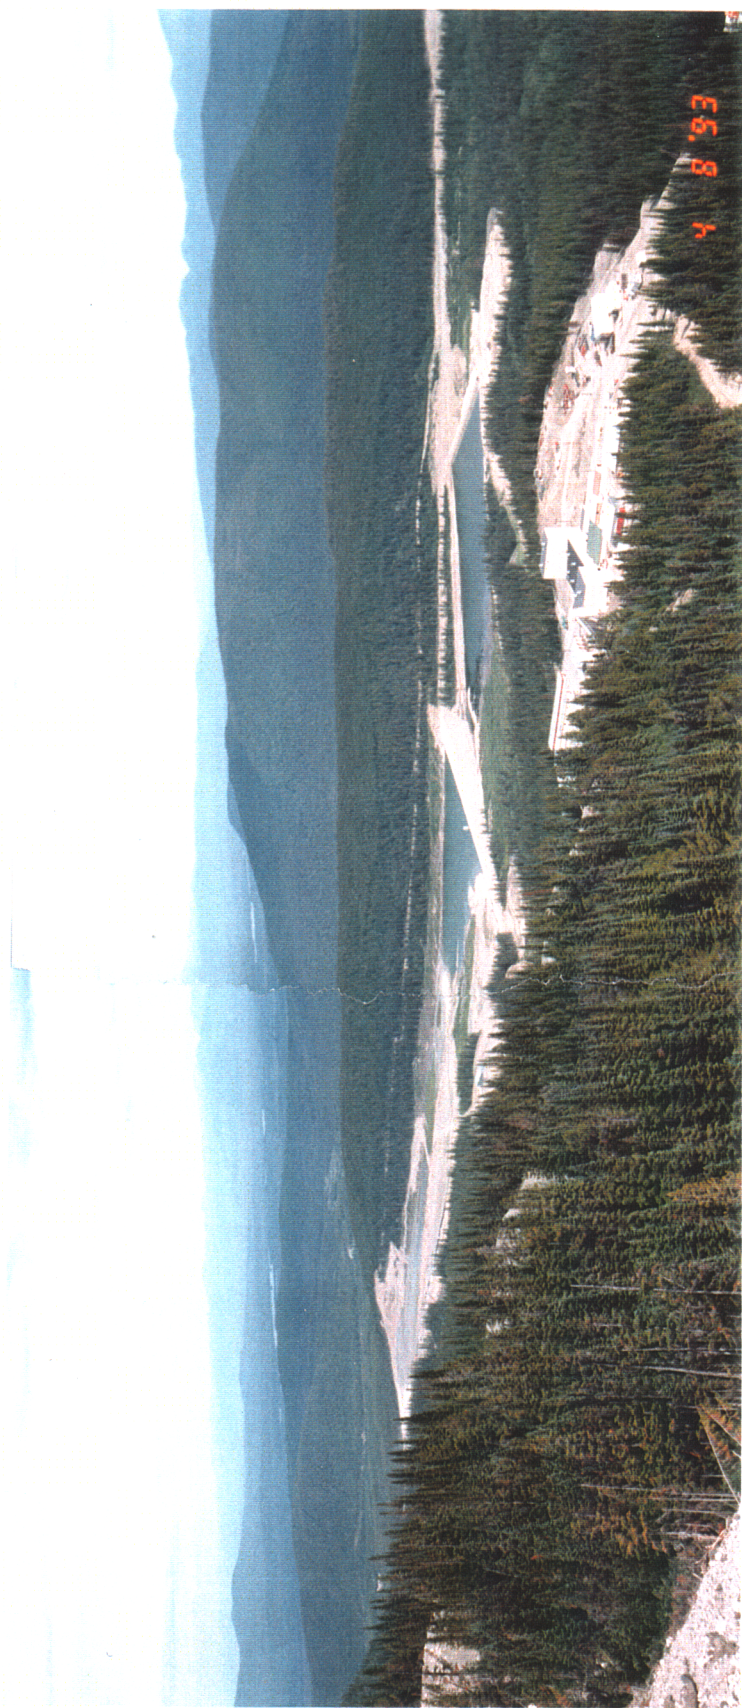
Photo 1; General view of the tailings pond (left), reclaim pond (right) and the mill from the Jewel Box underground mine waste dump.

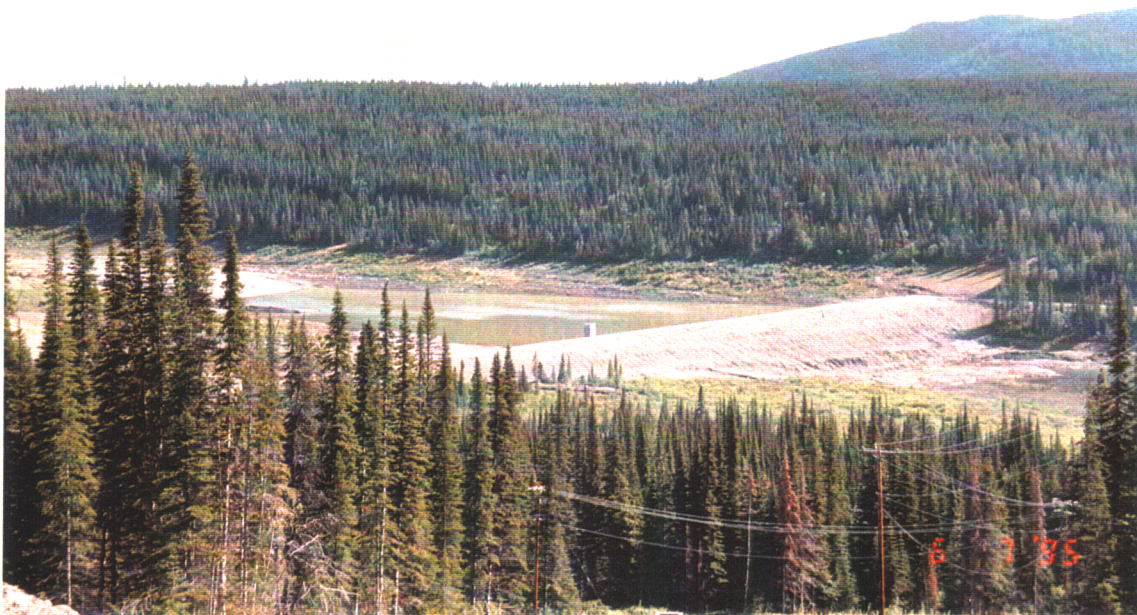
Photo 2: View of the South Dam and deposited tailings.

South dam shows signs of deformations along the upstream dam face. An almost continuous crack was observed on the dam crest, paralleling the face, in 1999. There were four minor and shallow slumps on the upstream dam face which were upgraded prior to the 1999 site visit. Erosion rills are relatively deep on the downstream side of the dam. Water (seepage) was heard to run through the toe berm. It was estimated, prior to the construction of the toe berm, that seepage at the low point of the dam could be in the order of 60 l/min. Heavy seepage was observed discharging from the east abutment.

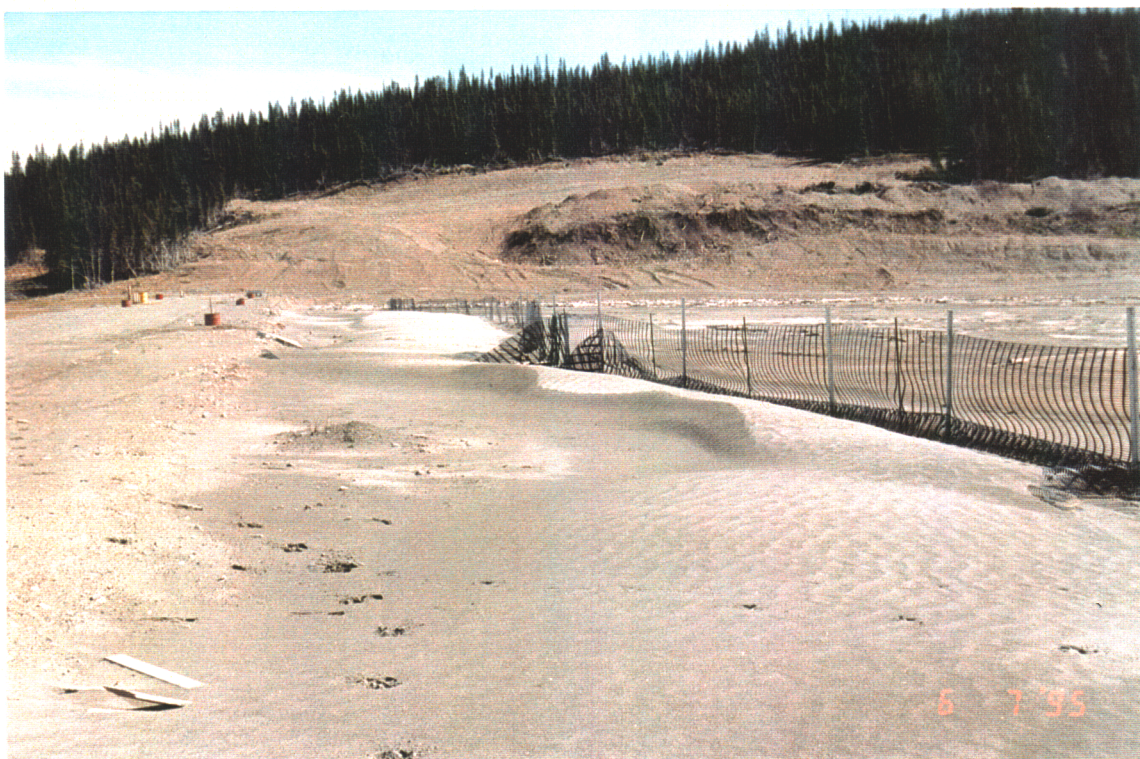
Photo 3: Windblown tailing at the north dam.

Very few changes have occurred at the north dam since its construction. Dry tailings in the pond are at the crest of the dam (elevation 1,098 m) at the west abutment and about 1 m below the crest at the east side. Airborne tailings are deposited on the crest and downslope side of this dam. No cracks or deformations were observed.

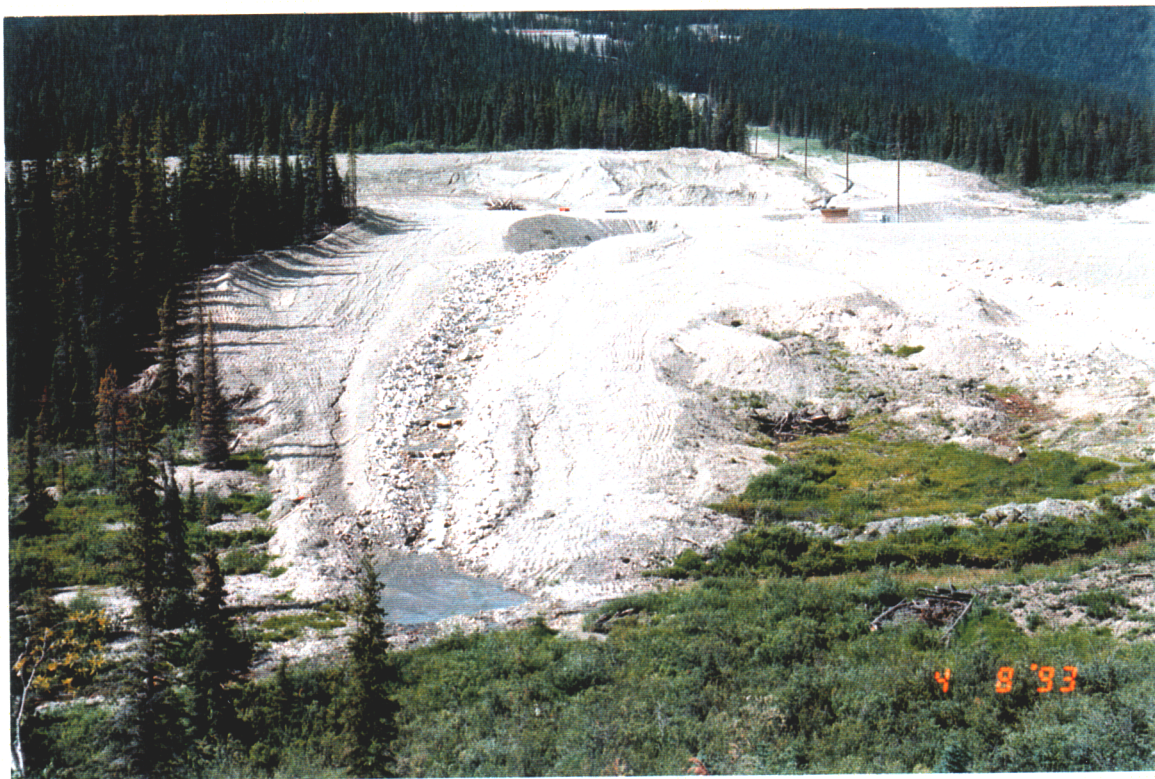
Erosion has occurred at both the outlets and inlets to the spillway CMP's. The erosion at the inlet end is caused by runoff from above the road that flows through the tailings pipeline CMP conduit.

Photo 4: General view of the reconstructed spillway chute at the Reclaim Pond dam.

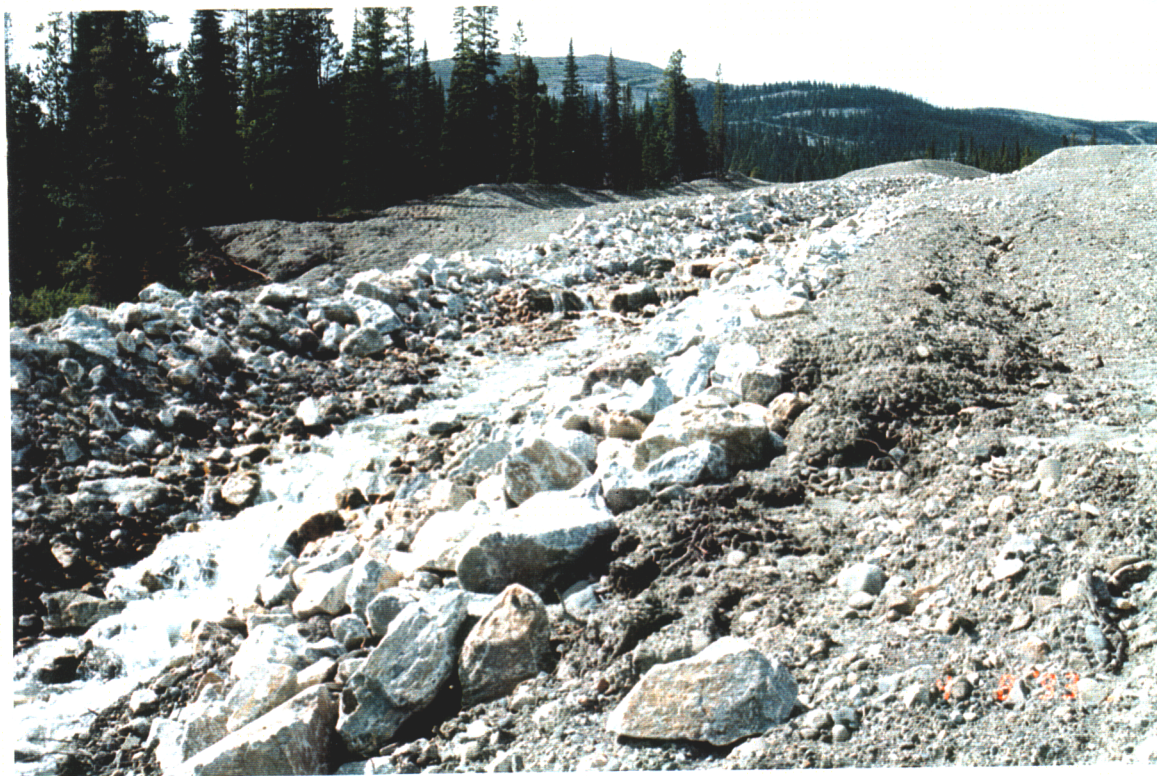
Photo 5: Detail view of the chute.

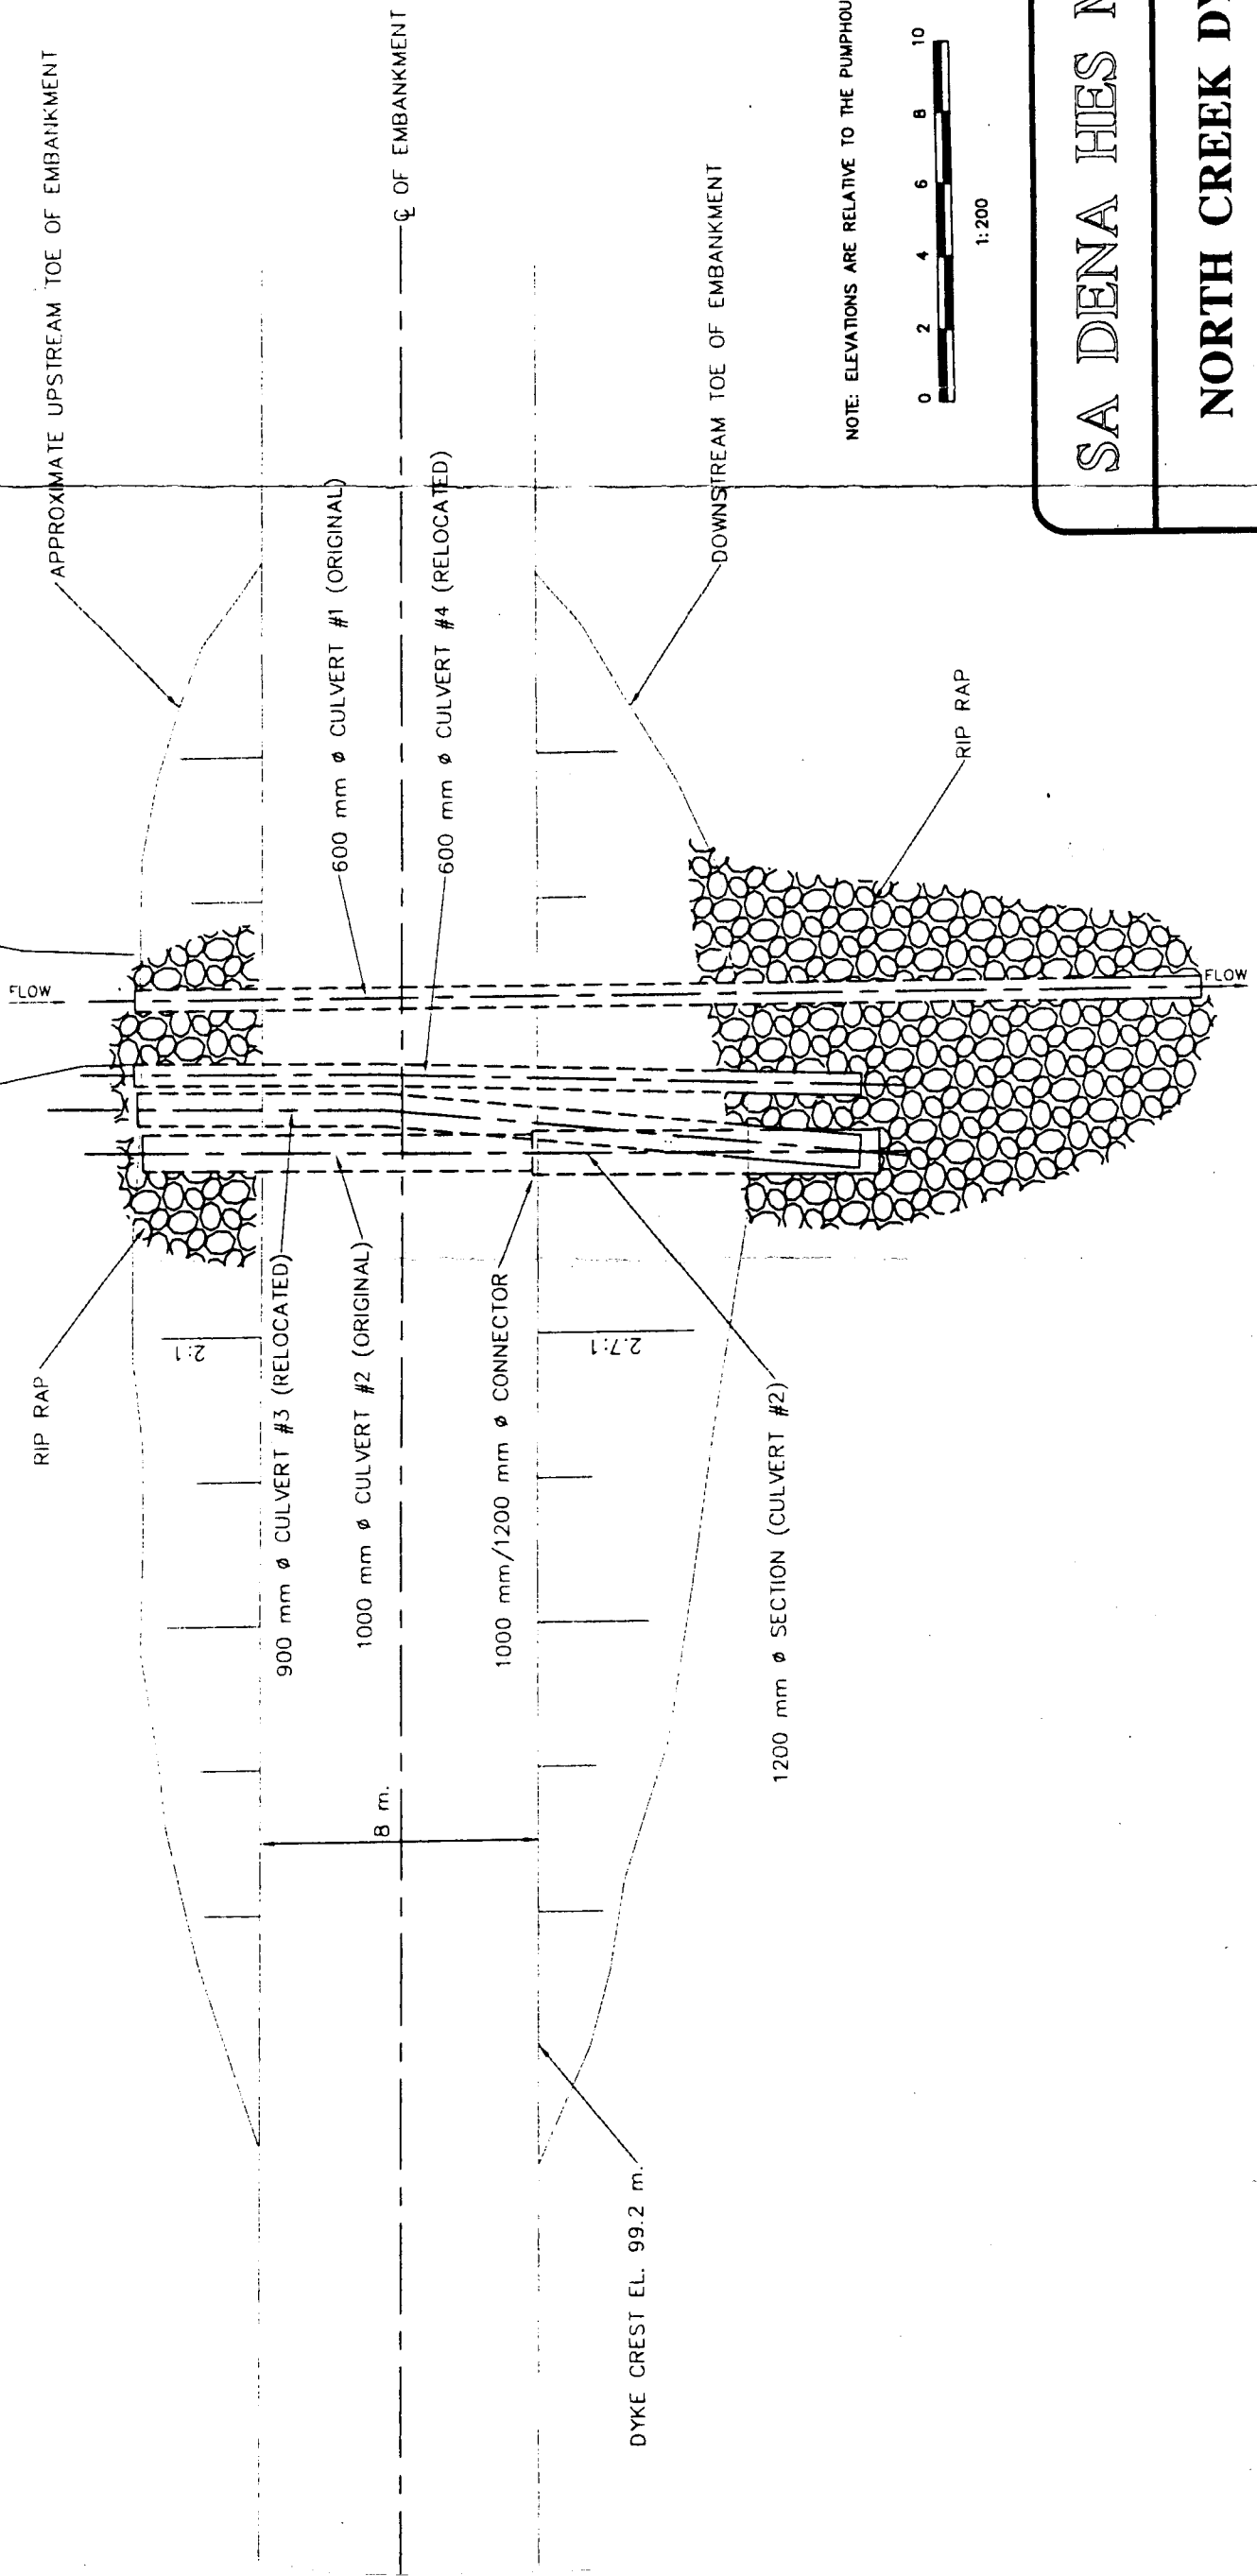
SCALE: 1:200	PROJECT No. G1776	FIGURE 4-6
-----------------	----------------------	------------

The dyke has a maximum height above original ground of about 5 m, it is about 50 m long and the crest is 7 to 10 m wide. The dyke slopes are 2.5:1 to 3:1. Fill used to construct the dyke is a silty sandy till and it is estimated that about 200 m<sup>3</sup> of this material was placed without significant compaction. This caused settlement and localized shallow sloughing. The dyke was graded several times and recently (1999) appeared to be stable.
