YONO (#70)
(MINFILE# 105M 55)

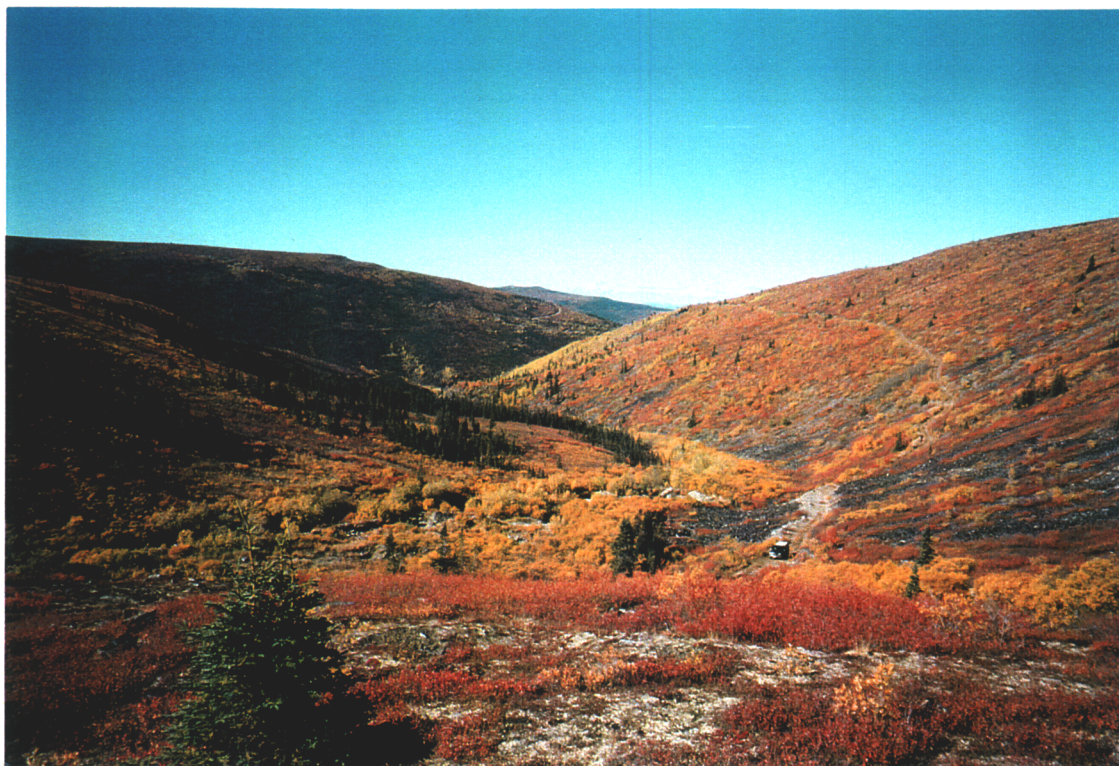
The Yono site is in Thunder Gulch on the southwest side of Bunker Hill. It can be accessed in a four-wheel drive vehicle on Upper Thunder Gulch Trail that leads up and over the western slope of Bunker Hill (photo 70-1). This trail switches back from Thunder Gulch Trail a few hundred metres past Bellekeno. The UTM coordinates of the Yono site are 7085660 m N 489400 m E. The elevation of the site is about 1300 m.

Photo 70-1 View from east of Thunder Gulch and access to Yono site. Sourdough Hill is visible in lefthand background.

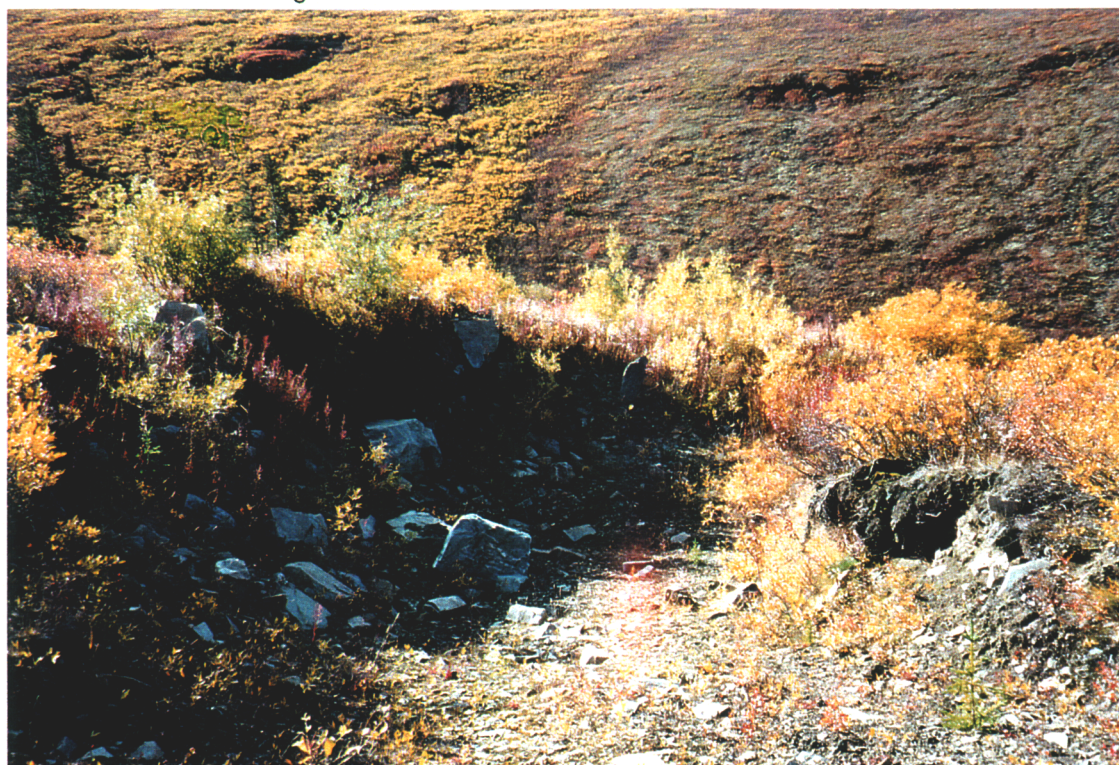
Trench 1 (photo 70-2)

Location: up hill from Upper Thunder Gulch Trail, 102 m east of Trench 2

Dimensions: 22 m x 5 m x 0-2 m – longitudinal bearing AZ 189

Condition: stable – 40% revegetated

Photo 70-2: View of Trench 1 at Yono site. (AZ 189)

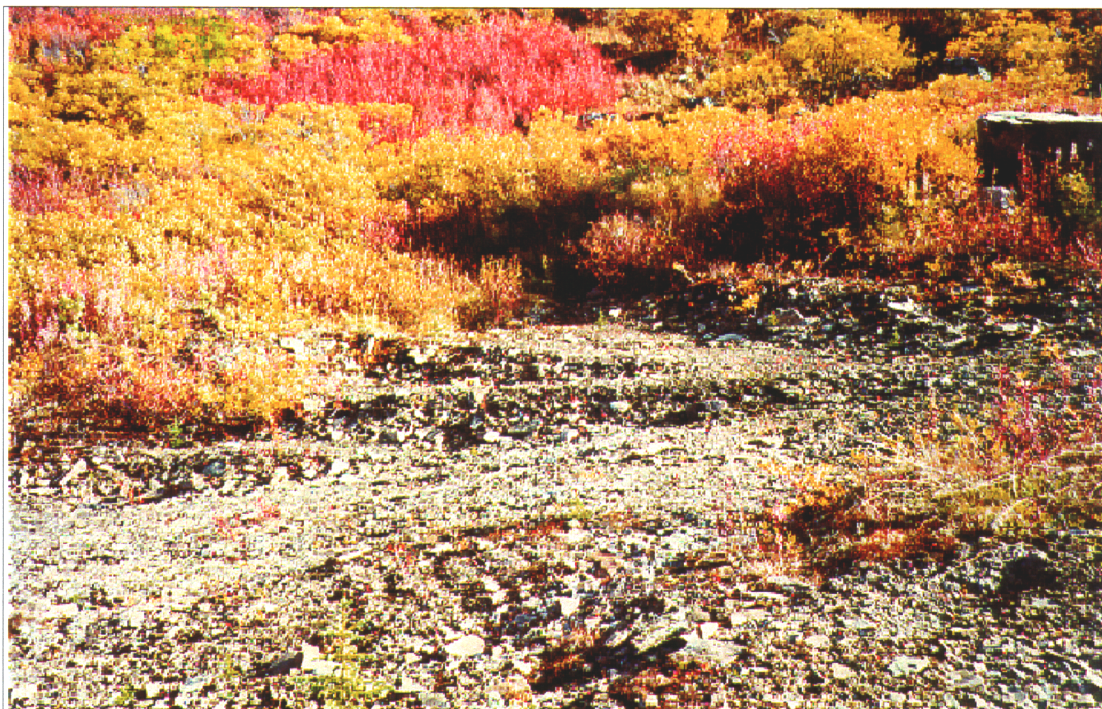
Trench 1 waste rock pile (Photo 70-3)

A pile of waste rock from Trench 1 was bulldozed at the mouth of the trench. It consists mostly of overburden with traces of rusting on 30% of the rocks.

Photo 70-3: Bulldozed overburden at the mouth of Trench 1.
