SILVER KING
SITE #1
MINFILE 105M 001ba

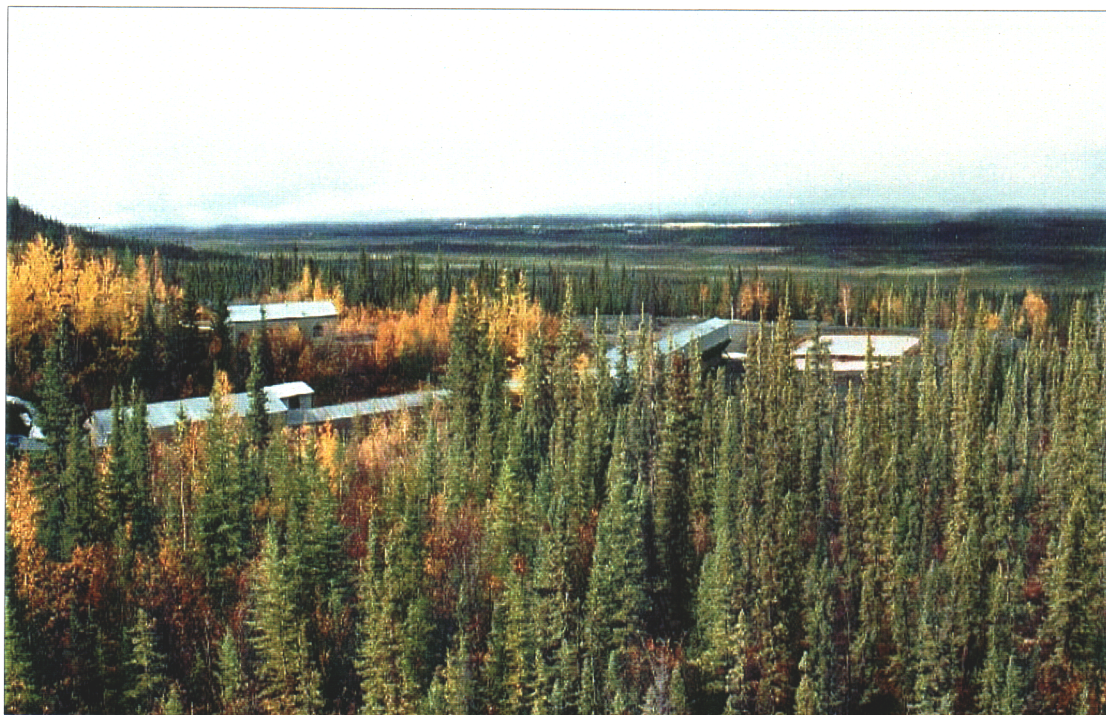
Description: This portal is currently under care and maintenance; access is maintained for pumping and treatment of mine water. There is a long (about 100m) galvanized shed that extends from the portal, covering the ore dump tracks.

Condition: Appears to be stable.

Description and type: Mine wastewater from the 100 Level portal is treated by mixing with lime, and settling in two ponds connected in series. The lime mixer is in an insulated part of the portal shed at the end of the tracks.

Impacted vegetation: There is some rusty precipitate deposited in the outflow area. Vegetation may be impacted in an area about 10m by 20m.

Photo 1-1 : Silver King. Silver King 100 Level Portal site, showing buildings (1A, 1B & 1C) and settling ponds. Looking northwest from the open pit waste dump across Galena Creek.

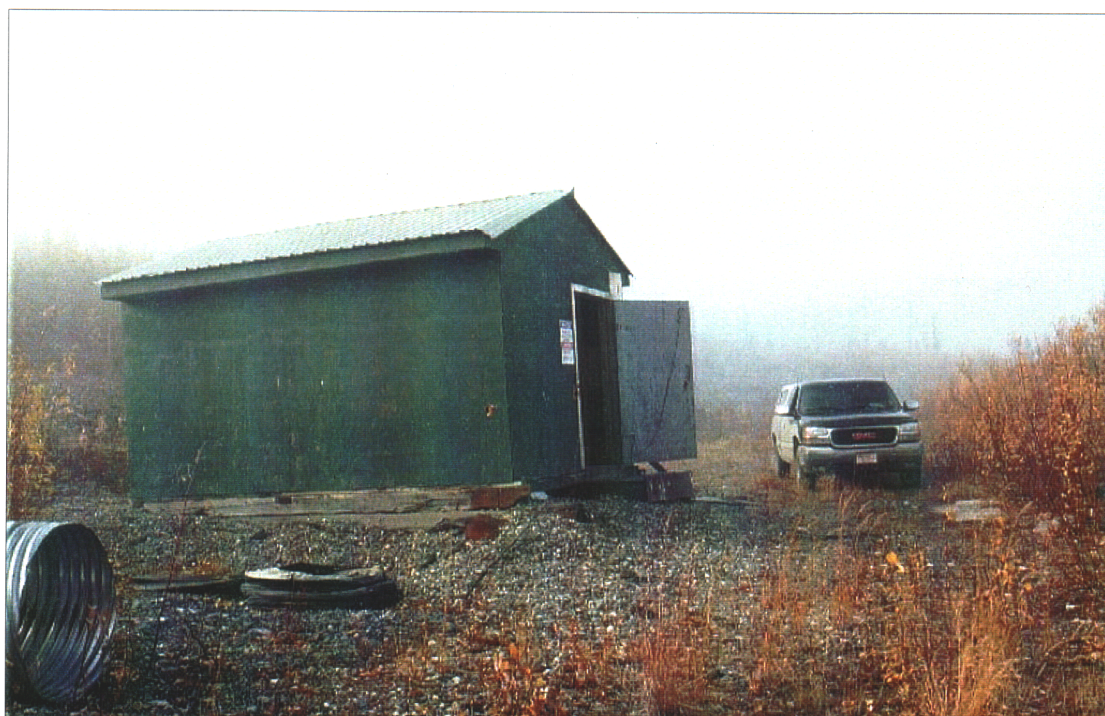
Description: A ventilation raise is covered by a wooden shed.

Condition: Appears to be stable.

Accessibility: The shed is kept locked, and steel mesh covers the raise entrance.

Photo 1-2 : Silver King. Ventilation Raise Building. Looking west, about 100m southeast of the open pit.

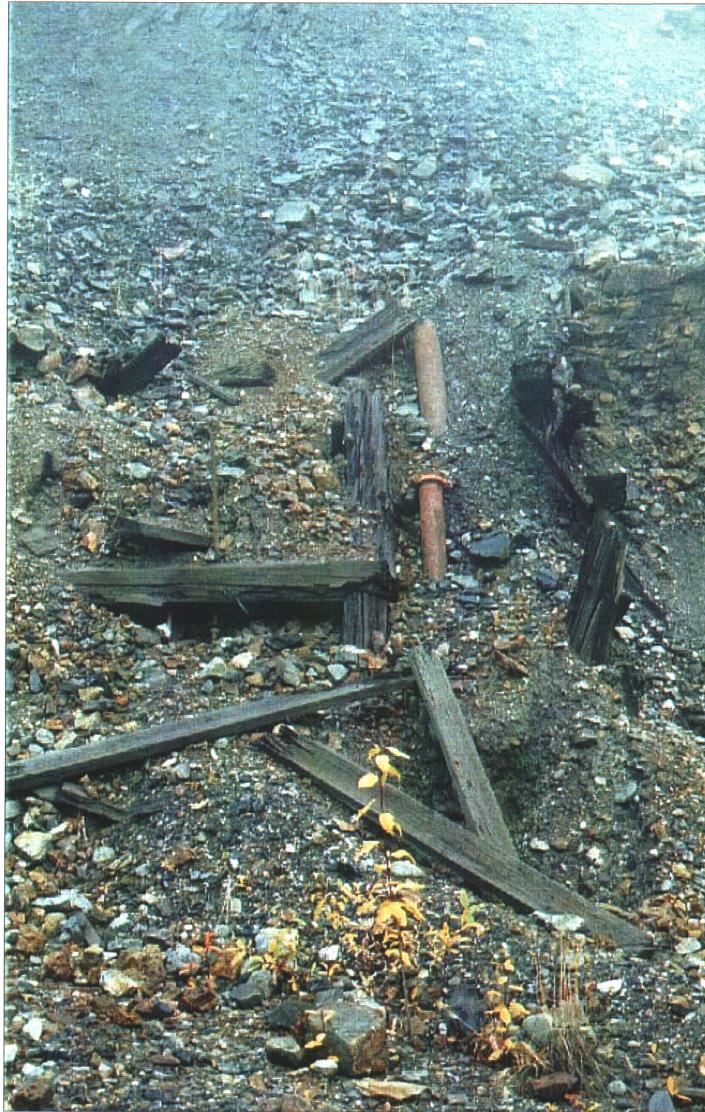
Description: Timbers and pipes exposed in the bottom of the open pit identify former shaft, filled with waste rock. This is likely the number 3 shaft, which was the main production shaft for this part of the mine.

Condition: Appears to be stable.

Accessibility: Access to underground is blocked with fill.

Photo 1-3 : Silver King. Timbers and pipe identify a filled-in raise or shaft (Shaft 1). Looking northwest at the bottom northwest corner of the Silver King pit.

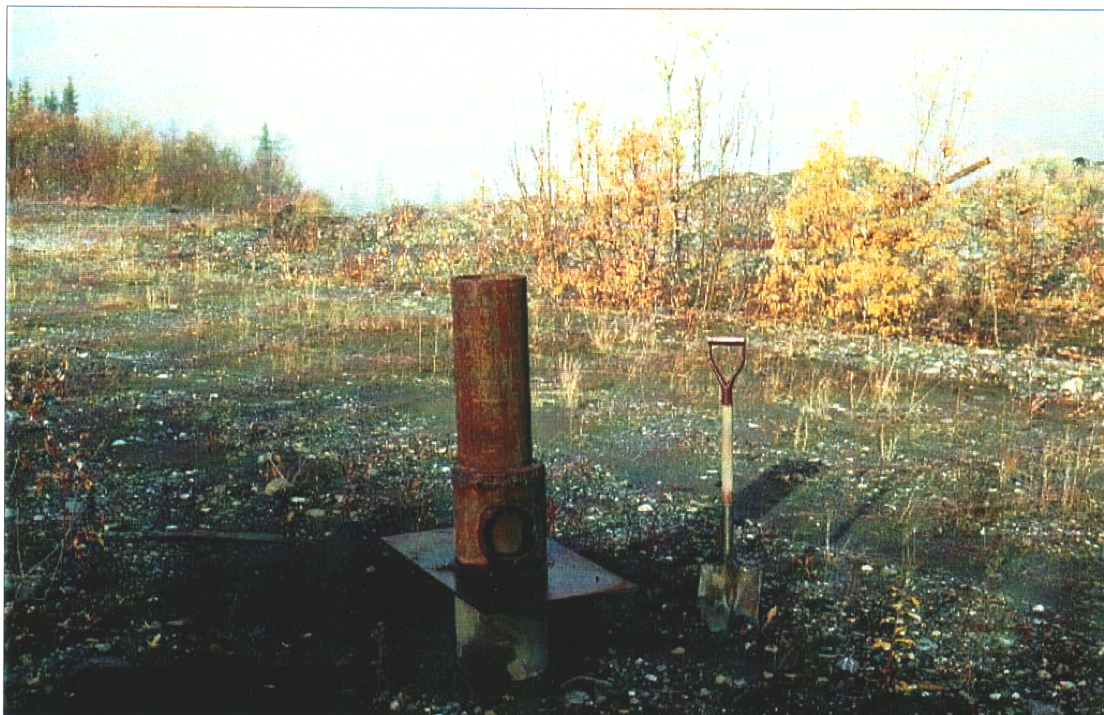
Condition: In sound condition.

Accessibility: Not capped. Access to site by road.

No significant hydrocarbons in soil were noted. A small, very shallow (<0.1m) stain from drilling lubricant or hydraulic oil was noted around the Backfill Pipe.

Photo 1-4 : Silver King. Backfill pipe, 100m south of the open pit. Looking northwest.
Note hydrocarbon stain at base of pipe (likely drill lubricant or hydraulic fluid).

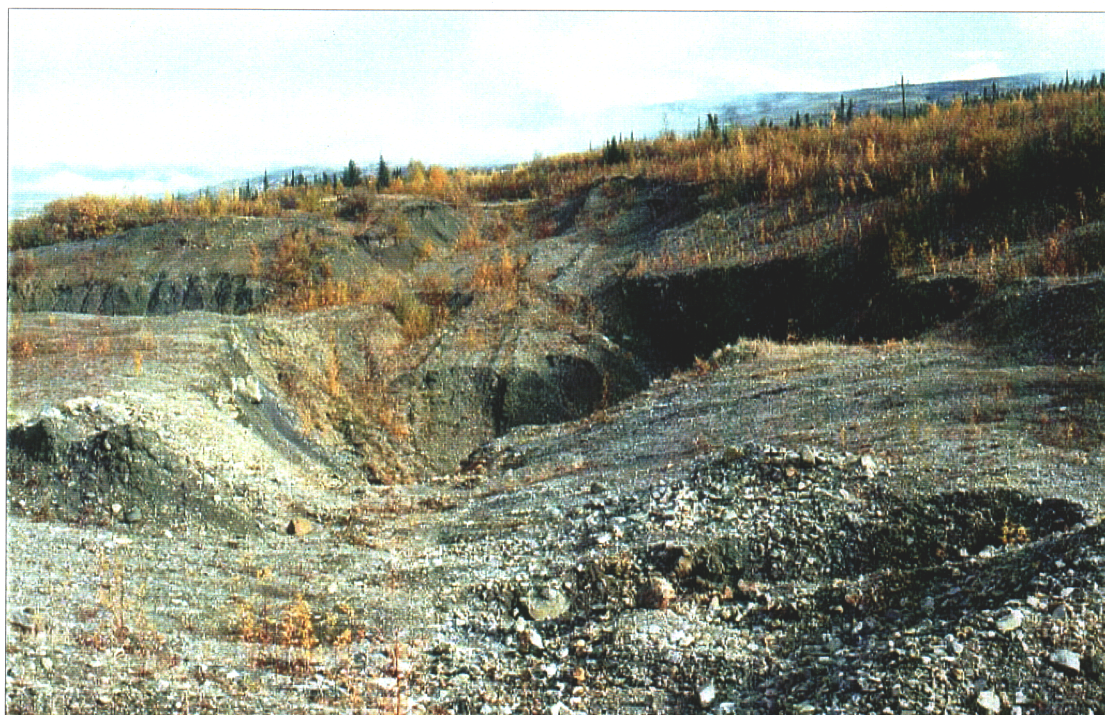
Condition: The pit walls are mostly gravel, at a moderate angle of repose, and appear to be stable. There is considerable natural revegetation in and around the pit.

Photo 1-5 : Silver King. Silver King Pit, looking east-northeast. Note moderate pit wall slope, abundance of overburden versus outcrop, and natural revegetation.

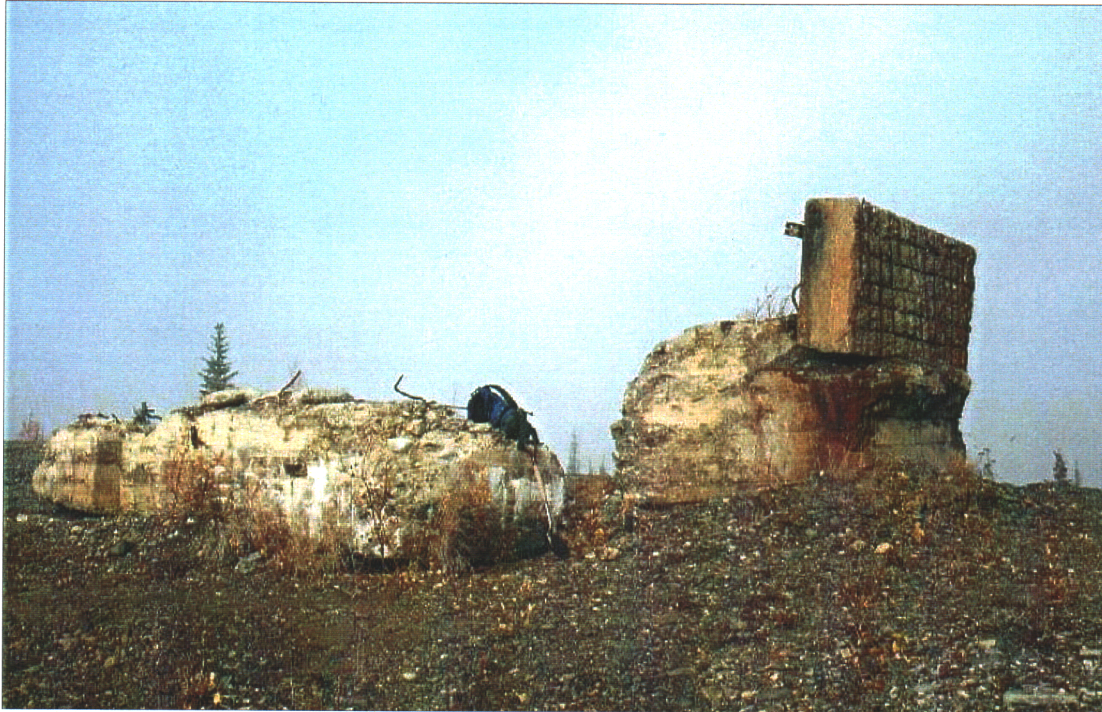
Photo 1-6 : Silver King. Concrete shaft hoist foundations. Looking northwest, northwest of the open pit.

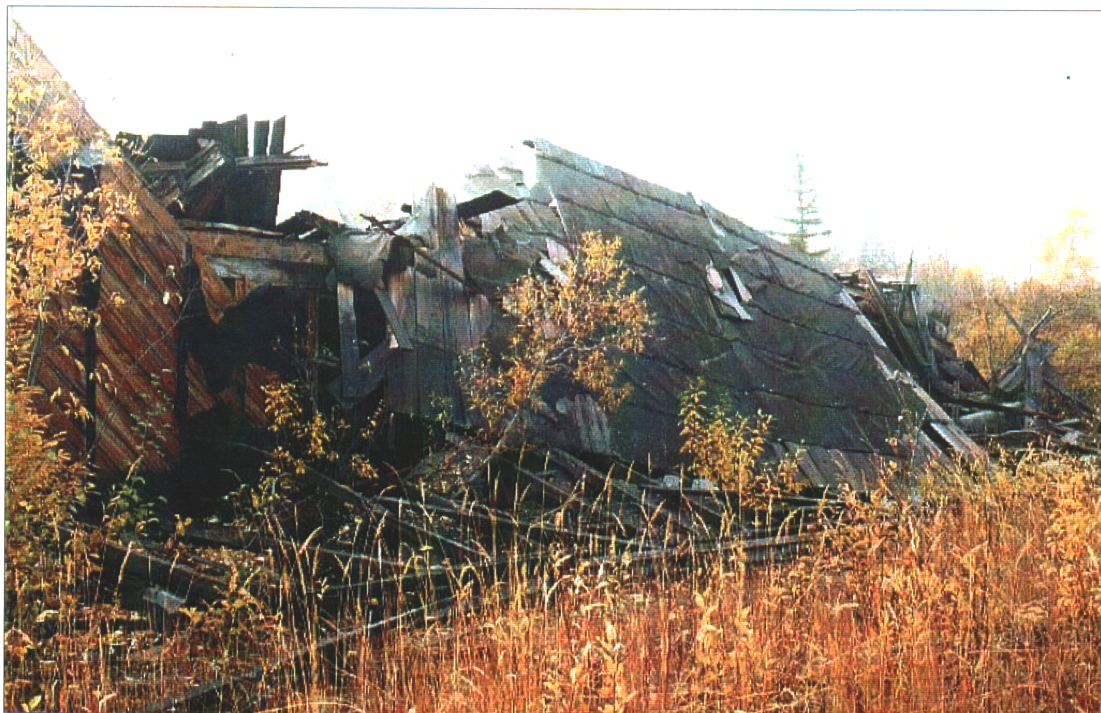
Dimensions (L x W x H): About 9m by 5m, was about 6m high before collapse.

Photo 1-7 : Silver King. Large, collapsed storage shed. Looking south, near transformer station south of highway, west of Galena Creek.
