HUSKY #2
(MINFILE#105M 001bb)

HUSKY SOUTHWEST #2
(MINFILE # 105M 001bb)

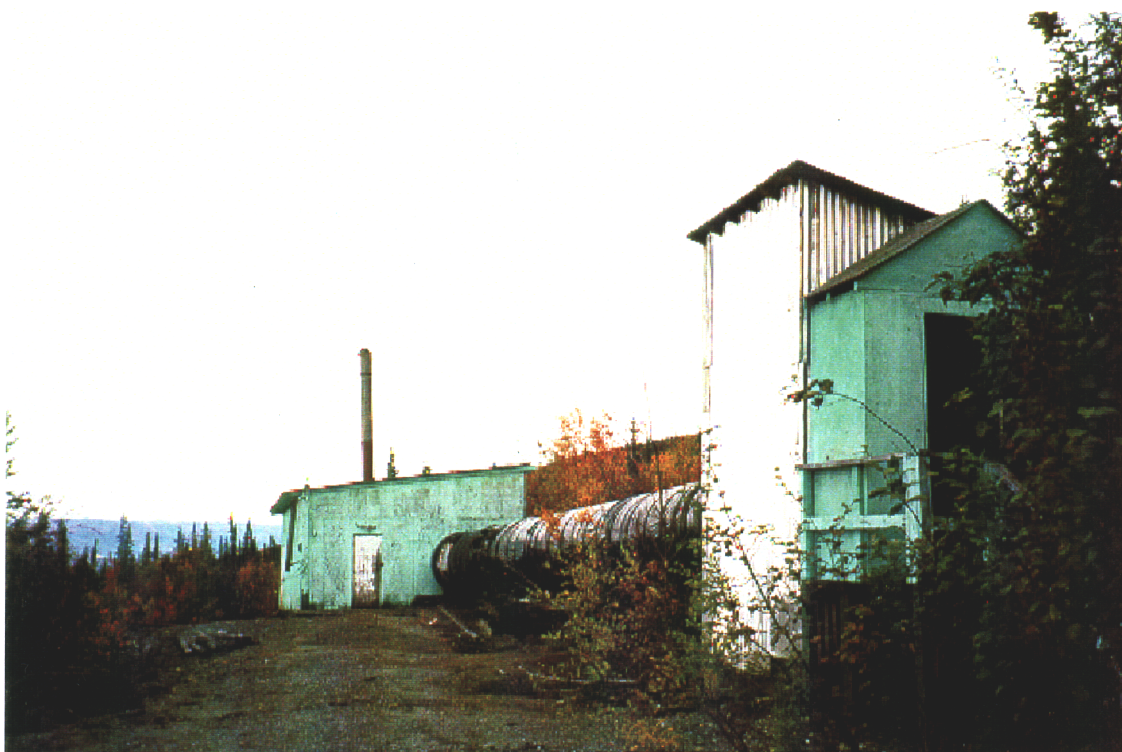
Husky mine is accessed via a shaft. The workings are flooded to surface. There are two raises to the surface. One of the raises was used for ventilation to the underground workings and has a heating furnace and downcast fans at the surface (photo 2-1).

Photo 2-1: Boiler house down draft raise & duct.

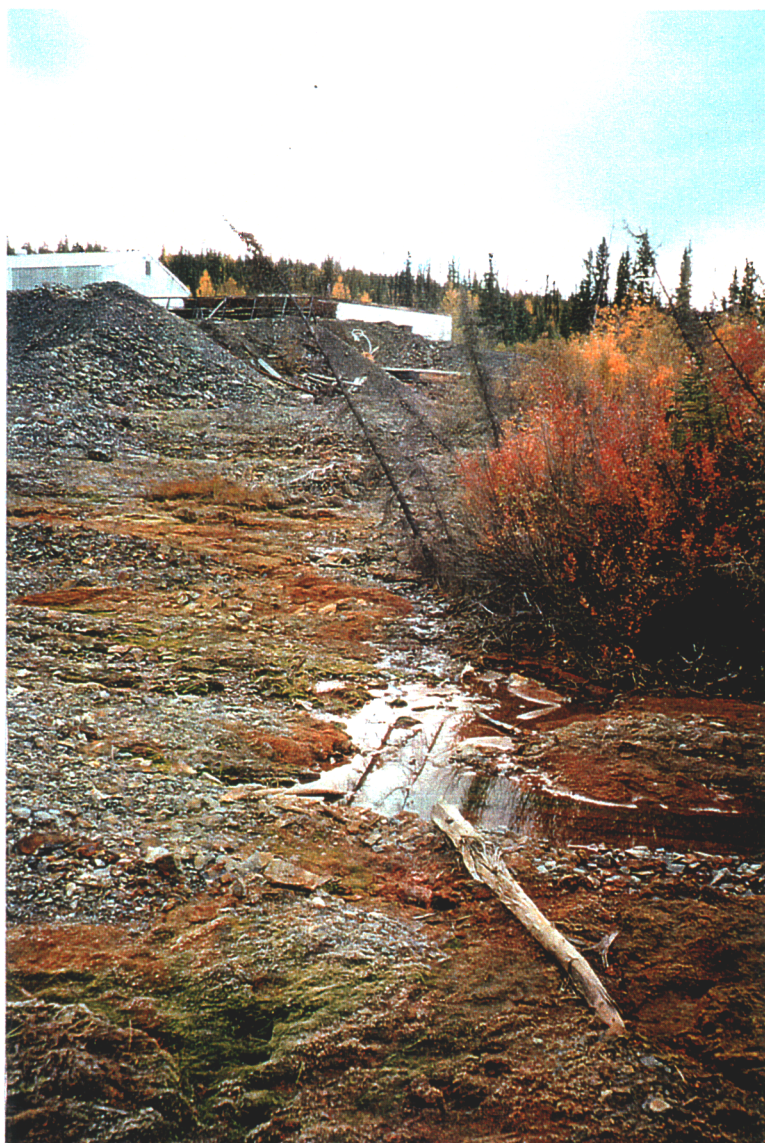
The dump is located on the north side of the shaft pad area. It consists mainly of quartzite with some quartz and minor amounts of schist. The quartzite has disseminated pyrite, arsenopyrite and quartz veinlets. The toe of the dump shows significant iron staining and precipitates. The vegetation near the flow is heavily stressed (photo 2-2).

Two water quality samples were taken at the site. Sample 02-03-water was collected 78m from the headframe building @170° (photo 2-2). The sediments at this location were orange brown with a noticeable sheen on the surface. Water flow rate at the sample location was .3L/s with a pH level of 2.6 and conductivity at 147 μ S.

Photo 2-2: Sample location 02-03, water taken 98 m from headframe.

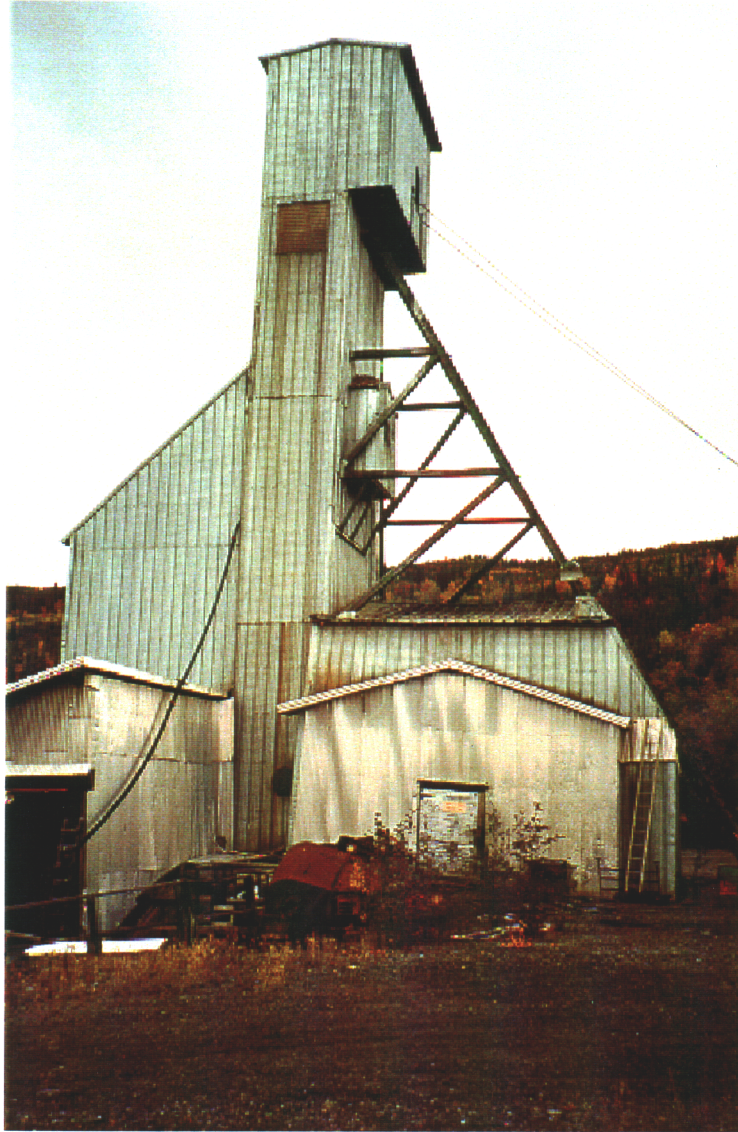
Building 2A – Shaft Headframe (photo 2-3)

Construction: The building appears to be wood frame with metal sheathing encompassing the structure, roof and headframe. There are timber supports tied into the concrete pads on the southwall and timber supports on the north wall tied into a submerged concrete wall, both were constructed to stabilize the headframe structure.

Hazardous Contents: There was one fuel drum that was not labeled sitting horizontally with a small amount of product having leaked from the bung. Soil staining was very minor.

Photo 2-3: Shaft & headframe.

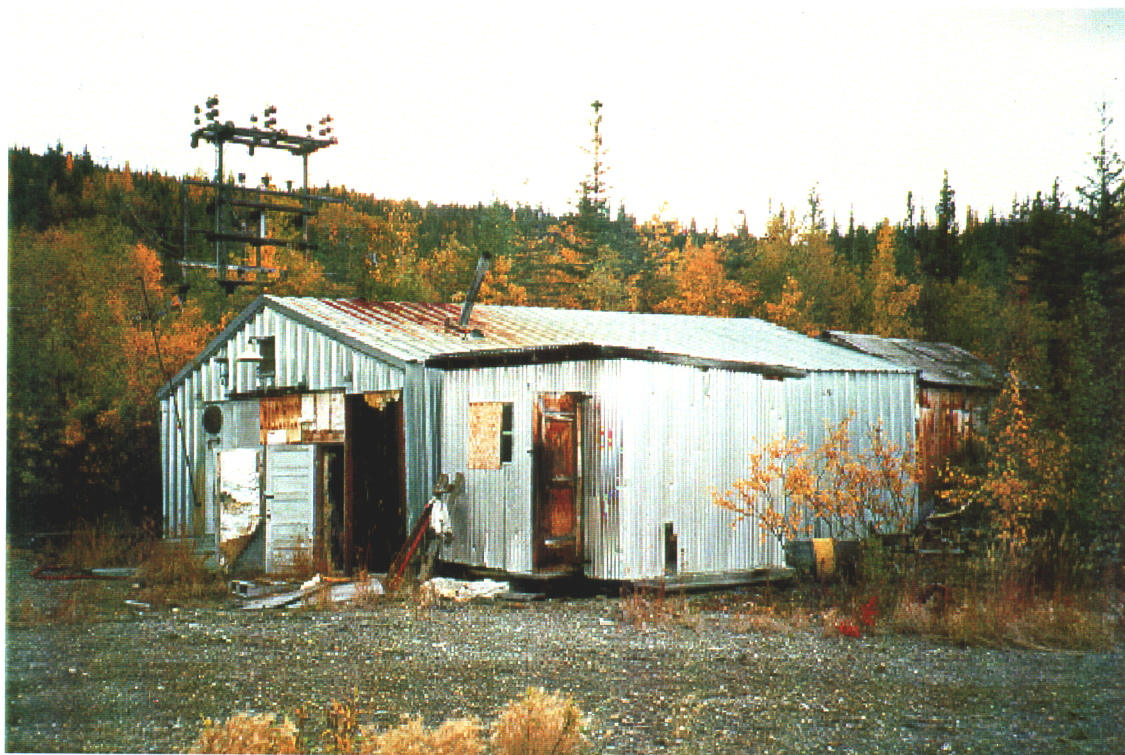
Building 2B – Hoist House (photo 2-4)

Construction: The structure was wood frame and encased in exterior steel sheathing including the roof. The building had fibreglass insulation. A small wooden porch was located off the west end. The doors were metal. The hoist cable openings were stained with lubricants and tar. There were some tar stains located directly under the cable openings, however, soil staining was minor in nature.

Photo 2-4: Hoist house.

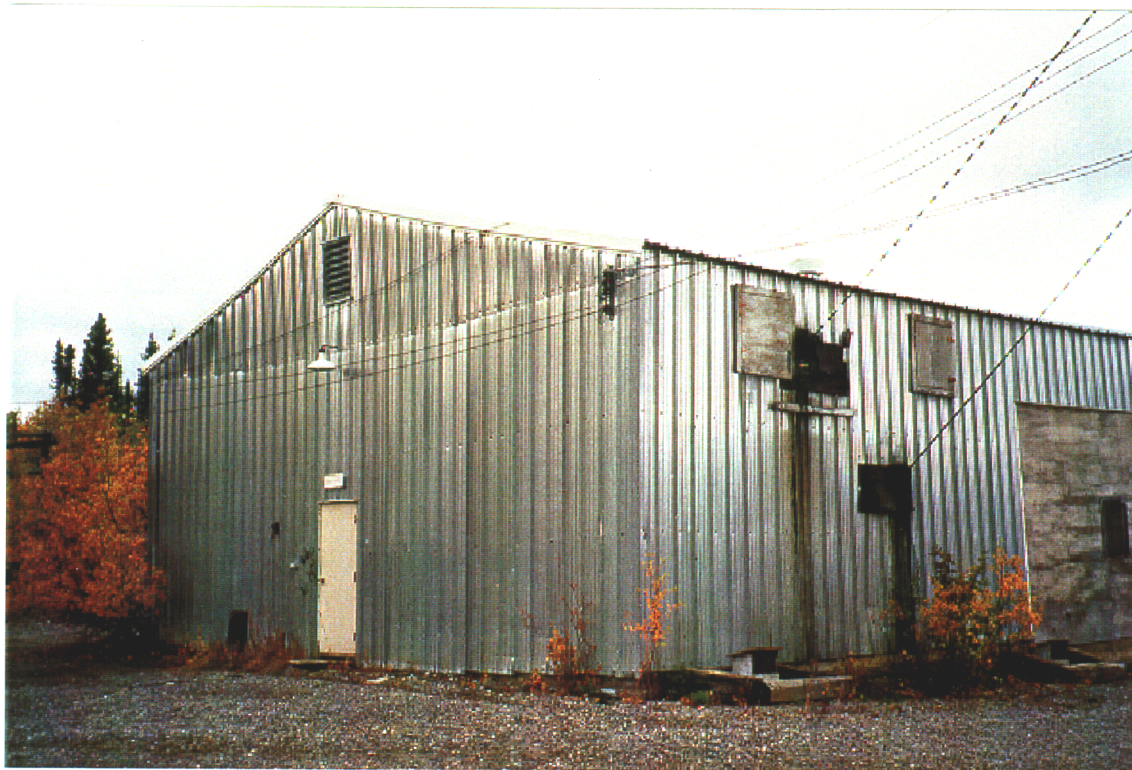
Building 2C-Boiler House (photo 2-5)

Hazardous Contents: There were two ASTs located in the interior of the building in the northeast corner. There did not appear to be any contents, however, it was difficult to determine as the tanks were encompassed with building debris.

Note: Staining was noted in the exterior of the building on the concrete floor as well as on the exterior of the rear addition. No staining was noted on the surrounding soils. A large vertical AST was located at the rear of the boiler house.

Hazardous Contents: The interior of the structure was heavily stained with both tar and rock drill oil. There was a drip pan under a 200L drum of rock drill oil that contained some product. There was some minor staining at the entrance to the building. 3 - 200L drums were located at the rear of the building and were empty. Minor surficial staining was noted surrounding the drums.

Photo 2-5: Boiler house.

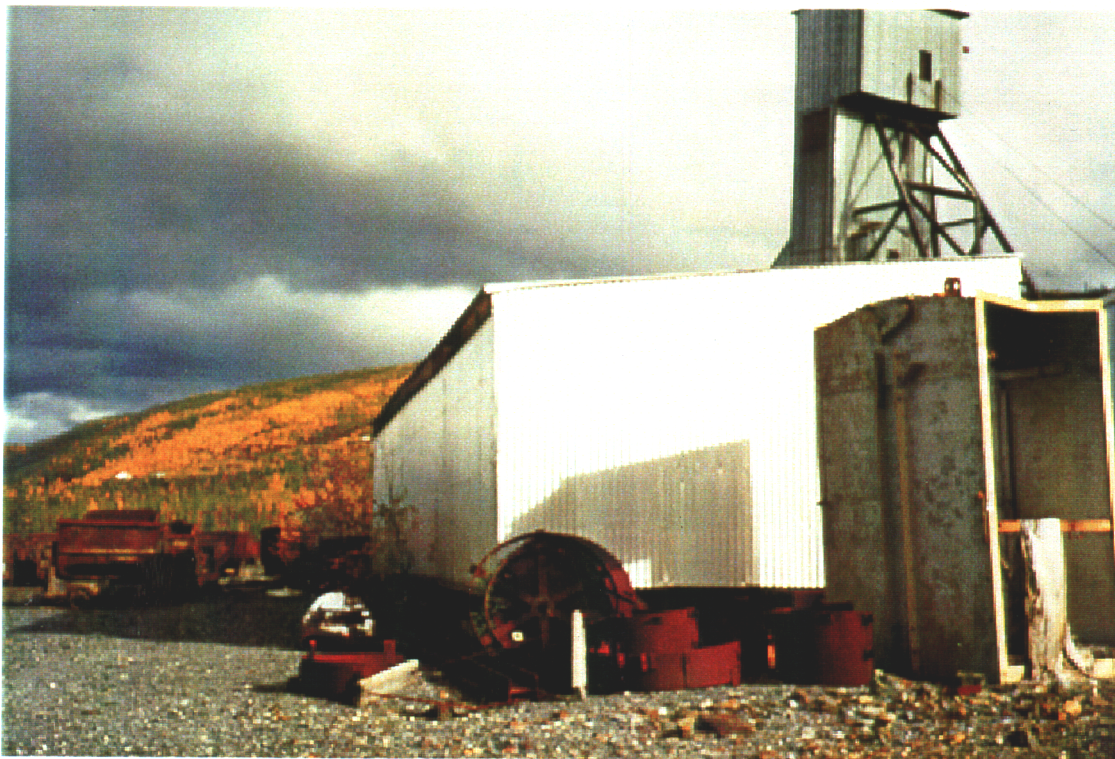
Building 2E - Large Storage Shed (photo 2-6)

Photo 2-6: Large storage shed.

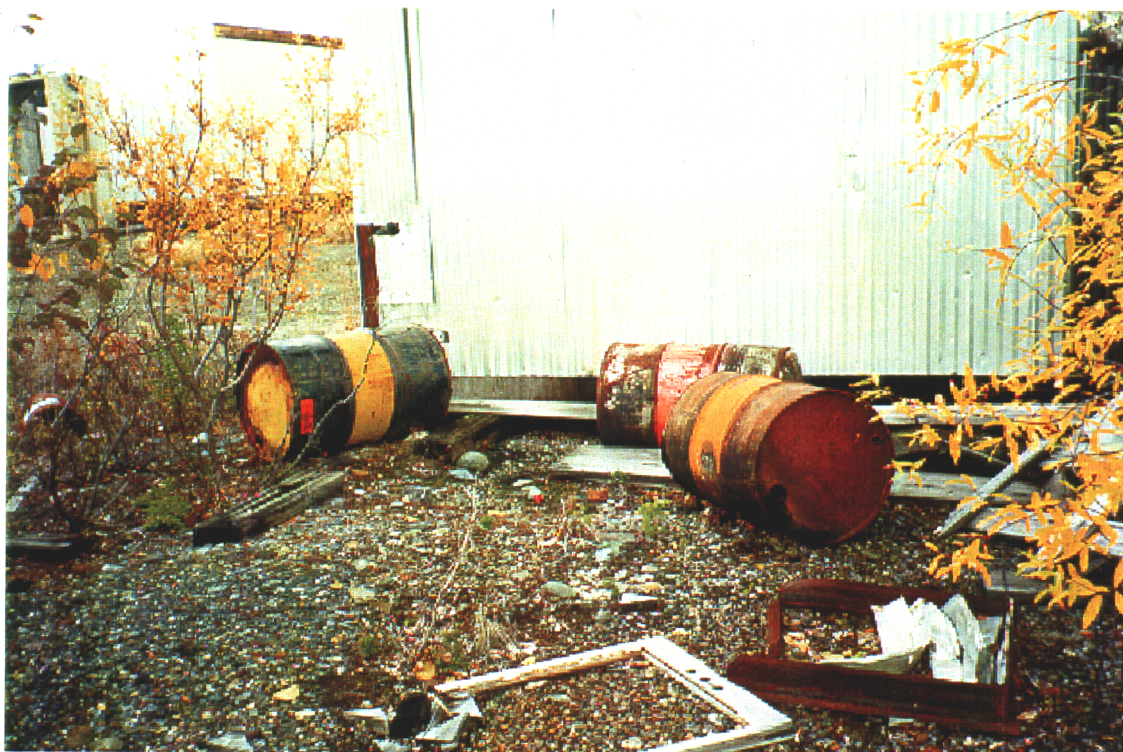
Note: There was some metal debris that was noted along the south side of the building that included empty and rusted out drums (photo 2-7). There was no sign of staining around the perimeter of building 2E.

Photo 2-7: 200L drums at rear of storage shed.

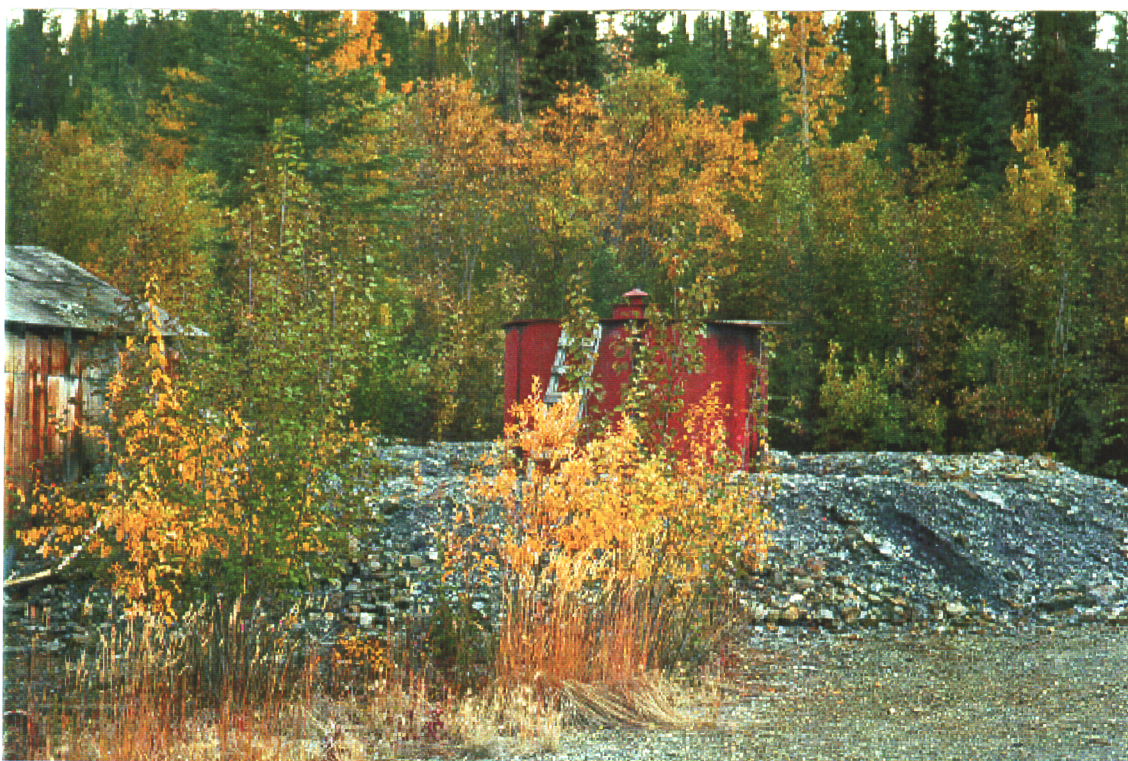
Location: An aboveground storage tank was located behind the boiler house (photo 2-8).

Soil staining was apparent in numerous areas of the site. Most of the areas were surficial in nature and did not appear to be adversely affecting the surrounding environment. The major area of concern noted was the aboveground storage tank. There is staining around the perimeter of the AST and it is difficult to determine the extent of contamination as the AST was placed on top of

Photo 2-8: AST behind boiler.

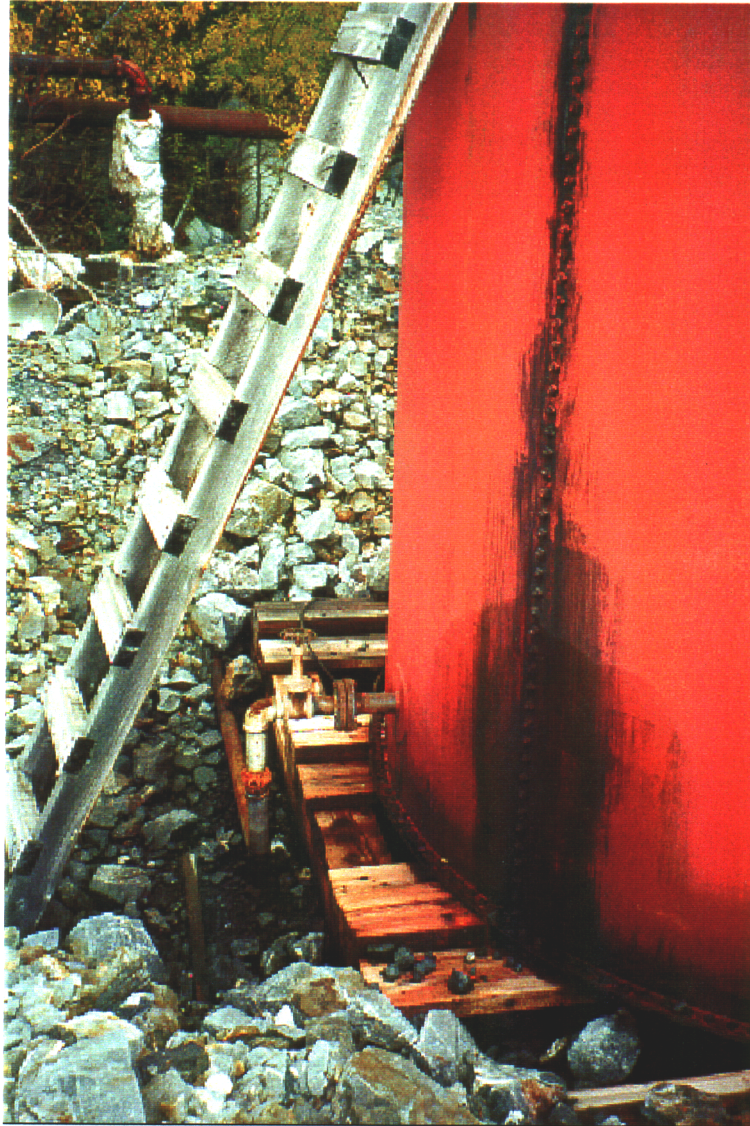
Above Ground Storage Tanks: The AST measured 3m in height and 2 m in diameter and consisted of steel bolted construction. There appeared to be staining along the bolted joints (photo 2-9). Soil staining was evident around the perimeter of the tank. There was heavy staining at the valves. A waste rock berm extends around the perimeter of the AST. Samples were not collected as the area surrounding the AST consisted exclusively of large waste rock.

Photo 2-9: AST & piping.

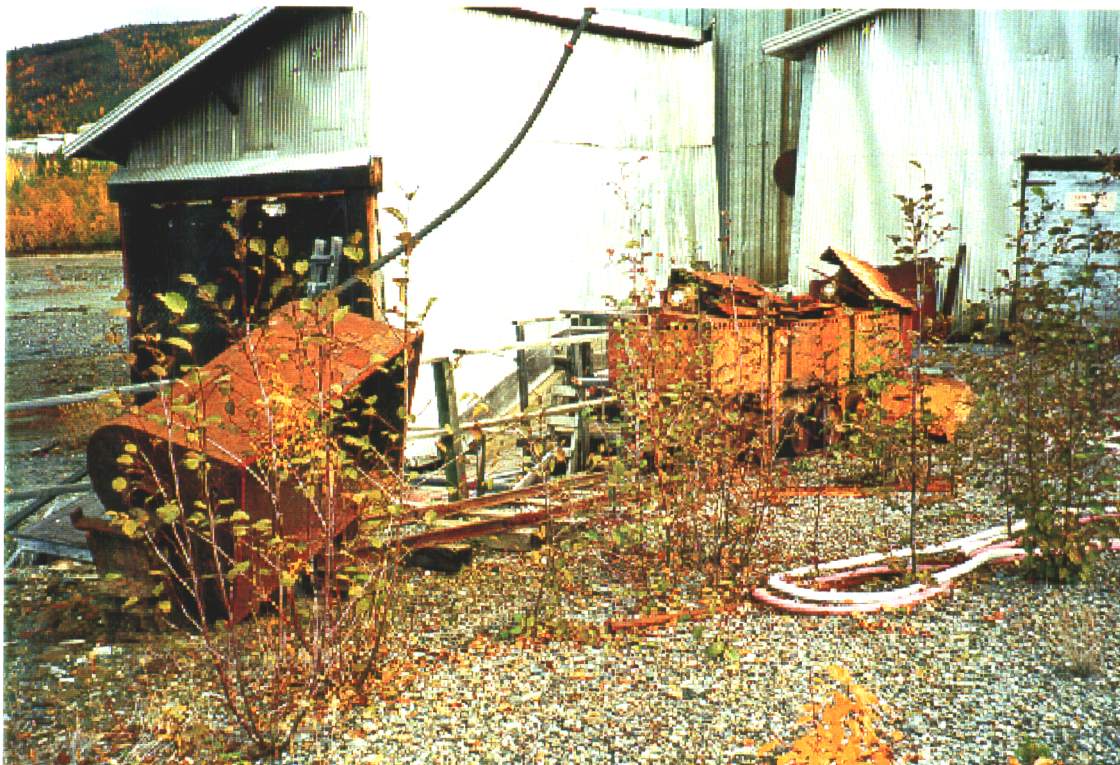
There were rails extending approximately 25m from the shaft house and stopped abruptly, rail debris and cars were abandoned in this area (photo 2-10). Approximately 28 rail cars were located behind building 2E (photo 2-11).

Photo 2-10: West side of headframe.

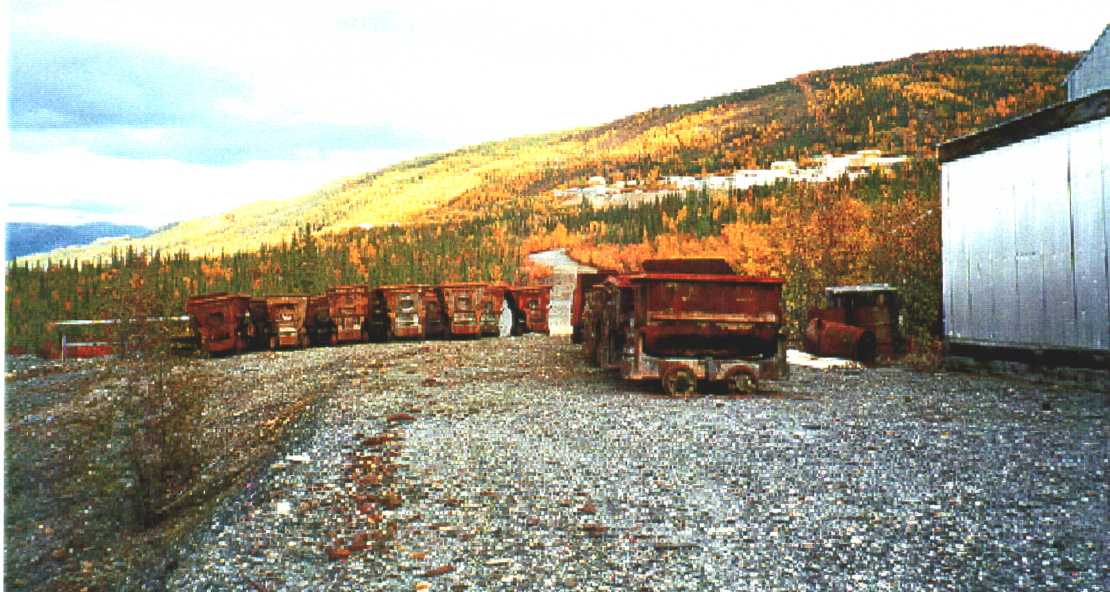
Photo 2-11: 28 Rail cars.

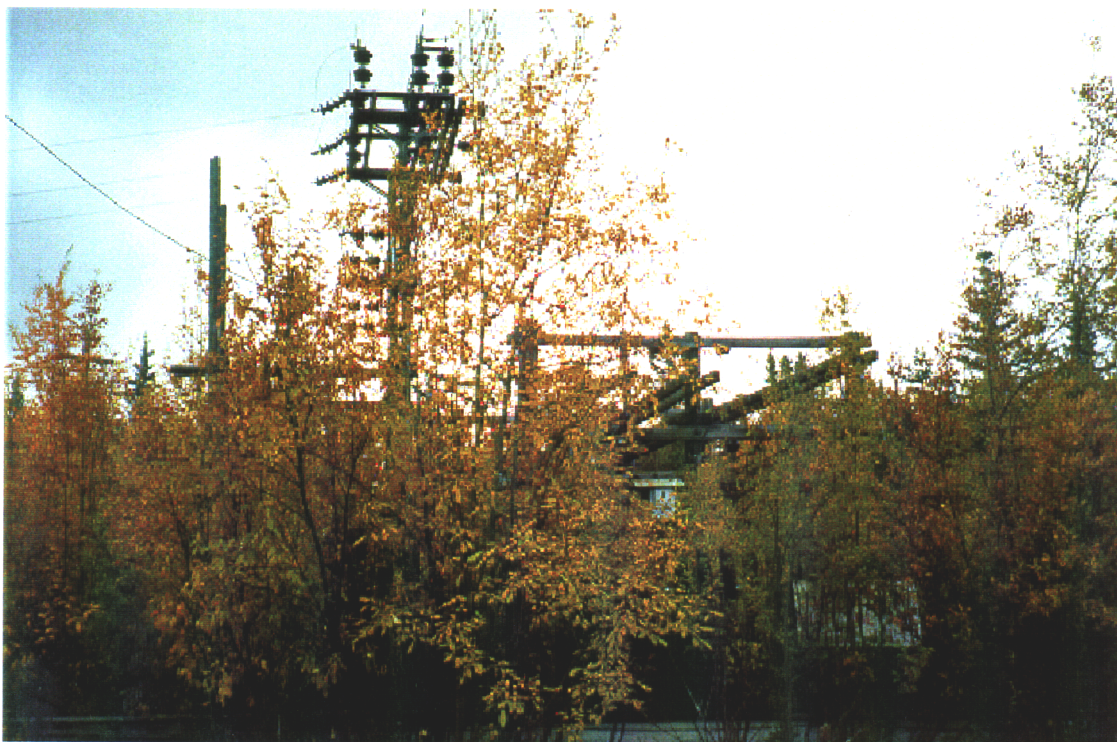
There were three transformers at the site located to the southeast of the boiler house (photo 2-12). No samples were taken as the transformers were still in use and the perimeter was fenced and padlocked.

Photo 2-12: Transformer compound.

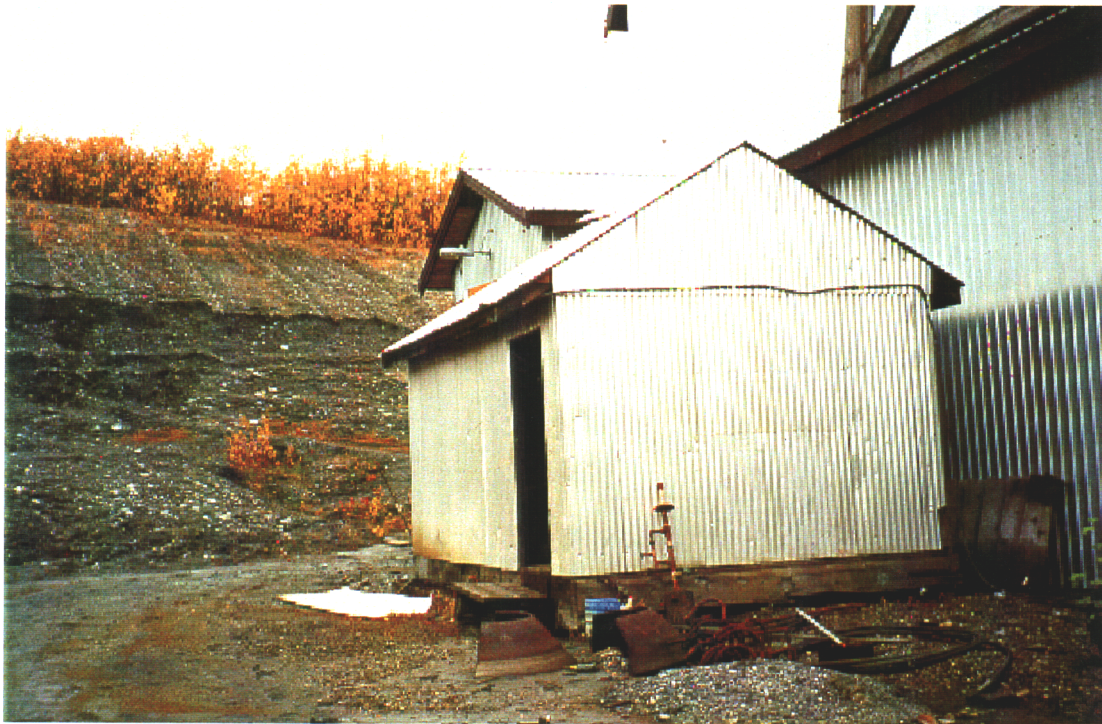
Building 2H – Workshop (photo 2-13)

Photo 2-13: Building 1 - Workshop.

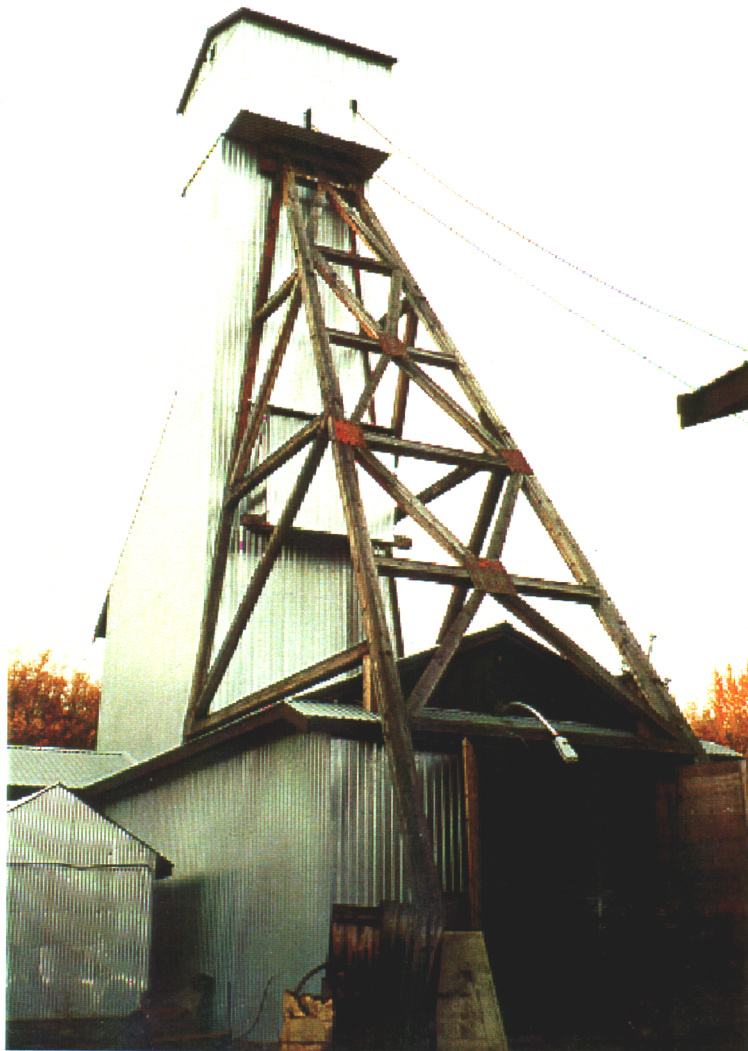
Building 2I – Shaft House and Headframe (photo 2-14)

Construction: The structure consisted of wood frame construction with exterior galvanized steel sheathing. A timber reinforcement structure was located on the west wall of the building to stabilize the headframe.

Photo 2-14: Shaft headframe house.

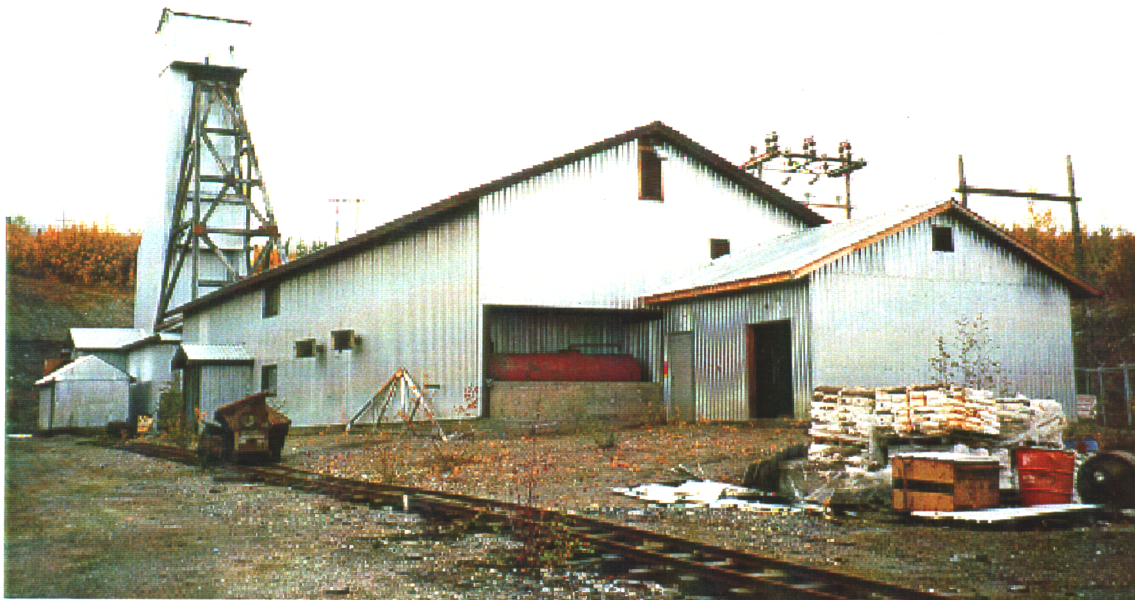
Hazardous Contents: An aboveground storage tank was located on the northwest corner of the building and was incorporated into the structure(photo 2-15). Secondary containment consists of a concrete berm that extends half way up the AST. The tank is open to the elements, however, it is located under a building overhang (photo).

There was one aboveground storage tank (photo 2-15) that was located on the northwest corner of the hoist house. The tank was welded steel and no leaks were noted - no staining was noted in the concrete secondary containment.

Photo 2-15: Structures at site.

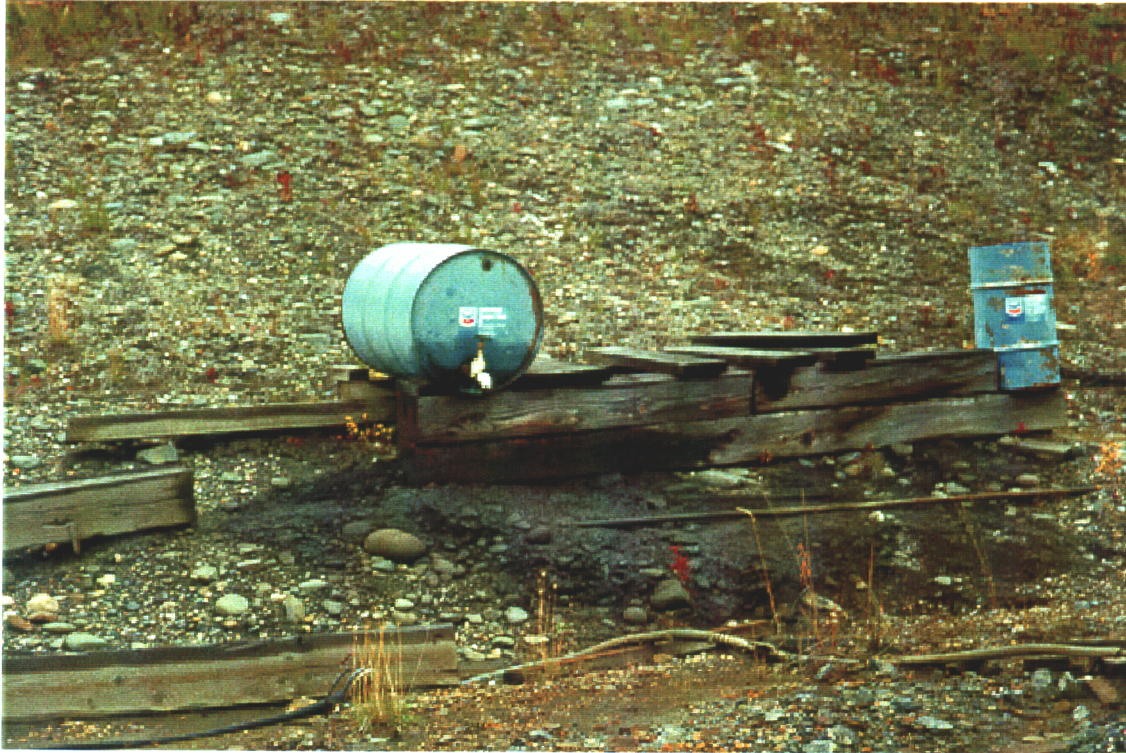
There were two 200L drums labeled as torque fluid. One of the drums was horizontal on a wood platform with a closed bottom valve (photo 2-19). The drums did not contain any product or residue however, the area around the horizontal drum was stained. Intrusive investigation indicated that the contamination was surficial. The area of contamination was estimated at 10m x 8m with an approximate depth of .25m.

Photo 2-19: Torque fluid 200L staining is evident.

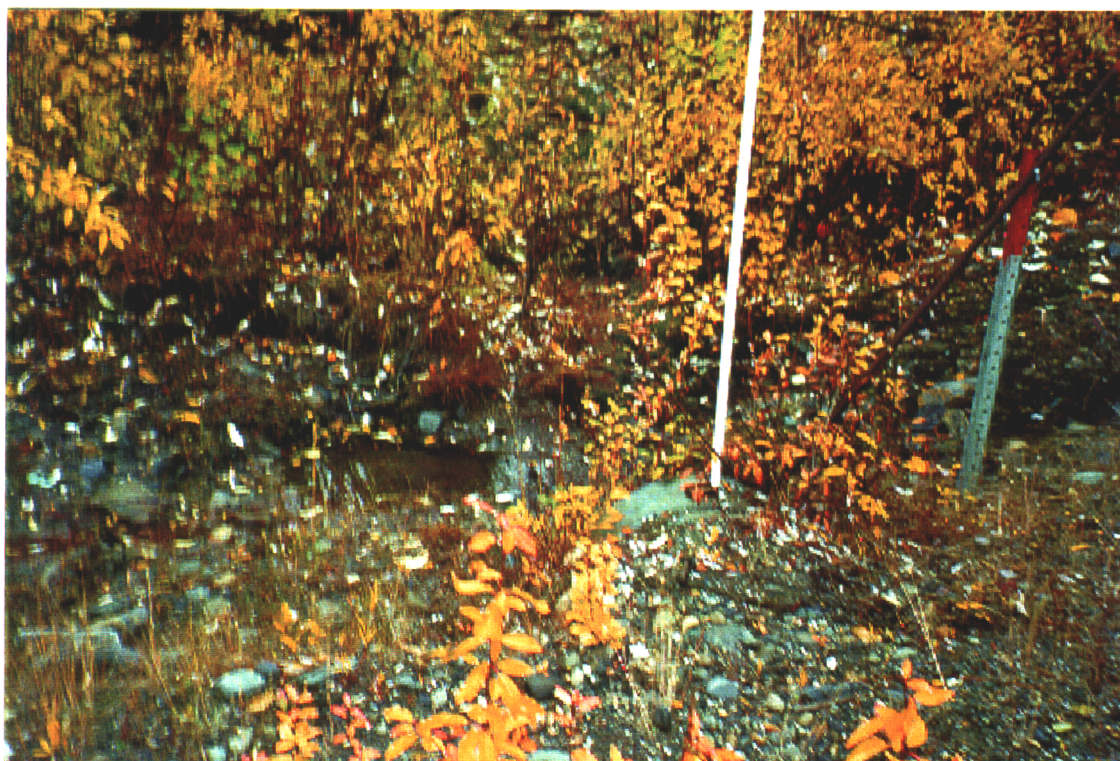
Two samples were taken at the Husky SW mine site. The first sample (02-01-upswater) was taken above the site (photo 2-22). The water was clear and there was abundant mosses and lichens along the rock faces. The sample was taken on the south side of the road at the culvert. Water flow at the sampling location was .75L/s with a field testing of 7.6 pH and conductivity at 18µS. Laboratory sample results can be found in Attachment B.

Photo 2-22: Sample location 02-01 - upstream. Sample location just off Hwy 2 at culvert.
