CORAL WIGWAM #5
(MINFILE# 105M 001C)

Public Works And Government Services Canada	Travaux publics et Services gouvernementaux Canada	designed by: coral int.	date: 11/99
	Architectural & Engineering Services Western Region		drawn by: C.S.	
			designed by: approved by: approuvé par: révisé par:	
			revision:	
Drawing title: Coral & Wigwam Site #5 Site Assessment		Time du dessin: 125-12.01		1 of 1
Yukon Territory		projet no. 125-12.01		date de dessin no. 1 of 1

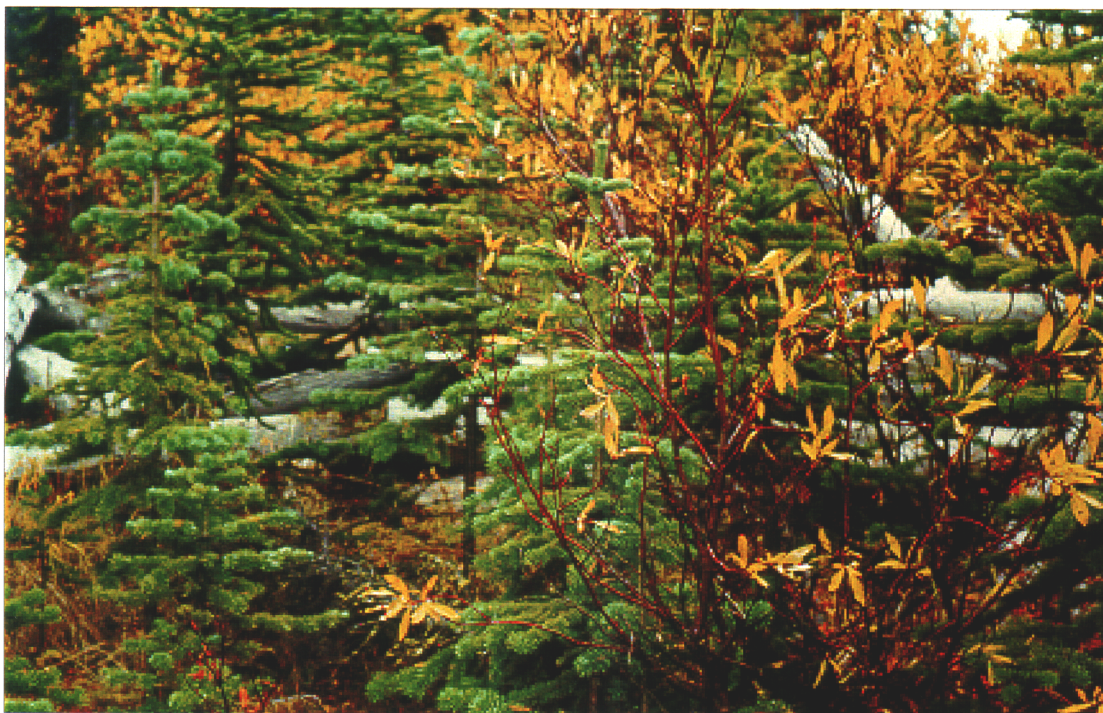
Building has collapsed and deteriorated.

Construction: The structure appeared to be of one room log construction.

Photo 5-1: Building 5A - Building was of log construction has deteriorated and collapsed.

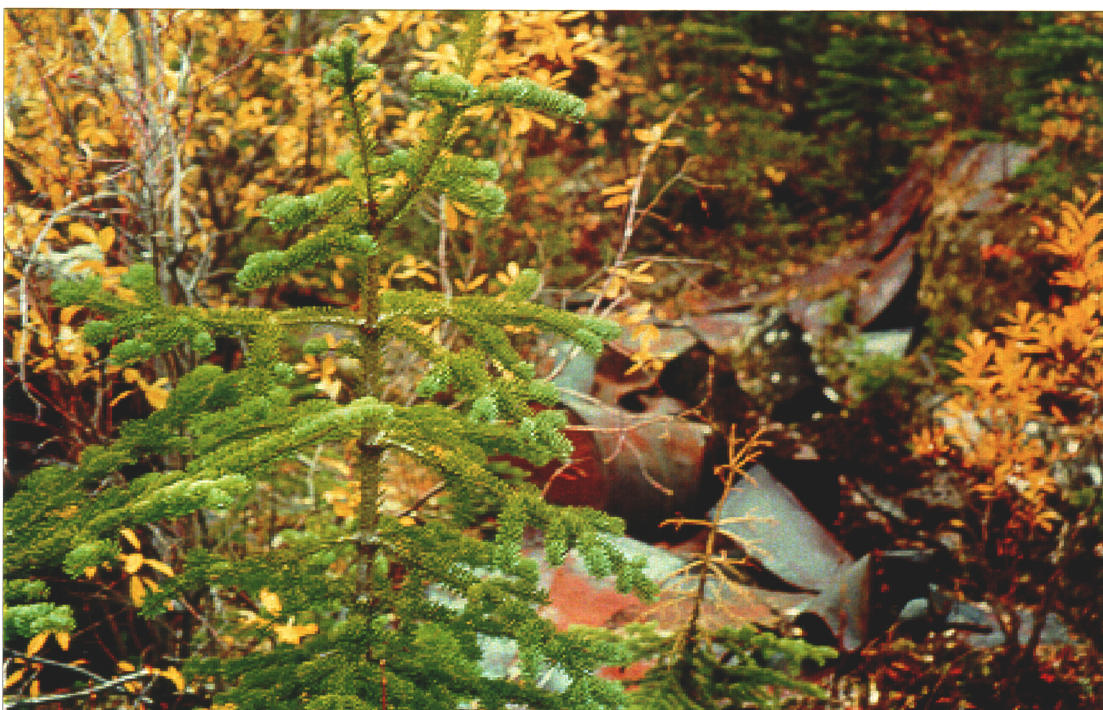
Building has burnt and collapsed.

Construction: There is some metal debris at the site, however, there is very little wood debris left at the site as any flammable or combustible materials have been incinerated.

Photo 5-2: Building 5B - Building had collapsed and burnt - metal debris appeared to be burnt.

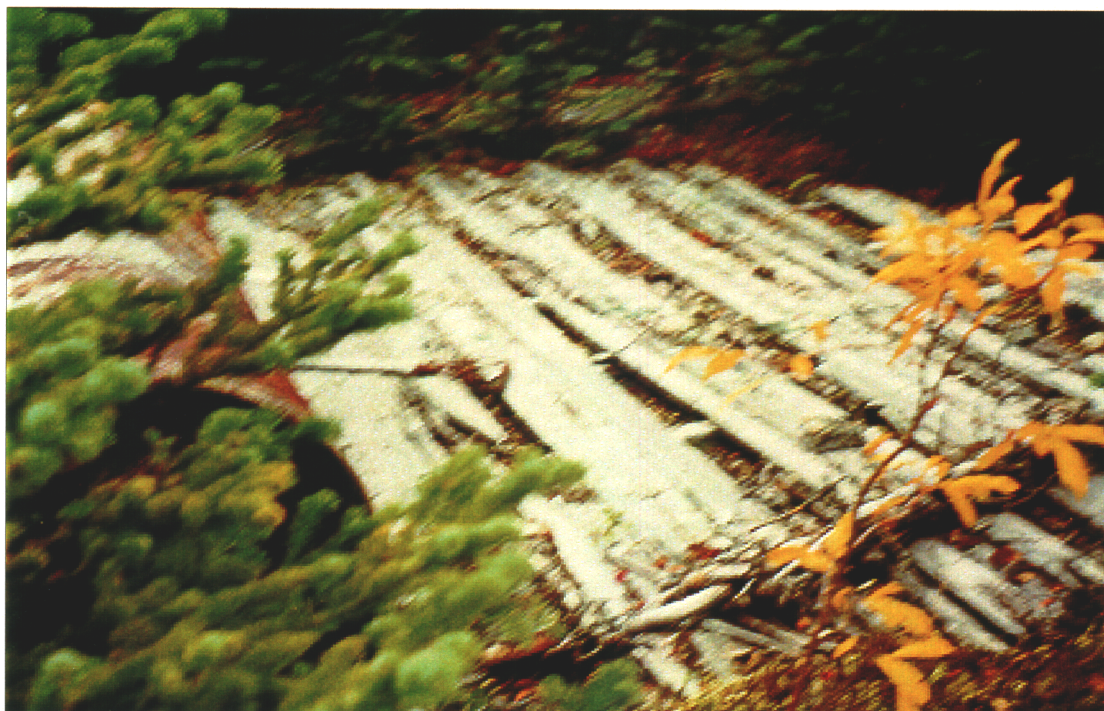
There is only wood plank floor remnants left at the site. A drum utilized as a stove was situated in the corner of the building site.

Photo 5-3: Building 5C - Building has collapsed and only plank flooring is evident.

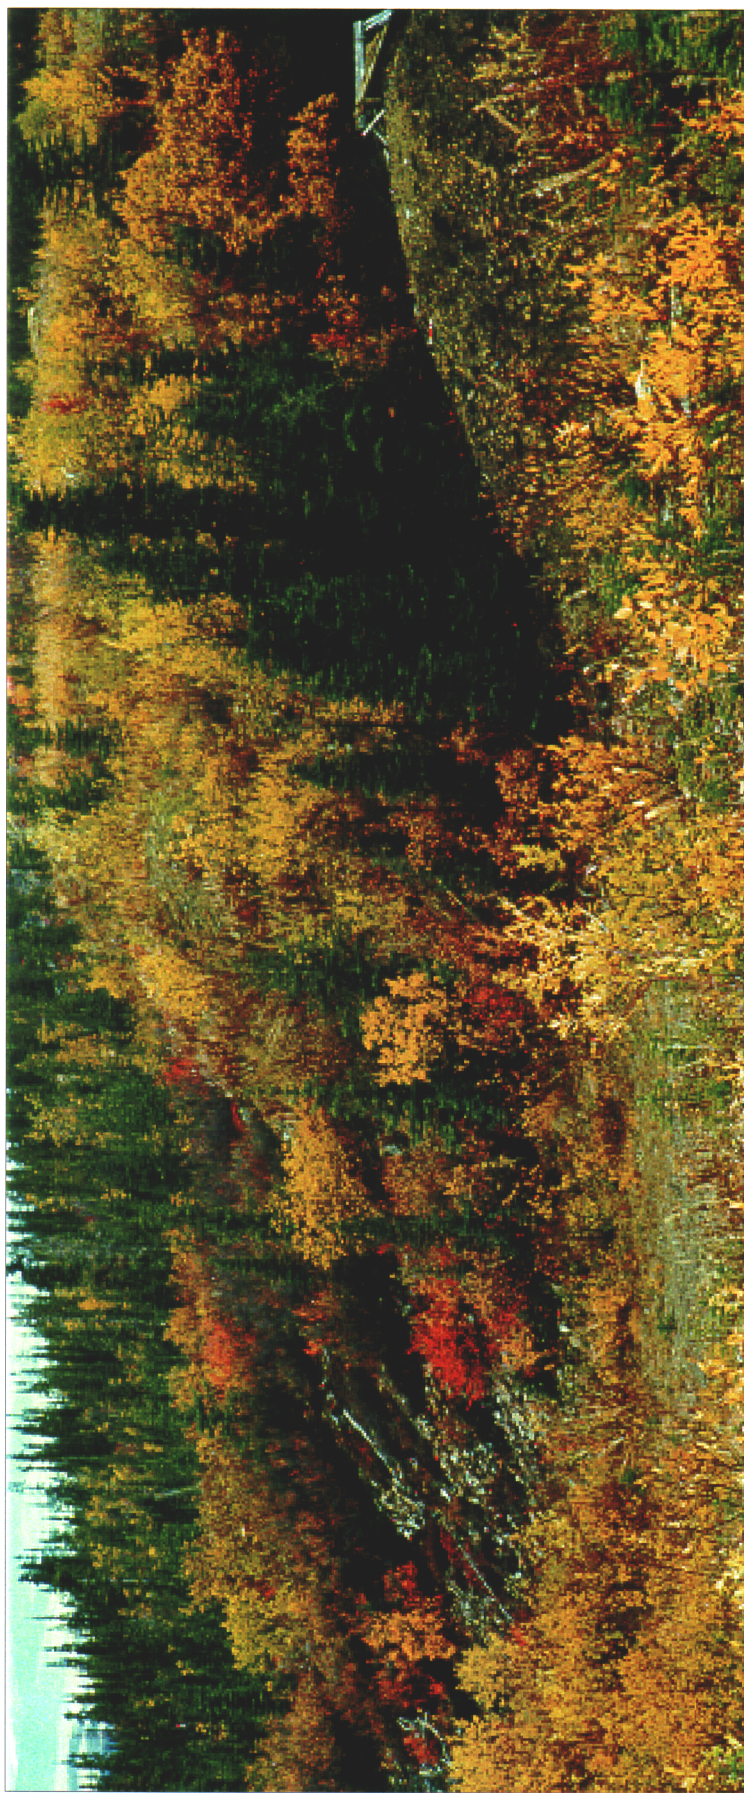
The structure was utilized as a shaft house, however, it has collapsed and deteriorated and is a safety hazard.

Photo 5-4: Trenched area below the collapsed shafthouse (shafthouse debris can be seen on the far right of photo).

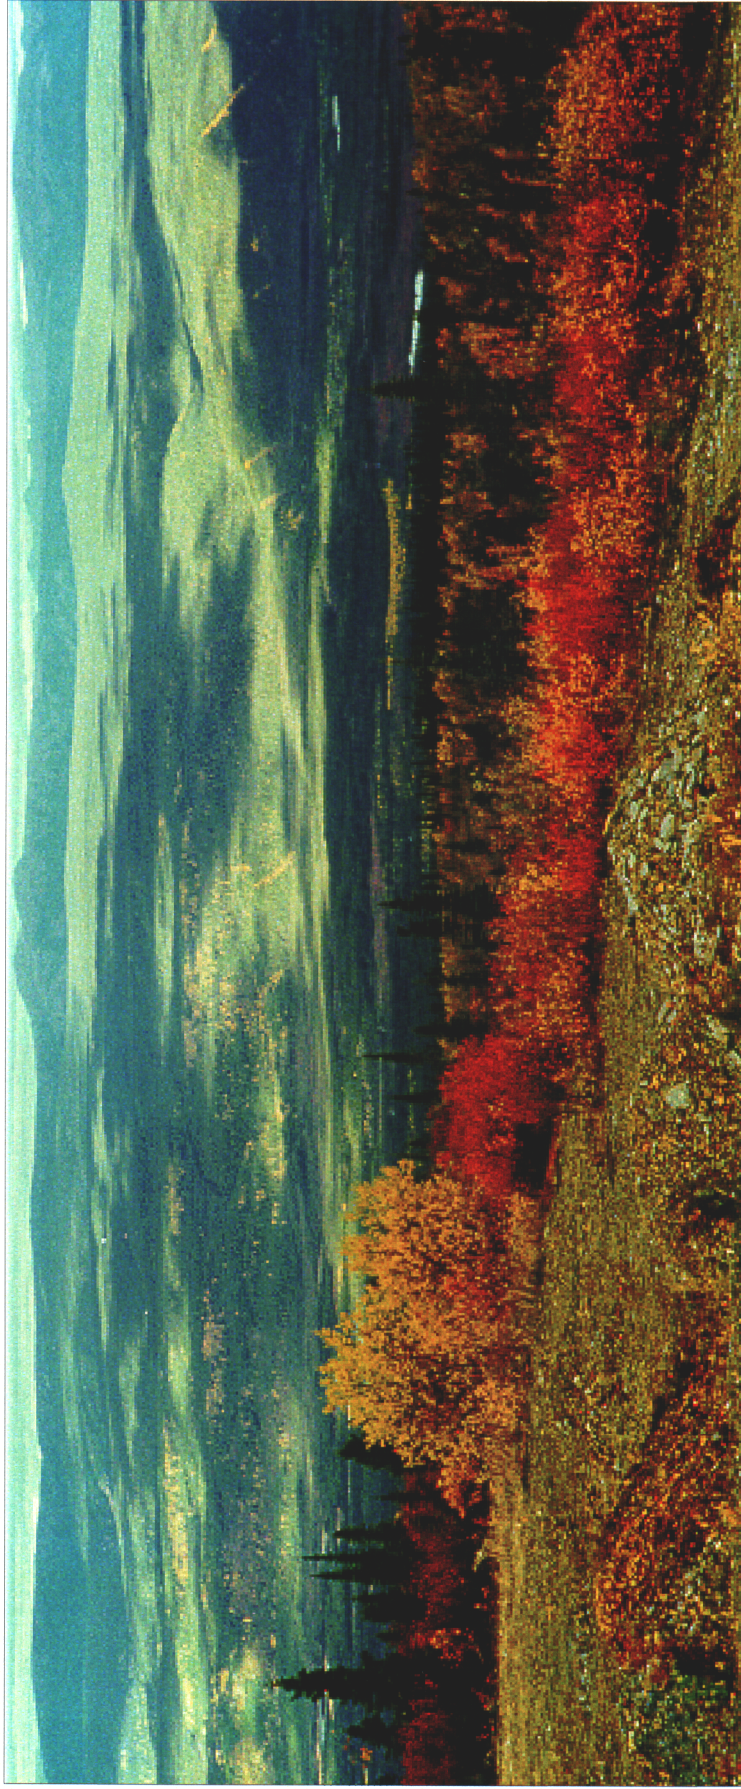
There are seven backhoe trenches in the stripped area. They are 1.5 to 2 m deep by 2 to 3 m wide and from 10 to 15 m long. The material taken from the cuts is piled alongside the trenches. The trenches present a minor hazard.

Photo 5-5: Small trenched areas can be noted in the foreground of the photo within the leveled area of the waste rock dump.

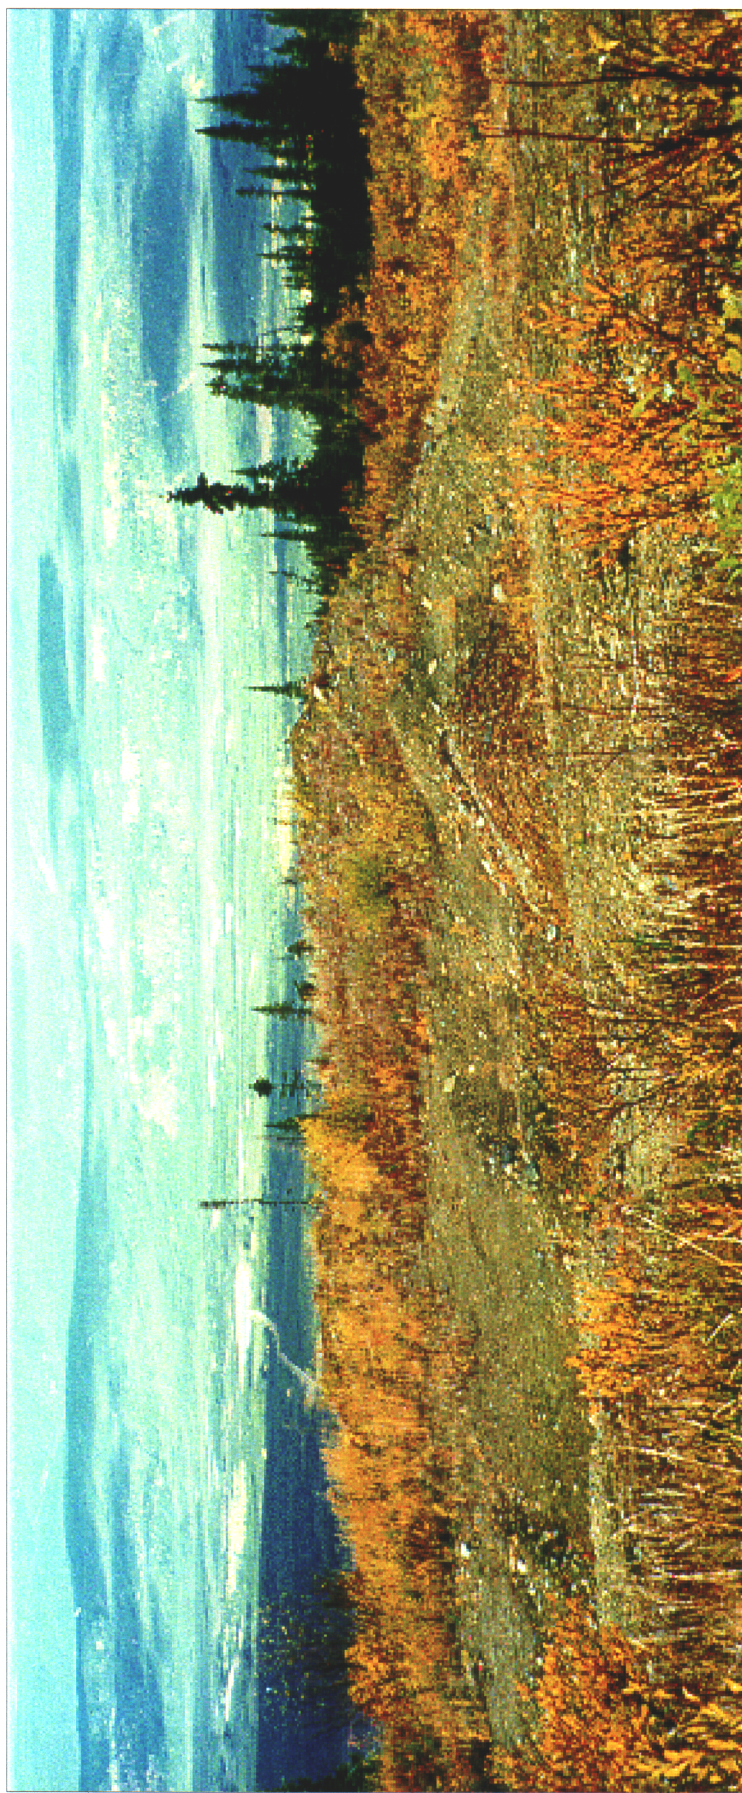
Photo 5-6: Trenched area is on the southwest portion of the Coral and Wigwam site.
