DRAGON (UN) & MILLER

Site No. 10

MINFILE: 105M 001j

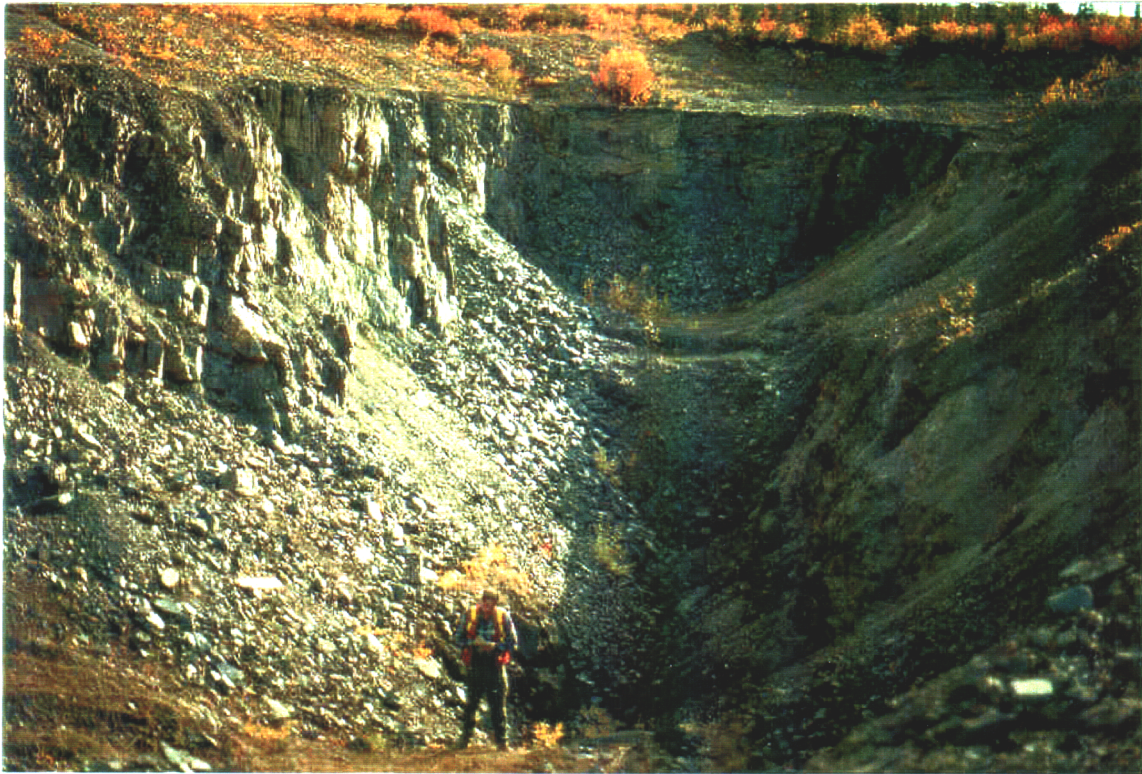
The walls of the Miller Pit are composed of thick beds of resistant quartzite (Photo 10-1). The walls show no mineralization but manganese oxide staining is common. The western wall of the pit has a strong manganese oxide stain, some clay alteration and a small amount of siderite, indicating the end of the mineralized vein. There is no outcrop outside the adit; the adit was not entered.

The Miller Pit is approximately 90 m long, 10 m wide and 15 m deep (Photo 10-1). The walls are composed of quartzite, and the north and east walls are both steep and thick-bedded quartzite beds can be seen. In contrast, the west wall of the pit, which is more altered, has more erosion.

Photo 10-1. Miller Pit looking south.

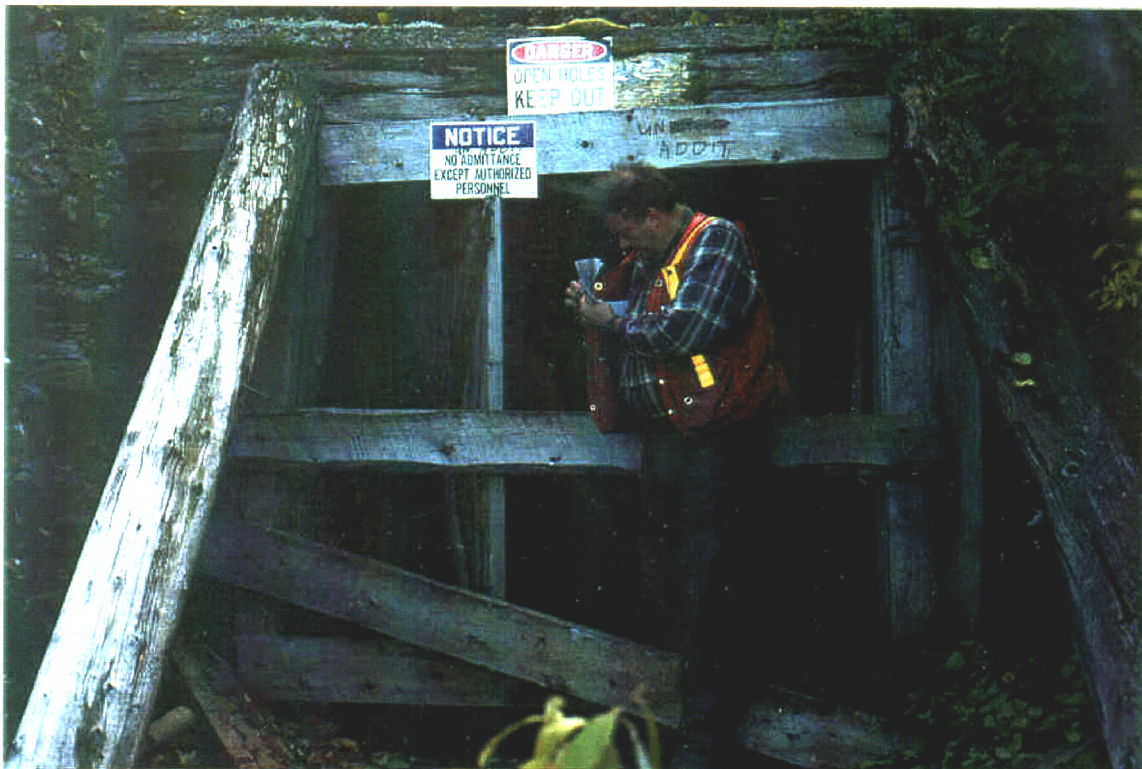
The UN portal is 2 m high and constructed with wood beams (Photo 10-2). The adit has a wooden door to the adit was open at the time of the site visit. The adit is blocked by ice that extends to the sides of the adit, and comes to within 20 cm of the roof. The ice block is reportedly present year round, but has never fully blocked the water flow (B.Dunn, pers. comm).

Photo 10-2. UN portal showing wooden debris and open door.

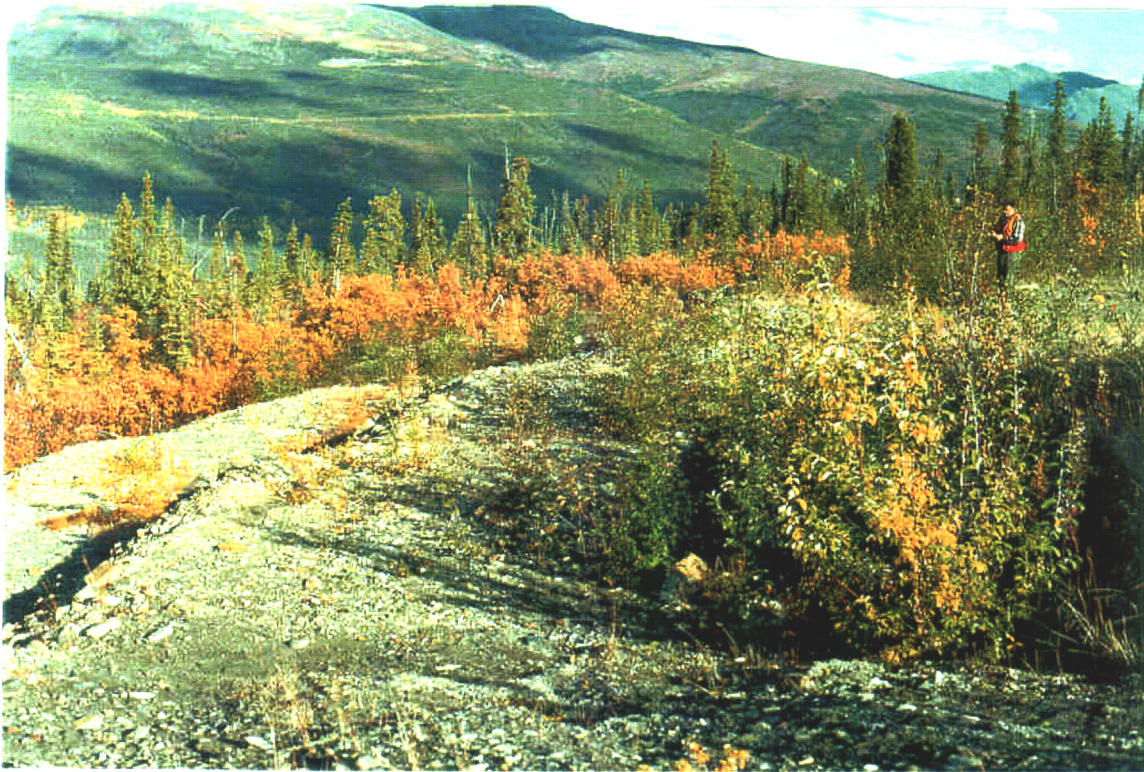
There are waste disposal areas associated with both the Dragon (UN) adit and the Miller open pit. The adit dump contains approximately 8,000 m³ of waste, and consists mainly of schists and quartzite with little staining or alteration. The surrounding vegetation has not been impacted by the dump, and has begun to encroach on the dump material (Photo 10-3).

Photo 10-3. Waste rock pile outside the UN adit, showing natural revegetation.

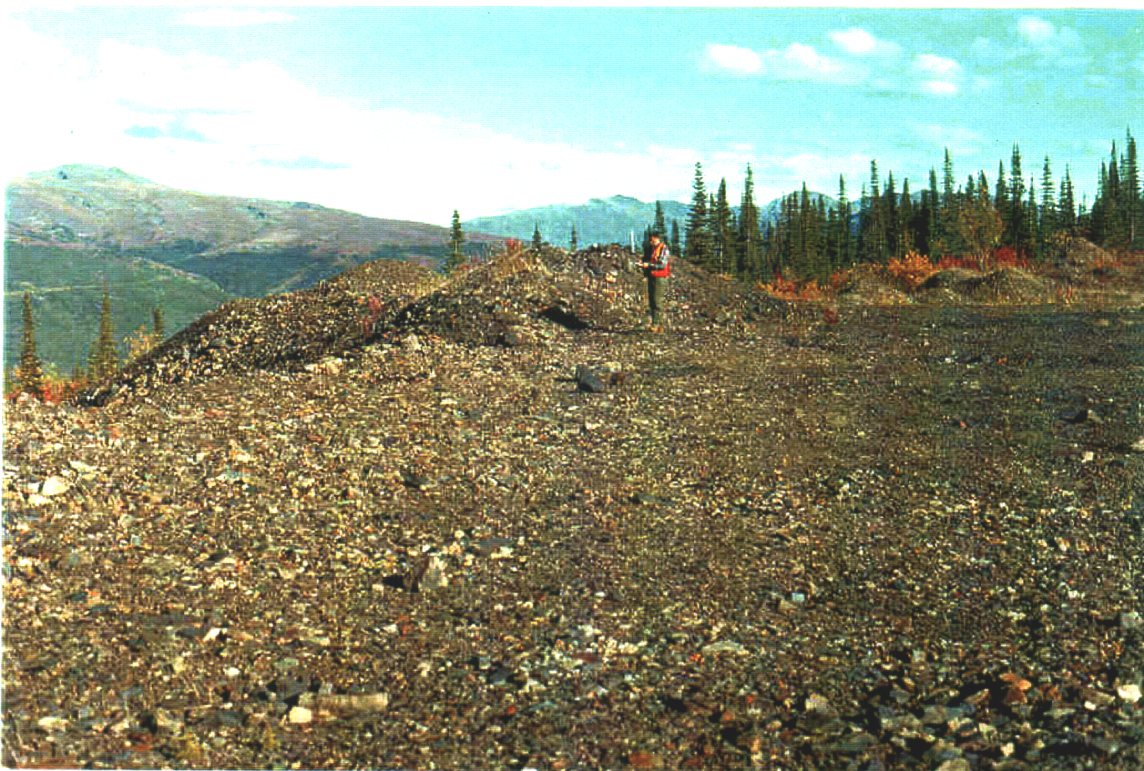
The estimated volume of material in the dump at the Miller pit is 80,000 m³ (Photo 10-4). The waste rock consists primarily of quartzite with some schist. There is little vein material and some manganese staining.

Photo 10-4. Miller waste rock pile.

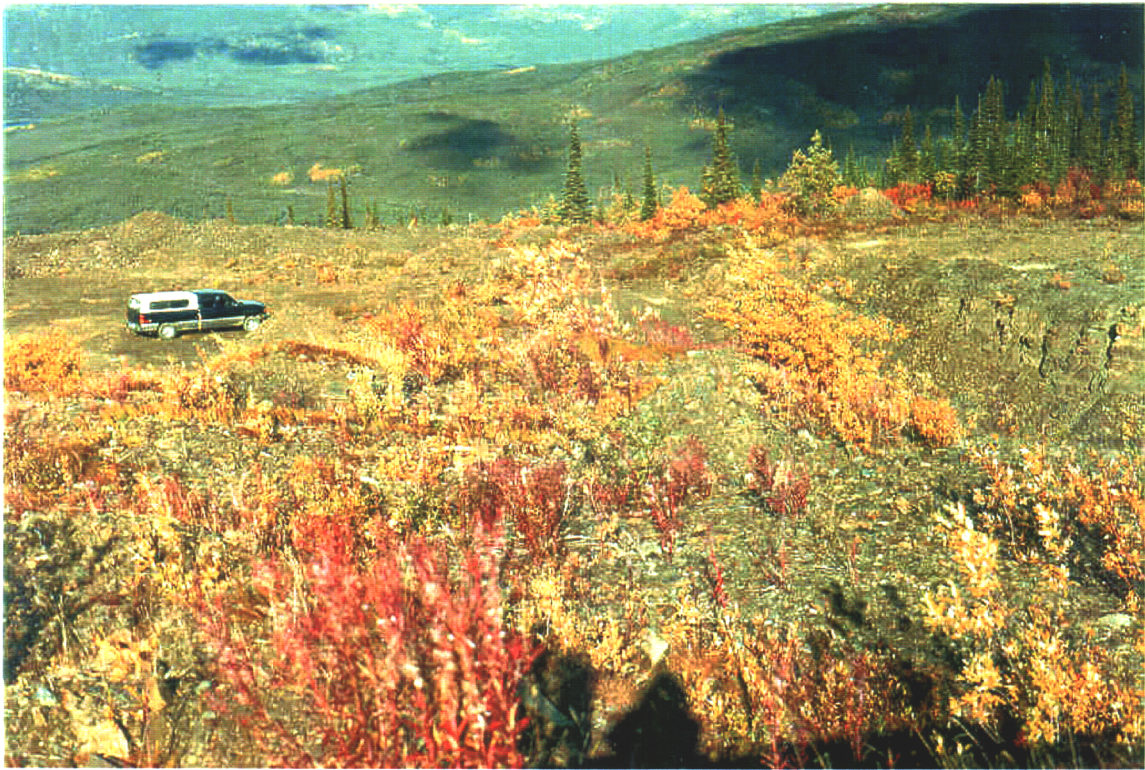
The waste rock pile at the UN adit and the disturbed areas surrounding the Miller Pit are beginning to revegetate (Photo 10-5). This will likely take a long time as there is mostly barren rock in these areas, and little water. Some revegetation of the waste rock dump is also beginning (Photo 10-4).

Photo 10-5. Natural revegetation of area adjacent to the Miller Pit that was cleared during mining.
