## **FISHER CREEK**

### **SITE #13**

#### **MINFILE# 105M001o**

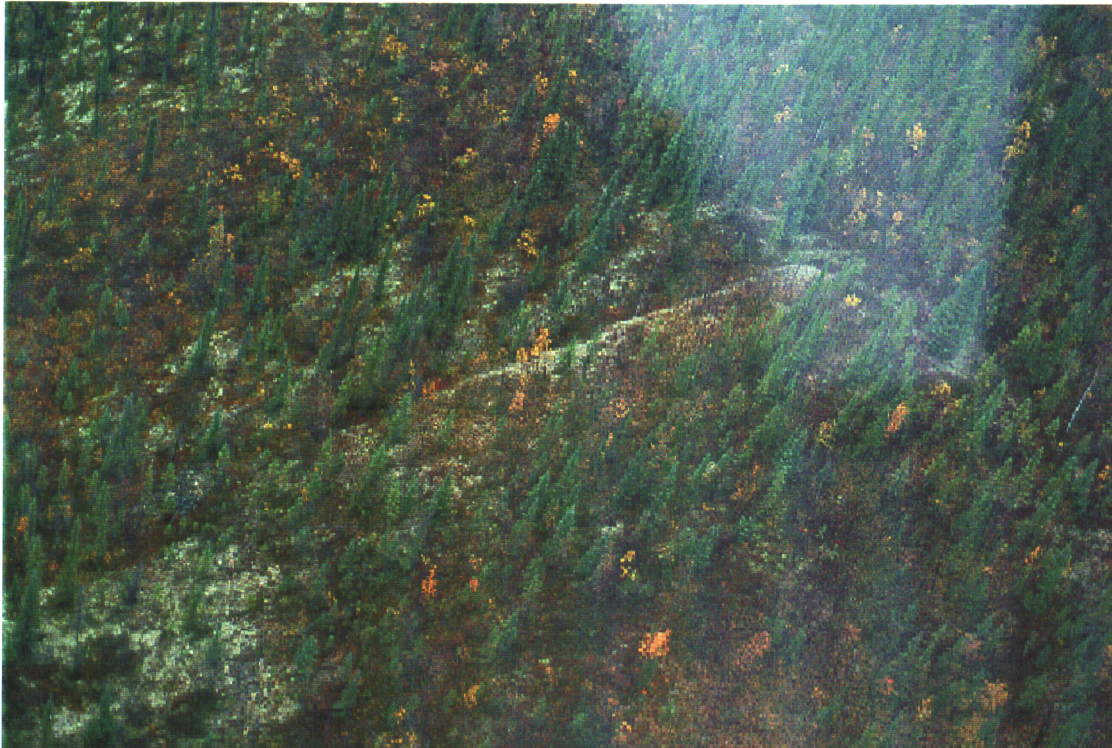
### **Trench 1 (photo 13-1)**

Trench 1 is has become overgrown with trees and shrubs.

Condition: There is no evidence of slumping of the trench walls, which were stable at the time of the site visit.

Photo 13-1: Aerial shot of trench #1. (Azimuth 180°)

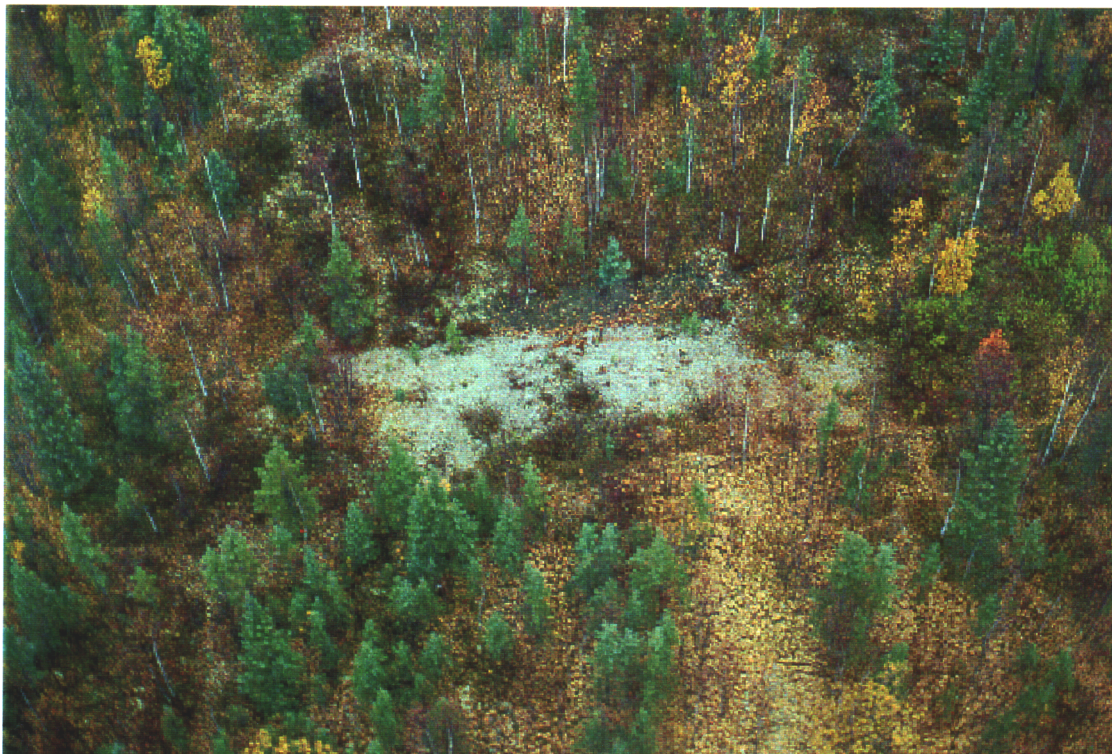
### **Trench 2 (photo 13-2)**

Trench 2 is shallow but wide. Sparse vegetation is growing within the trench.

Condition: There is no evidence of slumping of the trench walls.

Photo 13-2: Aerial shot of trench #2. (Azimuth 280°)

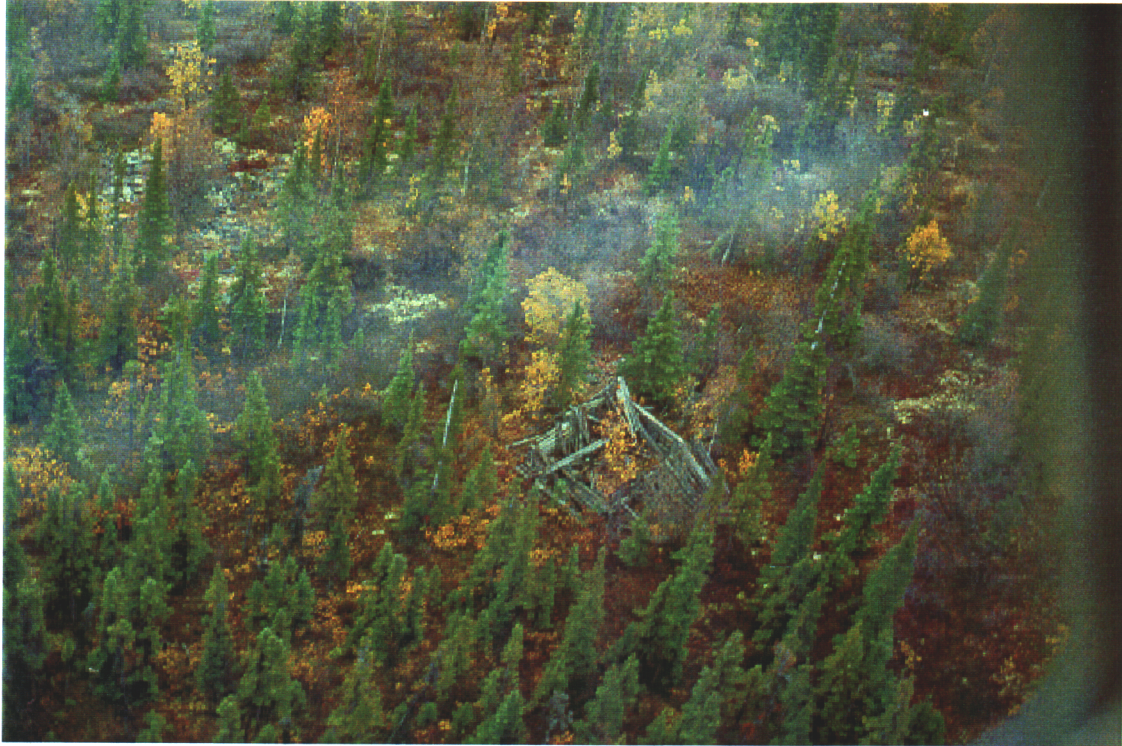
### **6.1 Building 13A (photo 13-3)**

One collapsed log cabin (Building 13A) was encountered.

Photo 13-3: Aerial shot of the collapsed log cabin. (Azimuth 260°)
