**BLUEBIRD**  
**SITE NO. 14**  
**105M 001b**

| <br>Public Works<br>And Government<br>Services Canada | Travaux publics et<br>Services gouvernementaux<br>Canada | designed by:<br><br>conçu par:<br><br>drawn by:<br><br>dessiné par:<br><br>checked by:<br><br>approuvé par:<br><br>approved by:<br><br>revisions: | date:<br><br>C.S.<br><br>NOV. /99 | project no.<br>drawn no.<br>no. du projet: | 125-12.01 | 1 of 1 |
| drawing title:<br><br>Bluebird Site #14<br>Site Assessment<br>Yukon Territory | | Title du dessin:<br><br>Bluebird Site #14<br>Site Assessment<br>Yukon Territory | | | | |

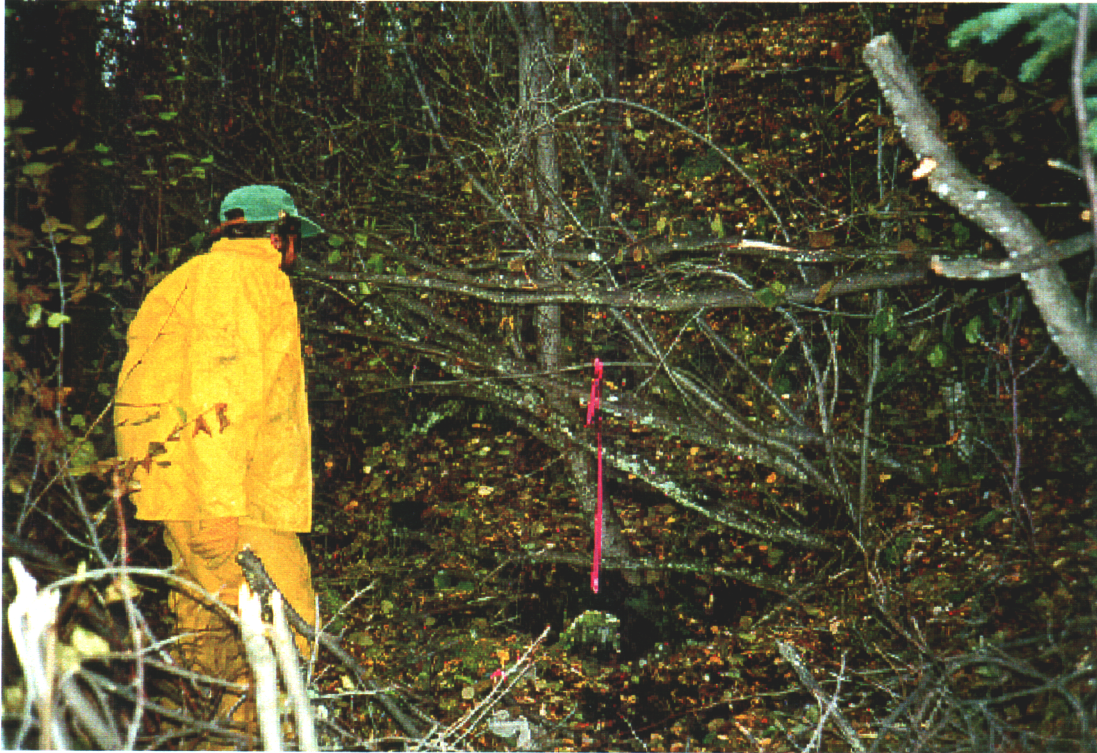
Condition: All of the shafts are partially to completely collapsed, and the northernmost shaft has 40 cm of standing water covering the fill material.

Photo 14-1: Lower shaft; opening located below flagging. (Azimuth 180°)

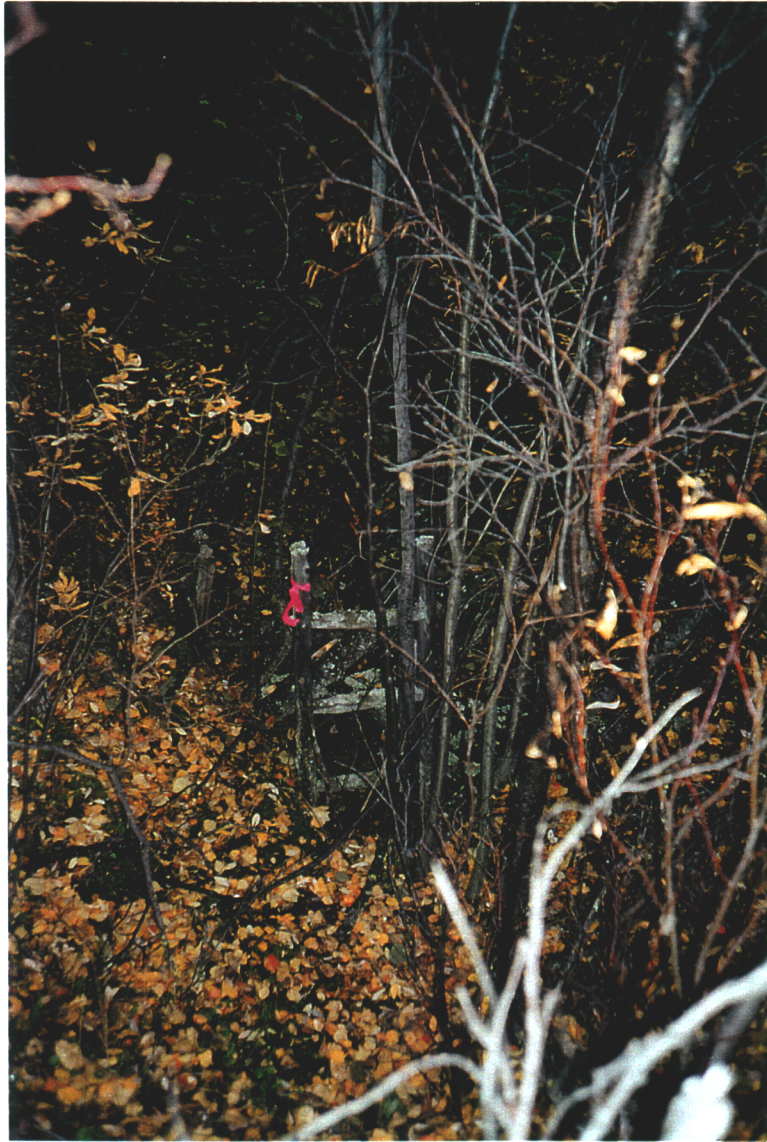
Supports: Some small rotten timbers are visible projecting out of some shafts. Rotten ladders are present at the upper three shafts

Photo 14-2: Lower-middle shaft; note ladder extending out of shaft opening. (Azimuth 040°)

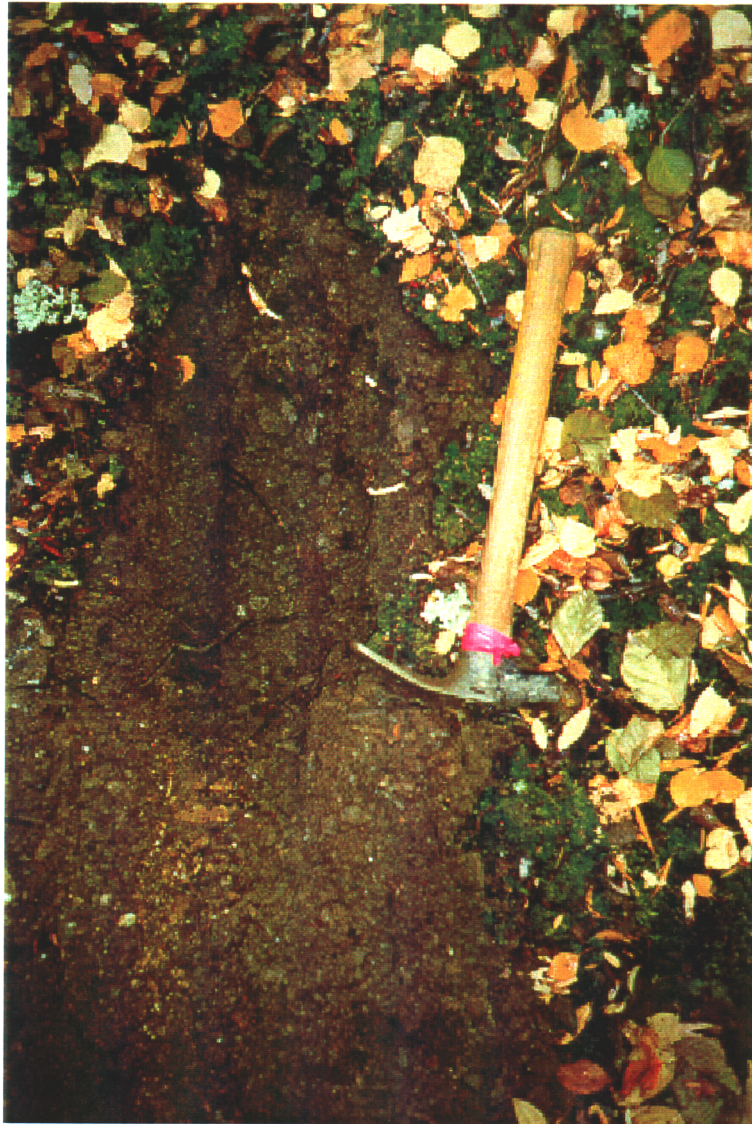
Sampling: No waste rock samples were collected. A 30cm test pit was dug, which revealed fine grey-brown phyllite flakes with 5% bright orange siderite material.

Photo 14-3: Test pit in rock dump for lower-middle shaft.

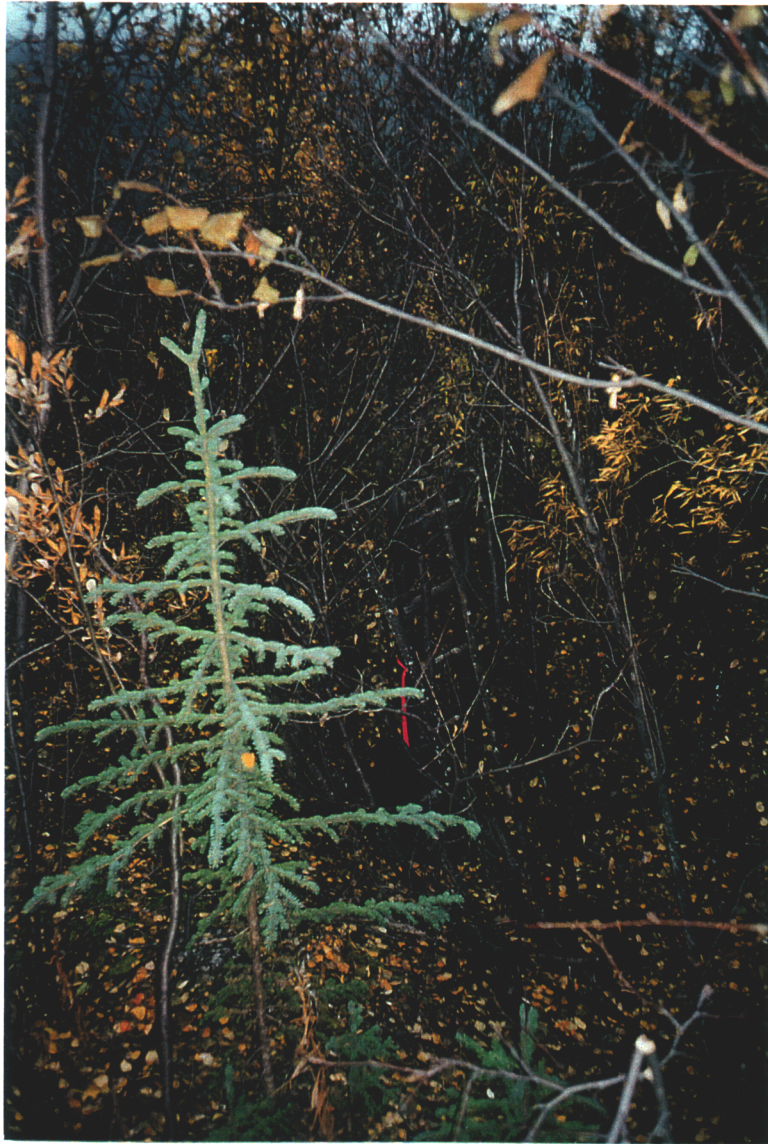
Dimensions: (L x W x H) Maximum size about 12 x 8 x 1m (Upper Middle); difficult to measure due to revegetation.

Photo 14-4: Upper-middle shaft and rock dump area; note flagging on ladder extending from shaft opening and mapper standing at end of rock dump. (Azimuth 120°)

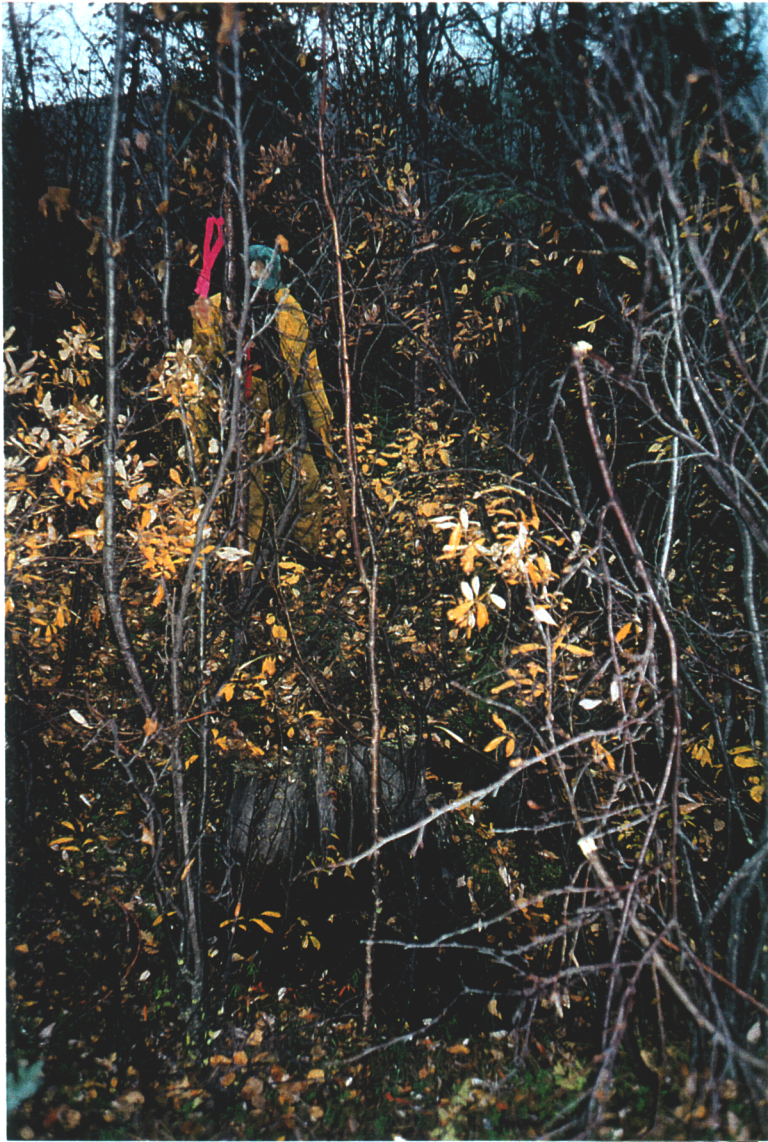
Photo 14-5: Upper shaft site. (Azimuth 050°)

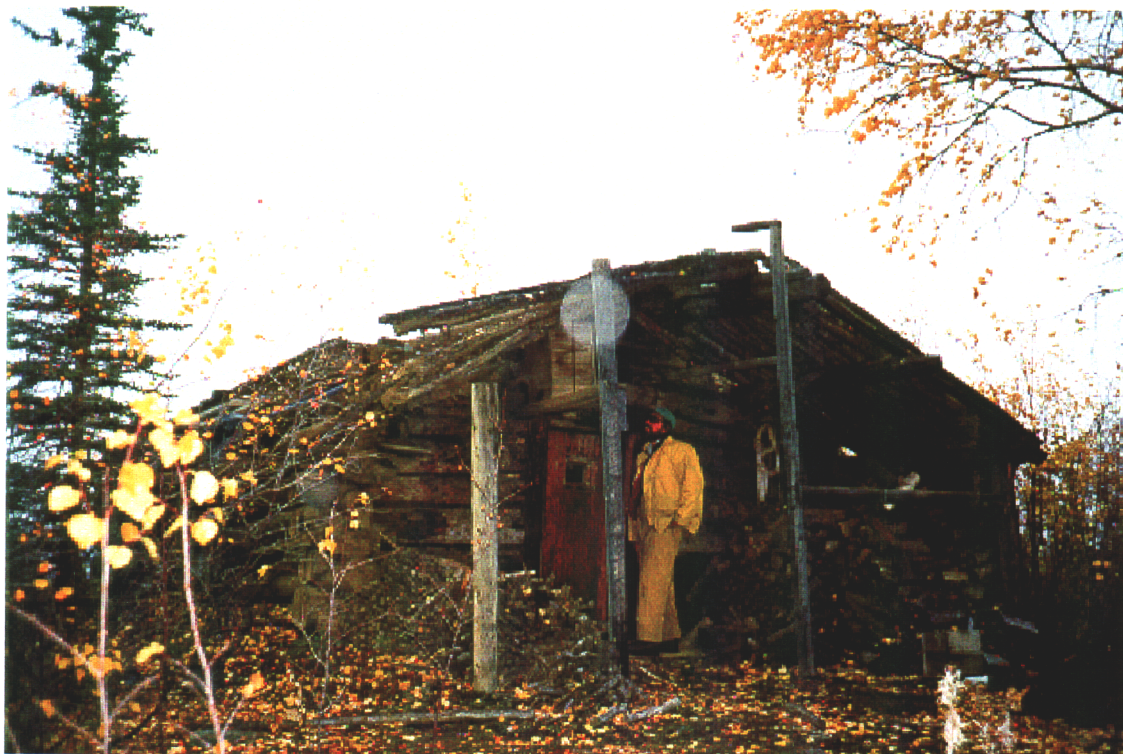
### Building 14-A - Cabin (Photo 14-6)

Description and type: Log cabin with a log and sod roof.

Hazardous Contents: No hazardous materials observed.

Photo 14-6: Recent cabin (early 1980's); note collapsed sod roof structure. (Azimuth 340°)
