RICO
SITE #16
MINFILE# 105M001r

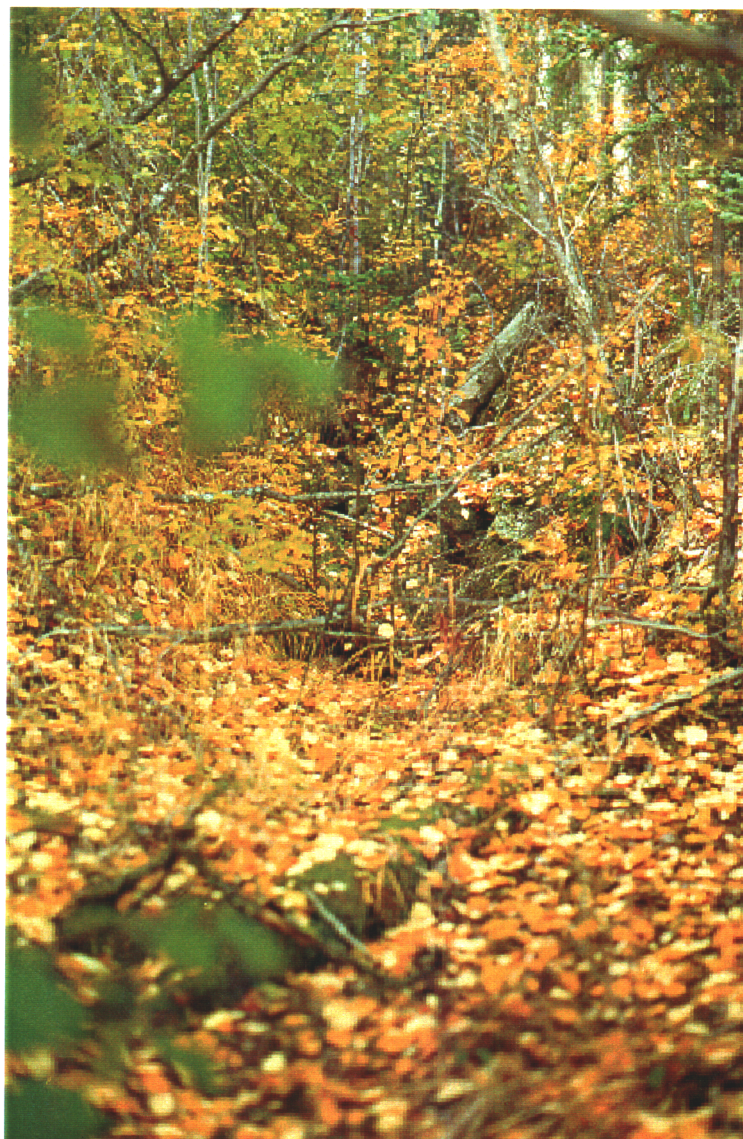
Rico Adit (photo 16-1)

The portal and adit were difficult to locate; they have collapsed and become overgrown with trees and shrubs.

Supports: The collapsed portal conceals all the original supports.

Condition: The first 20m of the portal have collapsed; the ground above the rest of the adit was stable at the time of the site visit.

Accessibility: The collapsed portal prevents access to the adit.

Photo 16-1: Collapsed and overgrown portal and adit are barely visible from under the leaf cover.
(Azimuth 270°)

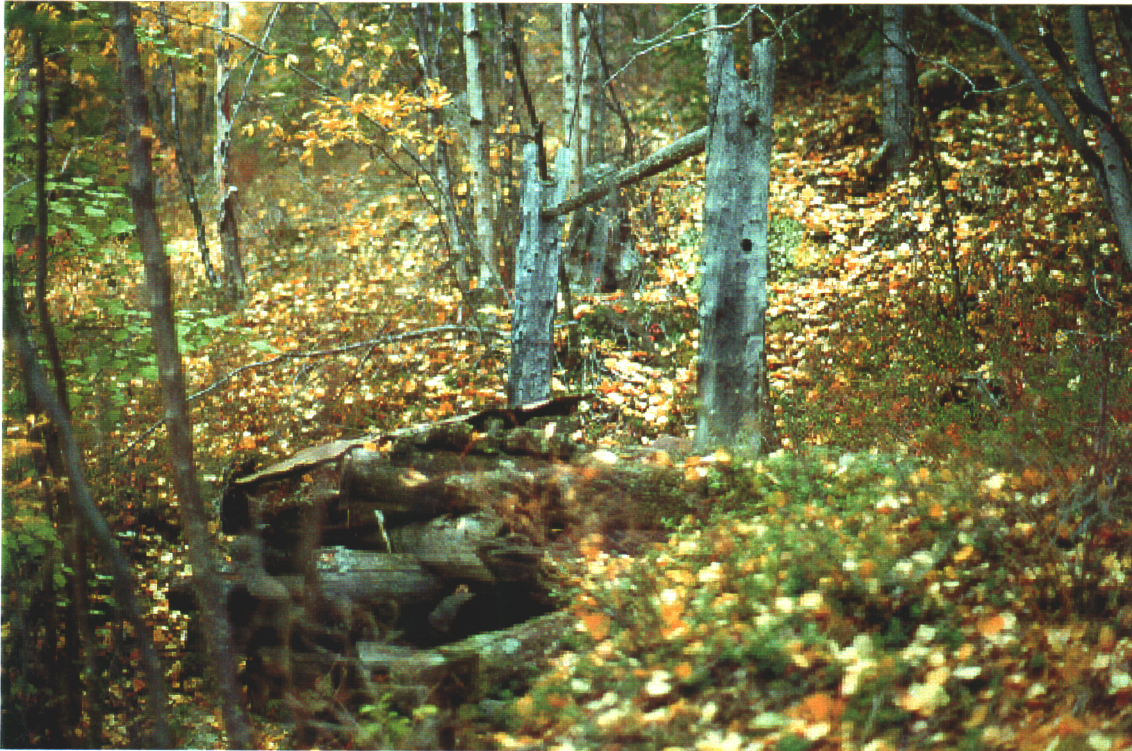
Rico Shaft (photo 16-2)

A small gully beside the adit leads uphill to a shaft. Log cribbing and a windless are built above the entrance to the shaft. A metal lid covers half of the shaft opening.

Supports: The shaft is well supported by logs.

Condition: It is fair condition; the logs are beginning to rot but were stable at the time of the site visit.

Accessibility: The shaft can be accessed through the opening at the top. There is water approximately 6m below this opening.

Photo 16-2: Rico shaft with windless on top. (Azimuth 210°)

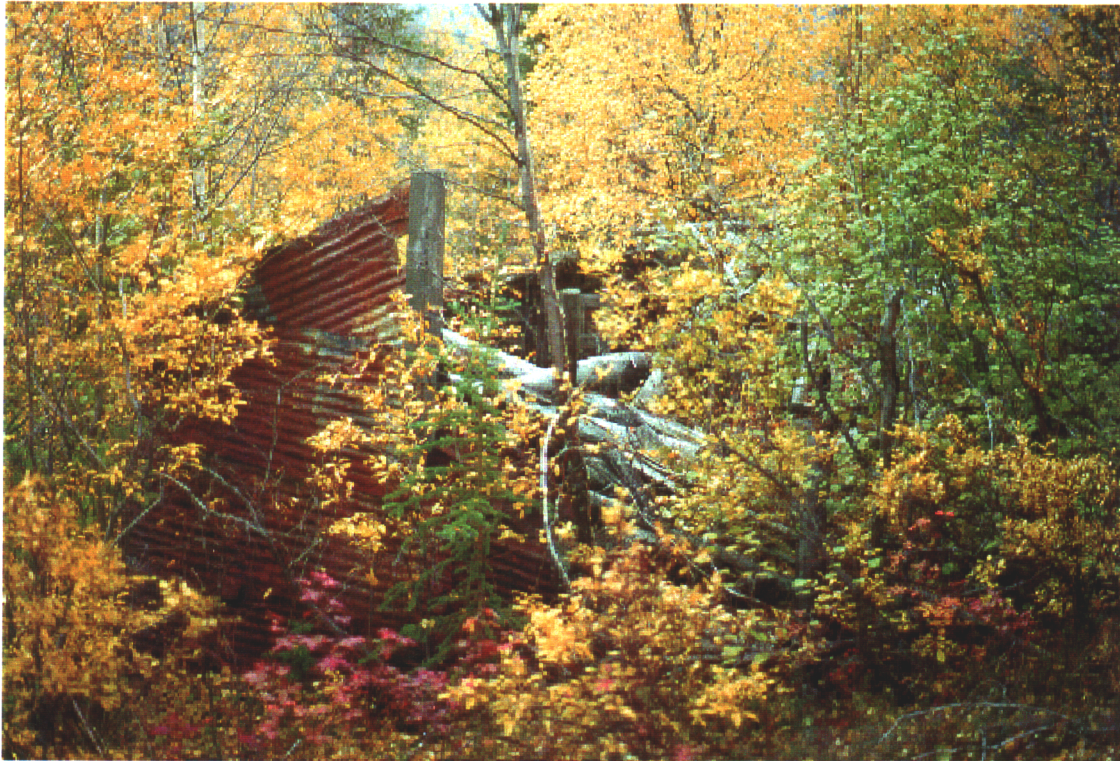
6.1 Building 16A (photo 16-3)

There is an old log cabin with the roof and one wall collapsed. Household debris of mainly glass jars and tin containers are scattered around the cabin.

Construction: The cabin is constructed of logs and has metal siding on the north exterior wall and roof.

Photo 16-3: Collapsed log cabin with metal sheeting which covers the north side of the cabin. (Azimuth 150°)
