LAKE
SITE# 27
MINFILE# 105M001ac

Public Works
And Government
Services Canada

Lake Site #27
Site Assessment
Yukon Territory

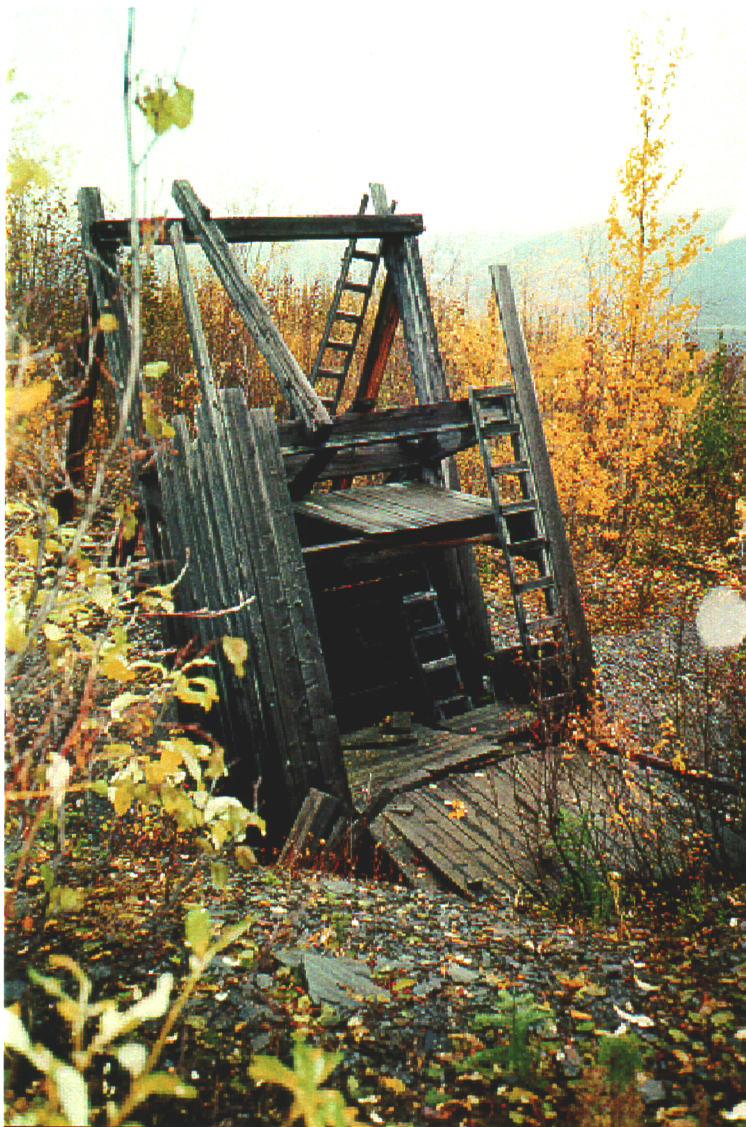
A series of ladders connects the top of the main shaft headframe to a deck located 3m below ground. The shaft is blocked by ice 4m below ground level. The shaft was excavated at an incline of 80°. Less than 20m of metal air and water lines extend from the shaft to surface.

Supports: The frame is constructed of heavy sawn timbers and planking. A retaining wall constructed out of 2"x 4" timbers supports the walls at the entrance to the shaft.

Condition: The headframe and the retaining walls are weathered but are still in fair condition.

Accessibility: The shaft is filled with ice and is no longer accessible below 4m. The manway opening was nailed shut with available planking.

Photo 27-1: Shaft headframe (Bldg. 27-1). (Azimuth 340°)

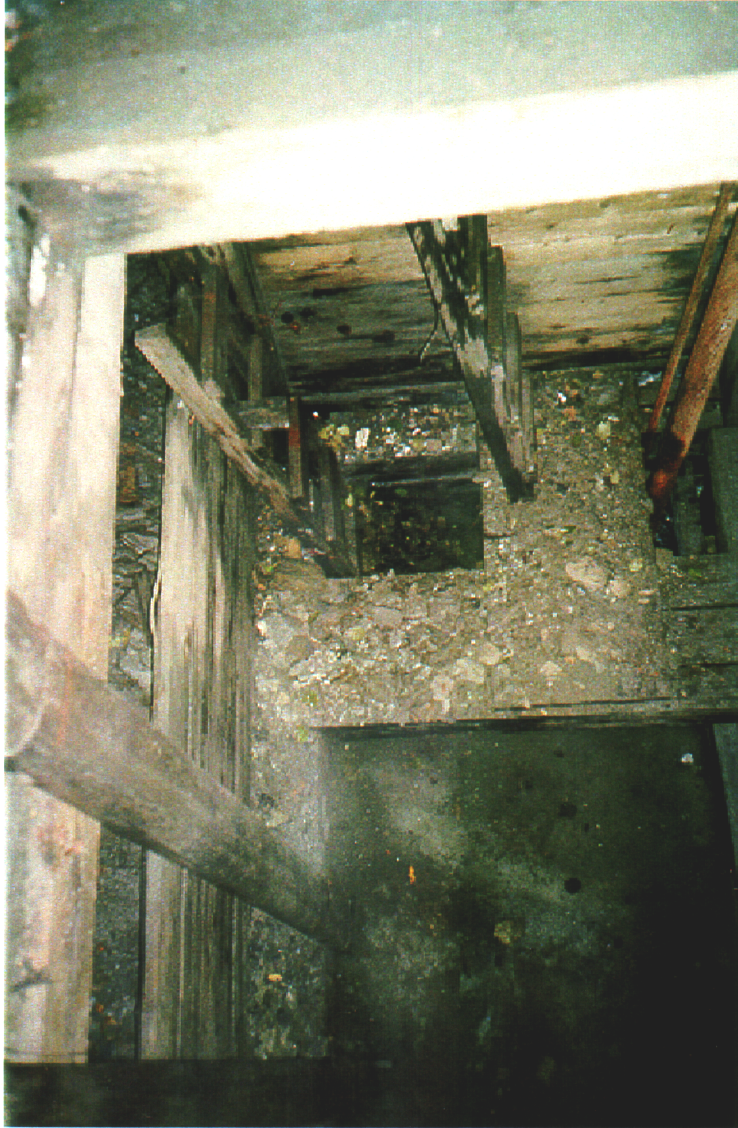
Photo 27-2: Interior of shaft A01 headframe (Bldg. 27-1).

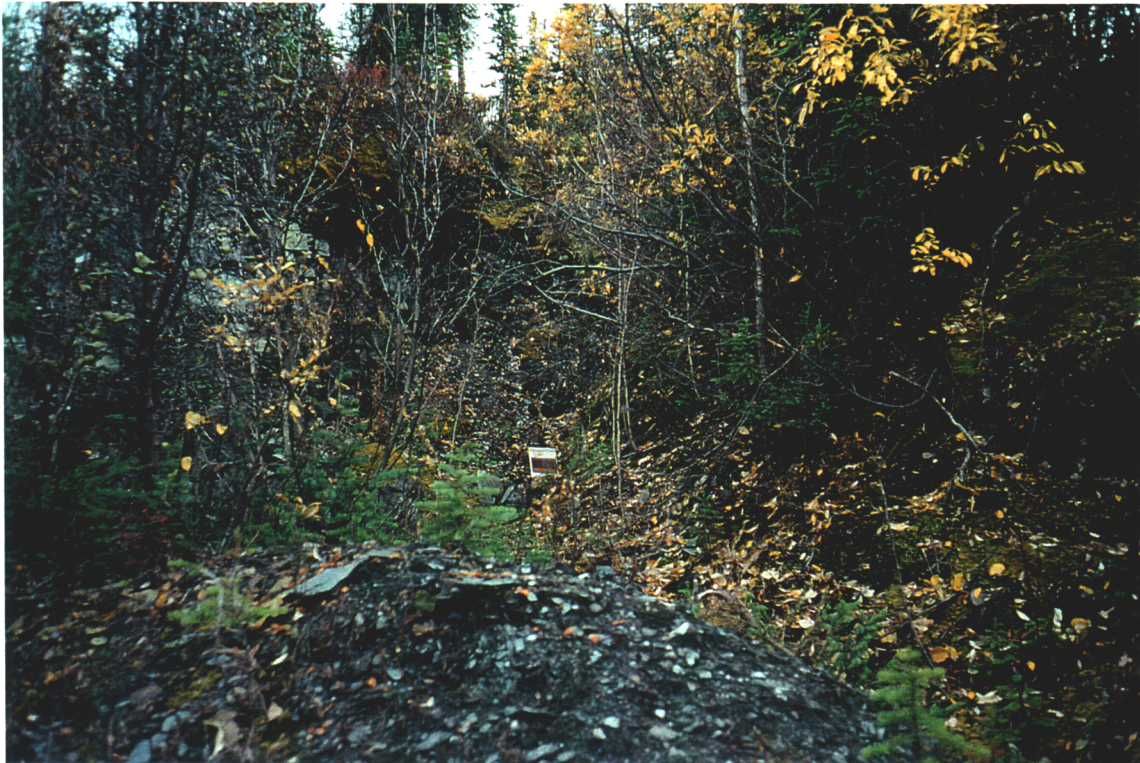
The portal to the lower adit is completely collapsed and covered by rock.

Condition: Collapsed

Accessibility: Inaccessible

Photo 27-3: Collapsed adit portal (A02). (Azimuth 220°)

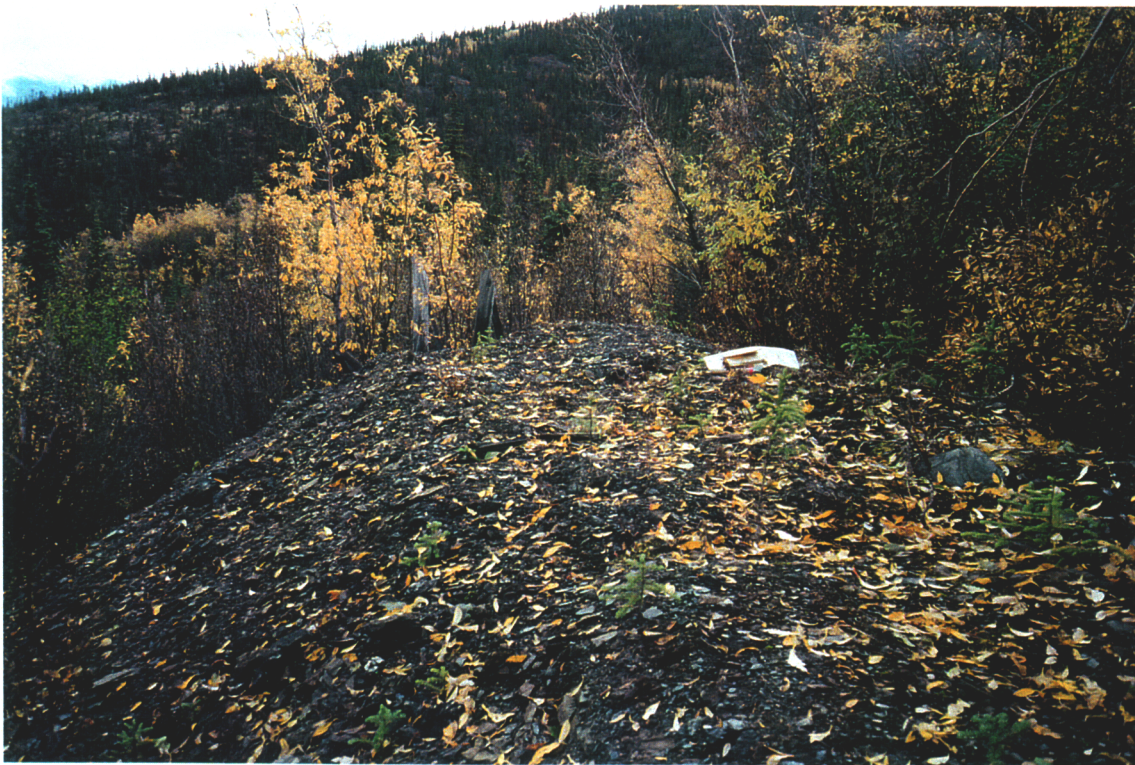
This long dump area has been broken down based on shape into three waste rock piles. These piles were formed by end dumping from rail mounted ore cars that transported rock from the underground workings. Observed content of the waste rock piles was predominantly thinly banded quartzite with graphitic phyllite interbeds. There are 0.2-2% disseminated pyrite and trace galena stringers up to 2mm wide within the quartzite and phyllite. These stringers occur parallel and perpendicular to quartz and quartz-siderite-pyrite veins up to 2cm wide. Only 2-5% of the waste rock material is the quartz-siderite-pyrite veining. The waste rock is bi-modal, ranging in size from sand to gravel. No apparent oxidation was observed.

Photo 27-4: Waste rock dump below shaft A01. (Azimuth 110°)

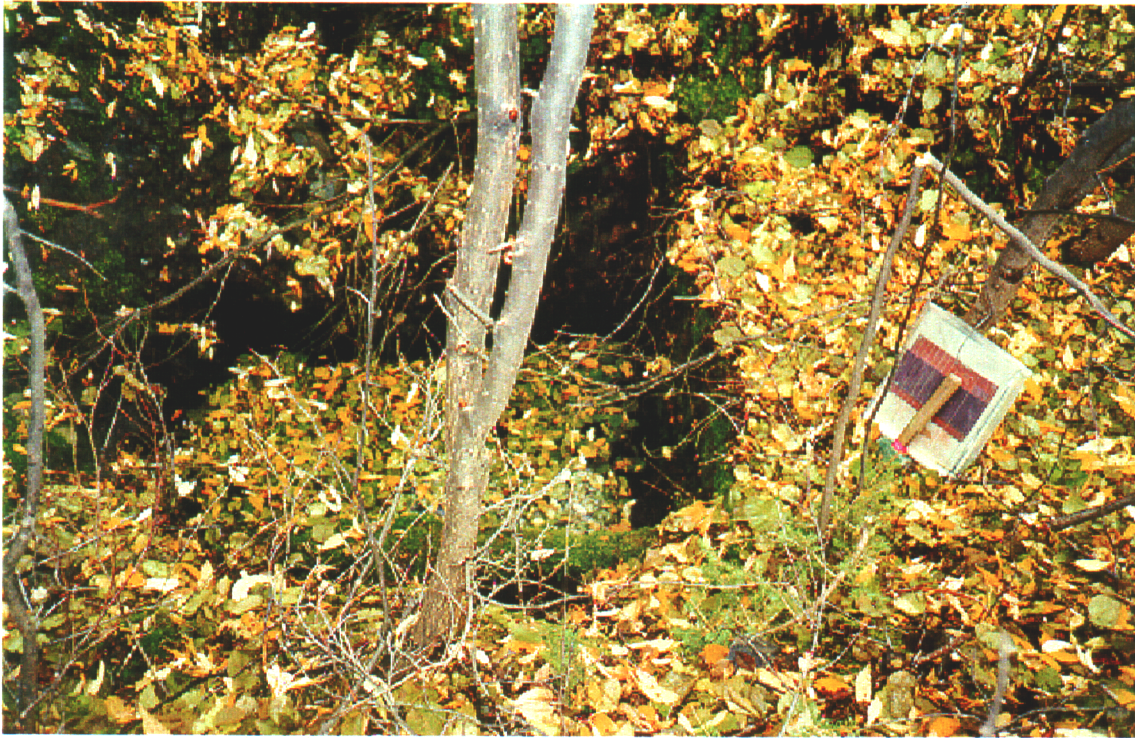
Developed probably for exploration, the upper shaft was hand-dug 3m into the overburden. The vertical shaft is filled with 2m of water.

Condition: Fair; no visible signs of collapse.

Accessibility: The shaft is filled with water and is no longer accessible. The shaft is situated in thick willows and alder with no perimeter barrier protection. Florescent, plastic flagging tape was hung around the opening to mark its location.

Photo 27-5: Upper shaft hole to left of clipboard (A03). Note leaves covering the surface of standing water.(Azimuth 070°)

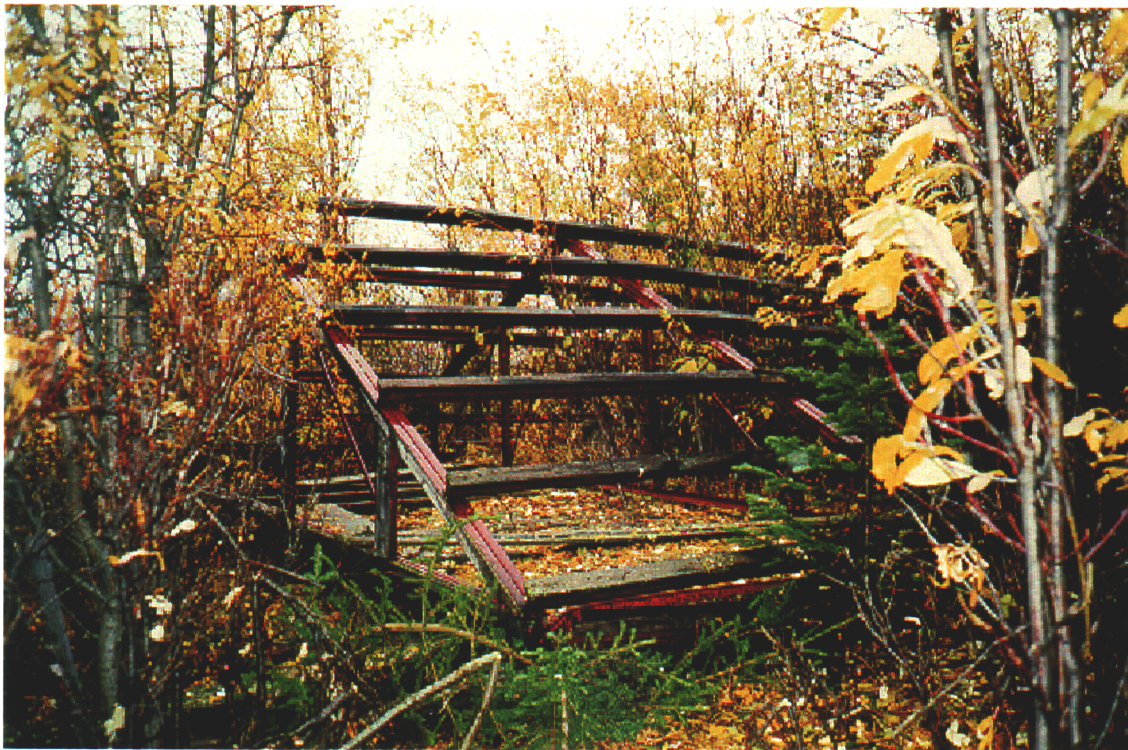
A collapsed steel building frame is located on the site. The steel and wood roof frame structure is intact, however the steel wall supports have collapsed.

Photo 27-6: Collapsed steel building frame (Bldg. 27-2). (Azimuth 120°)

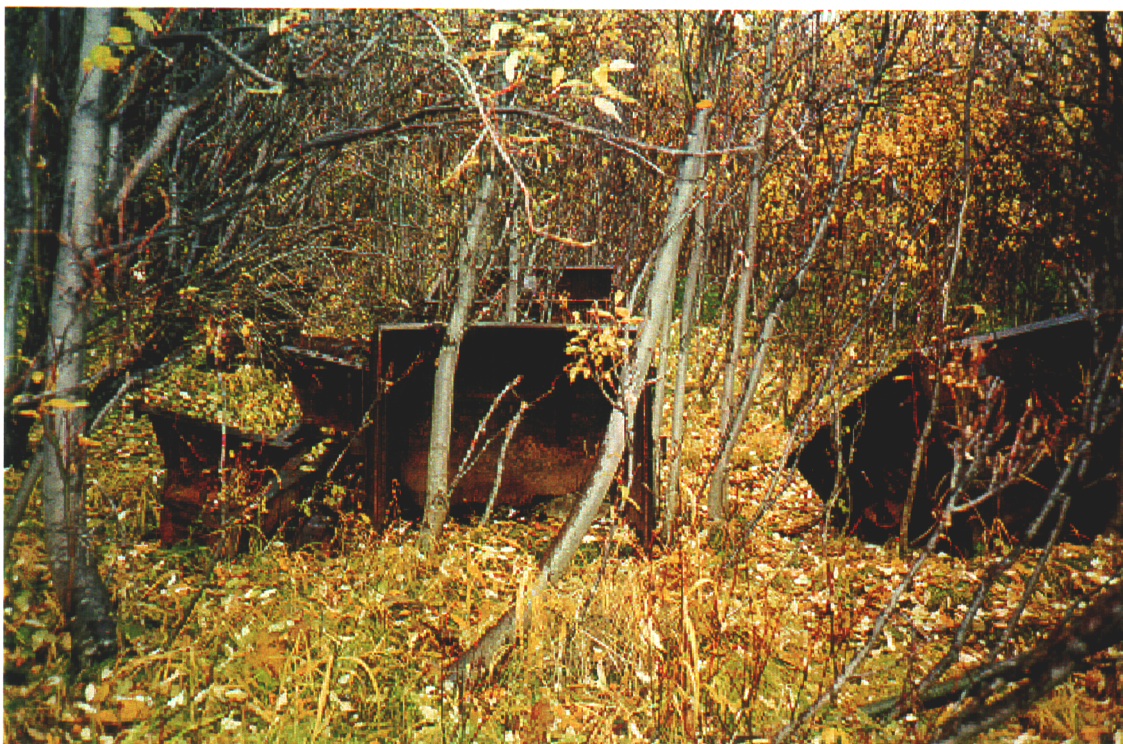
Waste material found on the site is comprised of old abandoned metal mine equipment.

General composition: 3 ore cars, some old fuel drums and some scrap metal.

Impacted vegetation: Healthy alders grow around the metal debris.

Photo 27-7: Abandoned ore cars. (Azimuth 240°)
