**SHAMROCK (Original Shamrock) (#28)**  
**(MINFILE# 105M 001ah)**

Public Works And Government Services Canada	Travaux publics et Services gouvernementaux Canada	designed by: concu par: drawn by: dessiné par: approved by: approuvé par: revisions:
	Architecture & Engineering Services Western Region	Architecture et Ingénierie Services Ouest	drawn by: C.S. NOV. 1, 99
Drawing title: Shamrock Site #28 Site Assessment Yukon Territory			project no. 125-12.01
CAD FILE: site28.dgn			dwg no. 1 of 1

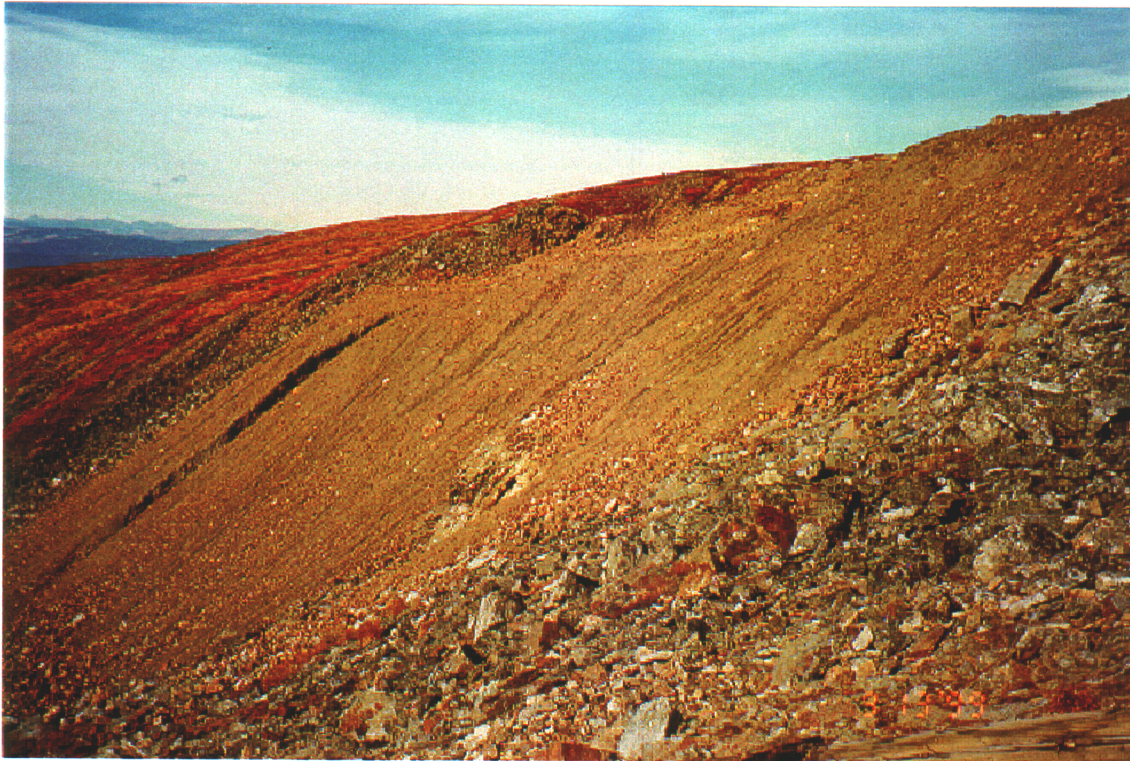
#### Open Pit – Original Shamrock (photo 28-1)

An open cut with waste dumped at the lower, southwest end. The pit recovered an ore pillar around the shaft.

Condition: Very steep pit walls appear to be stable.

Waste rock pile - ORIGINAL SHAMROCK (photo 28-1)

Overburden and waste rock were pushed downslope from the open cut. The pit drains through the dump, and deep troughs are present on the dump slope. No significant vegetation was noted. The dump toe rests on an underground waste dump at the 200 level.

Location: See site location map. Pit dump has a slope of 38 degrees.

Dimensions (L x W x H): Approximately 50 m x 50 m x 15 m.

Sampling: One sample was collected approximately mid-slope on the waste rock dump.

Photo 28-1: Waste rock below open cut at upper end of site. Note deep erosion path.

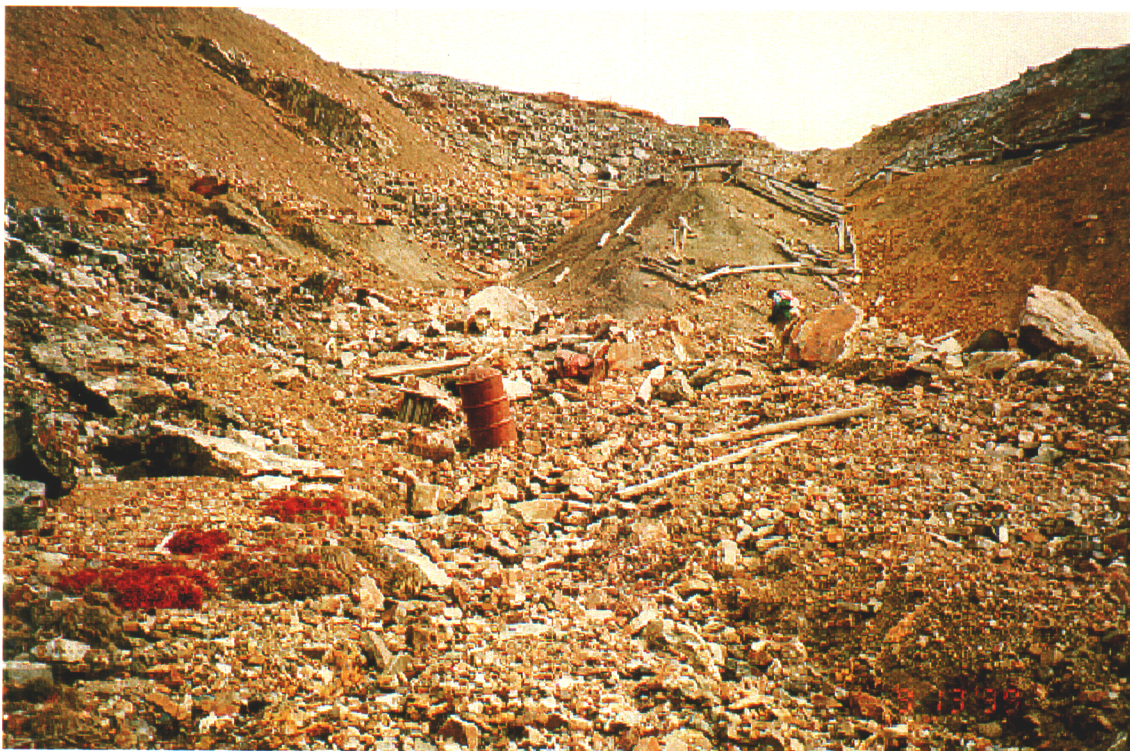
#### Waste rock pile - #200 level portal (photo 28-2)

Fine-grained underground muck extends along both sides of the gully at the portal elevation. The western dump is mostly covered by open pit waste, and appears to be mostly unmineralized waste rock. The eastern end of the eastern dump is well mineralized material. The waste that would have originally been in front of the portal has been removed by bulldozer and/or flash flood. The site is in a gully that was dry when visited, but bear evidence of considerable flow in the past. Mining debris is widespread below the site. Although some material is well-mineralized, only traces of sulphide were noted. An acidic pH was noted, however the sulphur levels are very low for all samples.

Dimensions (L x W x H): Eastern dump: about 20 x 3 x 3m. Western dump is approximately the same size.

Sampling: two samples were collected; based on field appearance 01 is highly mineralized, and 02 is of weakly mineralized underground material.

Photo 28-2: Ravine below adit and associated waste rock piles.

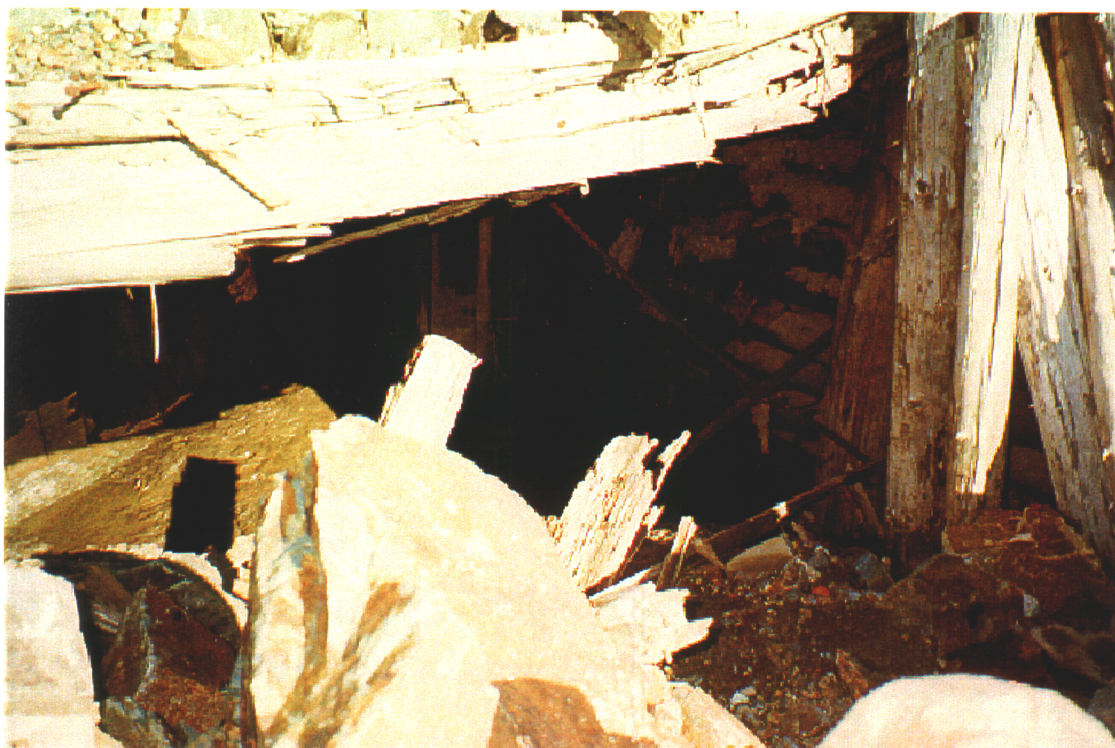
#### 200 Level Portal (photo 28-3)

Partially collapsed timbered portal. Underground waste dumps with rails are present on both sides of the adit. The adit is located in a gully, and waste from the open pit above has partially covered the adit site. Constructed in 1953.

Condition: Partially collapsed, mostly blocked by open pit waste and debris

Accessibility: Access is possible but difficult, risk of collapse is evident.

Photo 28-3: Partially open adit entrance.

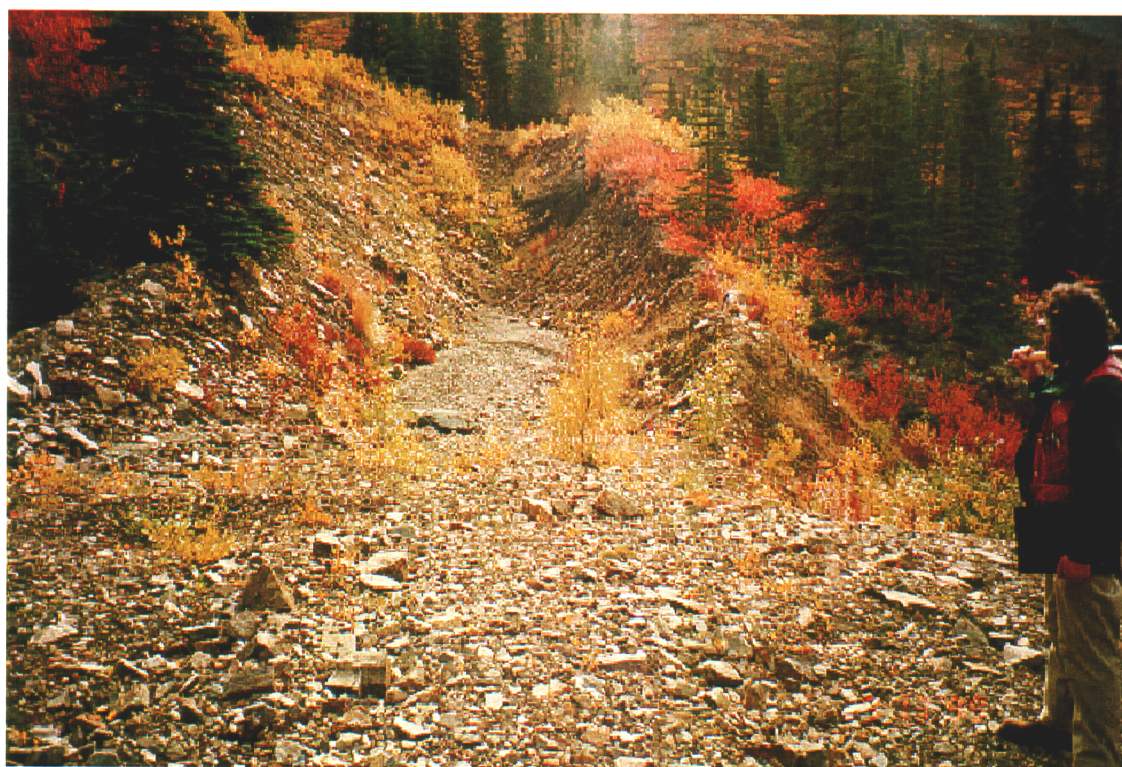
#### Six Trenches Southwest of Mine (photo 28-4)

Trenches cut across the mineralized structure that hosts the Original Shamrock mine to the northeast. Very little true outcrop is exposed, however subcrop indicates very strongly oxidized, rusty quartzite with minor schist. Veining and mineralization are weak. Manganese oxides are common. The trenches appear to be from the 1980's.

Location: See site location map. Deep bulldozer trenches are approximately 75 m long, with push piles adjacent to the creek gully. The lowest pile crosses the gully, and forms a dyke that has been breached. One trench is present on the east side of the ridge between the two gullies, the rest are on the NW side.

Condition: The trench sides are steep, with little revegetation. The adjacent, undisturbed gully area is similarly steep, with little vegetation.

Photo 28-4: Small test pit at lower end of site.

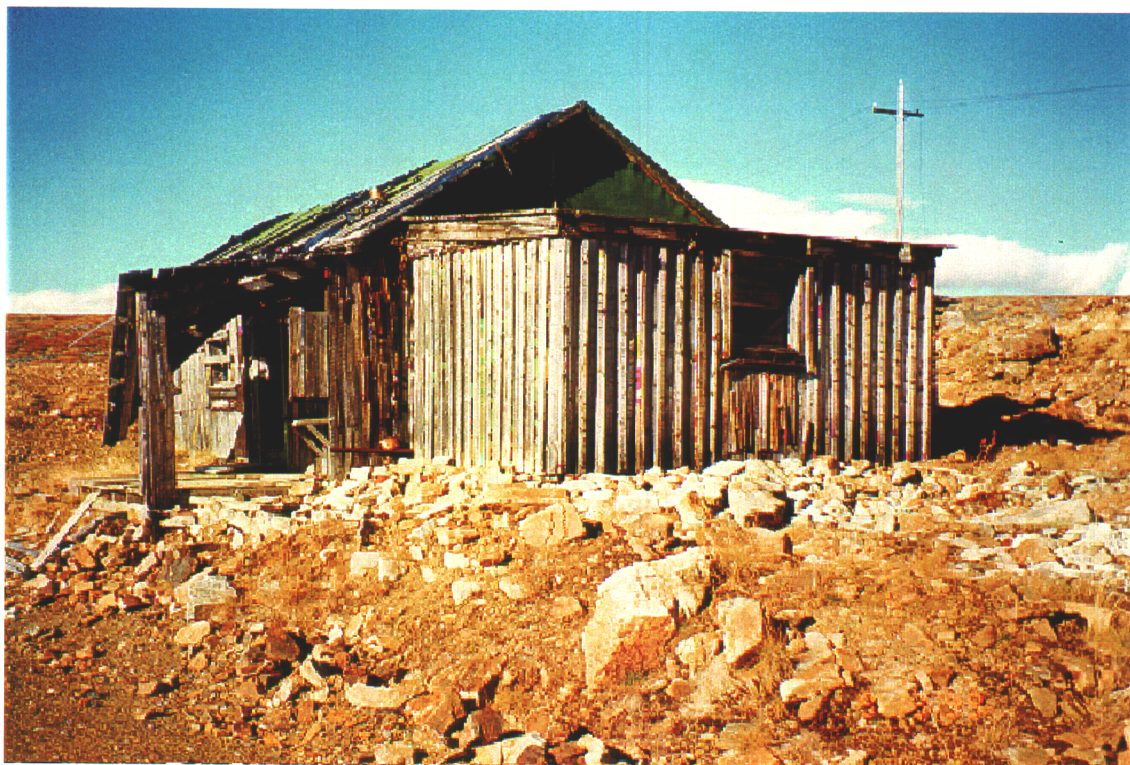
### Building 28A – Main Site Building (photo 28-5)

Building appeared to have formerly served as both living quarters and office space for site workers. An addition to the rear of the facility was probably used for storage space.

Construction: Wood frame; painted plank finished interior; rolled asphalt roof; fibreglass insulation; windows boarded up from inside.

Two small petroleum hydrocarbon-based stains were noted to the east of the building, both with dimensions of 1 m<sup>2</sup> or less. A two-inch diameter pipe was noted extending from the building, however its former usage could not be determined. No staining was noted at the pipe end.

Two very small hydrocarbon stains (< 1 m), possibly associated with former waste oil disposal practices, were noted on the east side of the main site building. Soils were found to be very thin or nonexistent and were not sampled. Due to the substrate, excavation was not possible.

Photo 28-5: Main site living quarters (building 28A).

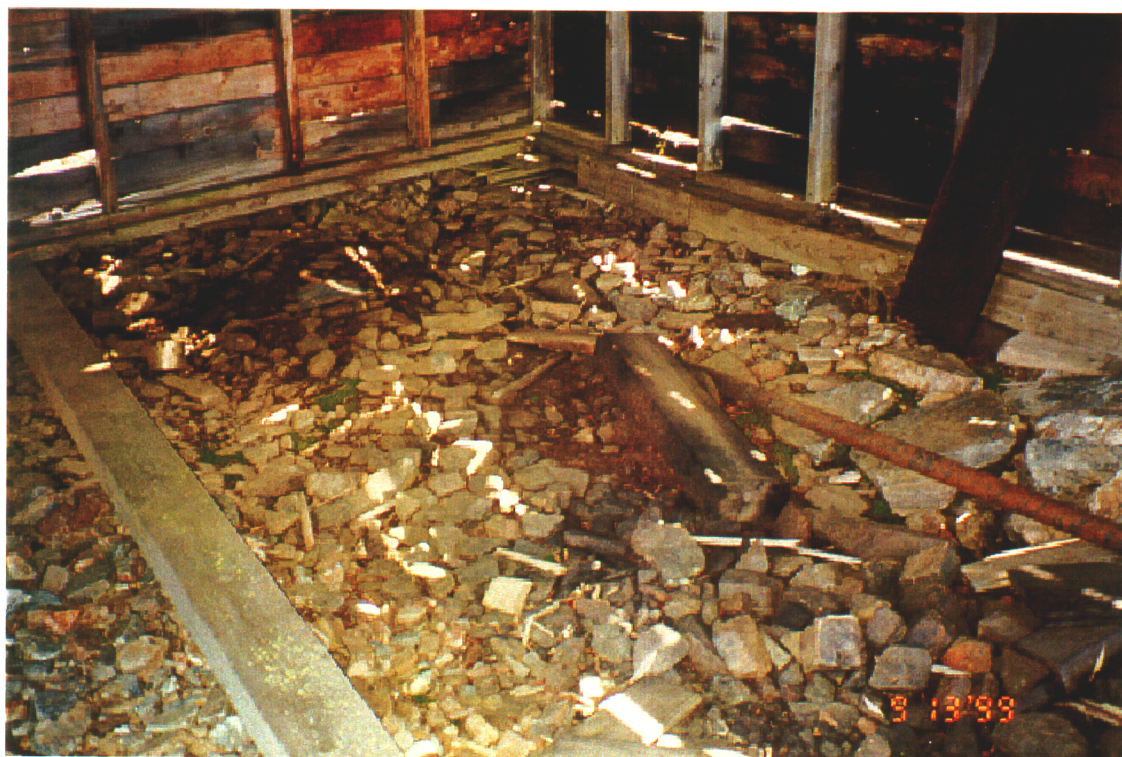
### Building 28B – Generator Shed (photo 28-6)

Shed consisted only of a wood frame structure directly on grade. A strong petroleum hydrocarbon odour was present in the building.

Soils within the former generator building were stained and strong odours were present in the building. Stained areas, approximately 4 m<sup>2</sup> in total, did not extend out of the building. Soils under the building are very thin or nonexistent with much of the building situated directly on cobble/rock or bedrock. Due to the substrate, excavation was not possible.

Photo 28-6: Interior of generator shed (building 28B). Note staining on rock.

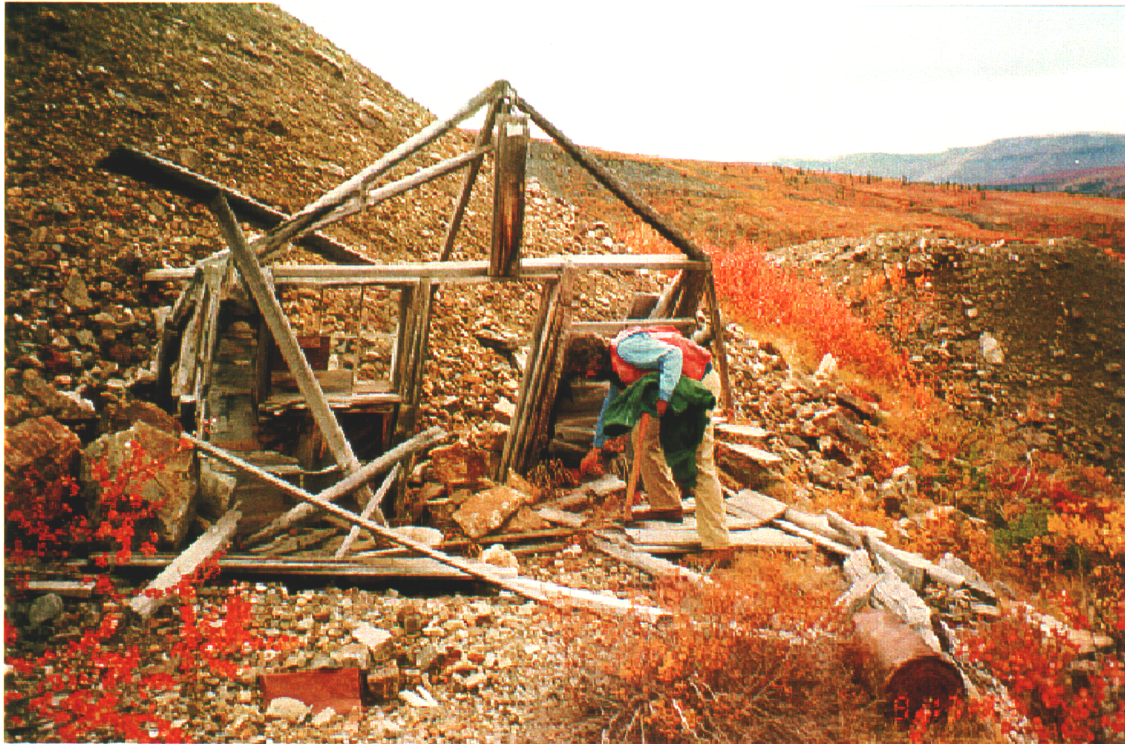
#### Building 28D – Collapsed Shack (photo 28-7)

The shack was formerly used as temporary living quarters (probably summer only). The building has completely collapsed.

Photo 28-7: Remains of collapsed shed (building 28D) at old shaft.

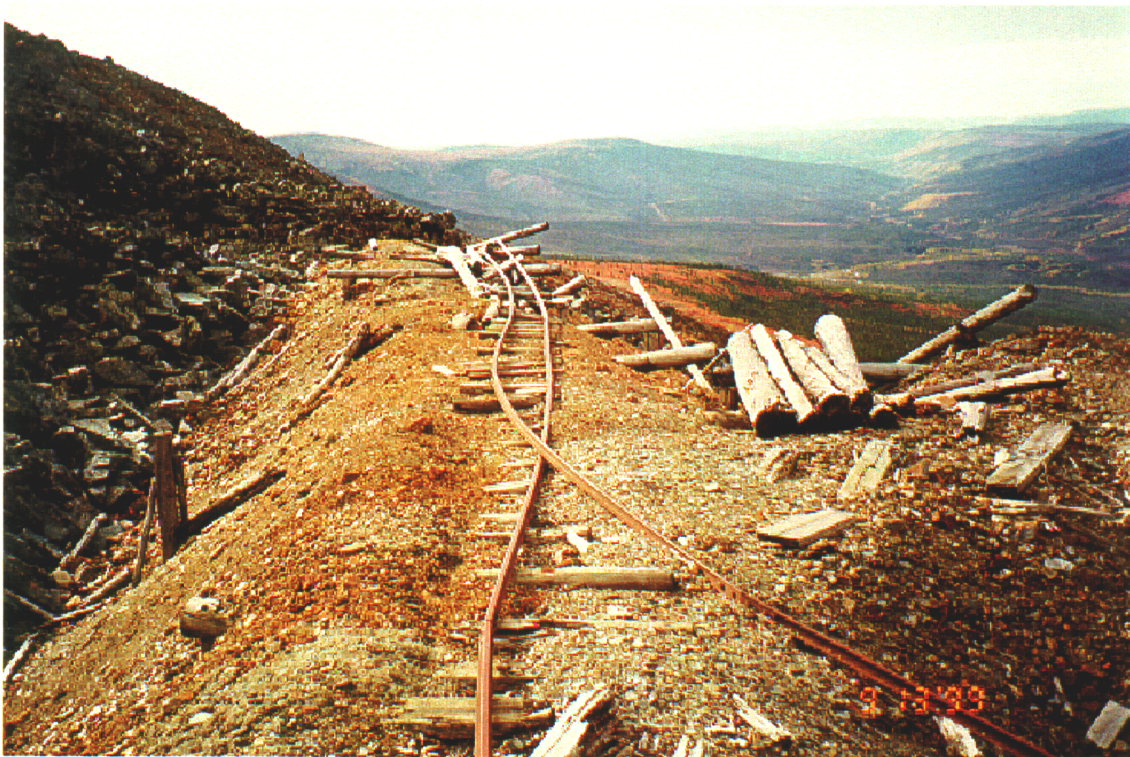
## 6.3 Rail and Trestle (photo 28-8)

Fabrication: Steel rails, about 20 m long. Some wooden trestle remnants. Large volume of timber and steel trash in area.

Condition: No significant hazard.

Photo 28-8: Rail and trestle at main adit.

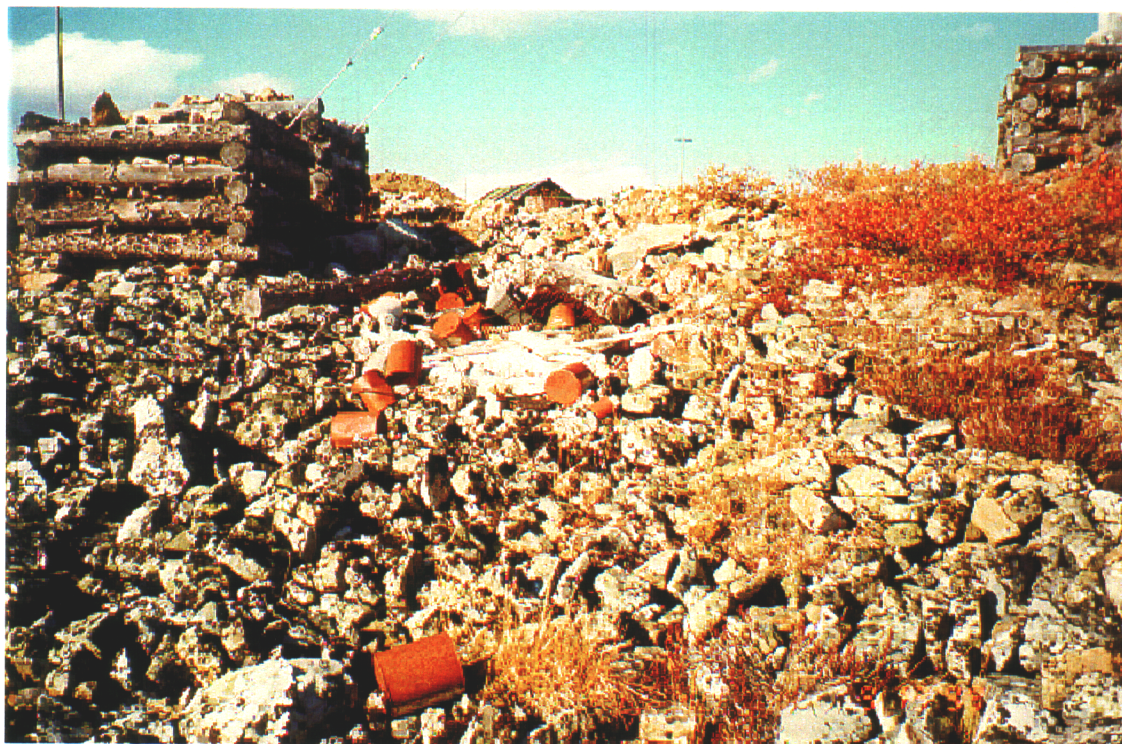
Location & access: approximately 50 m east of main building, near collapsed building and generator building and adjacent to power pole (photo 28-9).

Dimensions (L x W x H): 3 m x 5 m x 7 m

General composition: Approximately 11 newer paint cans, 6 used oil filters, wire, 1 lead-acid battery; evidence of burning.

Photo 28-9: Small solid waste dump adjacent to generator shed.
