MAIN FAULT & NABOB

Site # 33

MINFILE # 105M 001aq

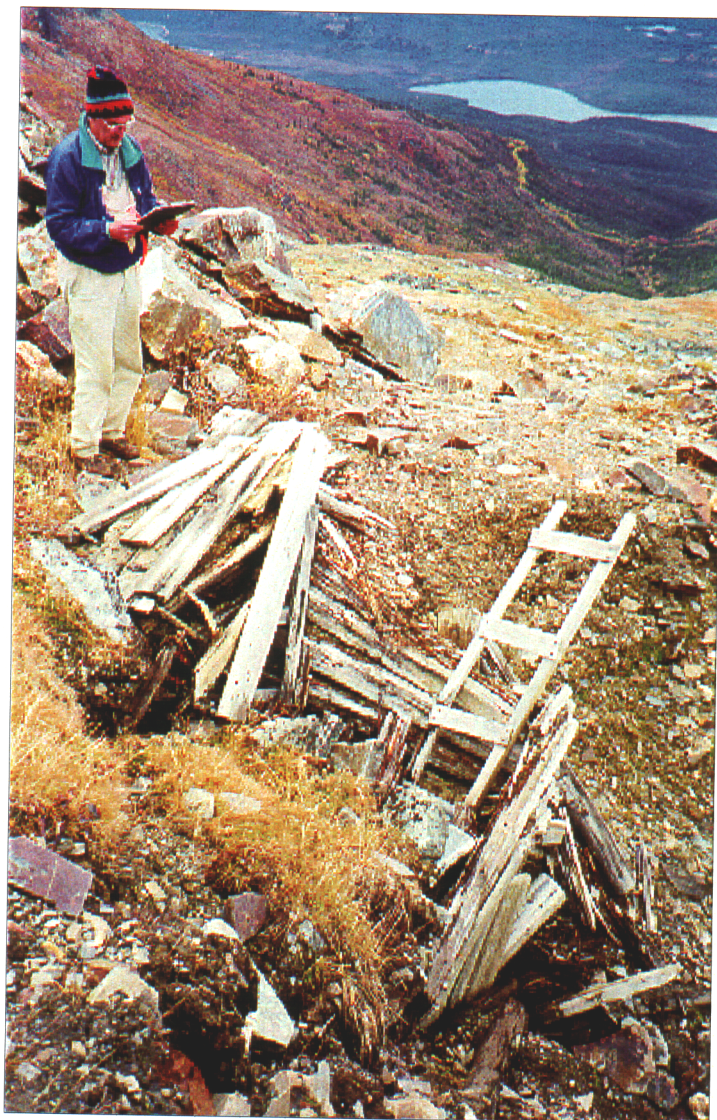
Main Fault Shaft (photo 33-1)

At the west end of Trench #2 is an old collapsed prospect shaft located on the Main Fault.

Condition: The shaft has collapsed at surface.

Accessibility: A ladder going down the shaft is still in place, however since the shaft has collapsed the shaft can no longer be accessed.

Photo 33-1 : Main Fault and Nabob. View of the Main Fault shaft, Gambler Lake is in the background. (Azimuth330°)

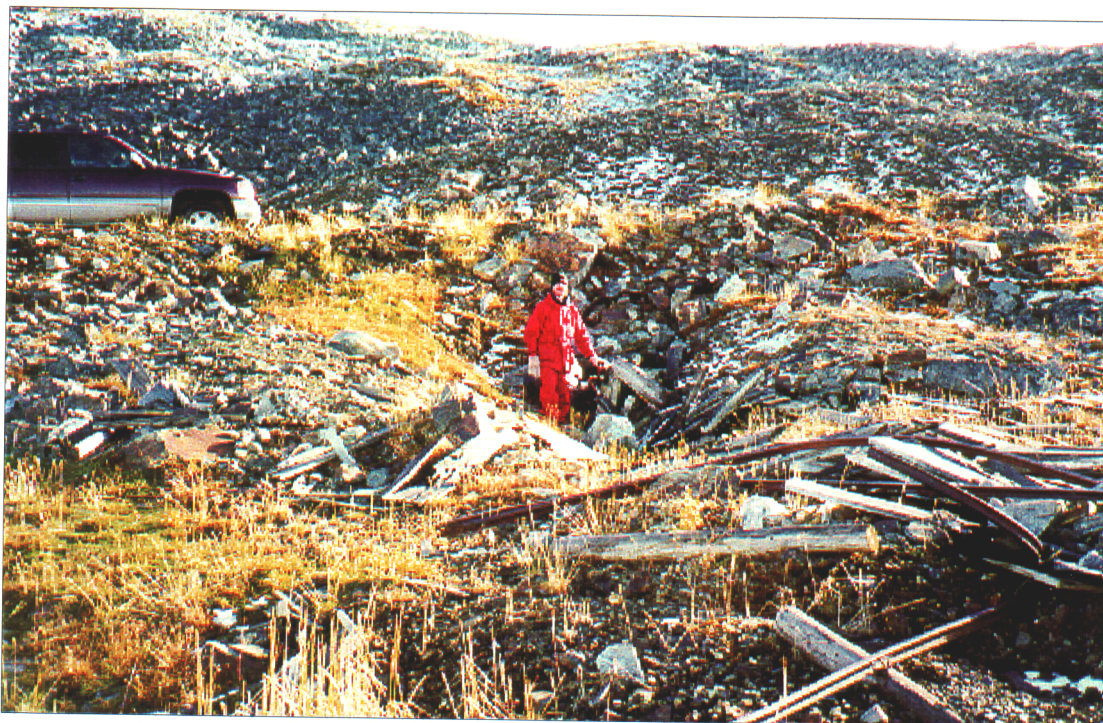
Main Fault and Nabob Adit (photo 33-2)

The adit is located on the west side of Silver Basin Gulch Trail, 150m north of the shaft. The portal has collapsed.

Condition: The portal and the first 5m (up to the road) of the adit have collapsed. The portal is filled with broken log cribbing and large boulders. No evidence of further stability problems was observed, the road above the adit did not appear to be slumping.

Accessibility: The adit can no longer be accessed.

Photo 33-2 : Main Fault and Nabob. Collapsed Main Fault -Nabob Adit, truck is on Silver Basin Gulch Trail. (Azimuth150°)

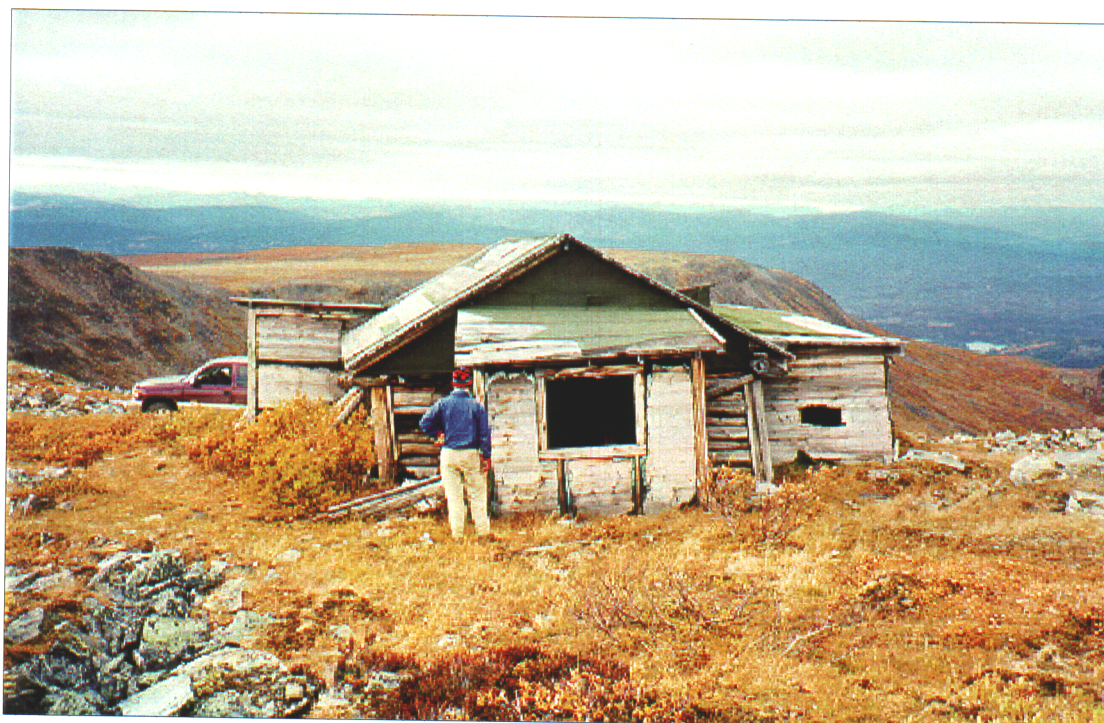
Building 33A (photo 33-3)

There is an old house located on the Silver Basin Gulch Trail at the edge of the cirque, 200m southwest of the trenches. Three additions were built on to the original 5m by 5m log cabin. Most of the asbestos tar paper cladding that covered the exterior walls has fallen off and is scattered around the building. The roof is mostly covered in sheets of asphalt shingling, with one small section, now collapsed, roofed with corrugated tin. No hazardous products were encountered inside of the building.

Photo 33-3 : Main Fault and Nabob Old log house on the south side of the Silver Basin Gulch Trail. (Azimuth335°)
