## **LAKE VIEW**

### **SITE #34**

#### **MINFILE# 105M001ar**

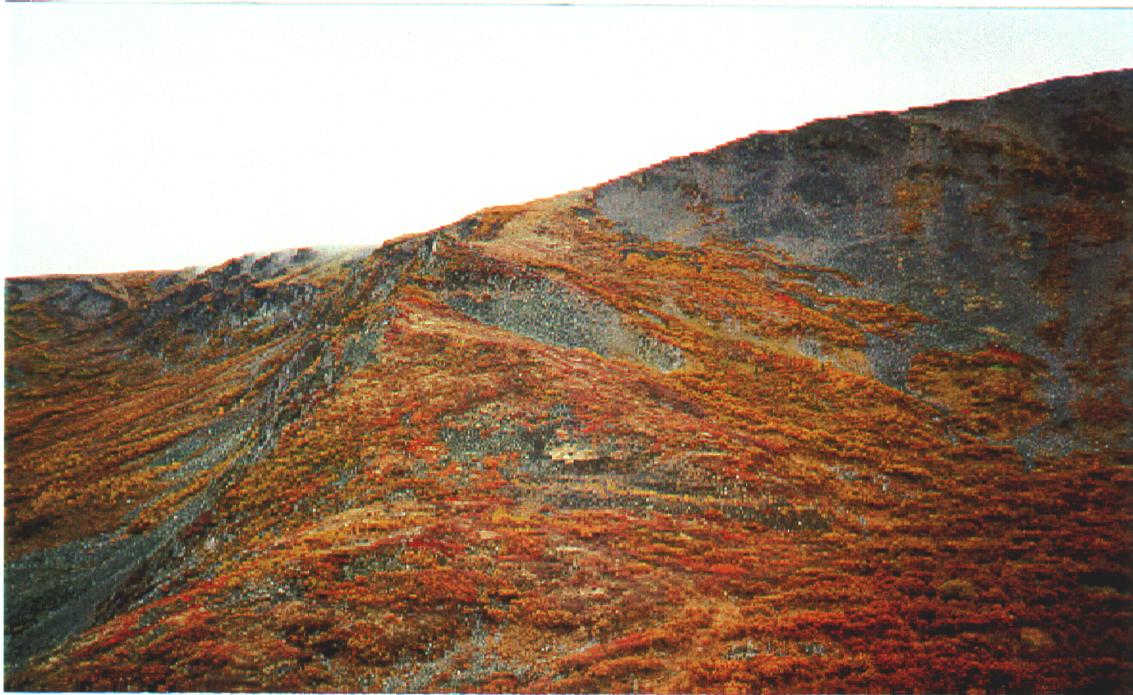
The Lake View site is located along the rib of a rocky east-west ridge. Coarse talus is common throughout the site and soils are poorly developed. Permafrost is considered very likely. The mine site is vegetated with subalpine herbaceous plants, grasses and shrubs(willow). A variety of moss and lichens grow on the talus. Surface water from the site drains northward into the Faro Gulch, a tributary of the Keno Ladue River. No surface water was observed on the site.

Photo 34-1: Overview of Lakeview site showing both recent and historic trenching activity. (Azimuth 100°)

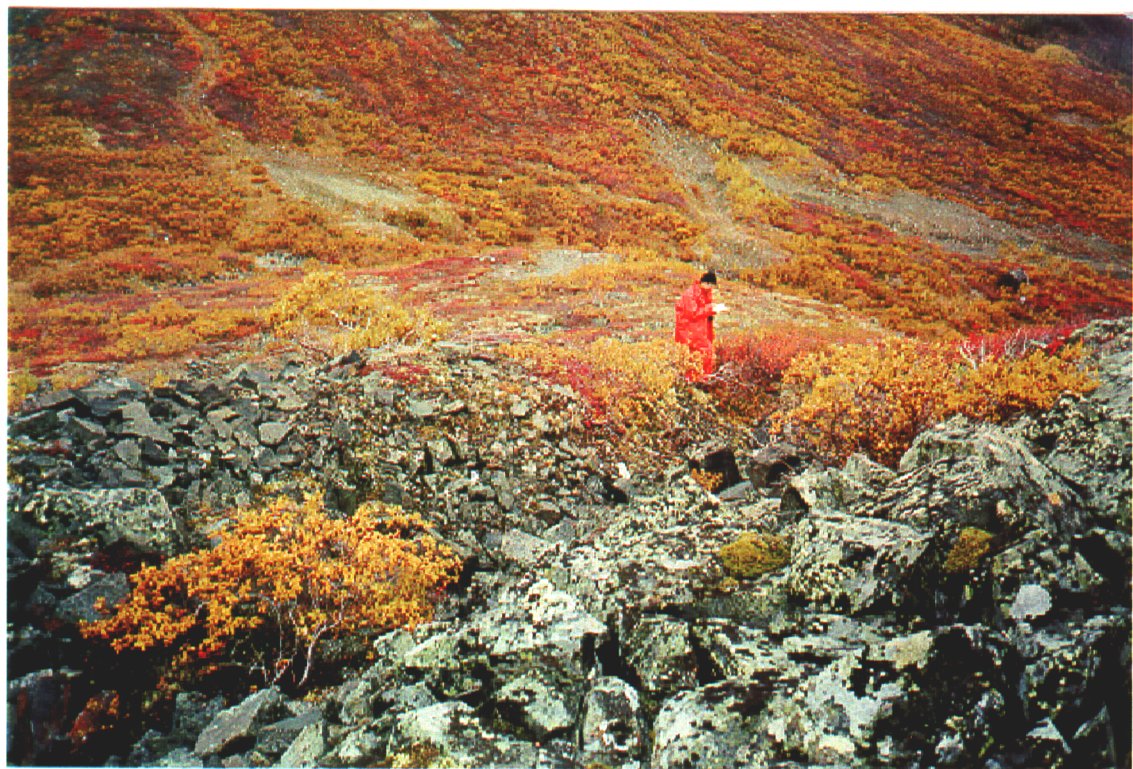
### **Trench #2 (Photo 34-2)**

Trench #2 is was hand dug in overburden consisting of colluvial soils composed of up to 70% coarse talus material.

Location: 30m up the ridge, roughly 20m south of the edge of the ridge.  
Dimensions: 10m long x 2m wide x 1.5m deep  
Condition: Good; partially slumped in.

Photo 34-2: Lakeview trench site. (Azimuth 310°)

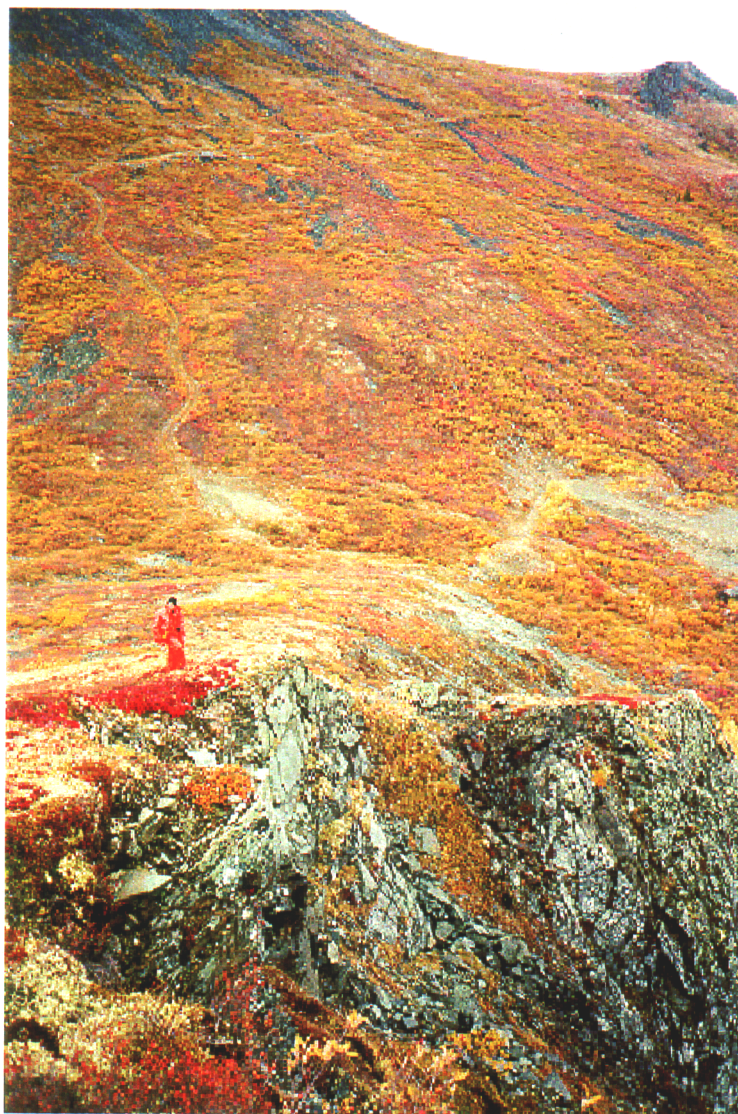
### **Trench #3/Open Cut (Photo 34-3)**

This location is more of a small open cut excavated into the exposed bedrock lip of the ridge.

Location: On cliff edge of ridge, roughly 80m east along ridge from Trench #1.  
Dimensions: 5m long x 2m wide x 1m deep  
Condition: Good; difficult to access.

Photo 34-3: Lakeview trench cut located 10m right of sampler.  
(Azimuth 280°)

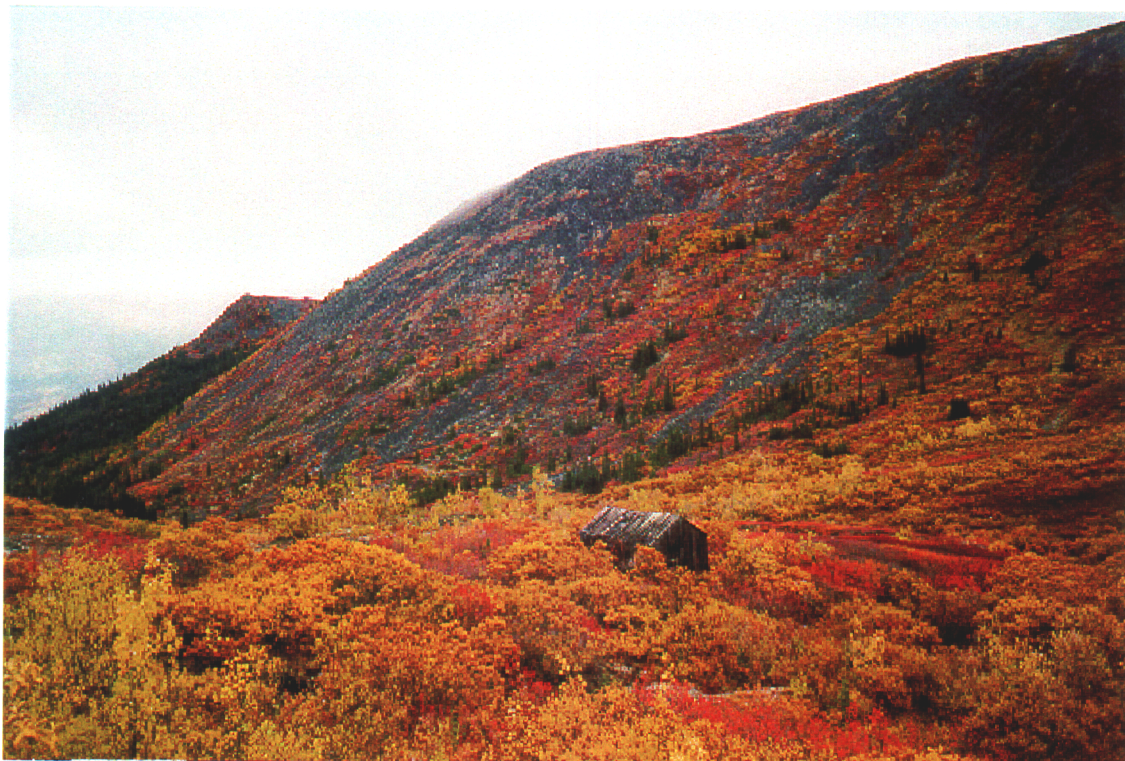
### **Building 34-A: Cabin (Photo 34-4)**

Dimensions: Building material is spread out over a 20m by 15m area.  
Location: End of the Upper Faro Gulch Trail, 70m north of the Trench #1.  
Construction: Wood frame construction with metal roof.  
Asbestos: None observed.  
Contents: No investigated.

Photo 34-4: Lakeview building (Bldg. 34-A). (Azimuth 280°)
