**DEVON**  
**SITE #41**  
**MINFILE# 105M 001az**

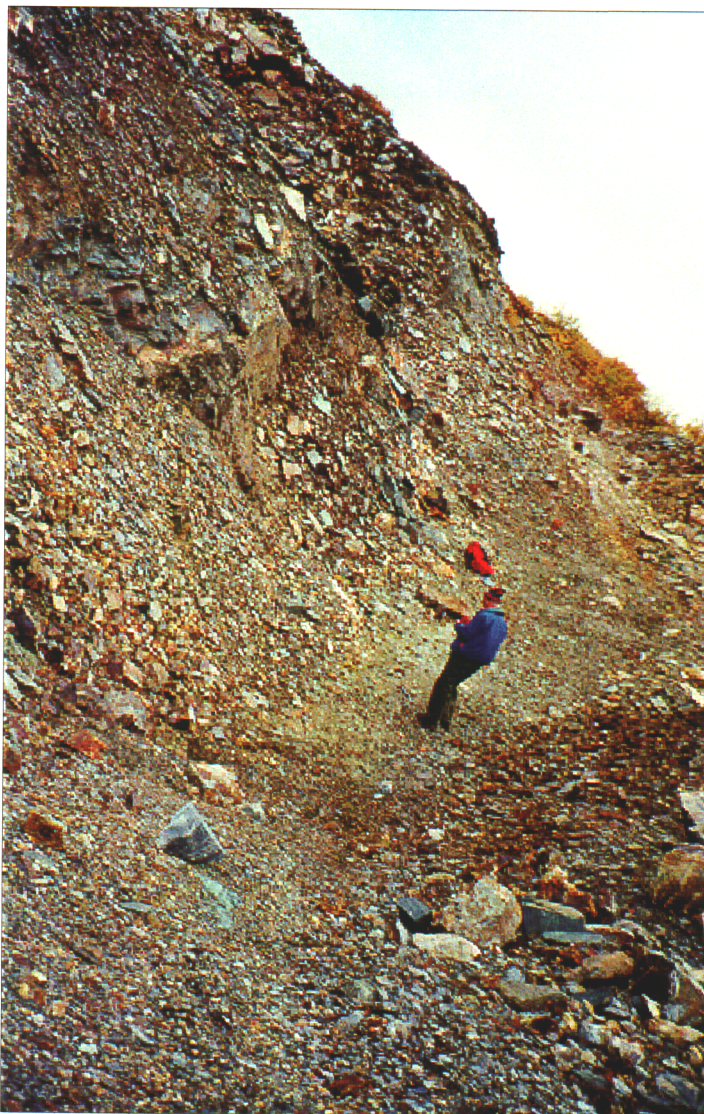
### Trenches (photo 41-1)

There are three trenches to the east of the adit. The walls of the trenches are comprised of stripped overburden and bedrock and appeared stable at the time of the site visit. All three trenches are roughly 5m wide by a maximum of 4m high. The first two trenches (T1 and T2) measure about 30m in length and the third trench (T3) about 65m in length. All three trenches were accessible by foot.

Photo 41-1 : Devon. View of Trench #3. (Azimuth  $052^{\circ}$ )

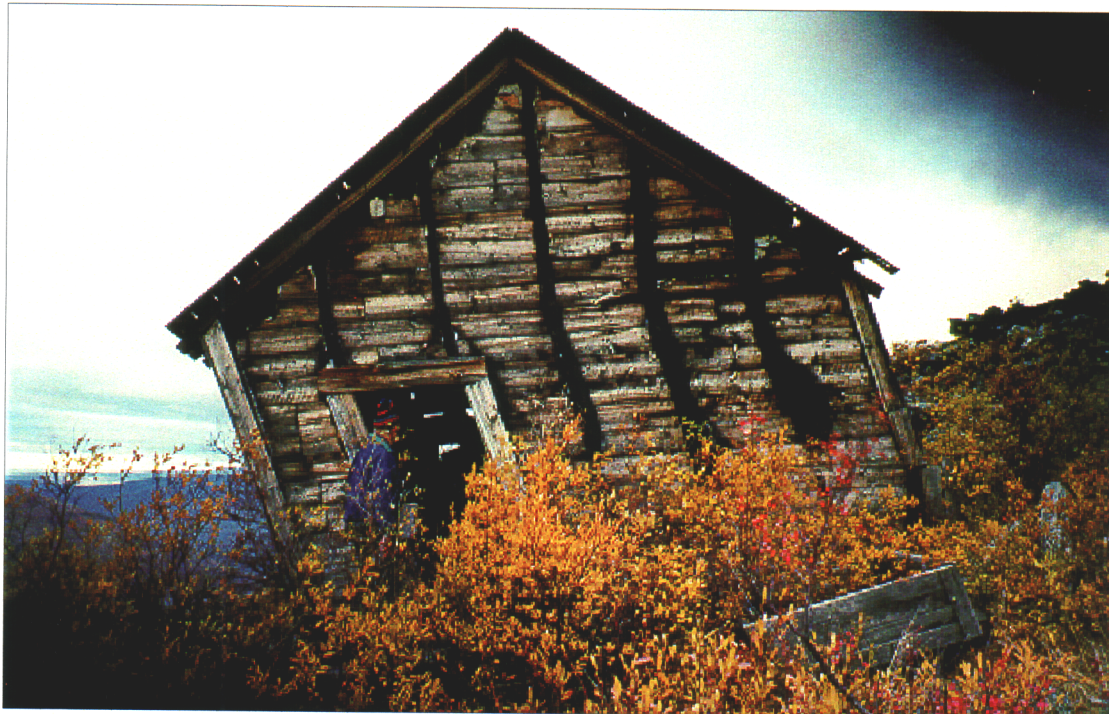
### 6.1 Building 41A (photo 41-2)

There is an old frame (heavy timber structure) cabin located about 10m to the south of the adit.

Dimensions (L x W x H): 4m x 3m x 4m

Asbestos: There was some asbestos tar paper cladding on the building and on the ground.

Photo 41-2 : Devon. Building 41A, located 10m south of the Adit.. (Azimuth  $280^{\circ}$ )
