MT. HINTON (#68)
MINFILE# 105M 052

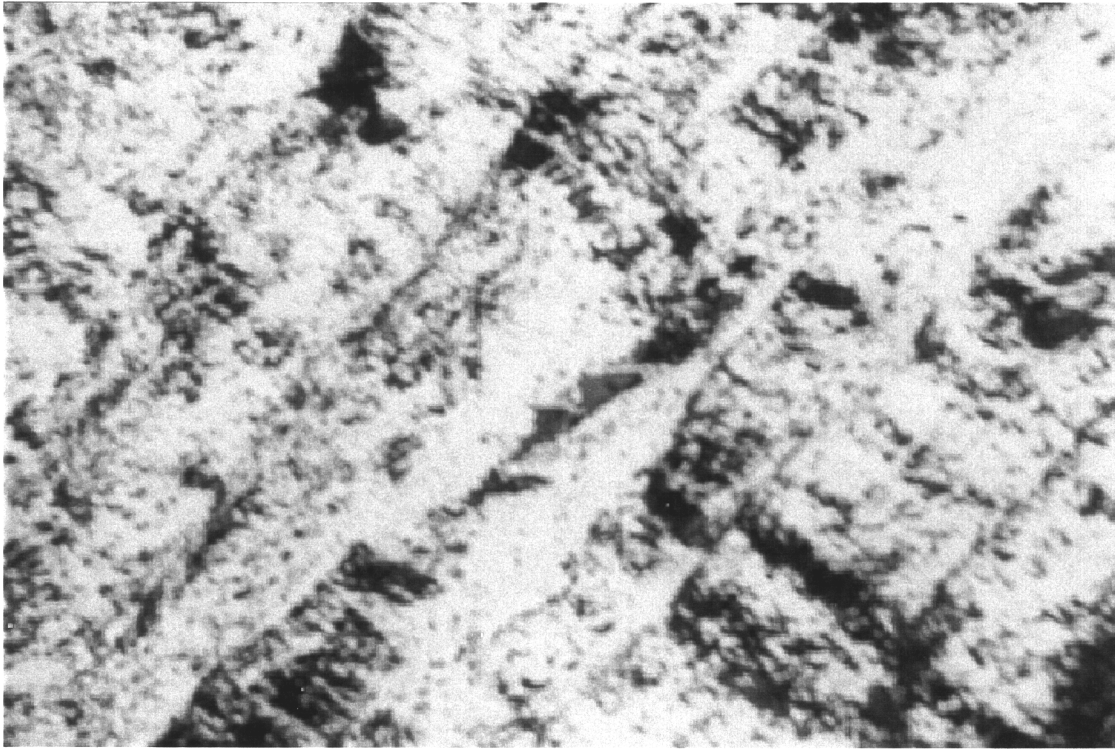
Poor flying conditions prevented access to the site and exploration of the mine workings. The minfile reports that the Mt. Hinton site has two adits and a shaft. It appears as if there is an adit at

Photo 68-1: Aerial photograph of Mt. Hinton Adit1 located at centre of photograph.

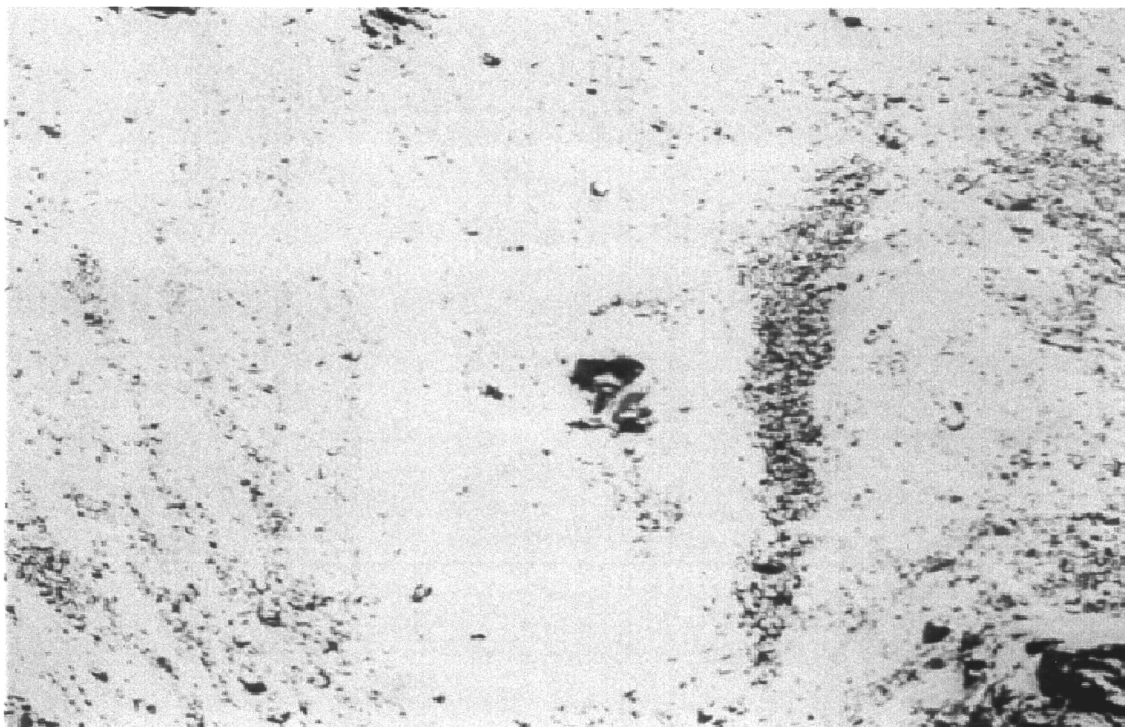
the Northeast occurrence (photo 68-1). The Centre occurrence appears to be the site of a shaft and possibly an adit (photo 68-2). The Southwest occurrence was not observed.

Photo 68-1: Aerial photograph of Mt. Hinton Adit2 located at centre of photograph.
