DUNCAN
SITE #43
MINFILE# 105M 003

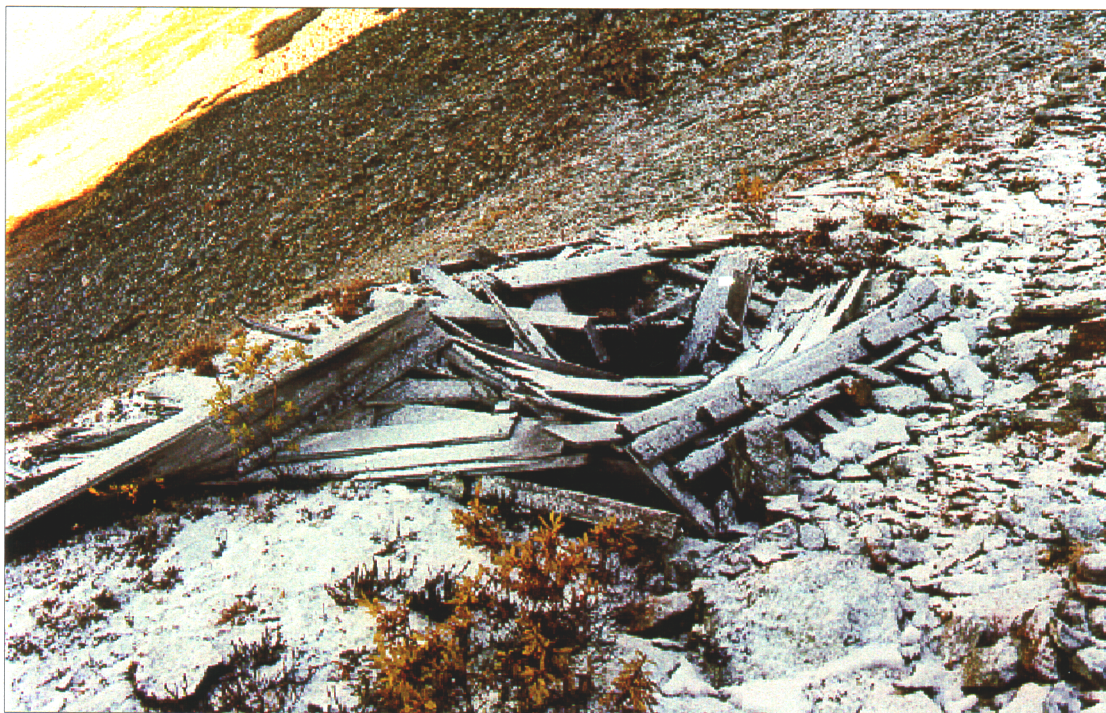
Shaft (photo 43-1)

The shaft is located roughly 90m vertically below the rim of the cirque. It has collapsed approximately 1m below the collar. There is a windless and broken log cribbing at the entrance to the shaft.

Supports: The log cribbing has collapsed and blocks the entrance to the shaft.

Condition: The shaft is collapsed approximately 1m below the surface.

Accessibility: The shaft could not be accessed.

Photo 43-1 : Duncan. Collapsed shaft with windlass still in place across the top. (Azimuth $\sim 090^{\circ}$)

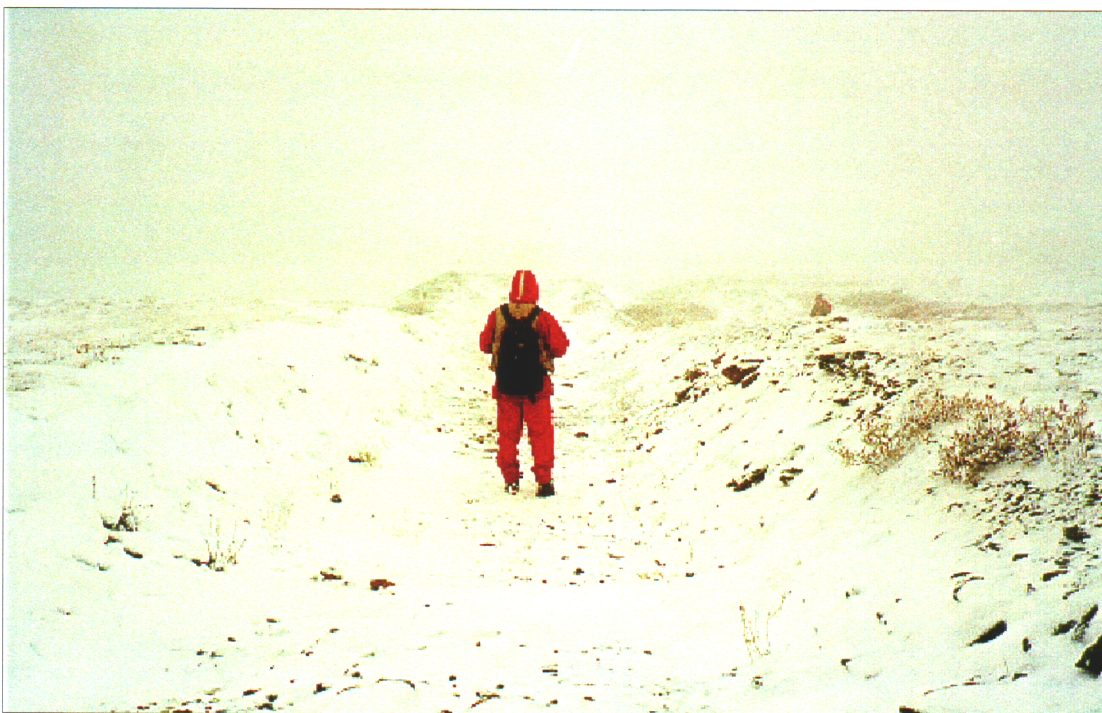
Trench #3 (photo 43-2)

Condition: The trench appeared stable at the time of the site visit.

Photo 43-2 : Duncan. Trench #3 with waste rock pile at the end. (Azimuth 215°)

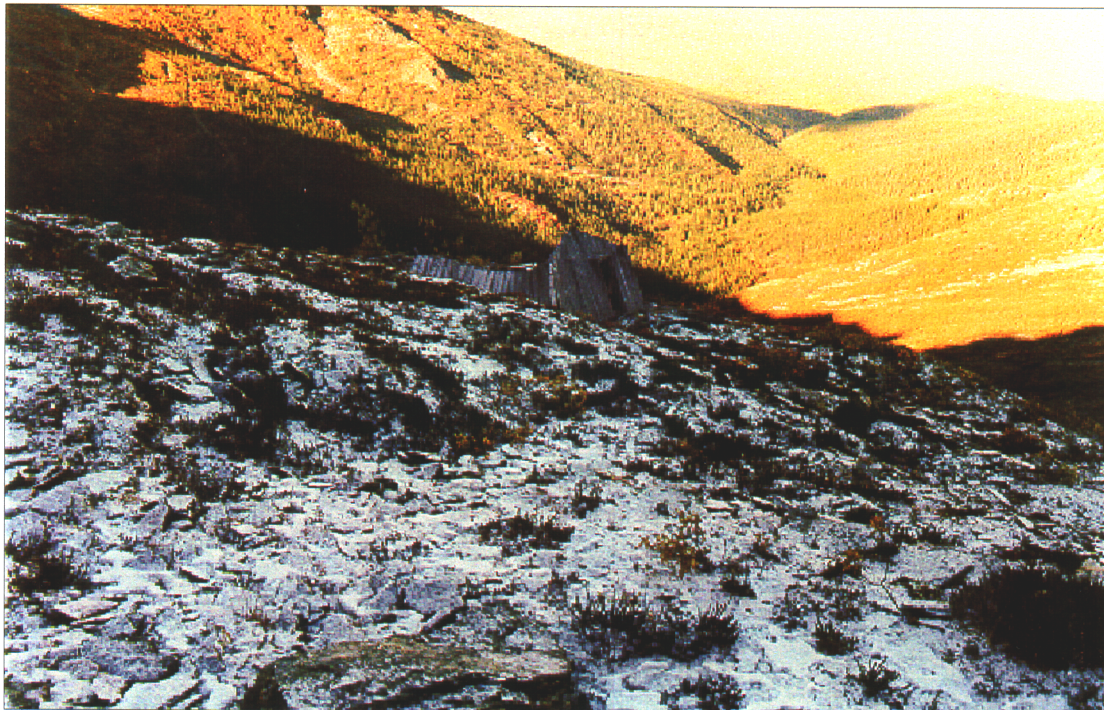
6.1 Building 43A (photo 43-3)

One collapsed wood frame building was noted on site located 25m northwest of the shaft.

Photo 43-3 : Duncan. View of Building 43A. (Azimuth $\sim 300^{\circ}$)
