**NABOB**  
**SITE #46**  
**MINFILE# 105M 006**

**1. LOCATION AND ACCESS**

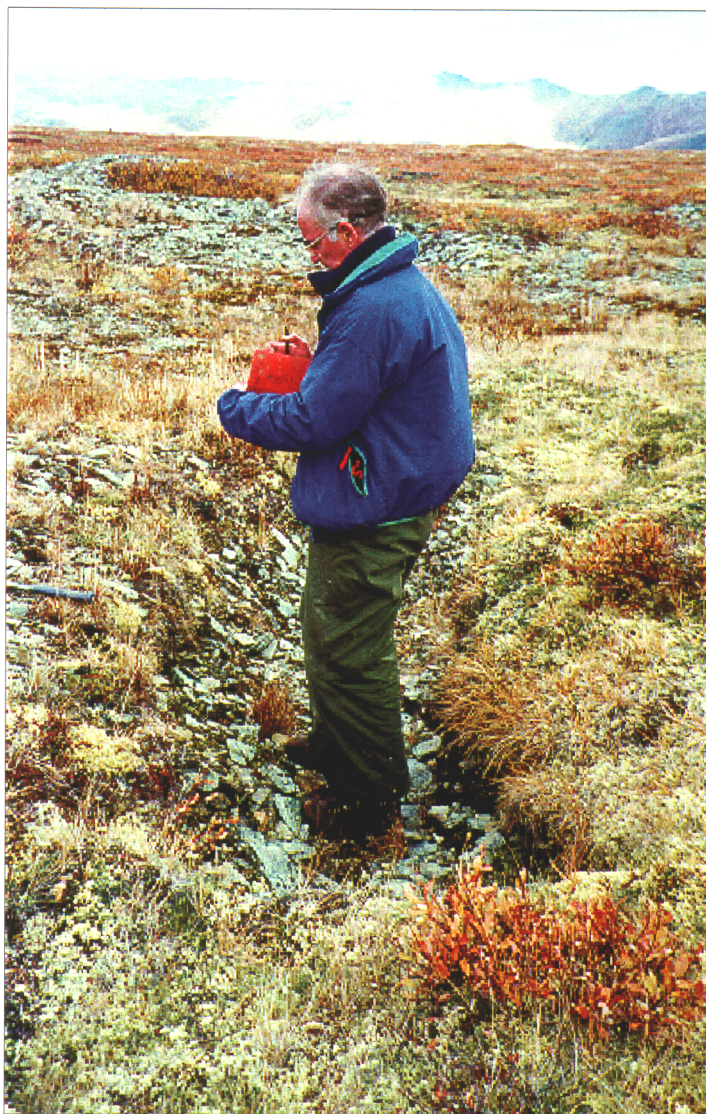
### **Trench #2 (photo 46-1)**

This hand trench is dug into overburden. The trench is oriented at 010°.

Dimensions (L x W x H): 3m x 1m x 0.5m

Condition: The trench is very small and shallow and does not pose any stability concerns.

Photo 46-1 : Nabob. Small hand trench dug into overburden. (Azimuth 010 °)
